Site Condition Report

LAND ADJACENT MAELOR FOODS LTD
CROSS LANES
WREXHAM
LL13 0UE

Report Ref. 1572-16 / Final
Revision 1 – 23rd October 2019

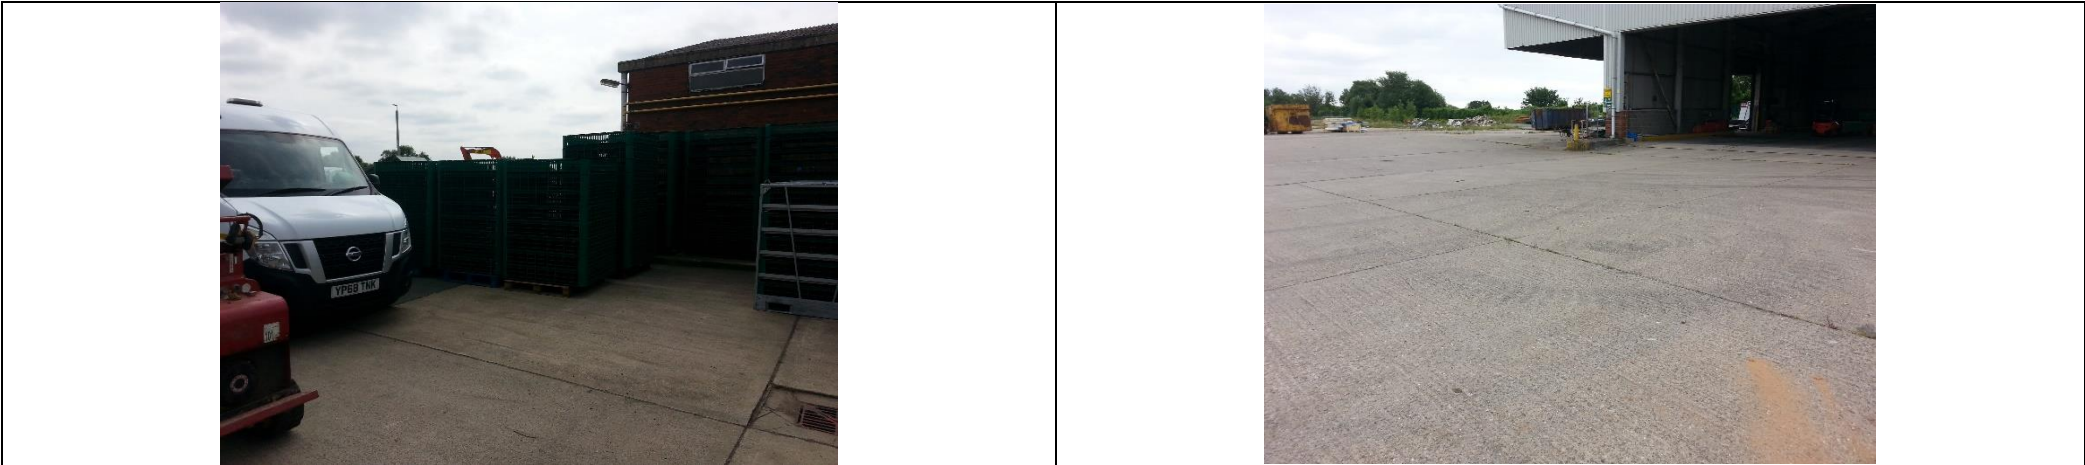
Plate 1. Photo from area around WS1 – Hardstanding in good condition facing south

Plate 2. Photo of current HGV waiting area carrying livestock, near WS2

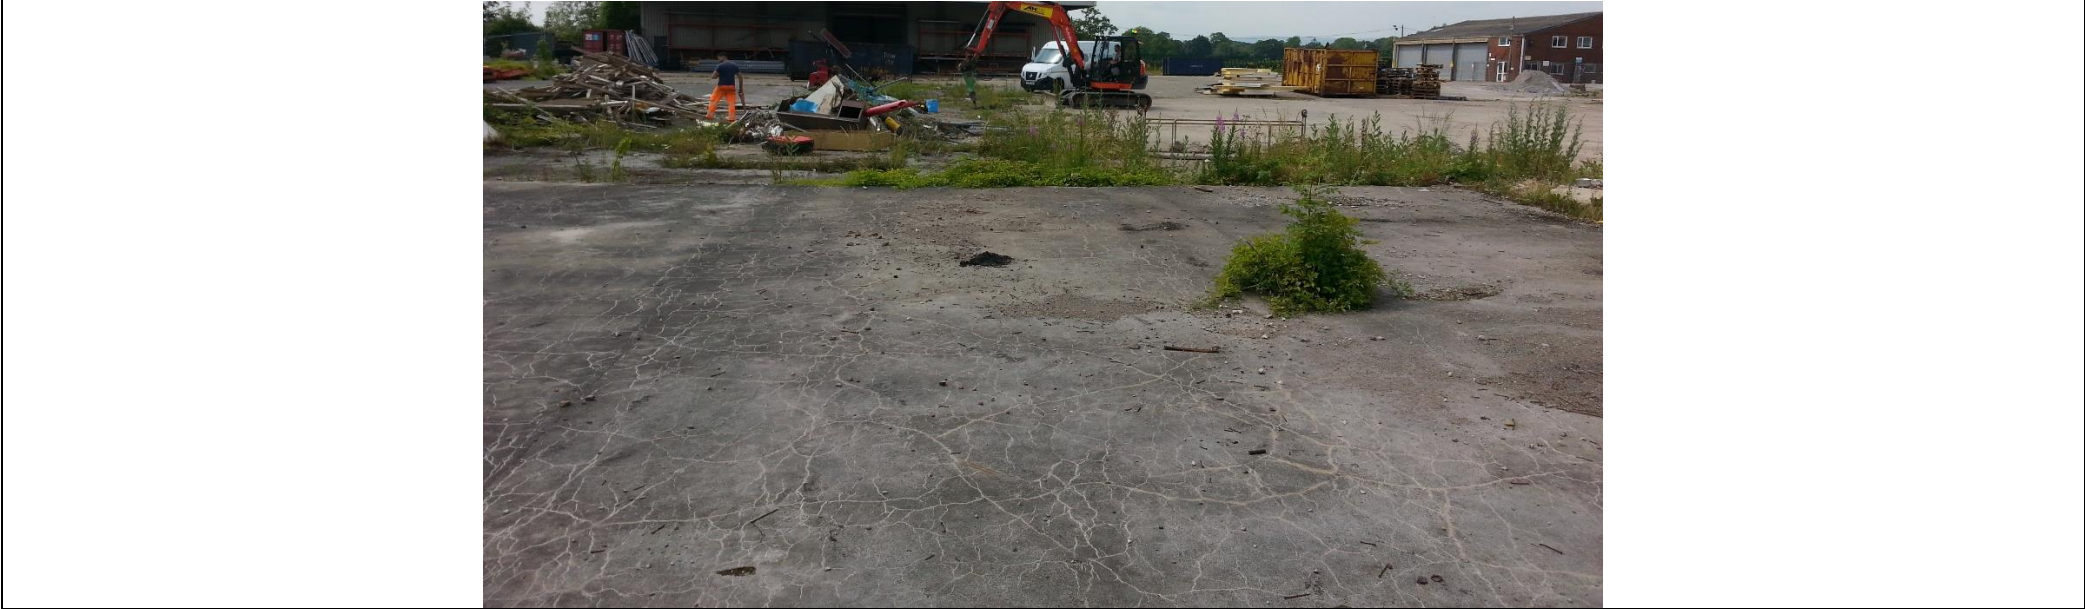
Plate 3. Showing poor condition of hard standing facing west, near WS3

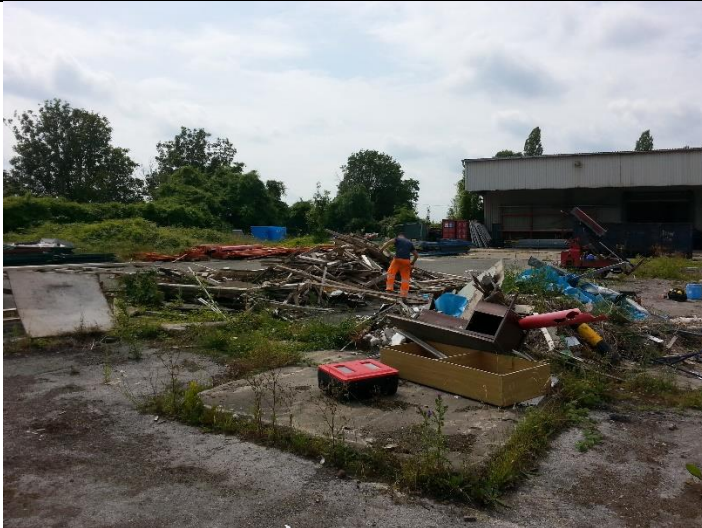
Plate 4. Showing stockpiles of waste material, heavy overgrowth and poor hardstanding condition facing west, near WS3

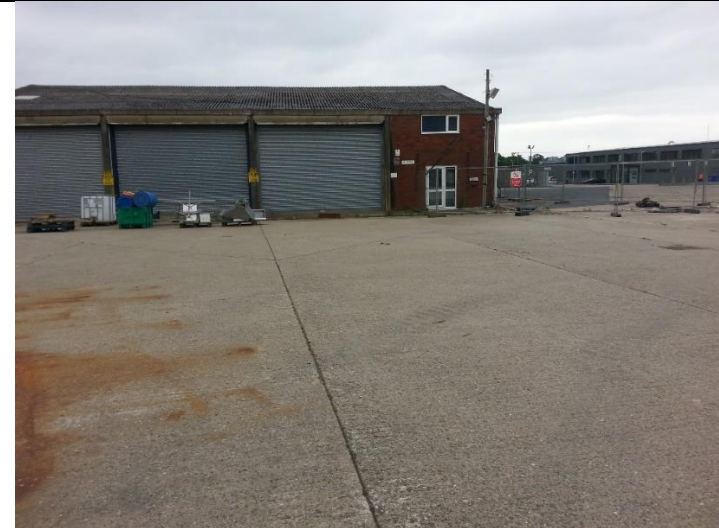
Plate 5. Photo of derelict building facing north, near WS2

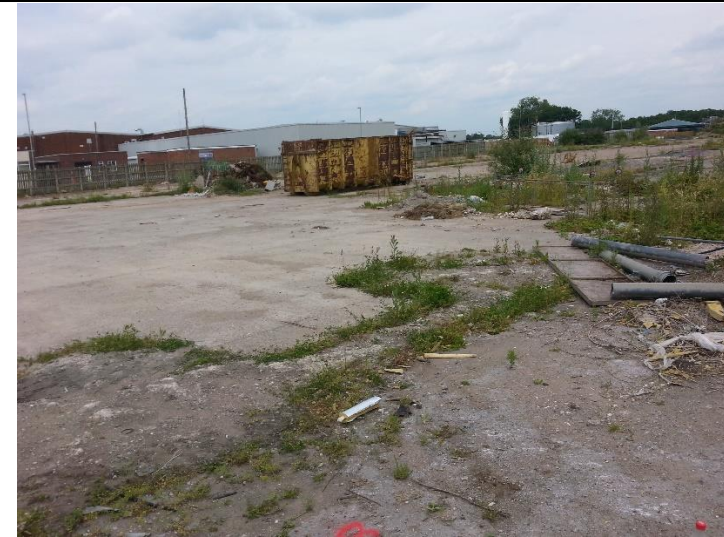
Plate 7. Showing poor quality of hardstanding, overgrowth and waste materials facing northeast, near WS3

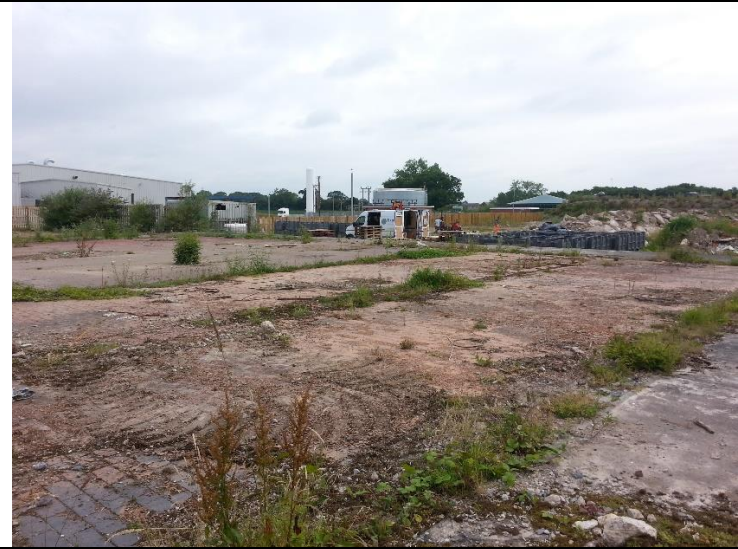
Plate 9. Showing condition of hardstanding surfaces facing northeast, Near WS5

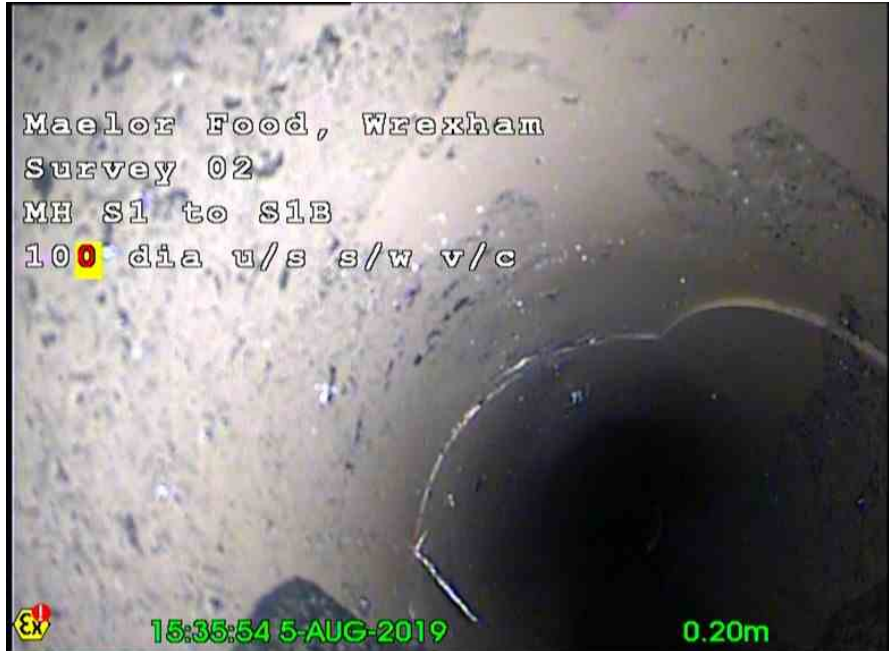
S1BX_b156a5fb-e561-4582-bede-1cc2464815b3_20190831_151707_263.jpg, ,0.50m
Fracture, circumferential from 8 o'clock to 11 o'clock

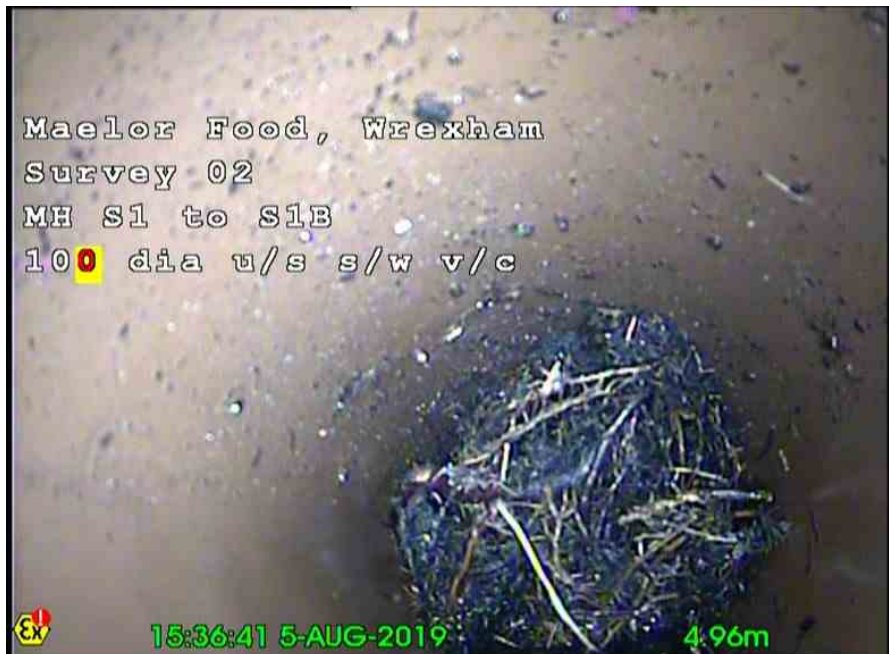
S1BX_2ba055a9-13eb-4fbb-90e1-8ddb62a9c48_20190831_151739_040.jpg, ,4.84m
Roots, mass, 80% cross-sectional area loss

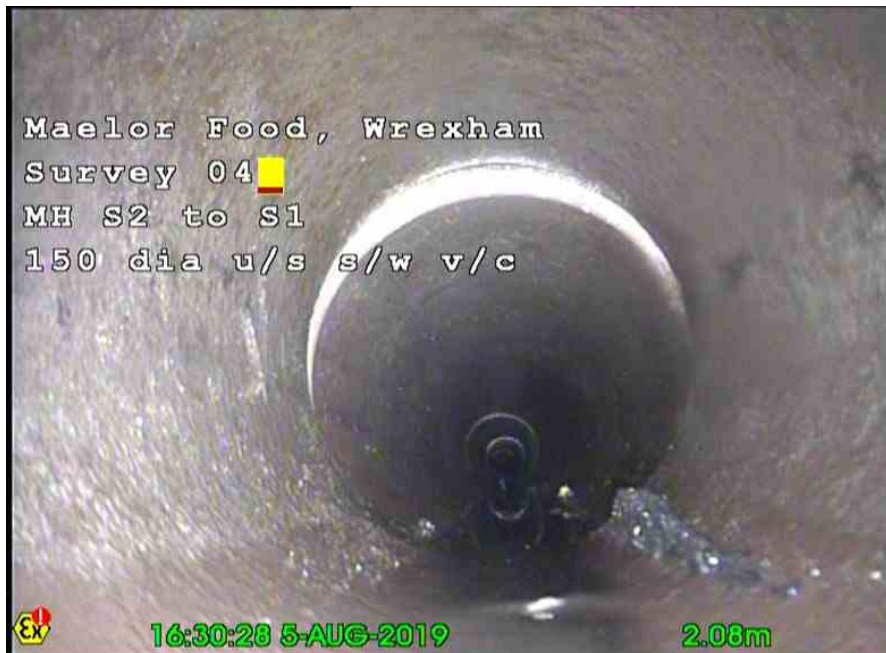
S1X_89ad0789-a15f-4878-9a5f-28bd63b423fc_20190831_152209_383.jpg, , 1.99m
Joint displaced, medium

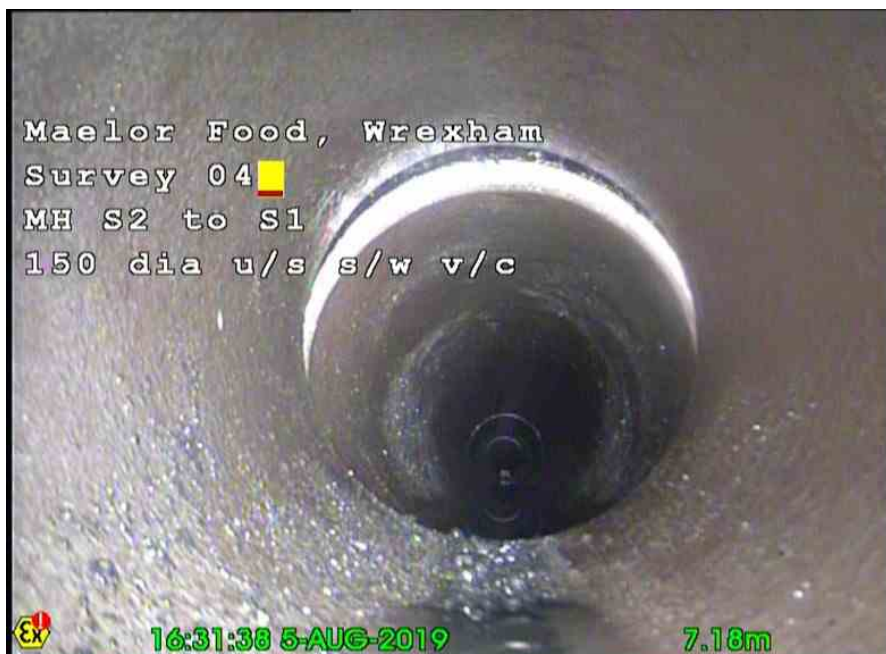
S1X_f076290c-a229-4d32-9721-ffcd157d96cf_20190831_152254_213.jpg, , 7.18m
Joint displaced, medium

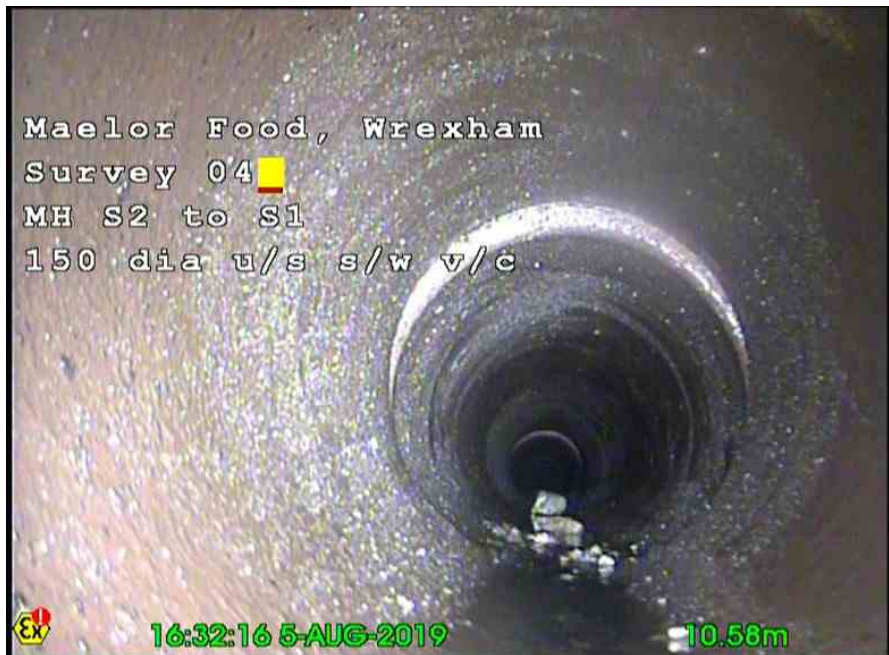
S1X_c2a9191b-cc80-48d4-ba1f-9bb299068c05_20190831_152321_169.jpg, , 10.58m
Joint displaced, medium

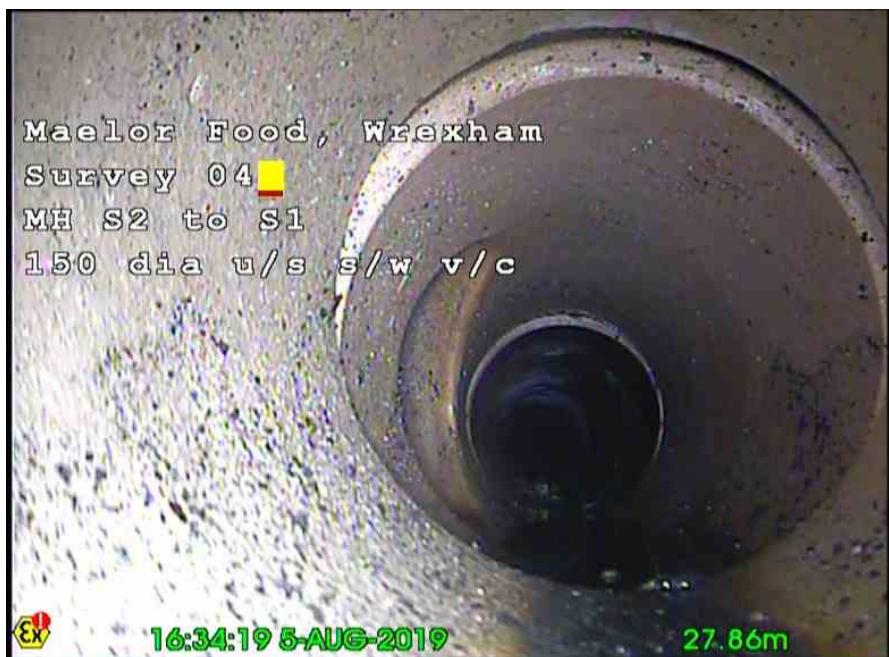
S1X_57513bce-5eb0-43a4-871b-4ff319134bec_20190831_152428_691.jpg, , 27.83m
Joint displaced, medium

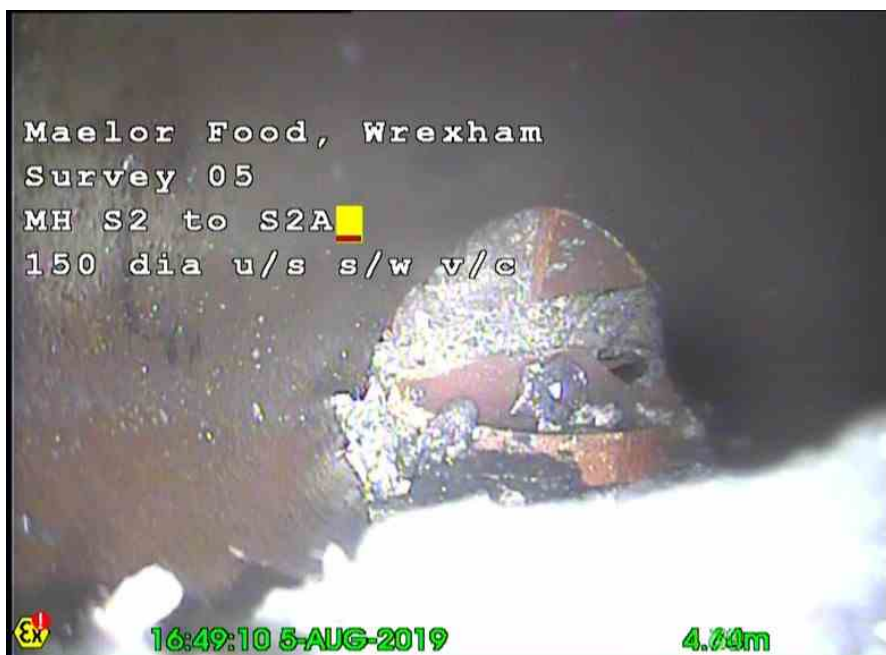
S2AX_bfa92ef3-b481-4bc5-9f70-bad4e8cc225d_20190831_152534_770.jpg, 4.75m
Collapsed drain or sewer

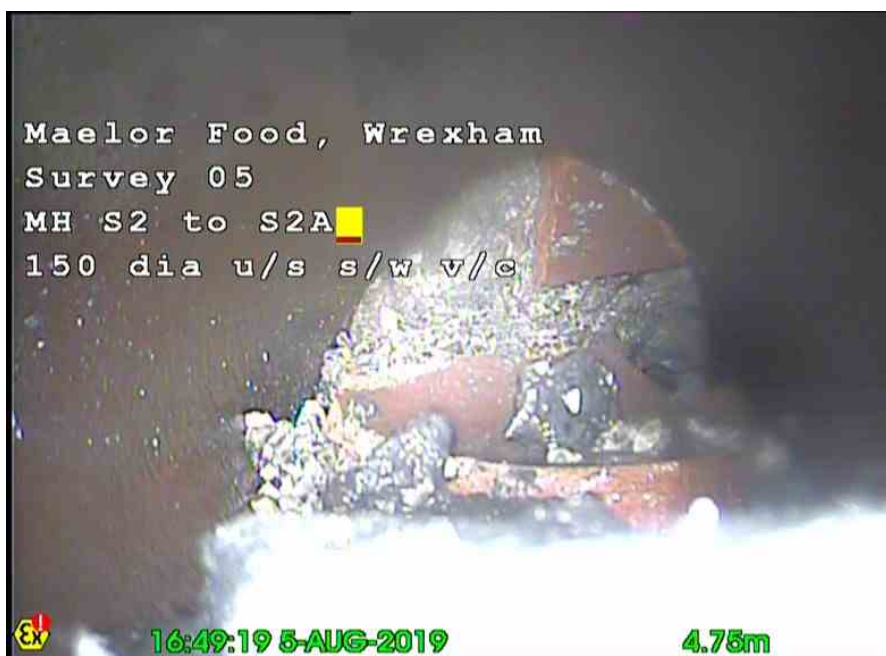
S2AX_ef852247-d9a3-4e89-b767-18eeffcb66a0_20190831_152544_502.jpg, 4.75m
Survey abandoned

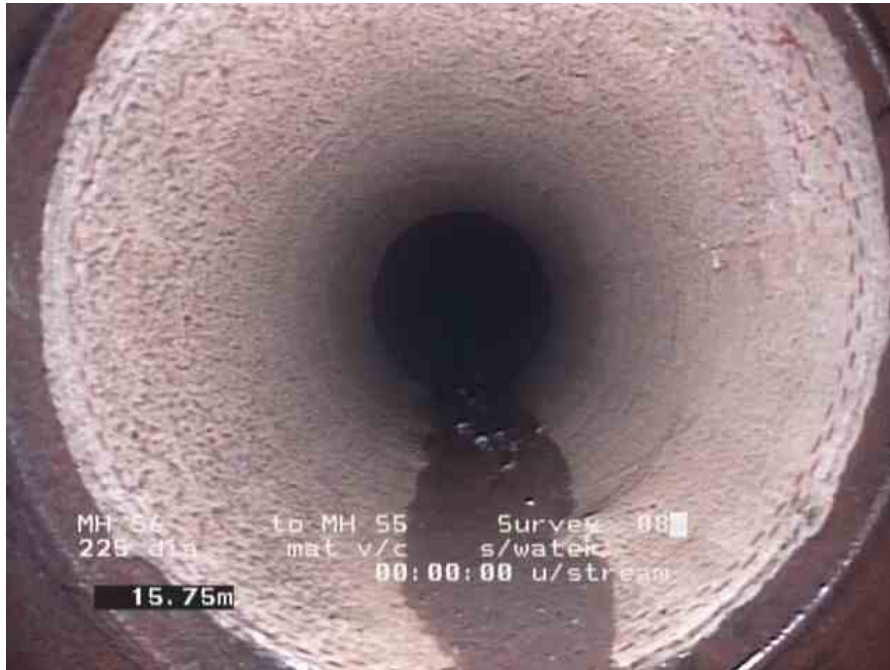
S5X_49f79797-b73d-4239-8ce6-aa7553c7f003_20190831_152956_167.jpg, , 15.75m
Point repair, localised lining from 12 o'clock to 11 o'clock

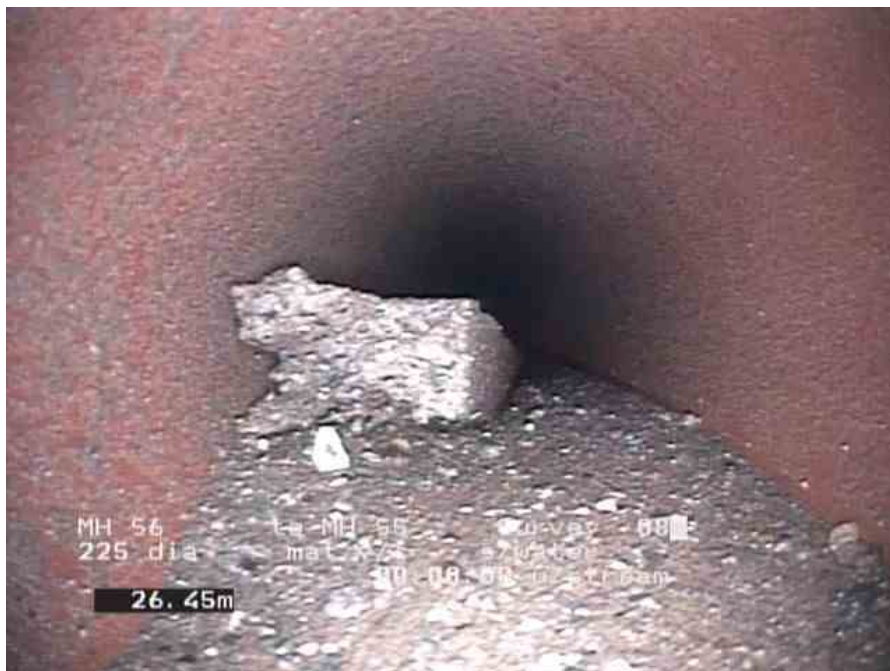
S5X_8b46bbdc-0edf-4bba-bda0-e6bca71cf85c_20190831_153057_297.jpg, , 26.45m
Settled deposits, fine, 50% cross-sectional area loss

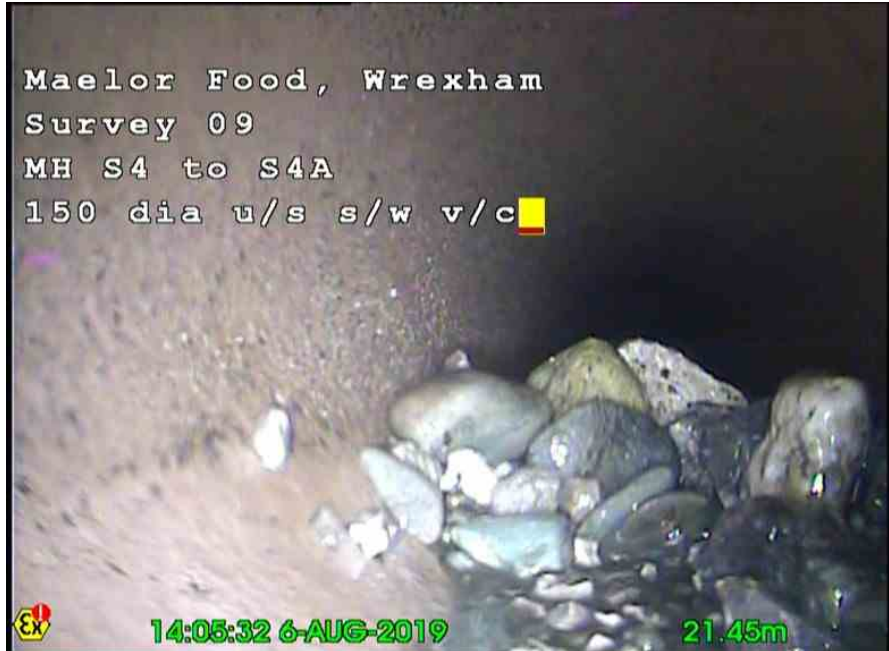
S4AX_cf6e278b-8b76-4949-9463-6e8631fc79dd_20190831_153519_168.jpg, , 21.54m
Settled deposits, coarse, 30% cross-sectional area loss

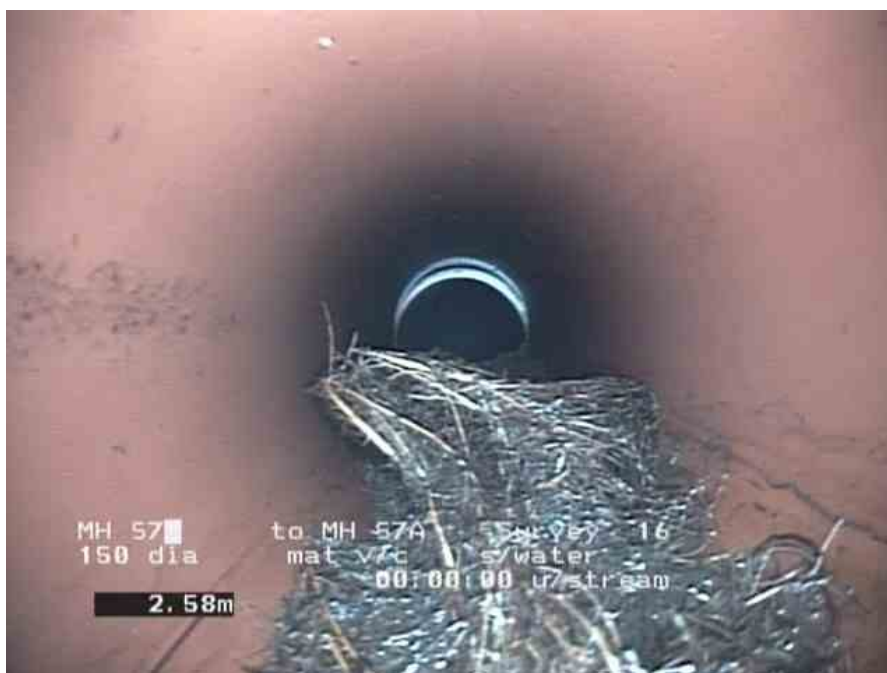
S7AX_4e6393c3-12bd-4b5e-a1d9-61dbb4d7ea56_20190831_154328_075.jpg, ,2.66m
Roots, mass, 40% cross-sectional area loss

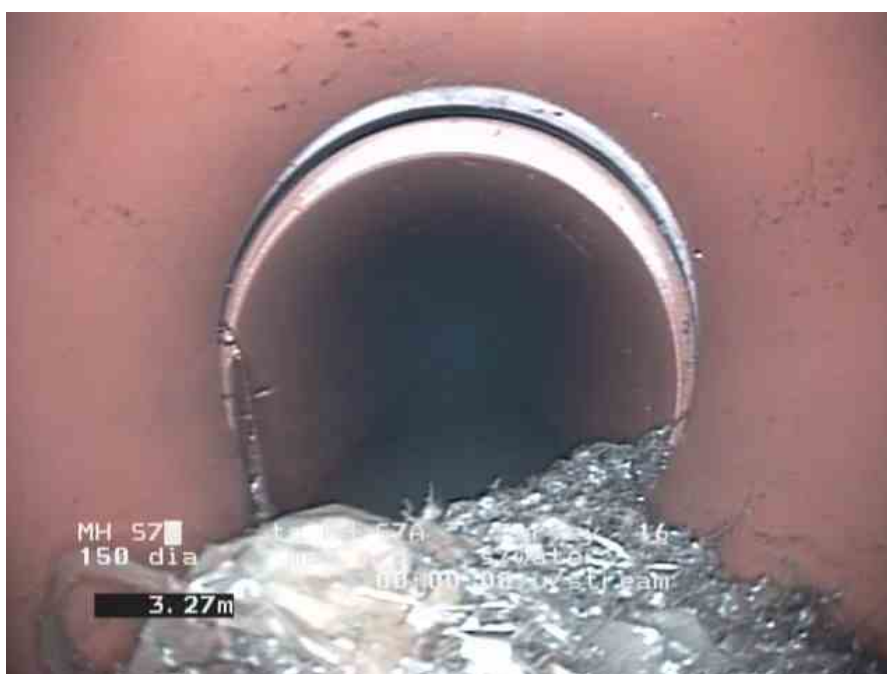
S7AX_ca0b25ba-d372-4765-bb6d-46a92d997eda_20190831_154342_689.jpg, ,3.27m
Joint displaced, medium

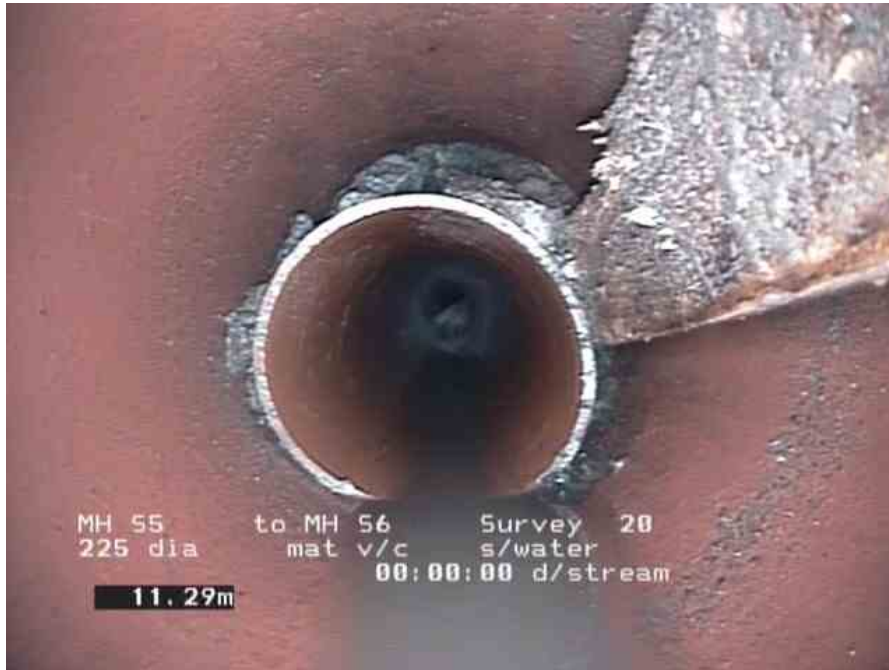
S5X_7f7dacf4-3dbc-476d-8d9c-5dbca32d2f86_20190831_154642_435.jpg, , 11.40m
Obstacles built into structure from 1 o'clock to 4 o'clock, 25% cross-sectional area loss

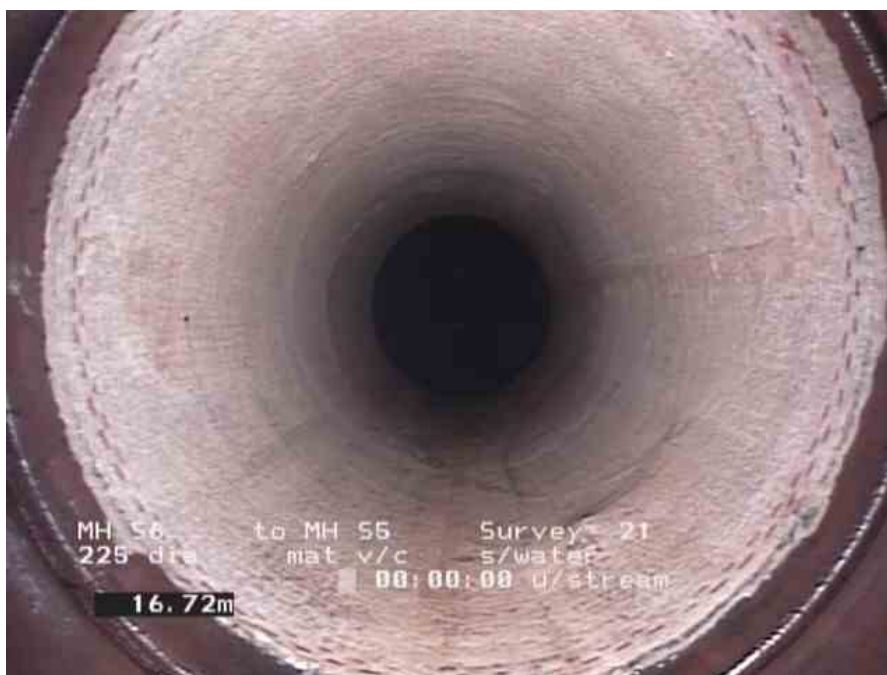
S5X_07b4e33c-280a-48a8-8a40-a63b7ba0fc5b_20190831_154800_512.jpg, 16.72m
Point repair, localised lining from 12 o'clock to 11 o'clock

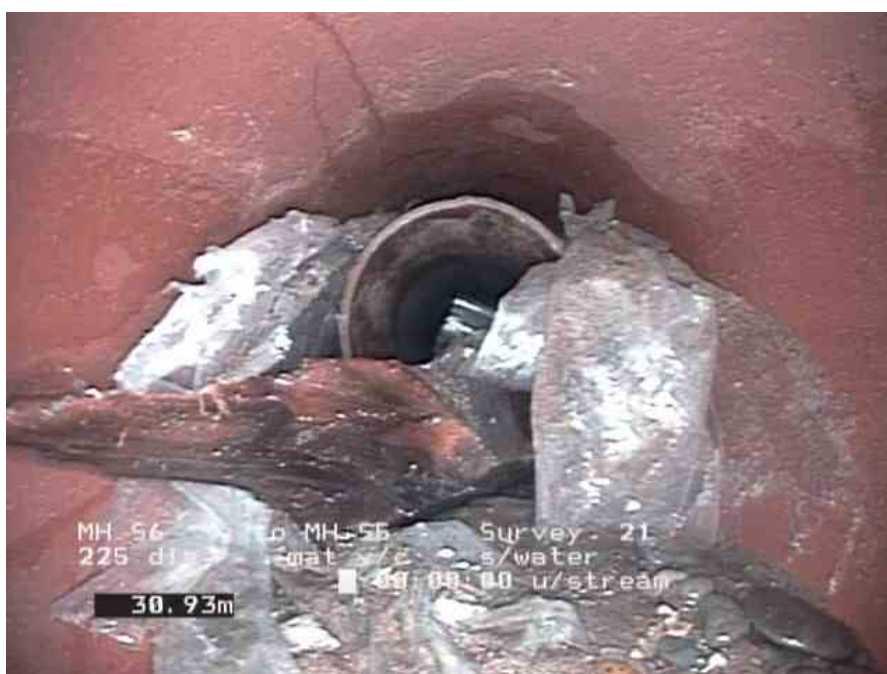
S5X_b9a80b22-8a74-4485-8e98-95494038ba3a_20190831_154920_610.jpg, 30.93m
Obstacles built into structure from 3 o'clock to 8 o'clock, 40% cross-sectional area loss

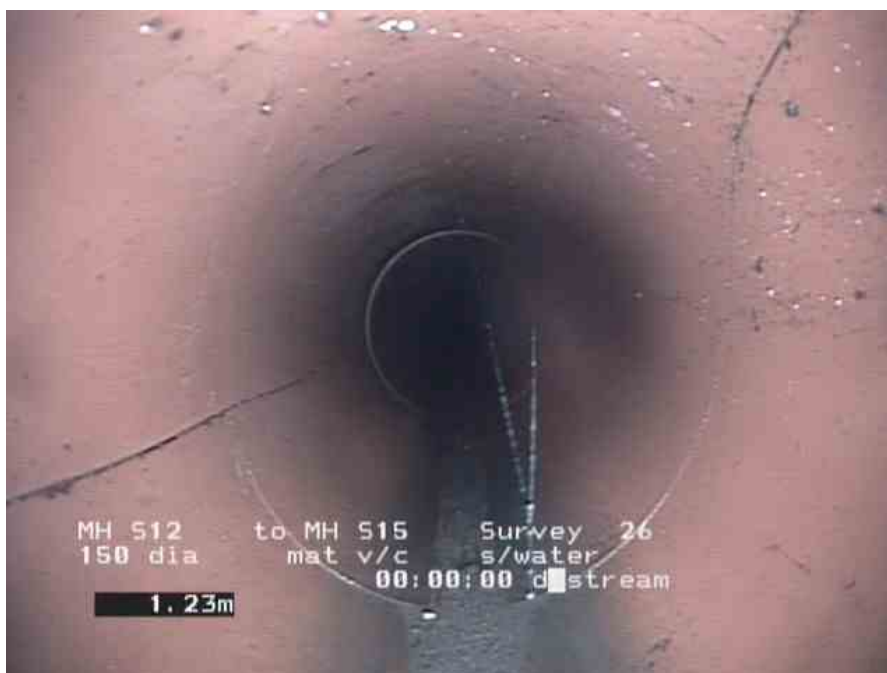
S12X_50c434ec-2dba-482b-9d2c-ca77962d7113_20190831_155227_638.jpg, , 1.23m
Fracture, circumferential from 1 o'clock to 9 o'clock

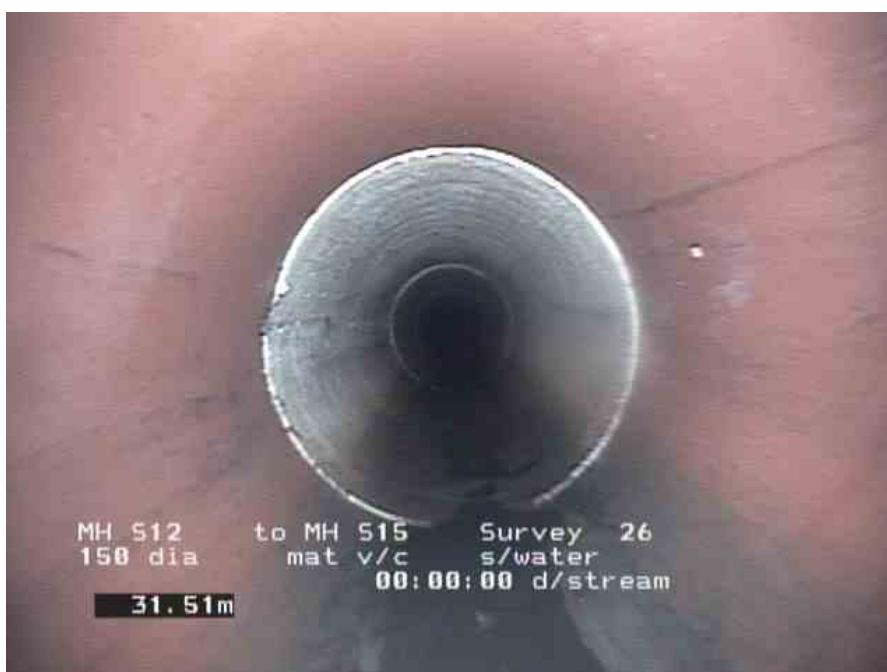
S12X_6b652c16-f3ac-4c81-866a-854d12ce5751_20190831_155341_367.jpg, , 31.87m
Point repair, localised lining from 12 o'clock to 11 o'clock

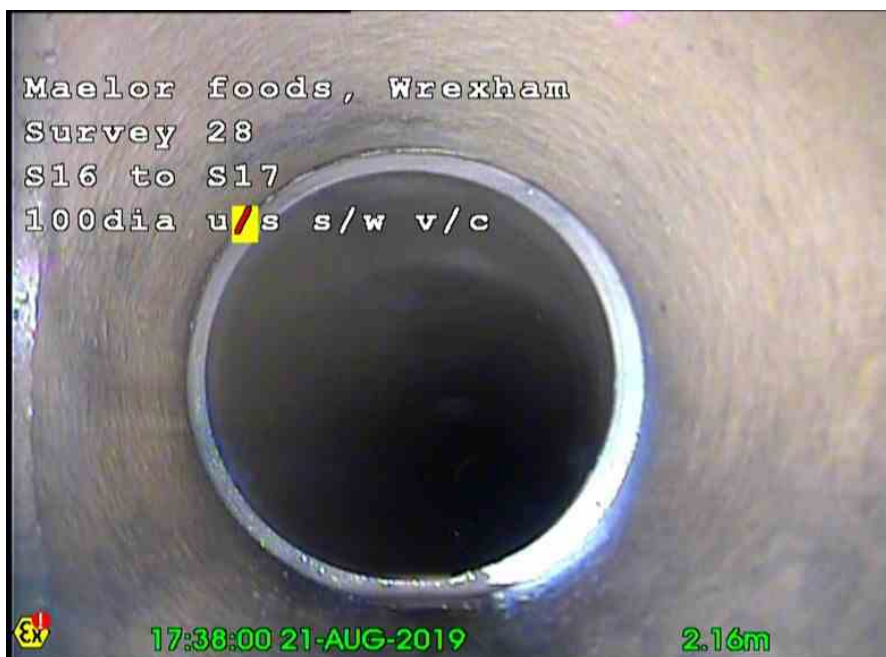
S17X_61dff4ed-df79-473d-bb73-f6807787cc87_20190901_142902_769.jpg, , 2.16m
Joint displaced, medium

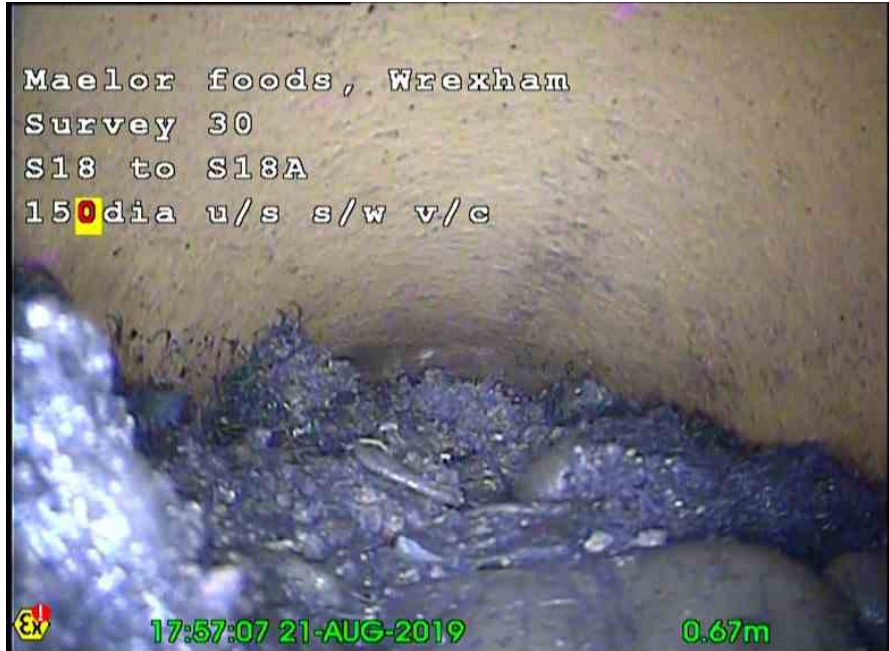
S18AX_10c15f4b-8ad3-4905-8990-d8c740d23703_20190901_143129_919.jpg, , 1.25m
Settled deposits, coarse, 80% cross-sectional area loss

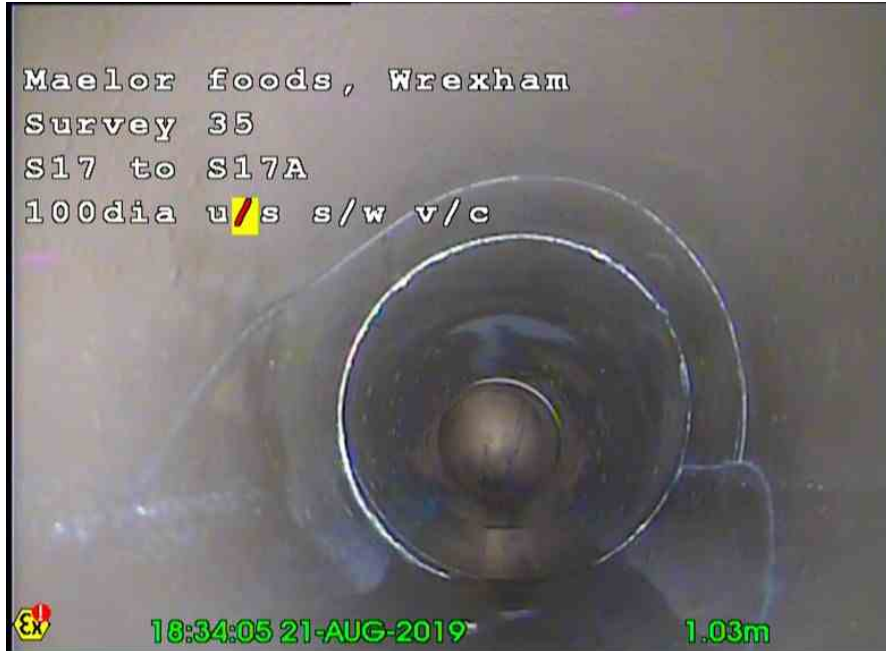
S17AX_3af38ca9-55df-4d11-aa63-5b291ee504bf_20190901_143608_665.jpg, 1.02m
Fracture, circumferential from 8 o'clock to 4 o'clock

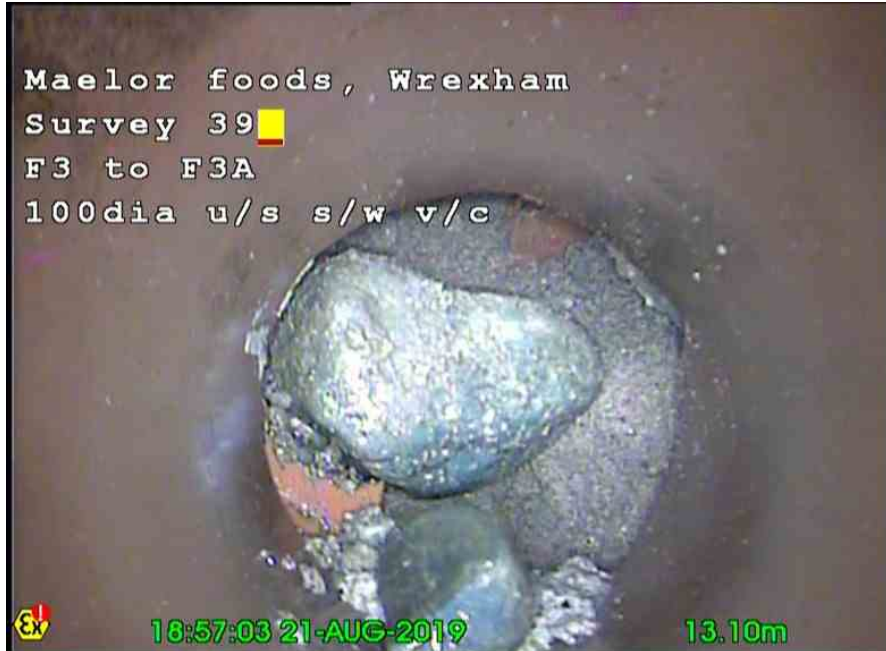
F3AX_08d98c01-fe34-4350-b699-8c7494d63b9b_20190901_144049_496.jpg, , 13.10m
Obstacles, brick or masonry in invert from 12 o'clock to 11 o'clock, 95% cross-sectional area loss

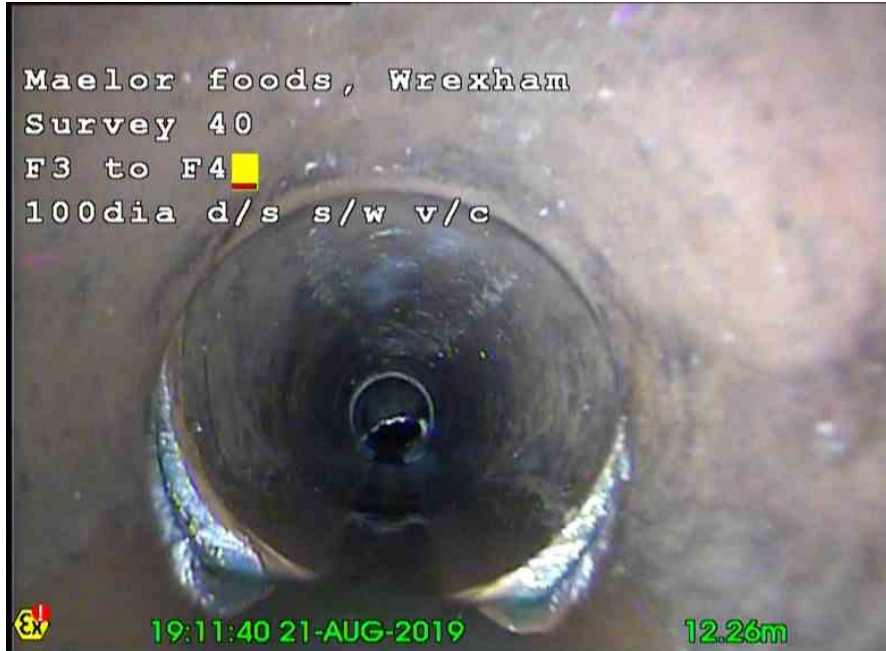
F3X_6abd29a4-a382-4ec8-91d1-ca435f9bd642_20190901_144154_920.jpg, , 12.35m
Joint displaced, medium
