## **Site Protection and Monitoring Programme Cogent Power Ltd., Orb Works, Newport, South Wales, October 2019 Review**

Date of issue: October 2019

Author(s): P. Knight

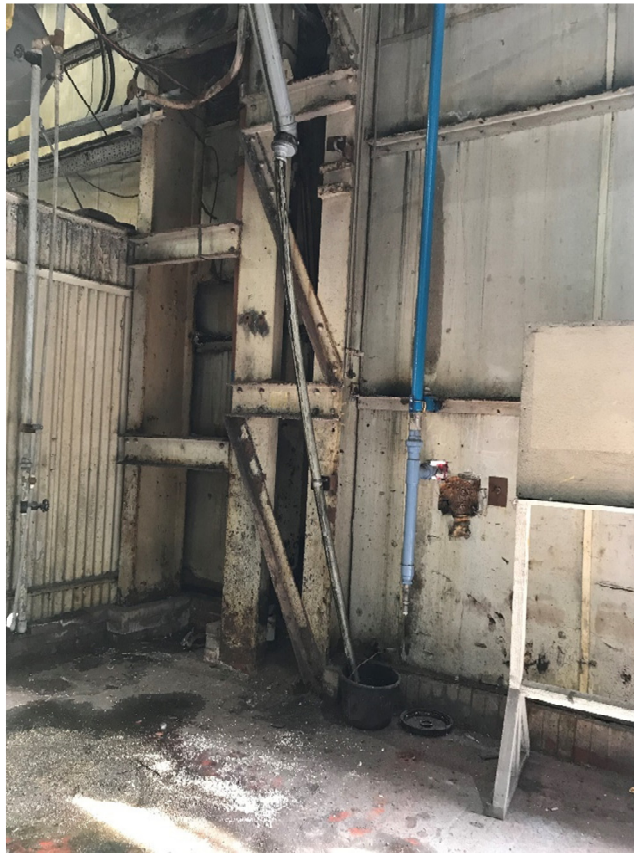
Photo showing makeshift pipe from guttering capturing oil from overhead crane collected in bucket. Note spillage on floor.

The site walkover identified a small number of areas where some corrective actions will be required. It was noted that in Area 2 a makeshift system to capture hydraulic oil from the overhead parked crane had been created which is not suitably captured and maintained. The scrap area at the south of the site is not on hard standing and therefore any hydraulic oils etc within scrap products could potentially migrate to surface soils. At the time of the inspection a vehicle was parked in the area close to the hydrochloric acid tanks. Consideration should be given to restricting vehicular access to this area. The cover of BH4 was missing. It is recommended that this is replaced. It appeared that there had potentially been some leakage from transformer number 10 and bunding to the transformer areas should also be considered.

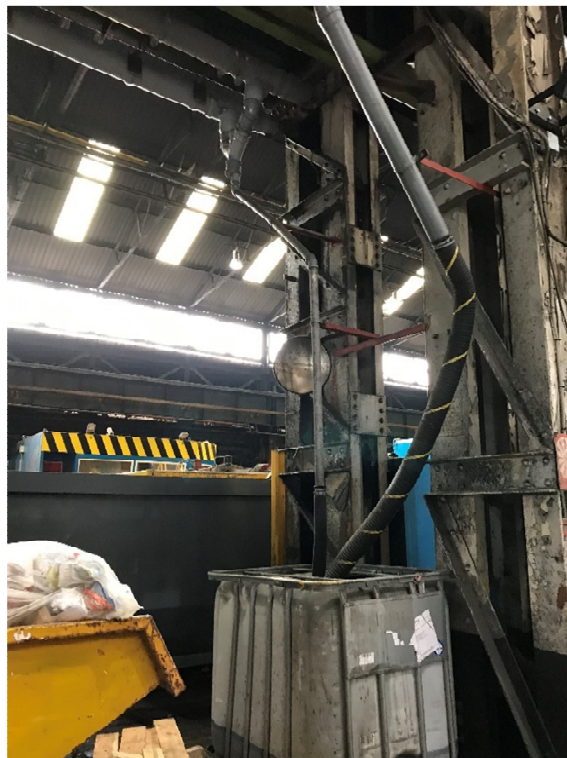
Photo showing makeshift pipe from guttering capturing oil from overhead crane collected in IBC. No evidence of control on collection.

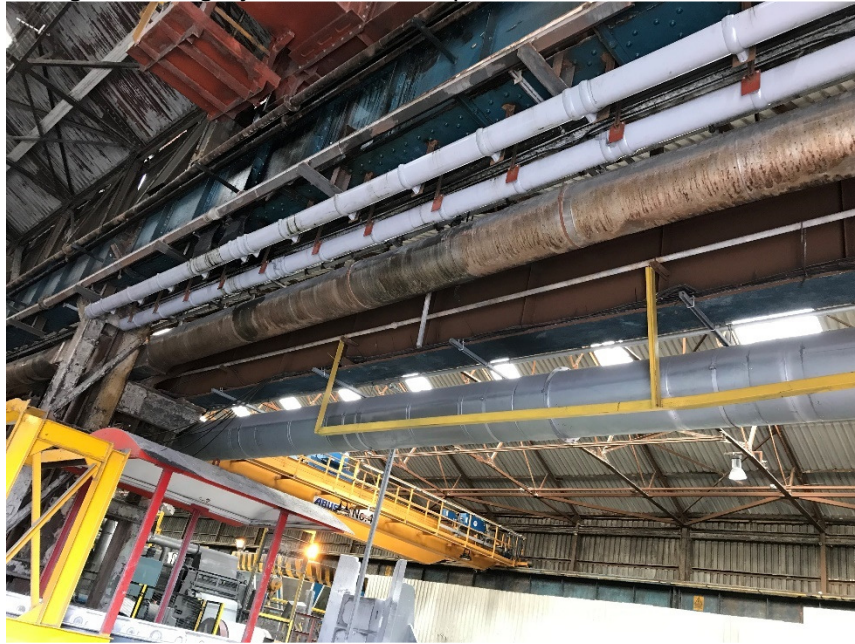
Overhead guttering collecting hydraulic oil from parked overhead crane.

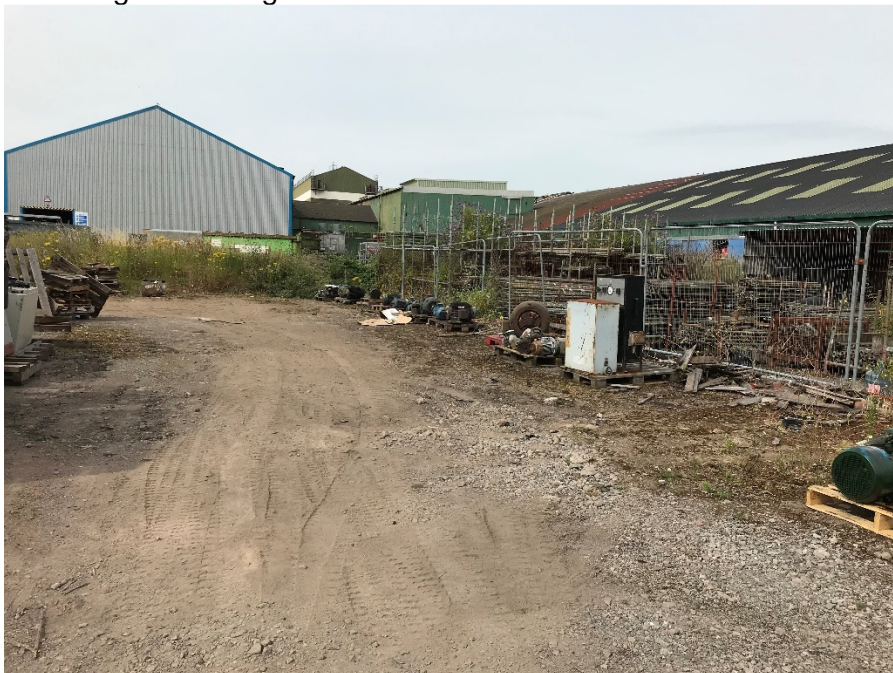
Scrap / spares storage on bare ground

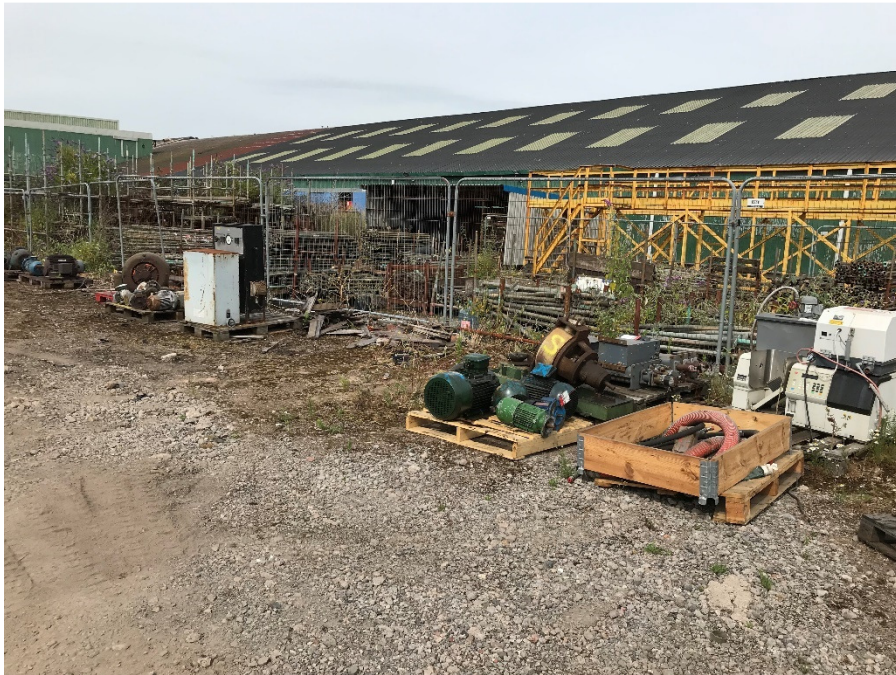
Scrap / spares storage on bare ground

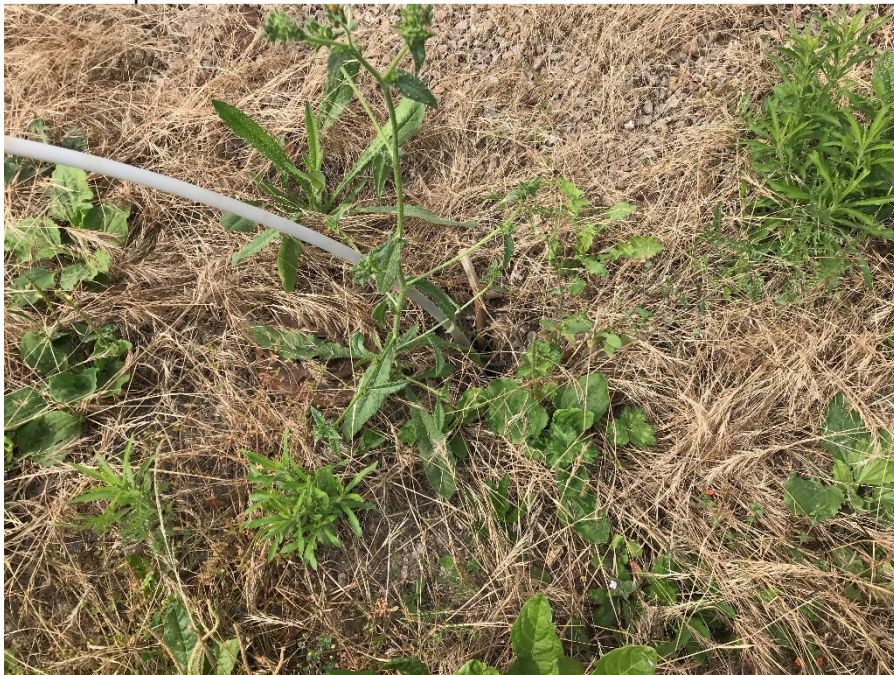
Borehole 4 No Cover present

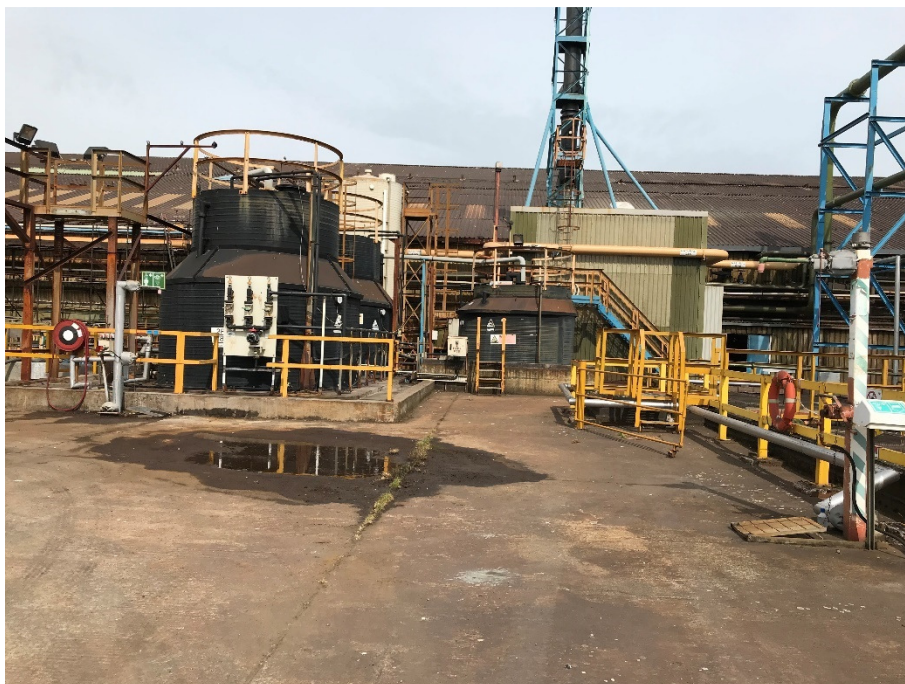
Hydrochloric acid tank – no barrier to prevent vehicular access
