# Outline Building Assessment

Crownhill Topsoil and Aggregates –  
Unit 1009 Caerwent Army Training  
Base.

Client: Crownhill Topsoil and Aggregates  
Author: Julian Gregory

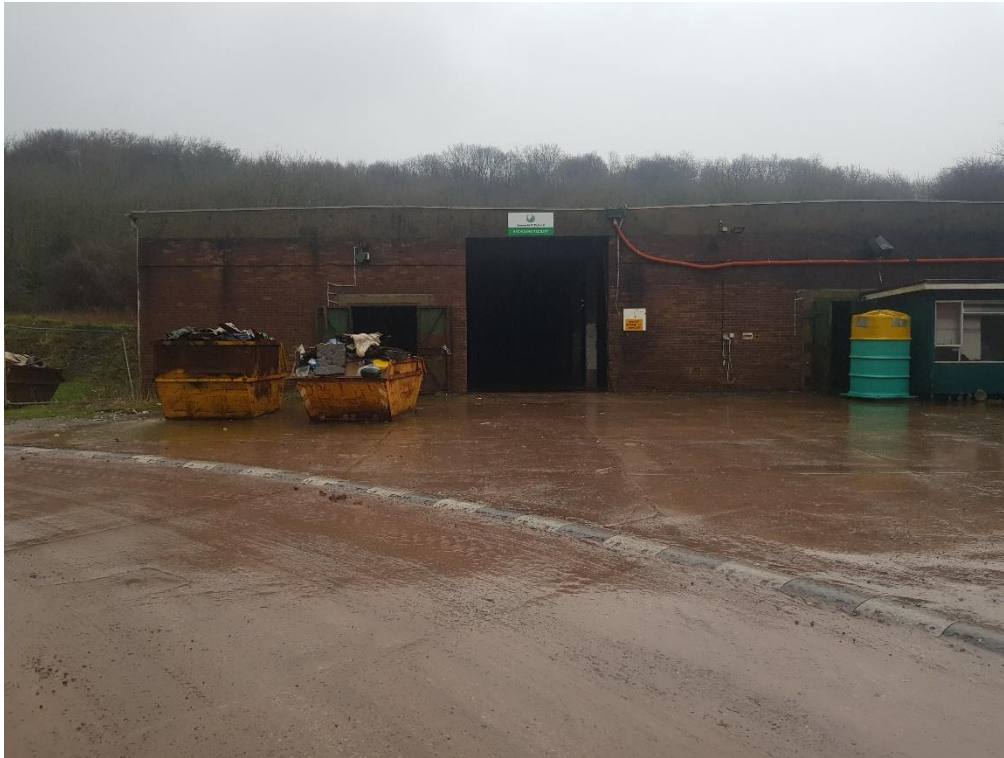
*Building 1 – Southern elevation, bund across forecourt to contain and direct runoff from the forecourt into a 1200l tank.*

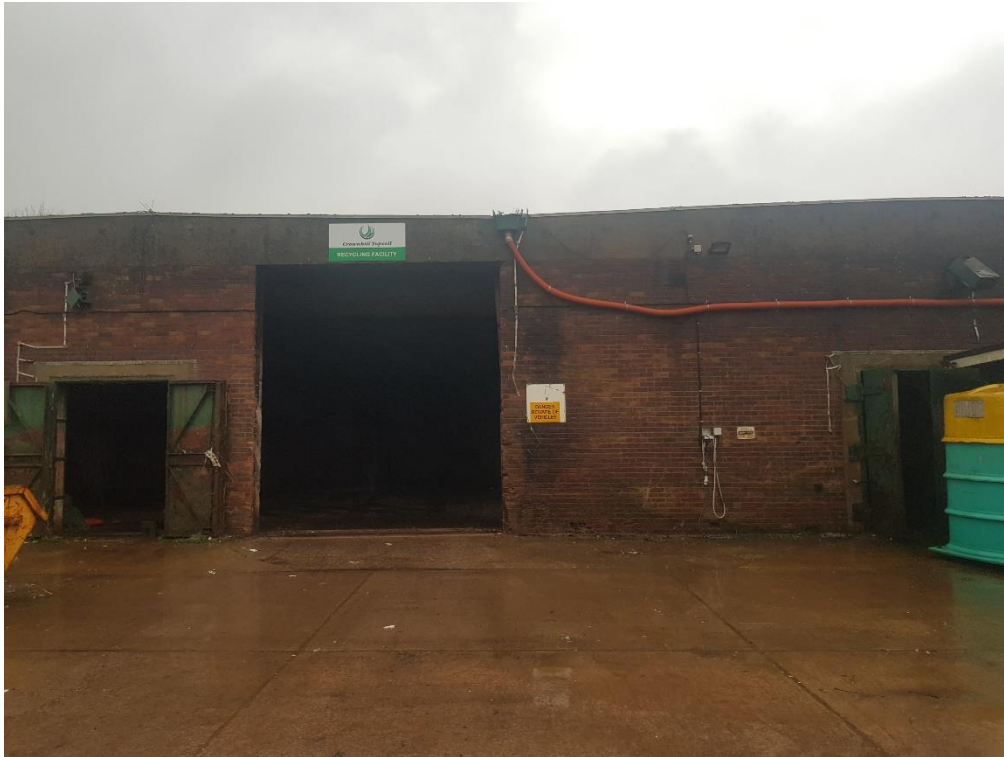
*Building 1 – Southern elevation with flexible pipe taking runoff from the roof to a soakaway to the east of the building.*

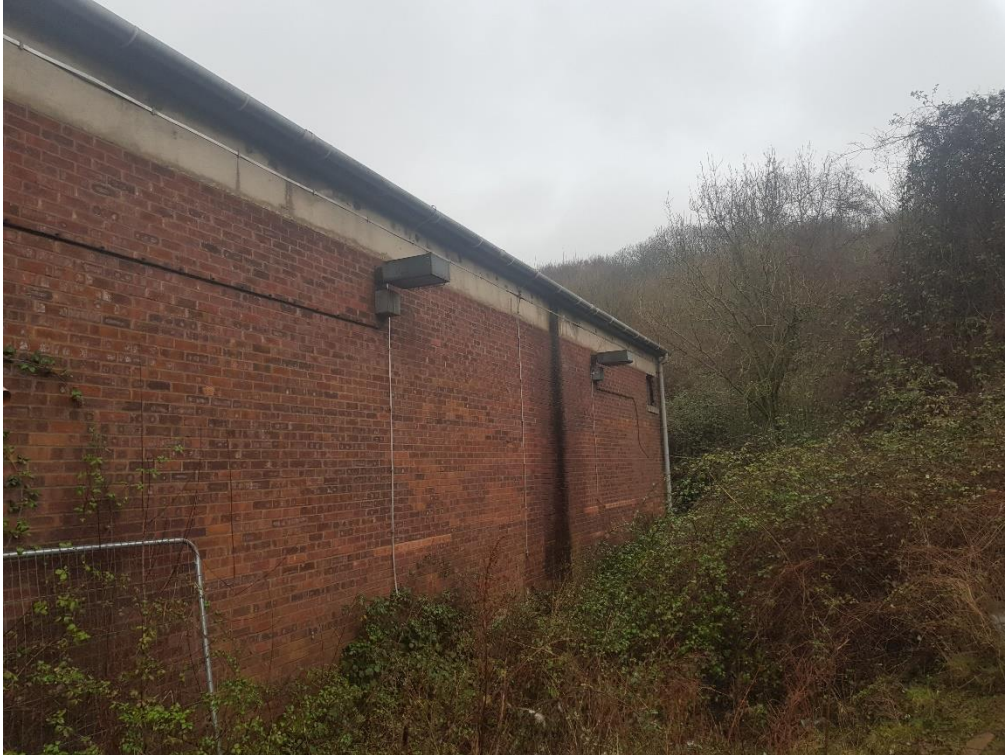
*Building 1 – Eastern elevation.*

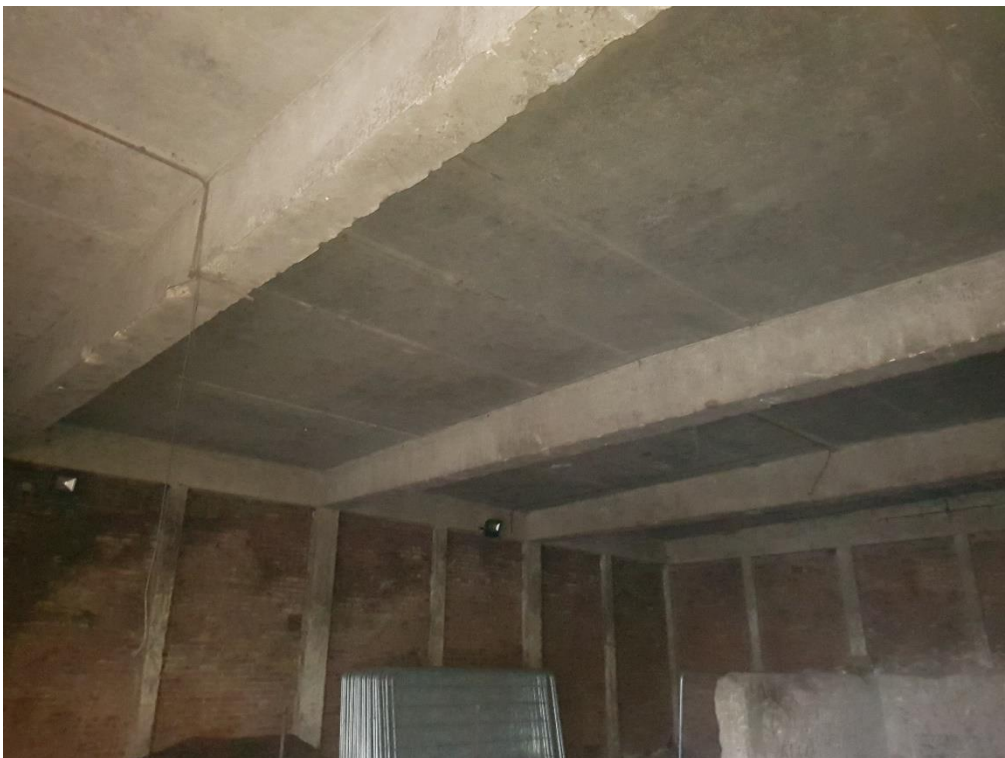
*Building 1 – Roof construction.*

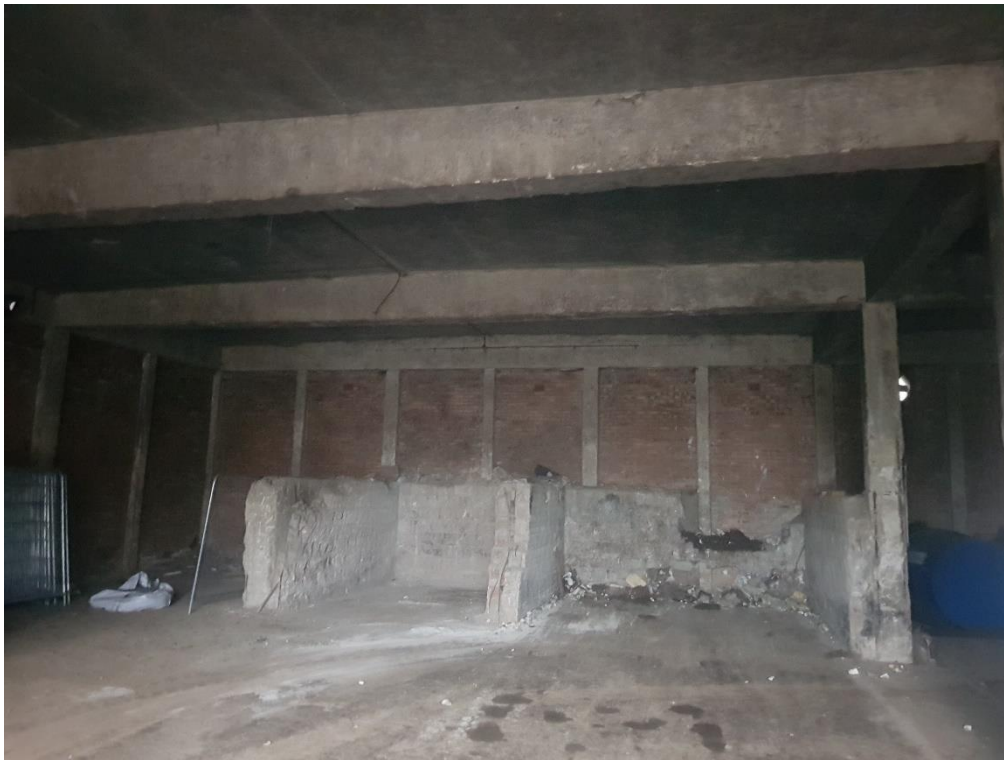
*Building 1 – Quarantine bays and brick infills between concrete pillars making up the walls.*

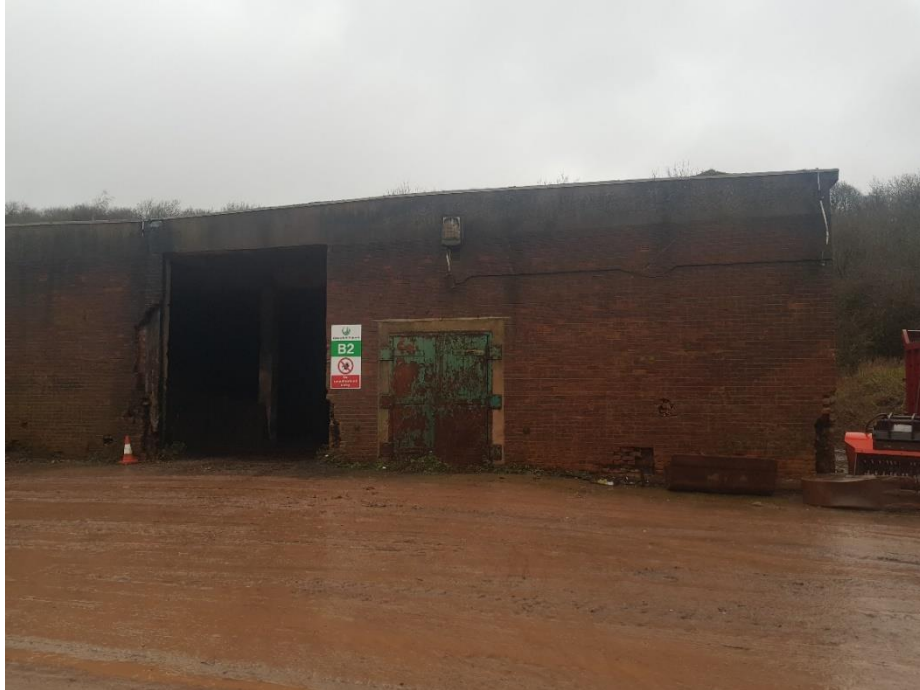
*Building 2 – Southern elevation with 3.5m wide vehicle access door and pedestrian door.*

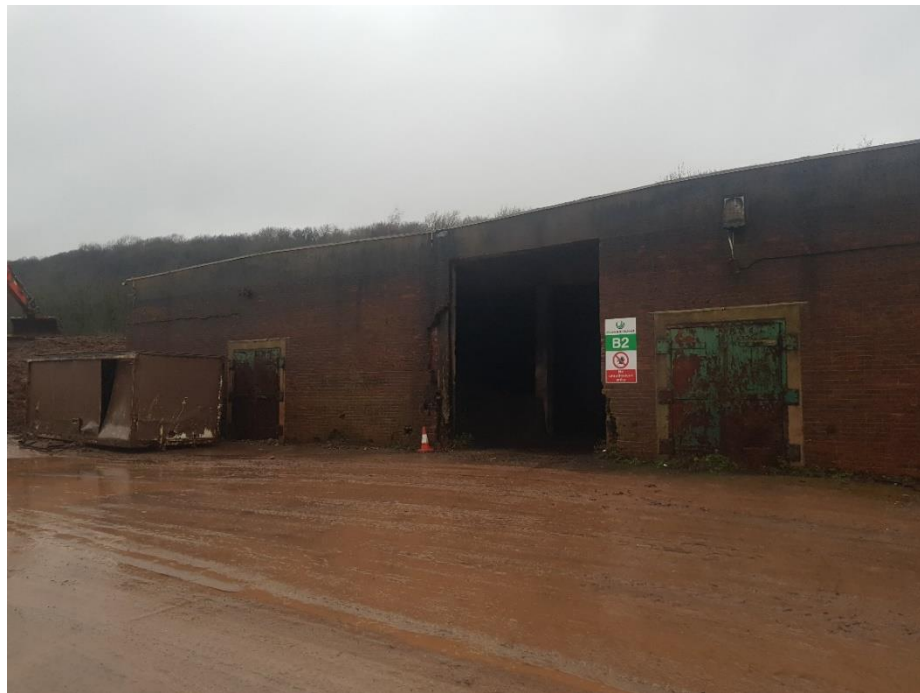
*Building 2 – western section – Damage to brickwork around vehicular door. Brickwork is not structural as the doorway is supported by a concrete portal frame.*

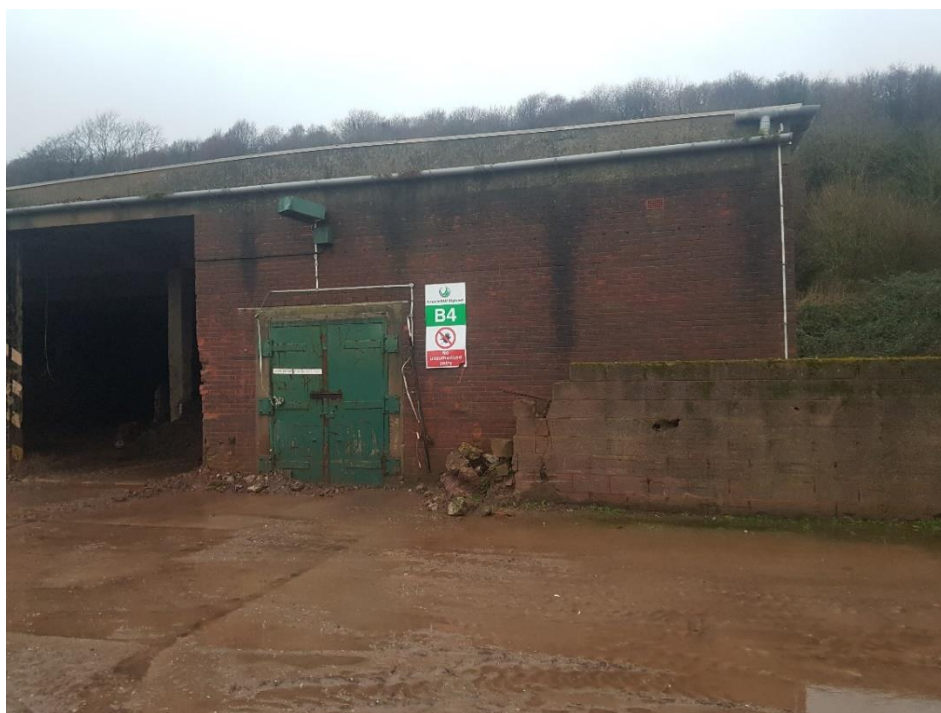
*Building 4 – Eastern end, with concrete frontage.*

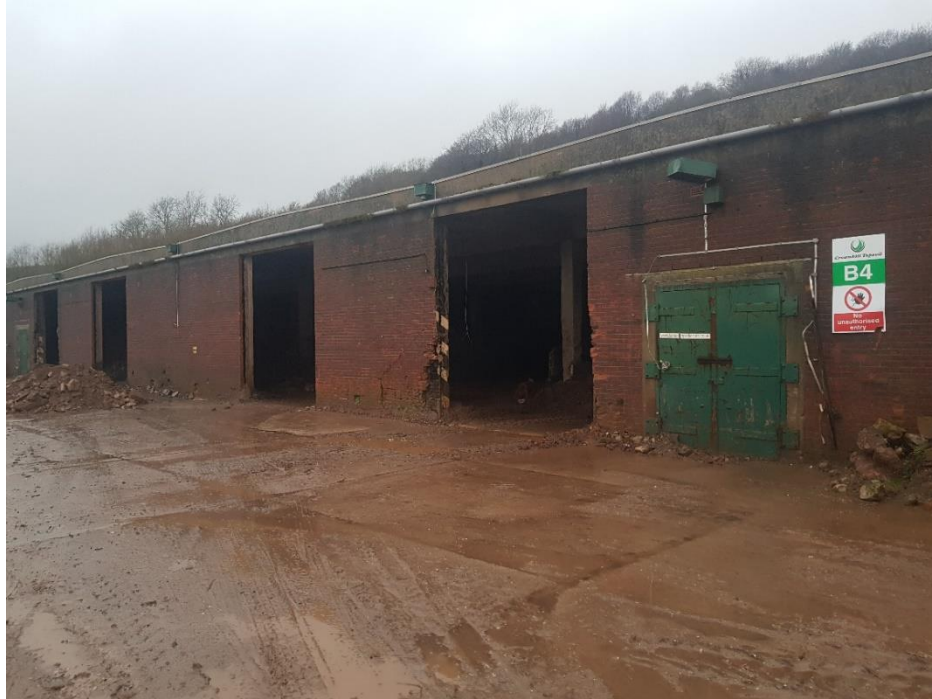
*Building 4 – This is a four bay building.*

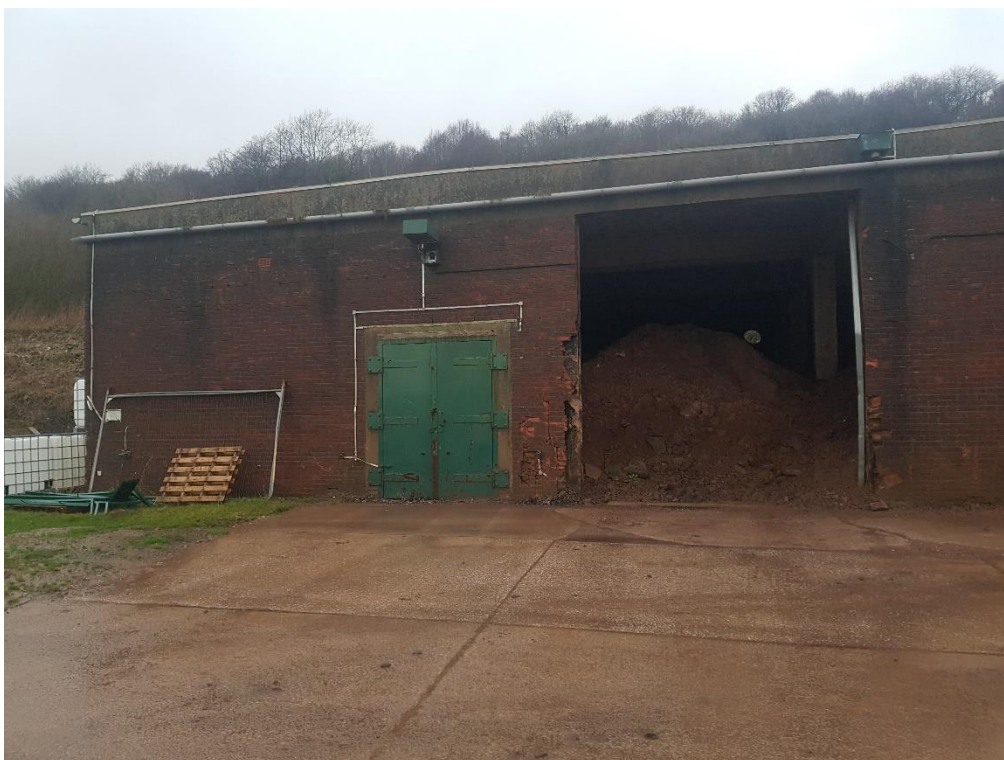
*Building 4 – Western side – Further damage to brickwork around vehicular door.*

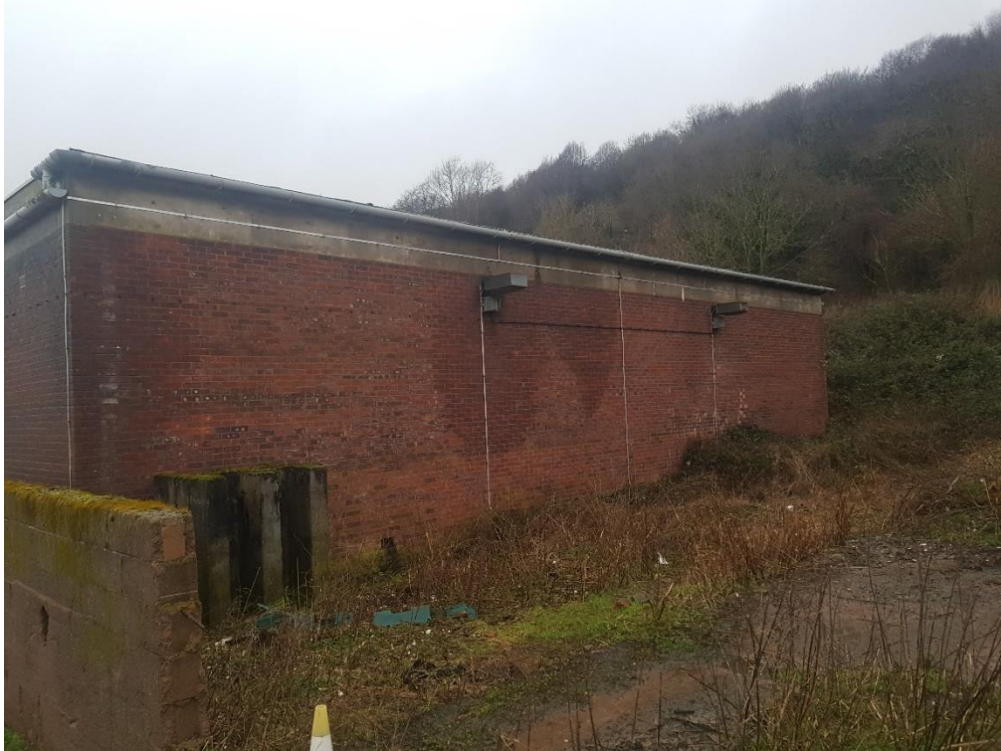
*Building 4 – eastern elevation – there is a 4m wide strip of vegetated soil along side of the building.*

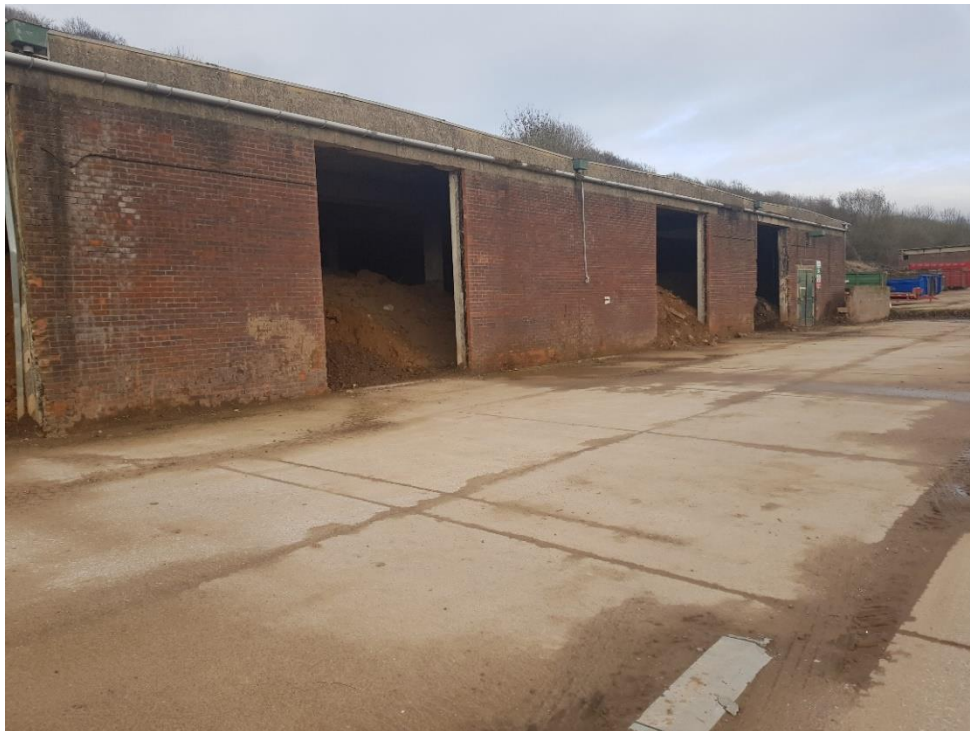
*Building 4 – Guttering along front of building, collecting rainfall from valleys between bays.*

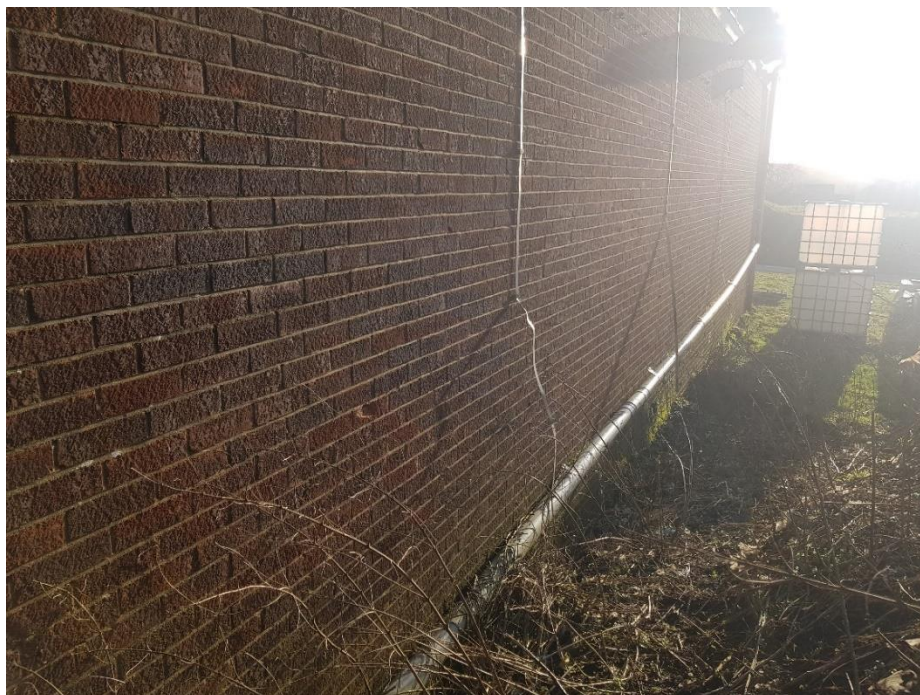
*Building 4 – Rainfall from guttering at front of building being channelled to vegetated areas behind building.*

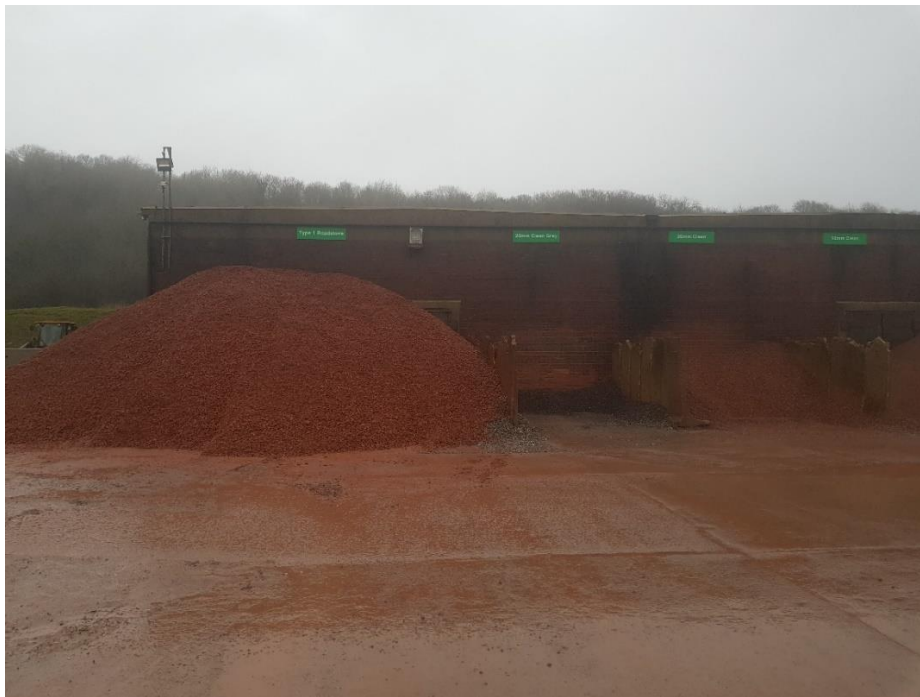
*Building 5 – Southern Elevation – Stockpiles of quarried aggregates stockpiled in bays against the building*

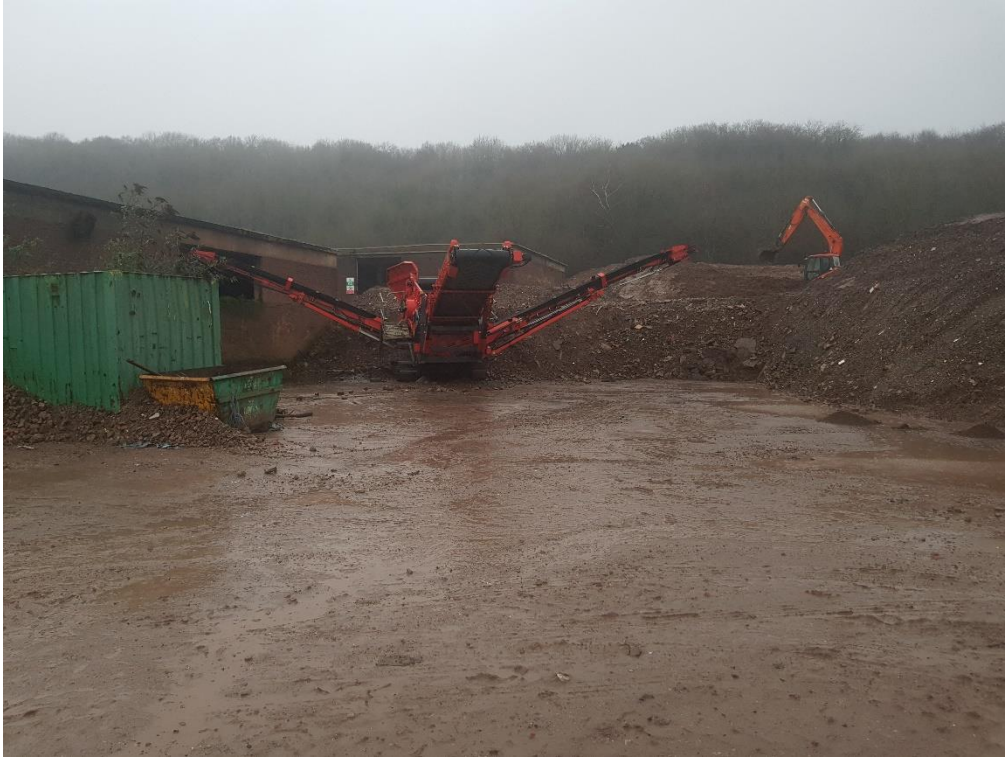
*Screen on hardstanding at the eastern end of Building 5 – screened topsoil is loaded into the building through the hole on the eastern wall of the building.*

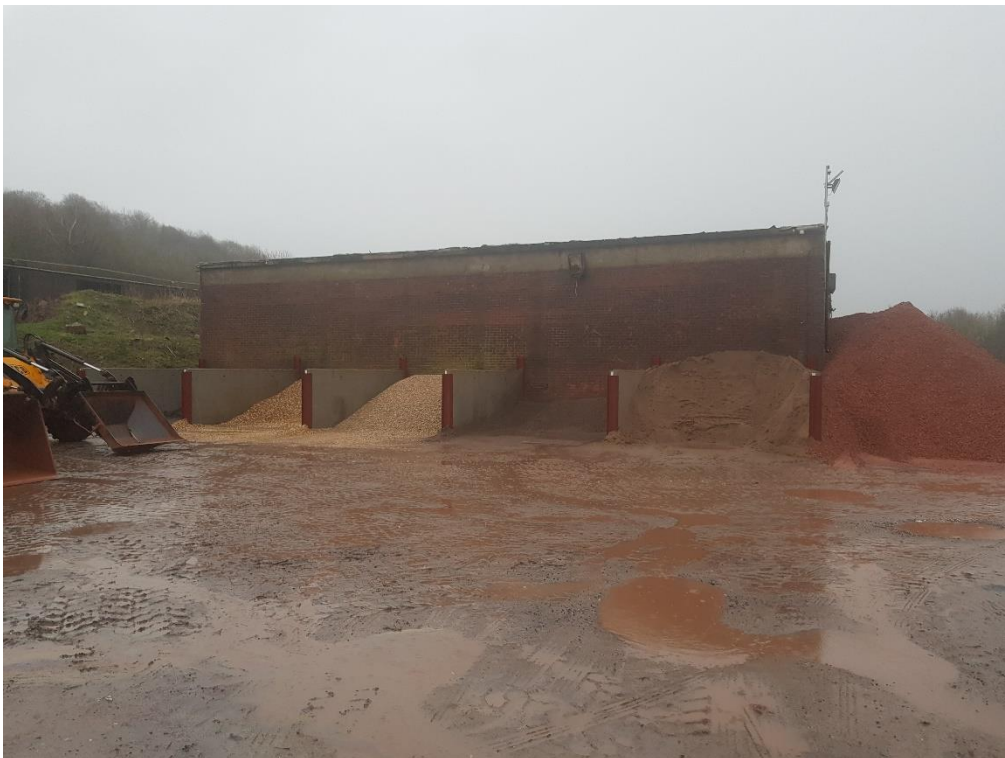
*Building 5 – Western elevation – Quarried aggregate bays. This section of the yard is compacted stone.*
