**MOSTYN MANUFACTURING SITE**  
**Groundwater Analysis Report**  
**February 2020**

P. J. Bryant. HSES Manager  
18<sup>th</sup> February 2020

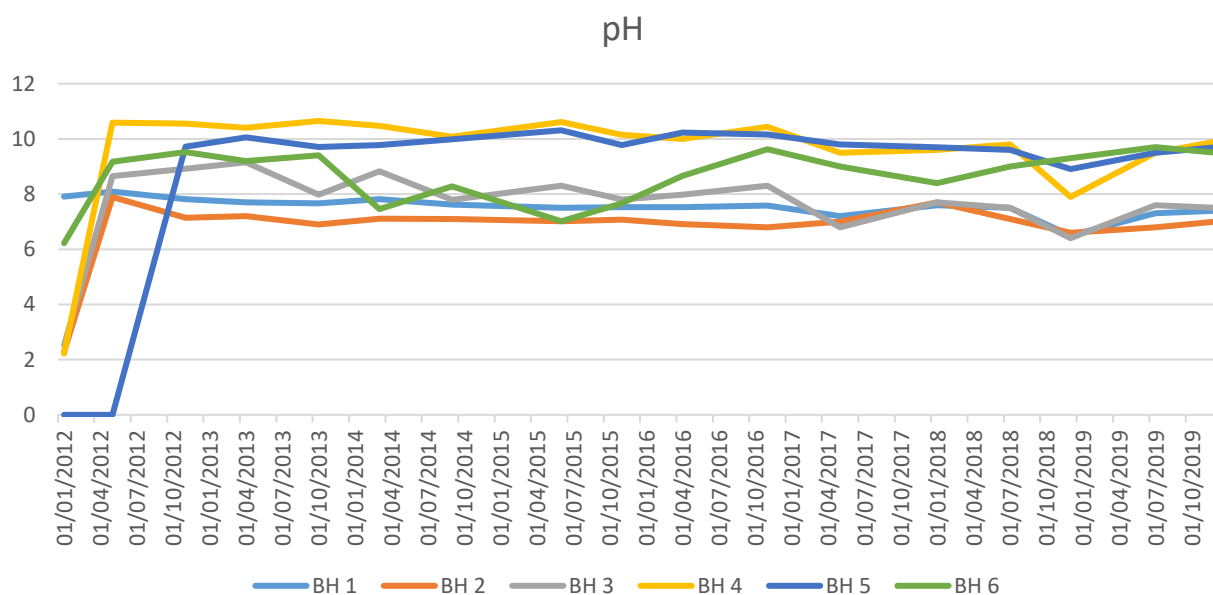
The pH of the groundwater in all six boreholes has remained fairly constant over the last seven years. Changes in the pH can mobilise metals within the surrounding areas but this does not appear to have happened to any extent. In June 2018 there has been a minor increase in the copper levels in borehole 3 (0.8mg/l to 15mg/l) when the pH fell by one unit. However, the high level of copper in borehole 3 in 2016 did not appear to have been affected by any pH change.

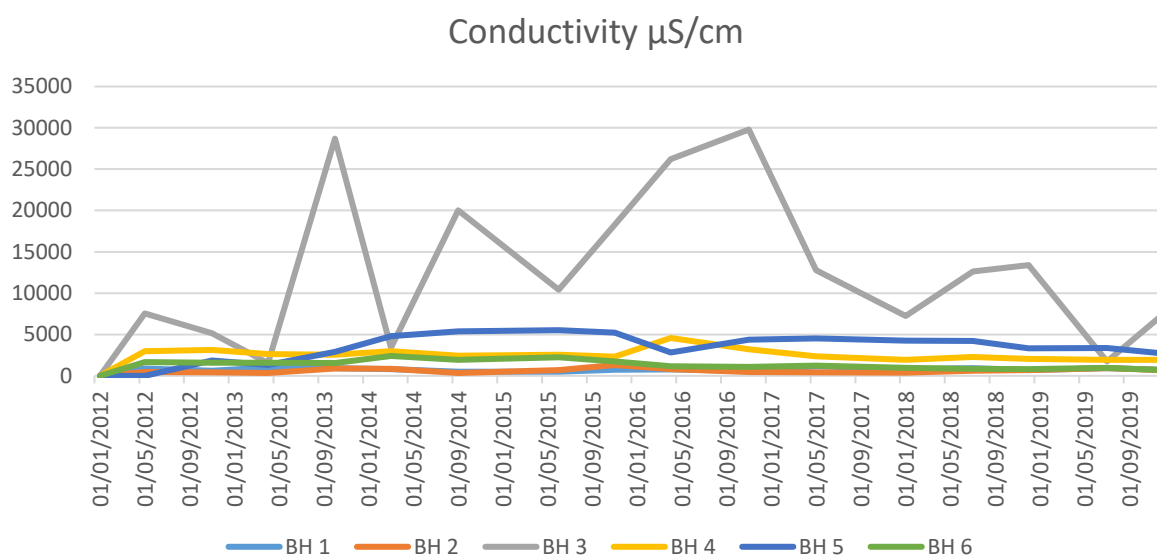
Ground water conductivity has also been quite consistent. The only anomaly has been with borehole 3. This borehole is furthest away from any manufacturing activity and, given that the groundwater flow is in the North East direction the activity has not been fully explained. This could simply be due to the levels of metals mobilised in this area. Discussions are on-going with our consultants regarding this issue.

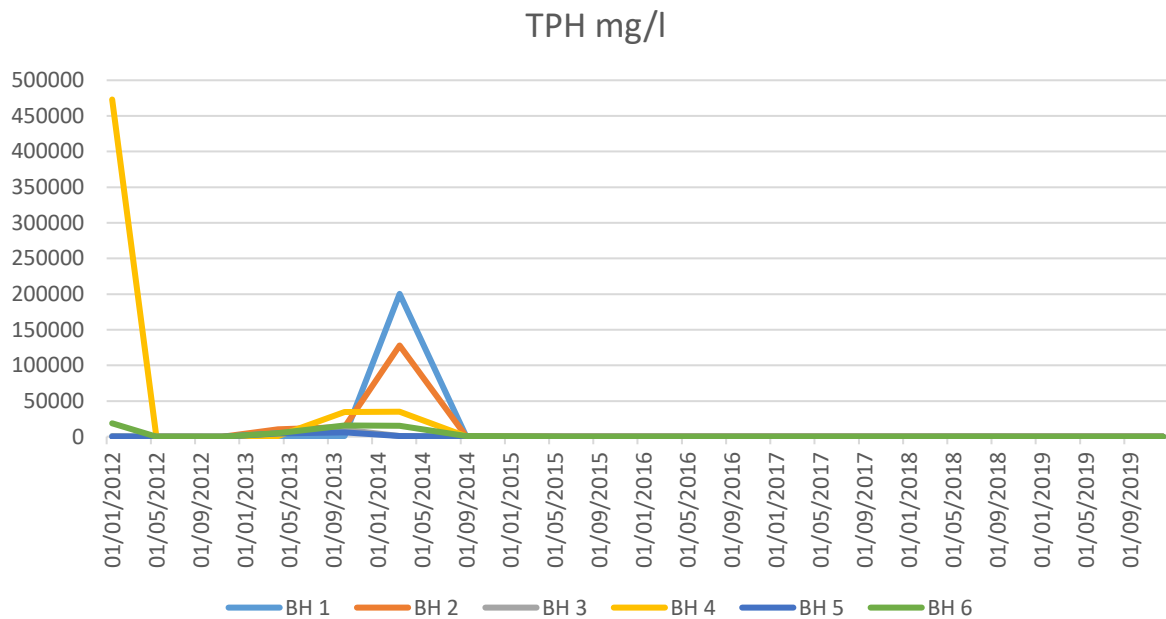
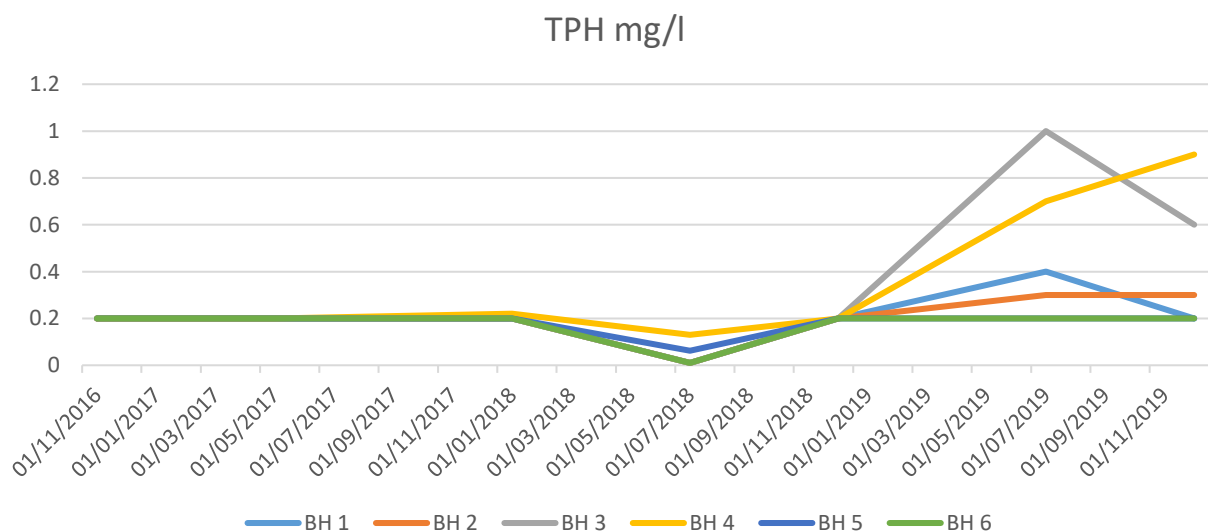
The diesel that caused some concern back in 2014 (historical spillage from 1998, hauliers fuel tank) has now effectively passed under the site, with the results consistently being between 0.1 and 0.4mg/l.

Recently there has been an increase in the THP level in Borehole 3 (0.2mg/l to 1.0mg/l). This is being reviewed as the groundwater direction under the site is in the North Easterly direction indicating that any potential spillage may have come from the neighbouring site.

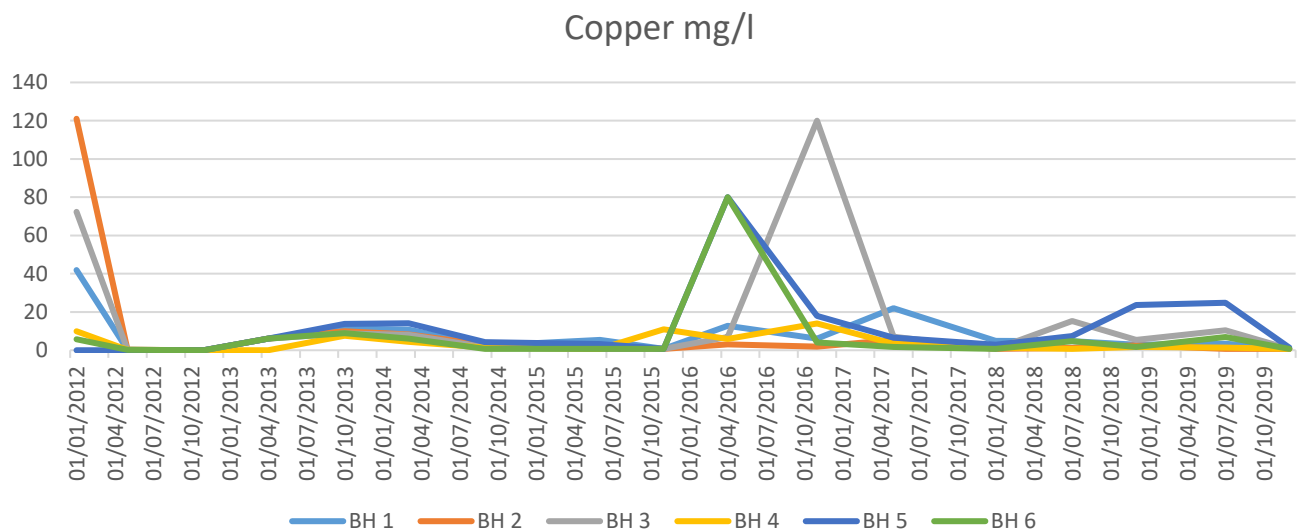
Copper levels in the groundwater remain consistent, the exception being Boreholes 3 and 5, although the levels have only increased from 0.8mg/l to 15.2mg/l and then back down to 0.8mg/l in Borehole 3, in Borehole 5 the level rose to 24.8mg/l and has recovered to 1.4mg/l. there does not appear to be any definitive reason for this; possible pH reduction, as discussed before.

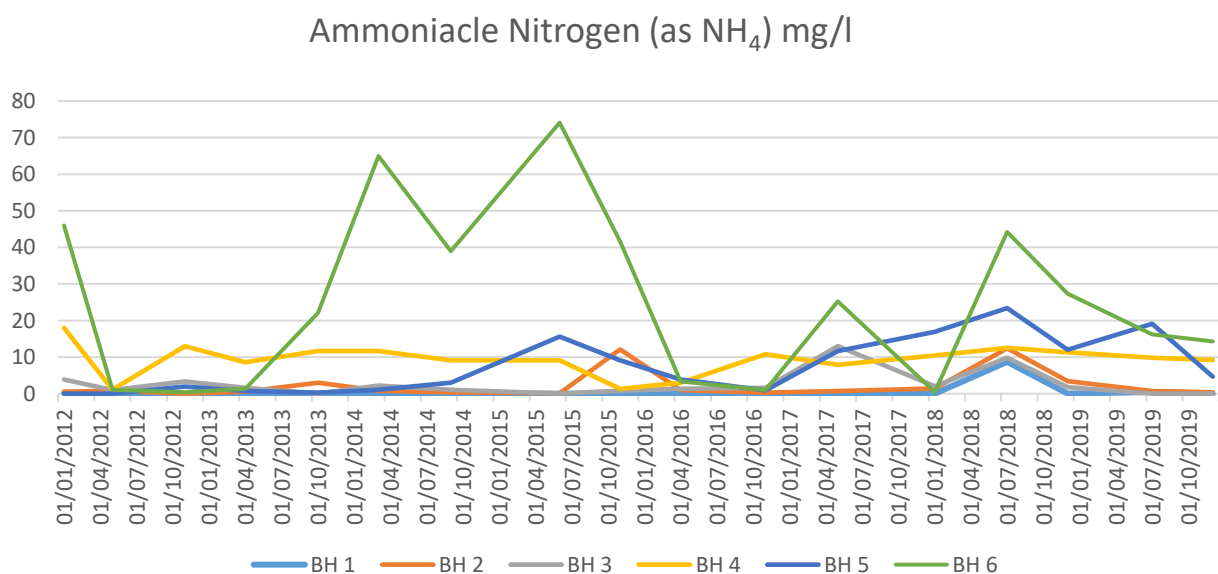
Levels of ammoniacal nitrogen are relatively consistent, apart from the fluctuations identified in borehole six. Discussions are continuing with our consultants about the causes for this.
