**This form will report compliance with your permit as determined by an NRW officer**

Site	Trostre Works	Permit Ref	BX9471IU
Operator/Permit holder	Tata Steel UK limited		
Regime	Installation		
Date of assessment	13 <sup>th</sup> February 2020		
Assessment type	Inspection		
Parts of the permit assessed	See section 2		
Lead officer's name	Neil Herbert	Accompanied by	Ieuan Davies
Recipient's name/position	Darryl Lewis – Environment & Energy Manager	Date issued	5 <sup>th</sup> May 2020

This visit was arranged primarily to assess progress with the investigations<sup>1</sup> into the effluent flume works and surface water contamination (Surface Water – east system (w2)).

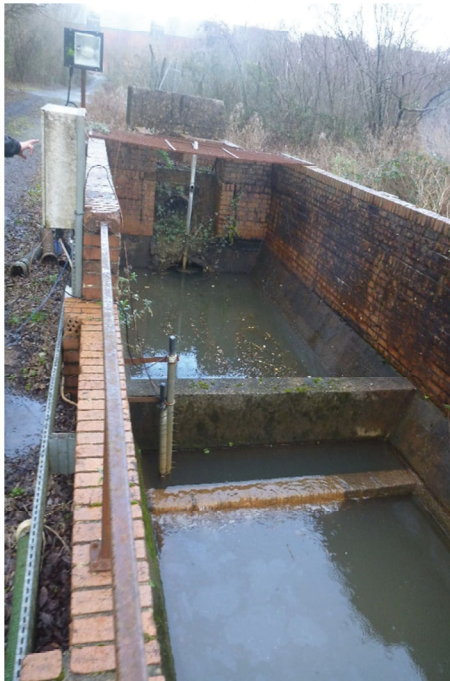
- We undertook a short visit to see the location of the effluent leak that caused the high iron levels near borehole A.
- We were also shown some of the “emergency” repairs undertaken on sections of the effluent flume.
- We also inspected the surface water interceptor. There is a significant improvement since previous visits (see photograph). Little evidence of visible oils in the interceptor system was noted since the misconnection was sealed off in late 2018. This suggests that the source of the contamination has been contained.

*SW Interceptor February 2020 – no evidence of major contamination. Vegetation cleared*

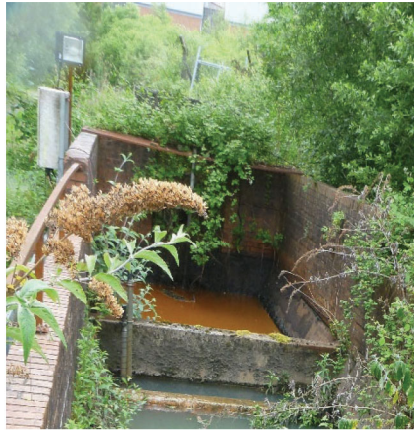
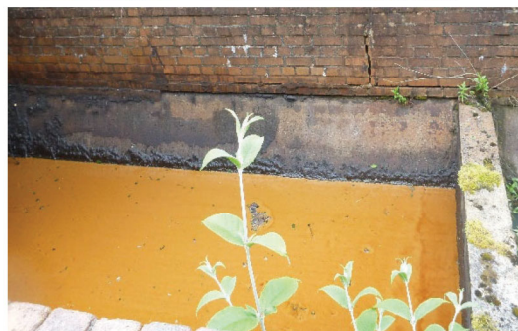
*SW Interceptor June 2017 – significant contamination in surface water interceptor.*
