Site	PB Gelatins EPR/DP3030ZC	Permit Ref	DP3030ZC		
Operator/Permit holder	PB Gelatins UK Limited				
Regime	Installations				
Date of assessment	29/05/2020	Time in	10:19	Out	11:55
Assessment type	Audit				
Parts of the permit assessed	Accident Management				
Lead officer's name	Harris, Geraint				
Accompanied by					
Recipient's name/position	Julie Campbell/ EHS Manager	Date issued	22/06/2020

PB Liners

Permit Number DP3030ZC

**Report ID:
CAR_NRW0036724**

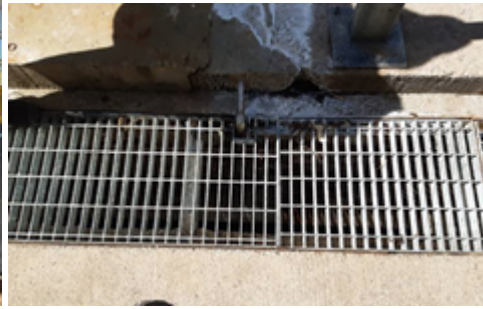
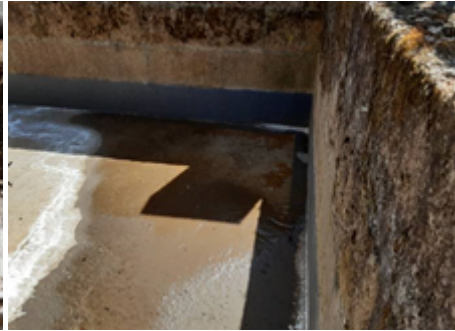
I arrived at the site in Treforest at 10:20 on Friday 29th May and met Julie Campbell and Mauricio Caetano Ramos at reception. We walked over to the area of the site where the incident occurred (The Farm). The area consisted of three large double skinned tanks adjacent to the site's perimeter fence. The area cannot be accessed by the public and is secured behind a locked gate. The middle tank, designated for caustic storage, is where the incident took place. The tank itself is a double bunded HDPE internally bunded tank with auto-dosing and above ground delivery pipework. The secondary containment is provided by an integrated HDPE bund attached to the primary tank and concrete hardstanding below the pipework. There are 900mm high concrete block masonry walls to three sides of the tank with large channel drainage which discharges to the industrial effluent sewer to the fourth side. The bund drain is piped to the effluent channel drain, which could be used if a spillage within the bund was to be detected. According to PB Liners permit application, the masonry walls and channel drainage provide a degree of tertiary containment which would contain minor spillages outside of the main bund. The corresponding pipework and Chem Guard (Housing the valves and pumps) are located adjacent to the Caustic Tank and within the tertiary containment.

The remnants of the spill were obvious upon reaching the area. A white trail of dried Caustic could be seen from the Chem Guard to the Effluent Drain. Within this area several significant cracks and holes in the concrete floor could be seen. Additionally, dry residue and liquid could be seen around the whole of the tank, with a pool of liquid located adjacent to the tertiary wall mentioned above.

Upon inspecting the whole Caustic system around Tank BC012 there are a number of concerns. Firstly, a number of large cracks and a significant hole were seen within the spillage area. These areas of concern

The cracks and hole identified on the concrete pad inside the side boundary are another potential pathway for caustic to reach the subsoil and groundwater. Both of these areas were surrounded in white residue and were located within the pathway of the leaking Caustic as it flowed to the effluent drain. It is unknown how fast the liquid flowed in these areas and it is quite possible that a considerable amount of caustic could have entered these defects. Furthermore, the presence of white caustic residues on the hardstanding several days after the incident is a cause for concern. Even more significant was the failure to identify the failure of the tertiary bund and hence the resulting contamination so close to the public pathway. Please provide NRW with a copy of your accident/incident management plan along with any reviews and updates of the plan considering this recent incident.

Action 3 PB Leiners 18th June 2020: Inspect the cracks and holes on the concrete pad adjacent to the Caustic tanks. Provide evidence that the Caustic didn't escape into ground below these areas. **Due 16th July**

Action 6: Remediate the cracks and holes within the impermeable concrete surface and the brick wall with immediate effect. Look into the use of chemically resistant products for both areas. Within the area there are tanks that contain Caustics and acids. Identify a product that can withstand both chemicals.

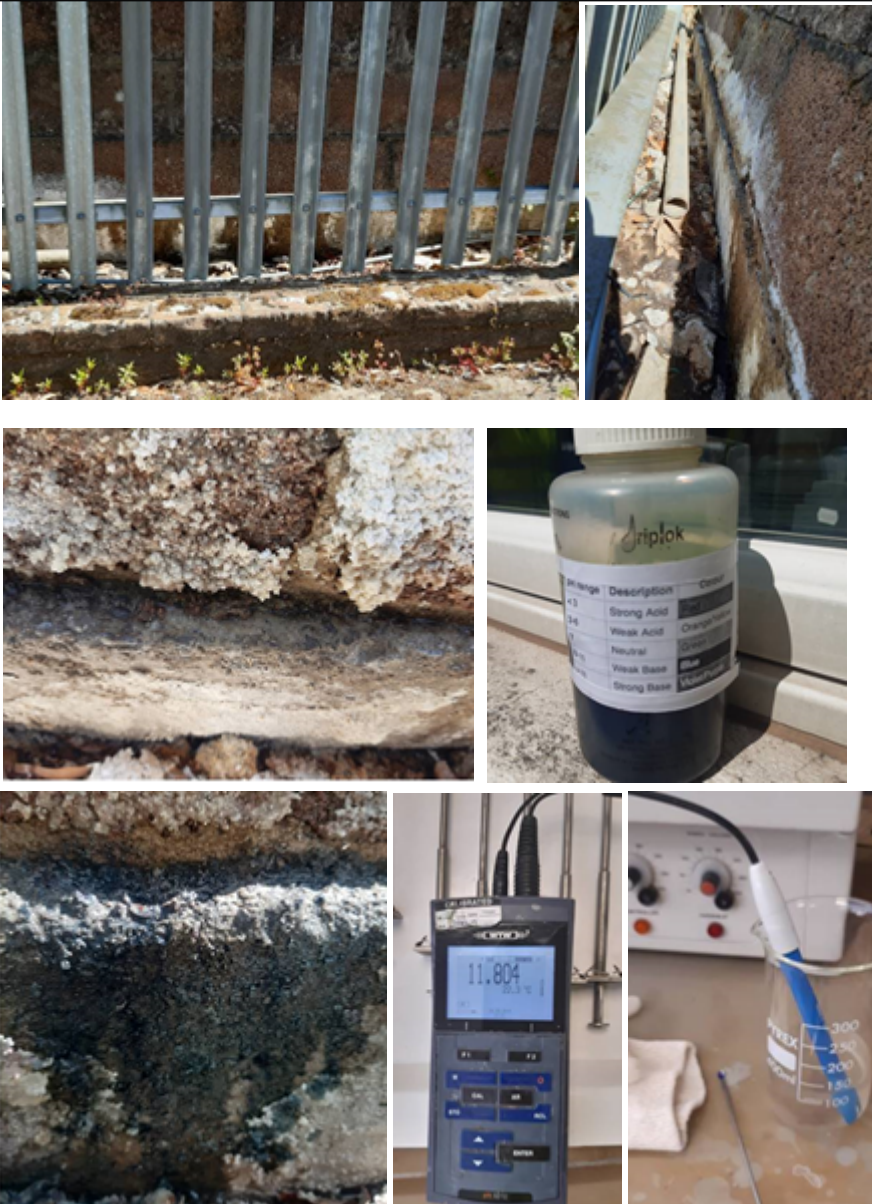
Finally, we walked out onto the public path located on the opposite side of the 900mm high concrete block masonry walls mentioned above. Upon close inspection, damp and dry patches of white residue were evident over a several metre expanse of the wall and soil at the base of the wall. These patches were located at the same height as the floor on the opposite side of the wall (the floor where the caustic had spilt). Since the other sections of the wall either side of the caustic tank were free from these patches it was thought prudent to test the liquid and the white solid to see if they were a result of the caustic spill. Julie Campbell was able to retrieve a pH indicator solution from PB Leiner’s Laboratory. We sprayed a damp patch of the wall with the indicator and waited for the colour change. Within a few seconds the colour changed from green to dark blue/purple indicating a high pH. Following this Julie removed a portion of the white solid and took it to the Laboratory for a pH test. The chemist at the lab dissolved the solids in deionised water and used a pH meter to analyse the solution. The result of which was a pH of 11.8 indicating a strong alkaline solution. These results had indicated that the 900mm high concrete block masonry walls used for tertiary containment had failed.

Although the area of contamination was relatively small and confined, the soil at the base of the wall was highlighted as a pathway for the contamination to reach the subsoil and groundwater within the local environment. Even though there was no evidence of caustic on the public footpath or road, given the extremely close proximity of the public footpath, had it been raining there would have been a significant chance that highly alkaline liquid may be created and spilt onto the public footpath and neighbouring surface water drains. Consequently Public Health Wales were informed of the incident.

PB Leiners were asked to clean up the contamination located on the tertiary bund walls along with extracting the contaminated soil located in the gap between the perimeter fence and the tertiary bund. This soil was identified as a possible pathway for contamination to reach the groundwater and surrounding environment. However, when PB Leiners extracted the soil they found it to be only a few centimetres thick and underlain with brickwork. The Caustic was prevented from leaching into the environment via this pathway and hence was contained. However, the potential to pollute is still significant.
