## Compliance Assessment Report

Report ID:  
CAR\_NRW0031976

| Site | Brookhill Landfill Site EPR/AP3739KS | Permit Ref | AP3739KS | | | |
| Date of assessment | 27/07/2017 | Time in | 14:40 | Out | 16:40 | |

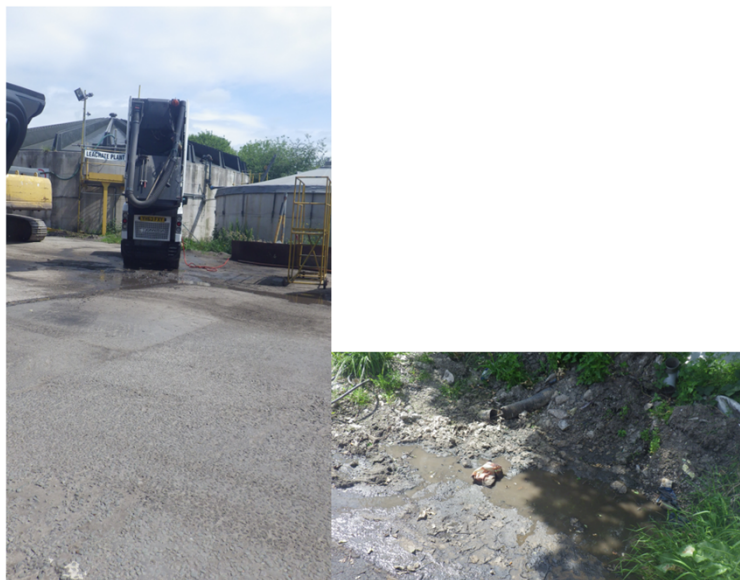
On the visit on the 16th June 2017 It was noted that sweepers were being washed by the weighbridge. Washings were flowing along the surface and soaking into ground above the canteen/office portacabin. Further conversation with the operator confirmed that all effluent should be flowing towards the old waste transfer pad where there is a sump.

Condition 3.1.1 stipulates that there should be no point source emissions to land except from the sources and emissions listed in schedule 3 tables S3.2 and S3.3.

As a result of unauthorised discharge of contaminated water to ground a CCS score of 3 has been applied.

You have subsequently advised that sweeper drivers not to use the weighbridge area and only use the transfer pads to wash down sweeper waste.

**ACTION 9.** Please can you forward the most up to date drainage plan for both waste transfer pads including areas around the weighbridge etc. Please can you provide these no later than 22nd September 2017.
