Tir y berth Depot – Biodisc Investigation

Report on existing Package Treatment Plant (PTP)

Job Number: TH 1173

Report Number: TH 1173/01

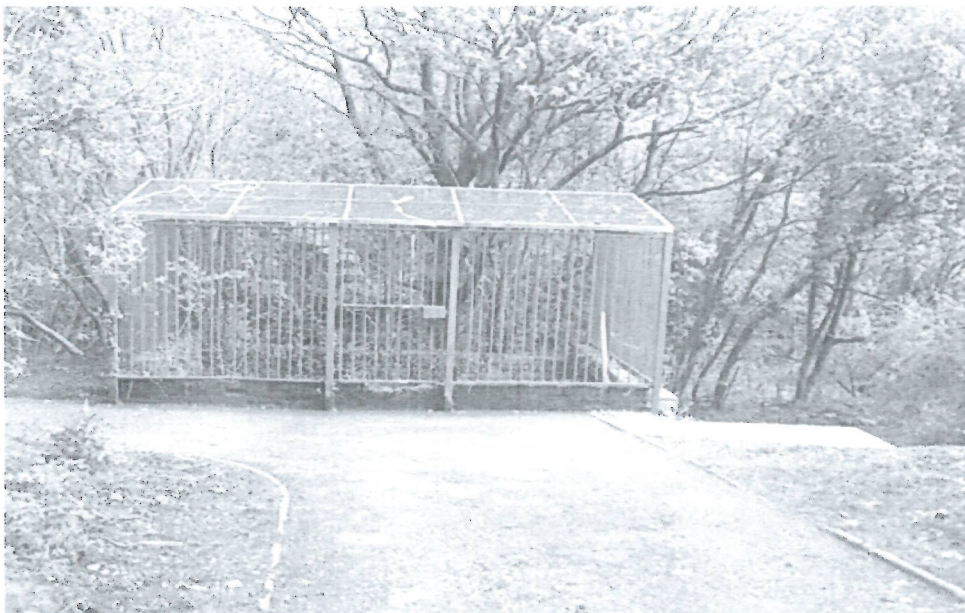
Plate 1 – security cage above the existing unit

4.2 The existing unit is contained within a brickwork structure measuring approximately 5 metres by 3.5 metres. The brickwork is approximately 1.6 metres in height. Within this structure, the actual mechanisms are protected from the elements by a fibreglass shroud of two halves. A steel security cage (as shown in Plate 1) and two locked access doors prevent any unauthorised entry to the unit. The unit is not fitted with any alarm or telemetry. The internal volume of the brickwork structure is approximately 20 cubic metres ie. in the event of a power failure the structure would attenuate 20,000 litres of flow before pollution occurs.
