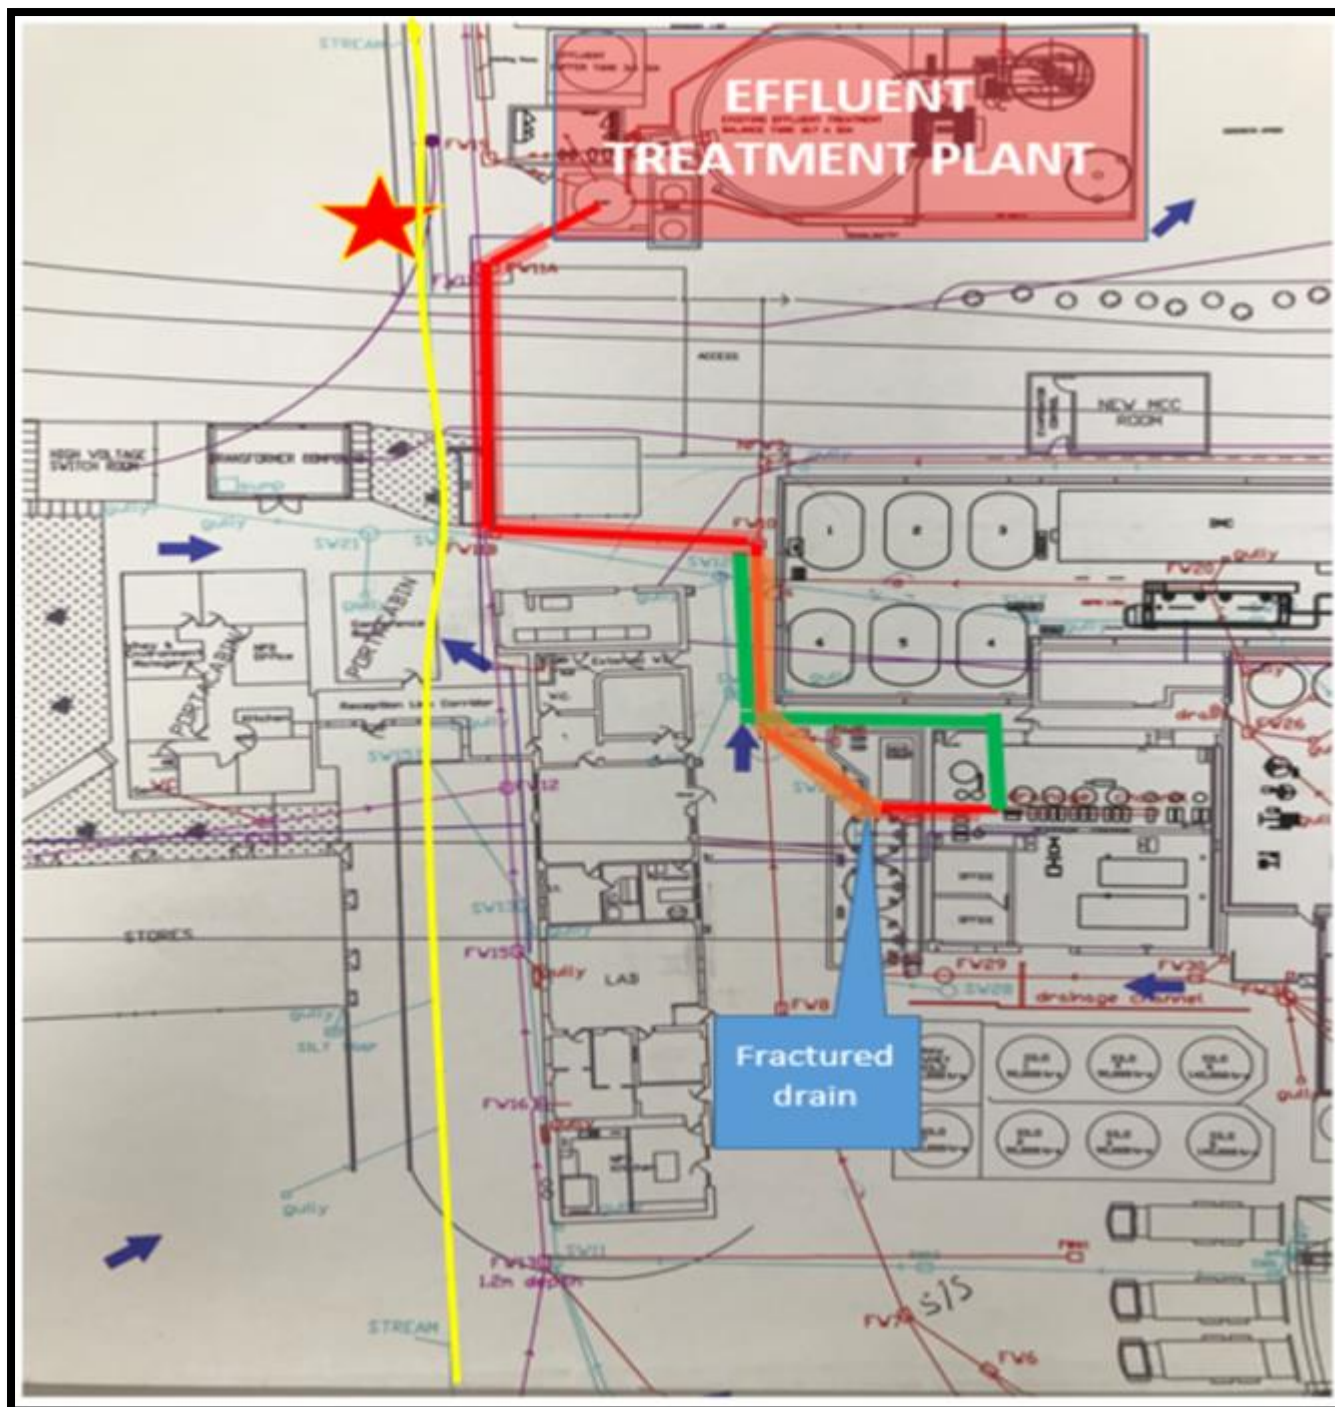
The construction of the pipework is stainless steel and clay resin lined, both of which are suitable for the type of effluent being conveyed. I have amended the Appendix 1 from our Schedule 5 submission to include identification of the drain construction.

Yes a CCTV survey has been completed. We did this when we had isolated the drain that we believed to be the source of the problem. The CCTV survey did show, although not clear, a possible fracture at the interface of the two drain construction types.

Our capital plan for the fractured drain is to abandon it and construct a new drain following a different route.
