Inspection photographs 12/02/21

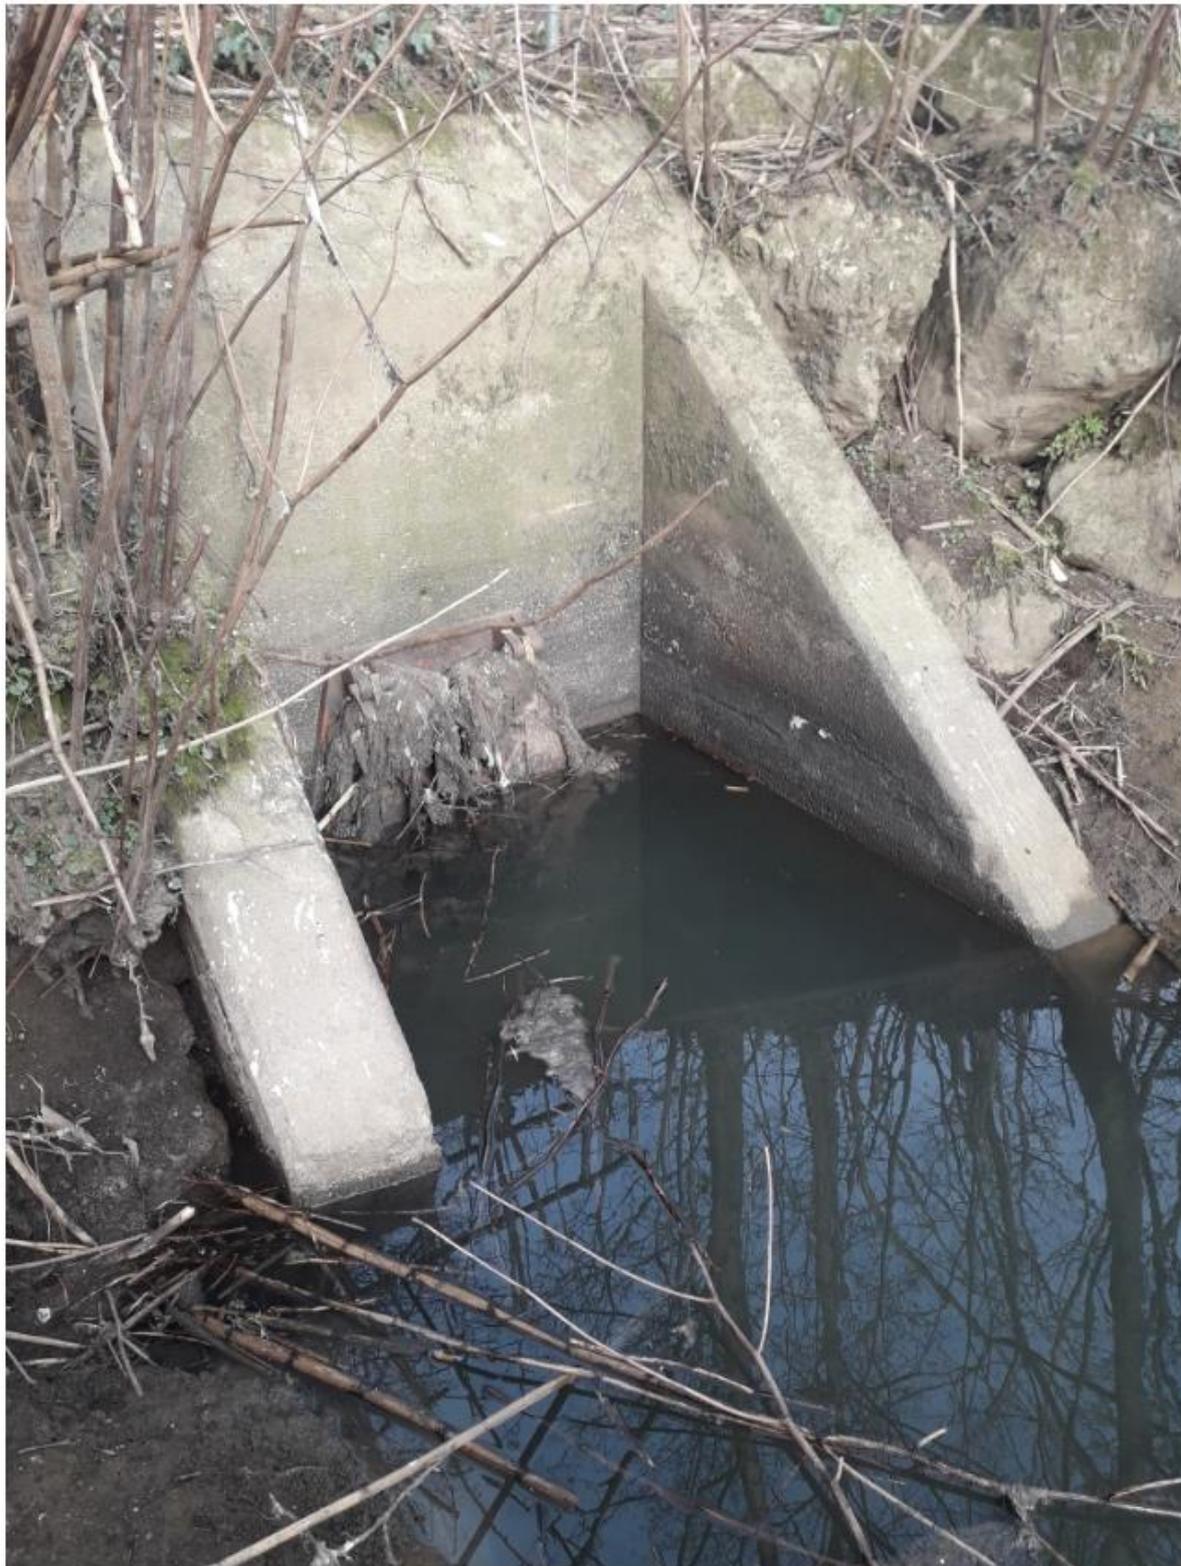
CSO outfall flap valve clogged with debris

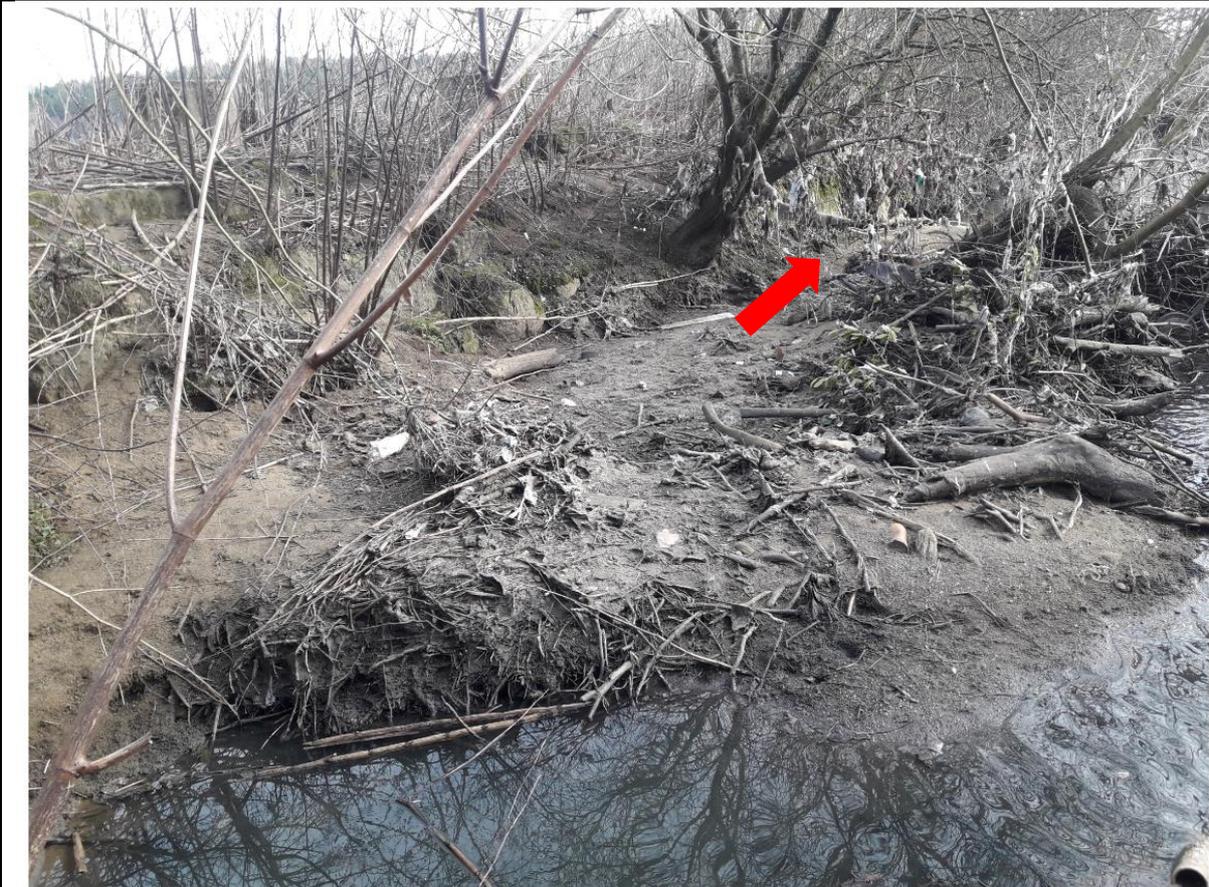
Sewage type debris in vegetation immediately downstream of CSO outfall

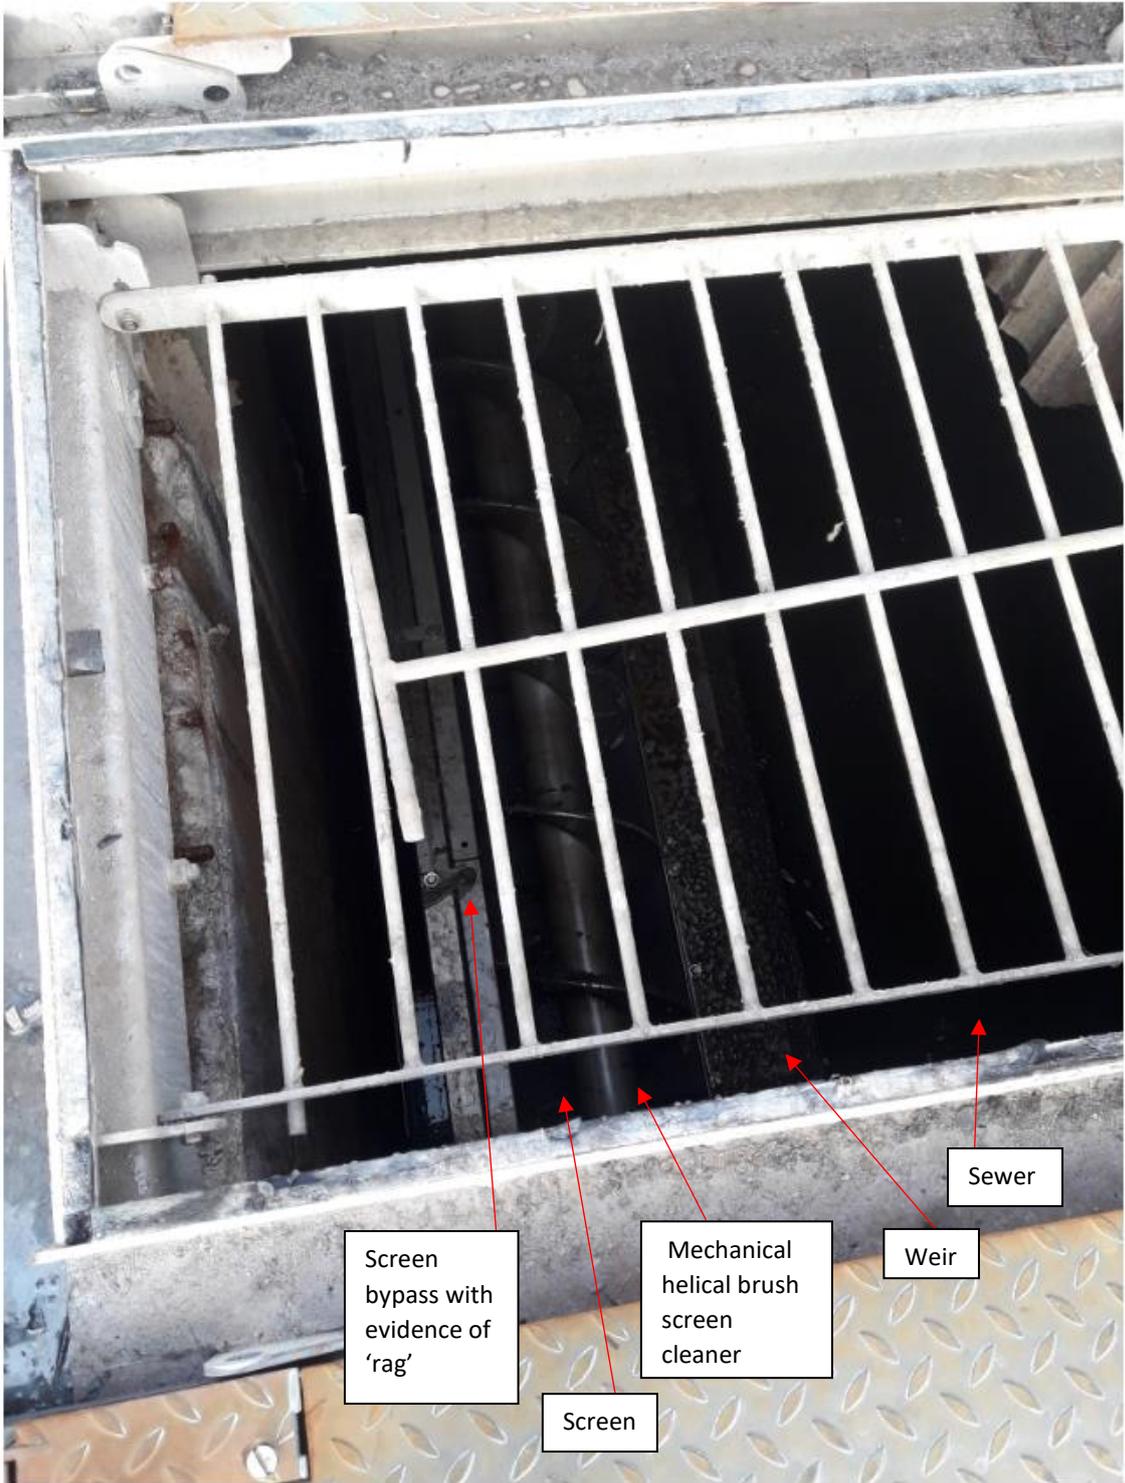
Screen bypass with evidence of 'rag'

Screen

Mechanical helical brush screen cleaner

Weir

Sewer

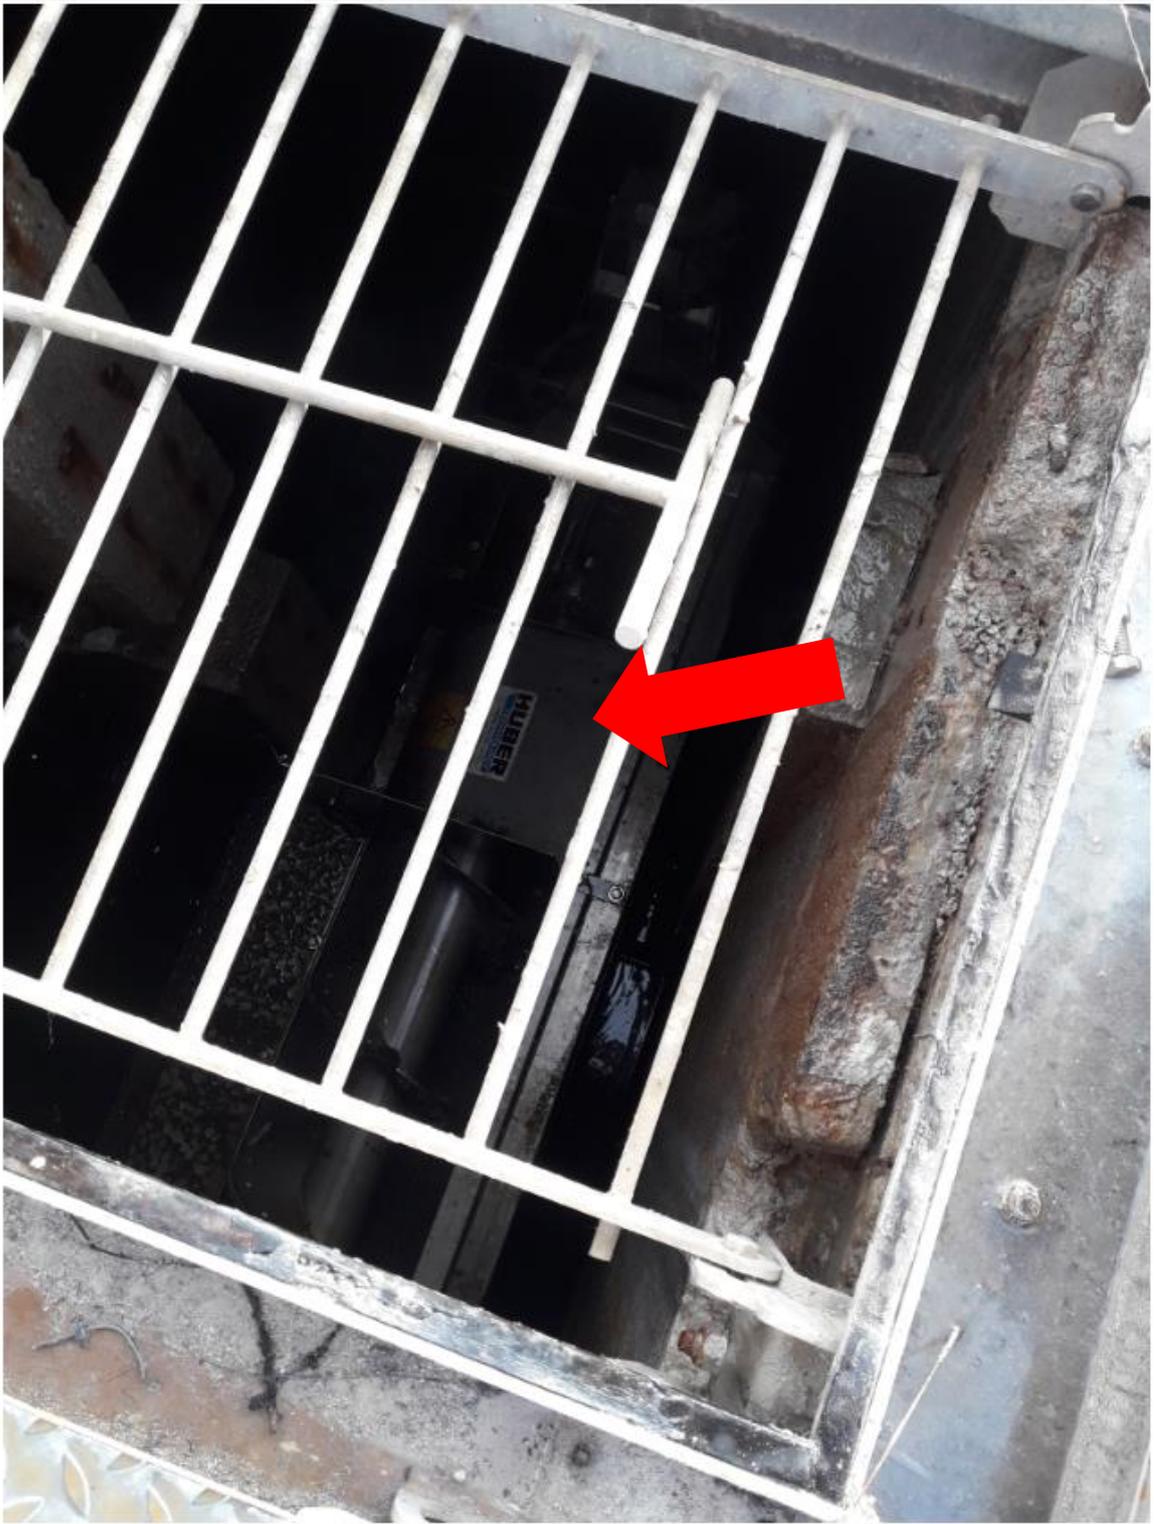
Screen clearing 'flipper arm'

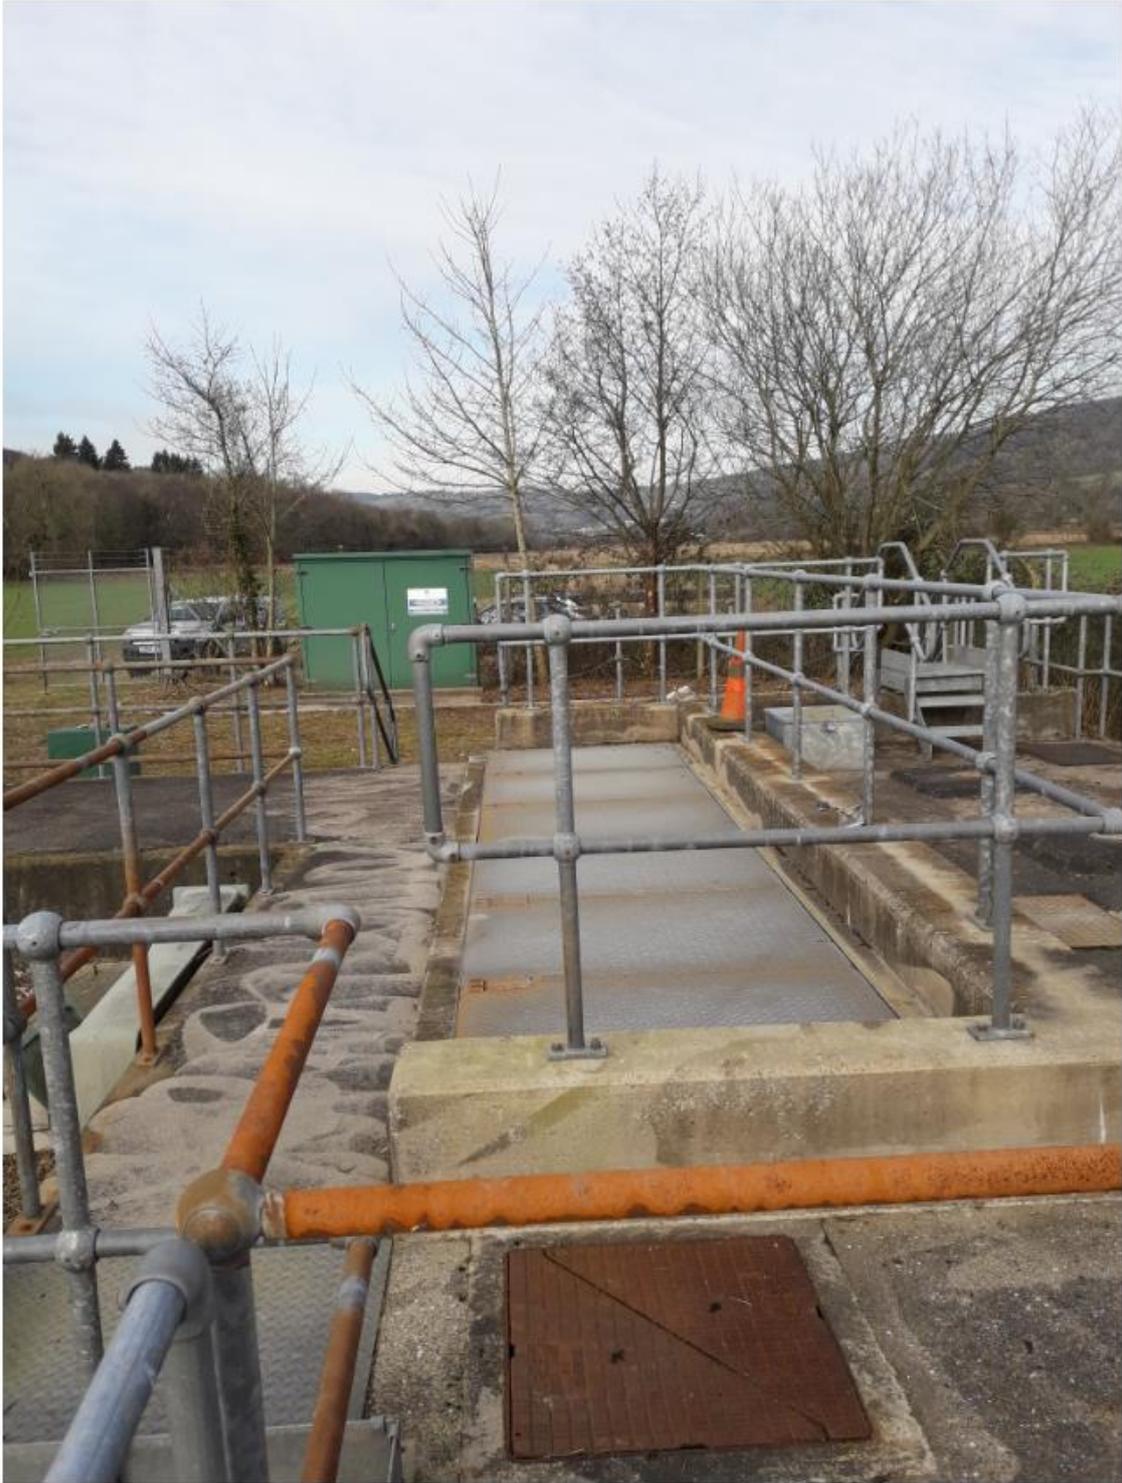
Sewer and screen access points. Power unit in background.

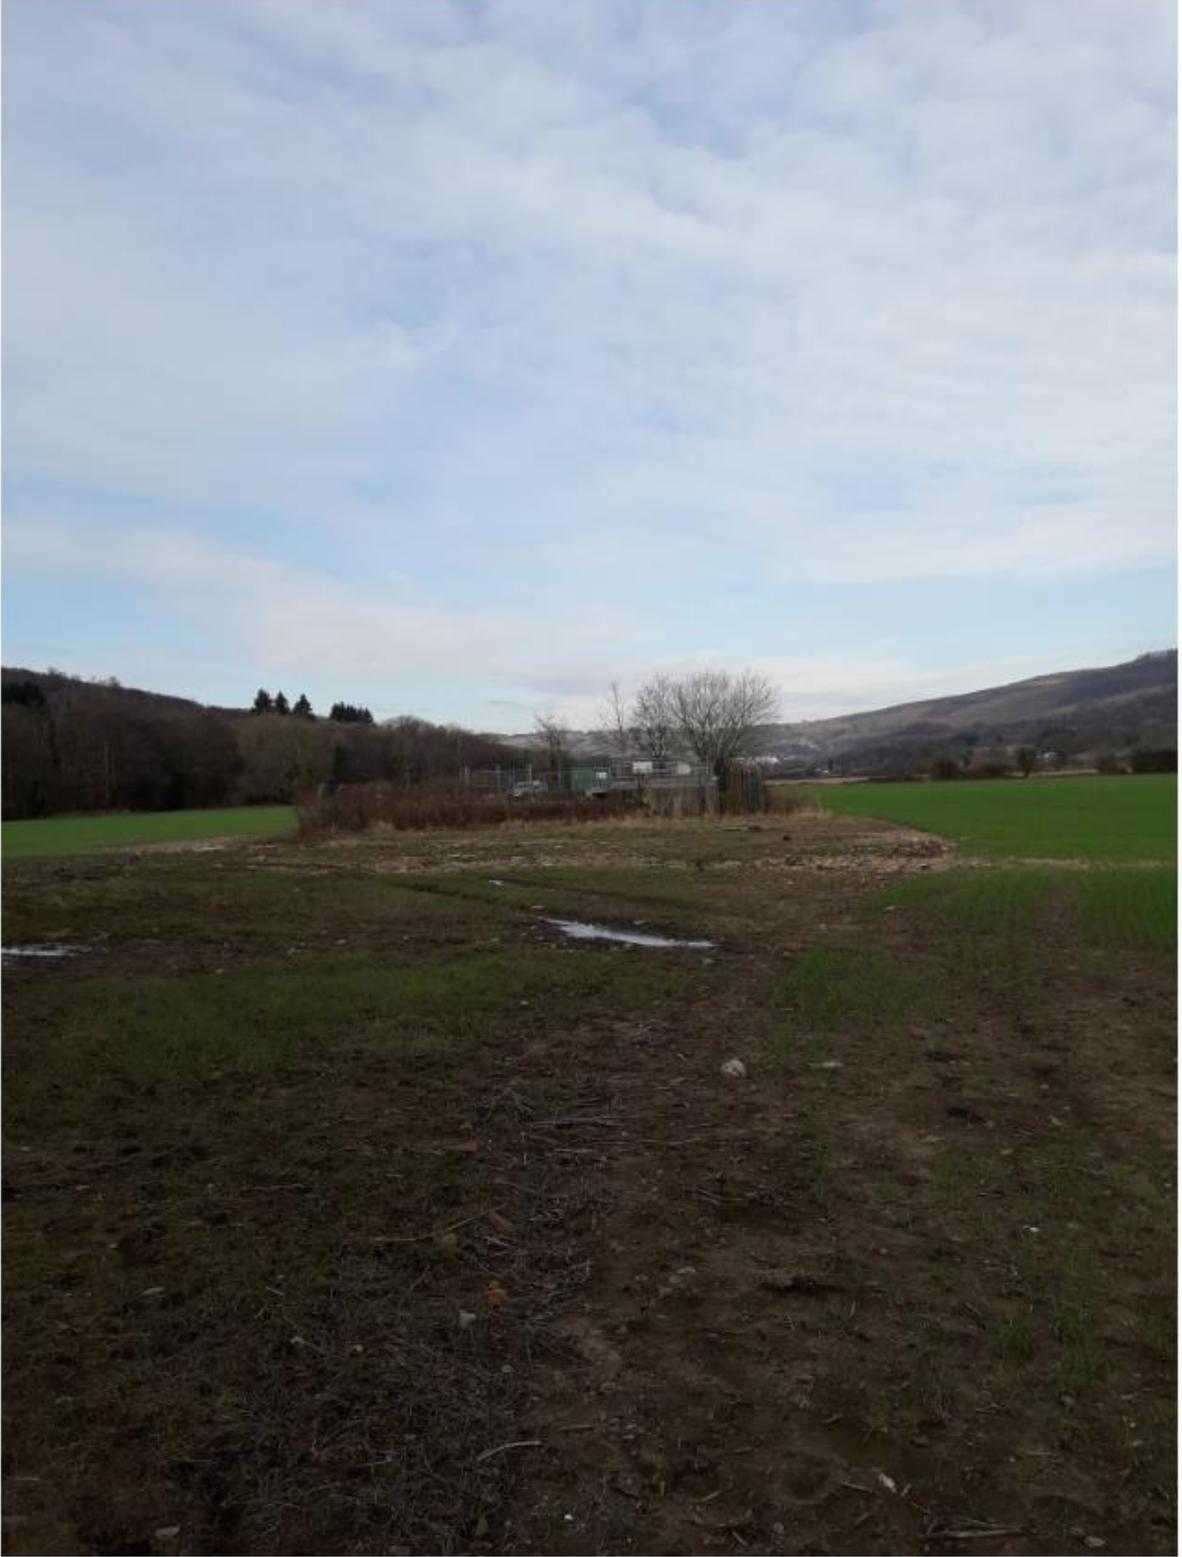
Asset from outfall into River Rhymney. Chain link fence visible.
