## **MORFA LANDFILL RECHARGE TRENCH**

### **Review of Progress**

*Report Number 2040r1v1d1020*

**October 2020**

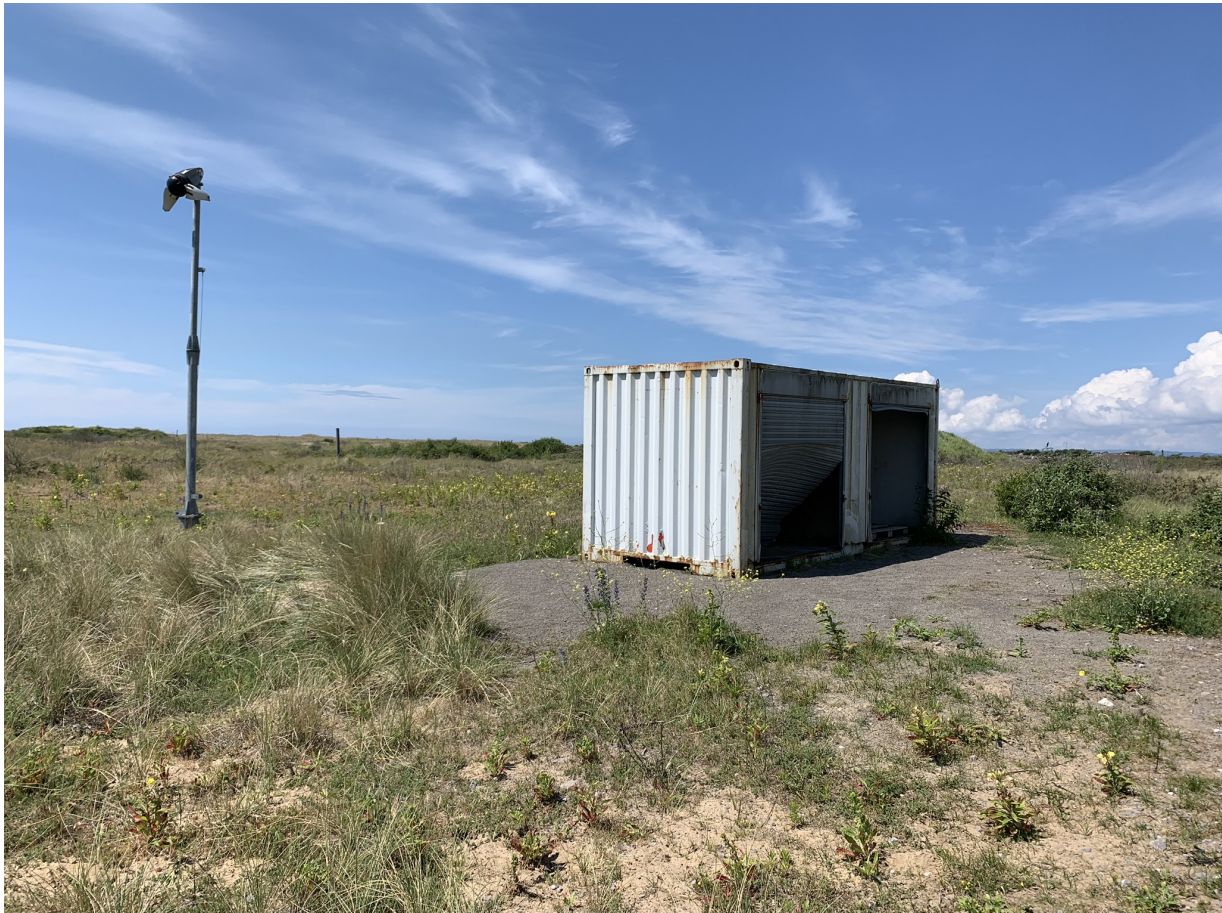
Despite patrols by Tata security personnel and the landfill operator, the current trench alongside MCL is not operating as designed due to significant vandalism and theft. As shown in Plate 4-6, one of the blades of the wind turbine is no longer in place, and appears to have been shot off, and the control room has been forcibly entered, all contents removed and vandalised. As a consequence, the system has no power, batteries or control systems. This has resulted in the system solely working by passive means. Figure 6 illustrates the location of the main emission points of surface run-off from the cap.

**Plate 4-6 Damaged wind turbine and control room**

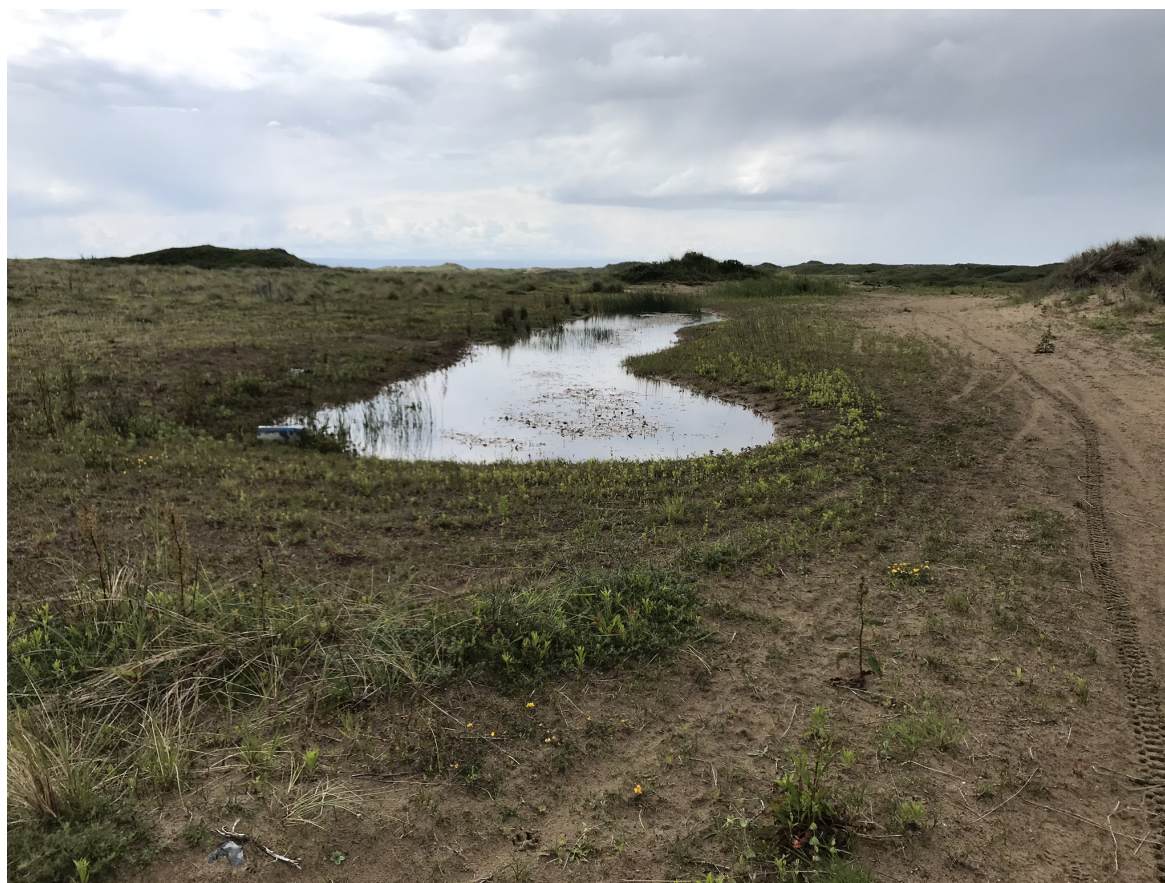
Some of the sand moved around the site by the wind has ended up in the topographic low points occupied by the ponds. As shown by the aerial image in Figure 6 and Plates 4-8 to 4-9, some of the ponds are significantly infilled. This sometimes results in localised over-topping of the linear pond arrangements resulting in wider, shallower littoral zones.

**Plate 4-8 Partially infilled pond on surface of MCL**

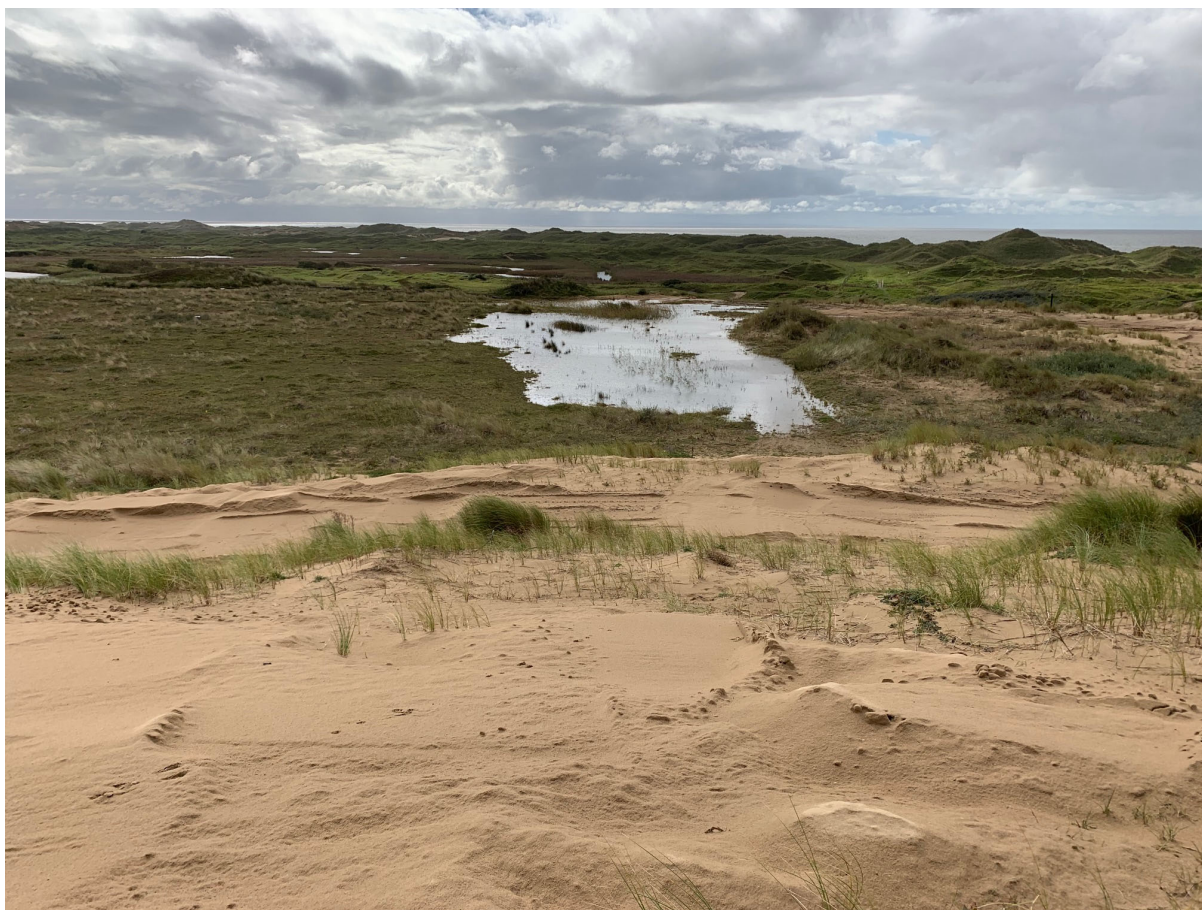
**Plate 4-9 Overspilling of Pond 7**

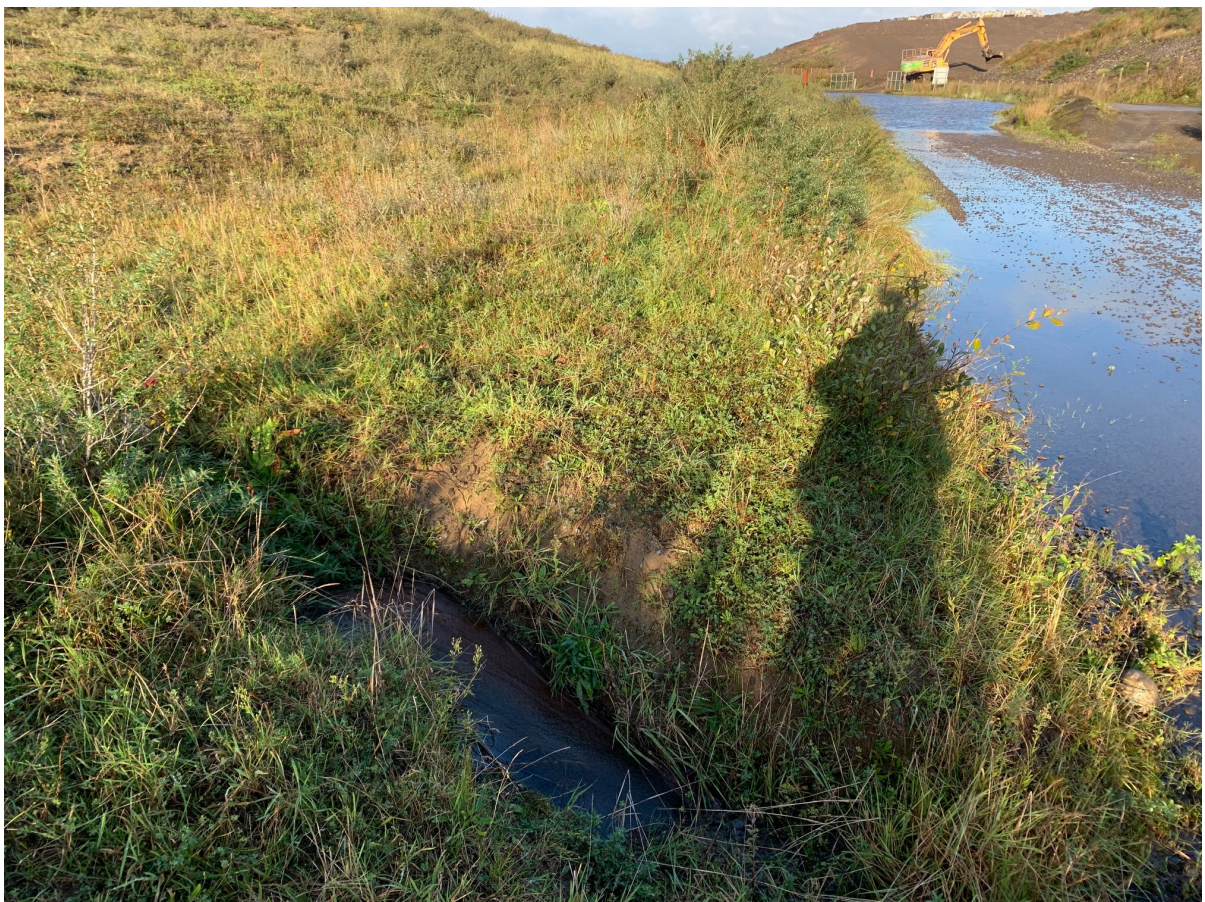
Inspection of the site reveals that recharge is occurring at several key principle emission locations, where rainfall captured on the surface of MCL is being passed to the wider environment. These areas are indicated on Figure 6 with further photographs of the processes occurring provided in Plates 6-1 and 6-2.

**Plate 6-1 Surface water ponding between toe of MCL (left) and Biocell (on right). Partly being caused by drainage channel overtopping at toe of MCL in foreground.**

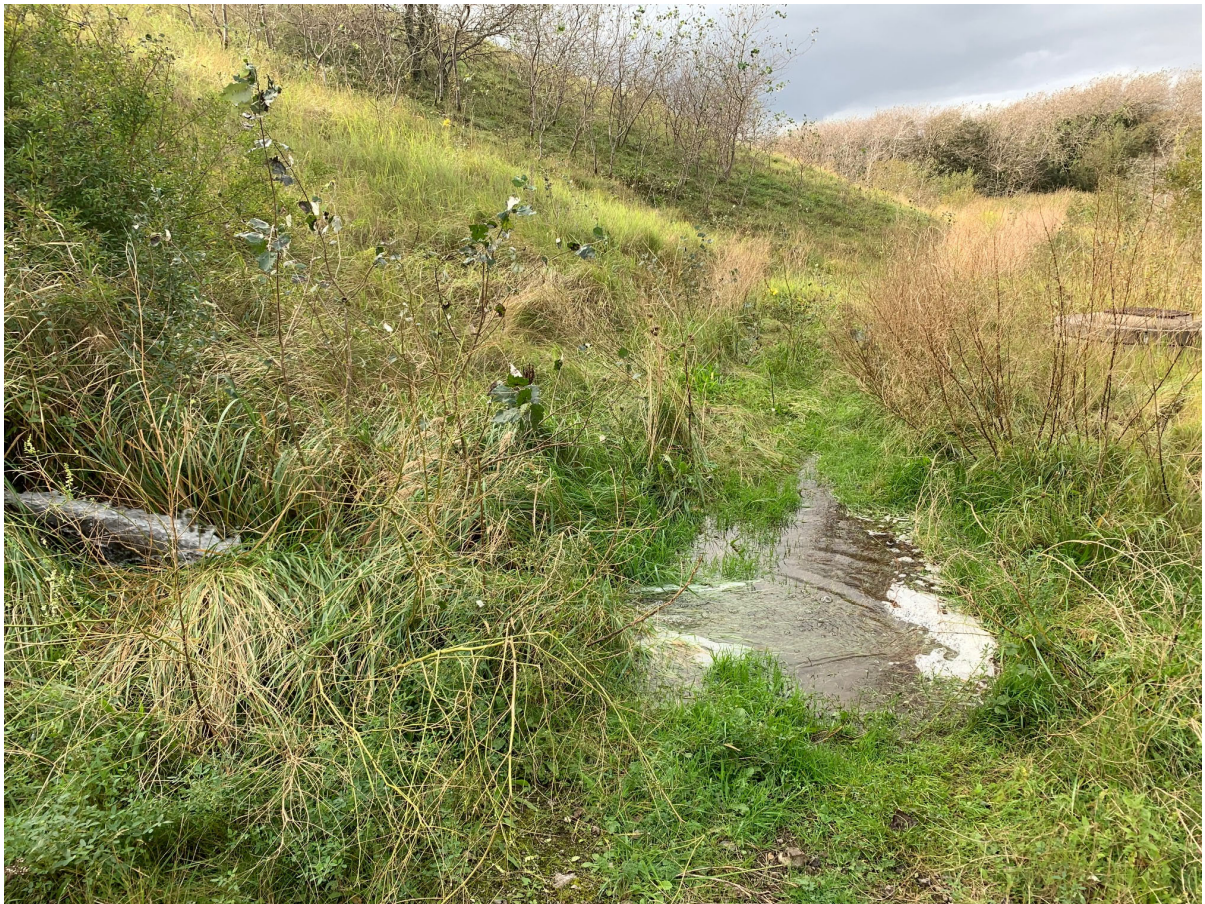
**Plate 6-2 Emission from Pond 2 (left) at toe of MCL draining northwards towards P10/P11 (Note recharge chamber on right of photo)**

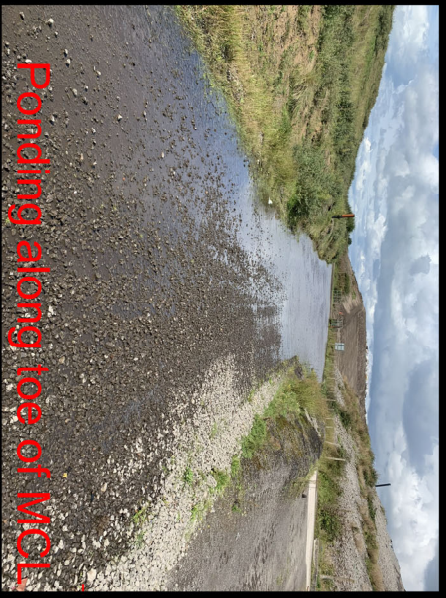
Ponding along toe of MGL

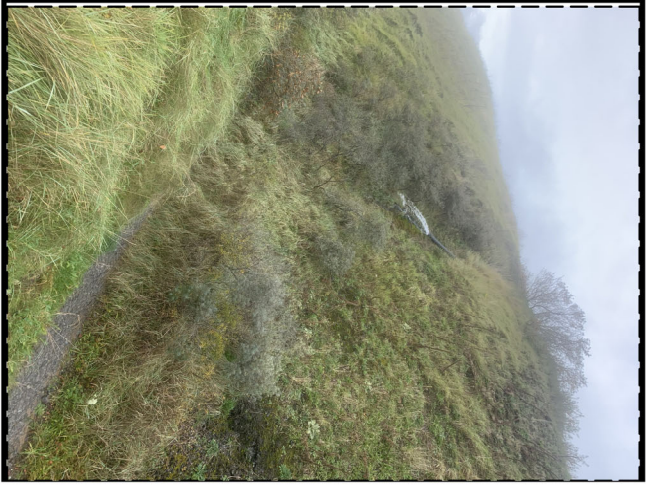
Runoff from Pond 3

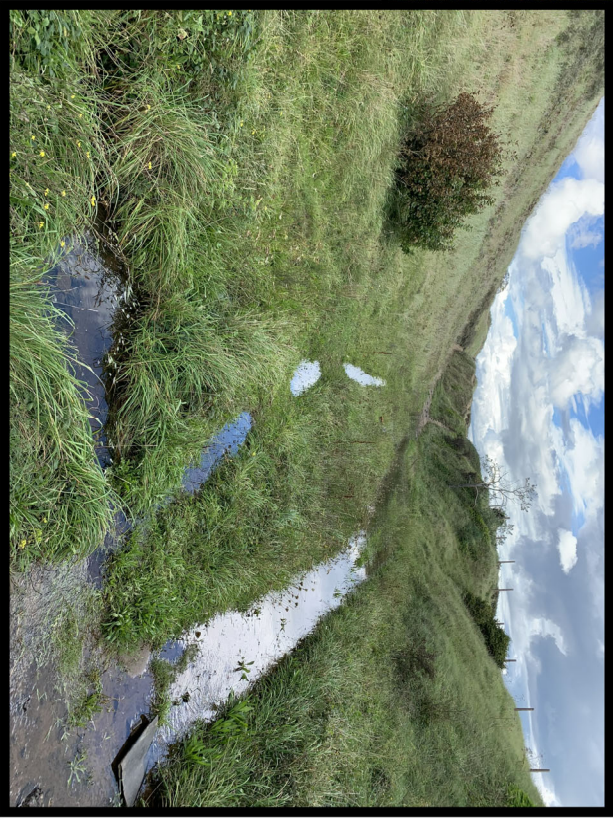
Discharge from Pond 4 and surface ponding
