## Compliance Assessment Report for: NRW0037068

| <b>Permit number</b> | BV7311IE | <b>Operator name</b> | Tata Steel (UK) Ltd. |

| <b>Site name</b> | Morfa Non Hazardous Landfill |
| <b>Type of assessment</b> | Site inspection & check sampling |

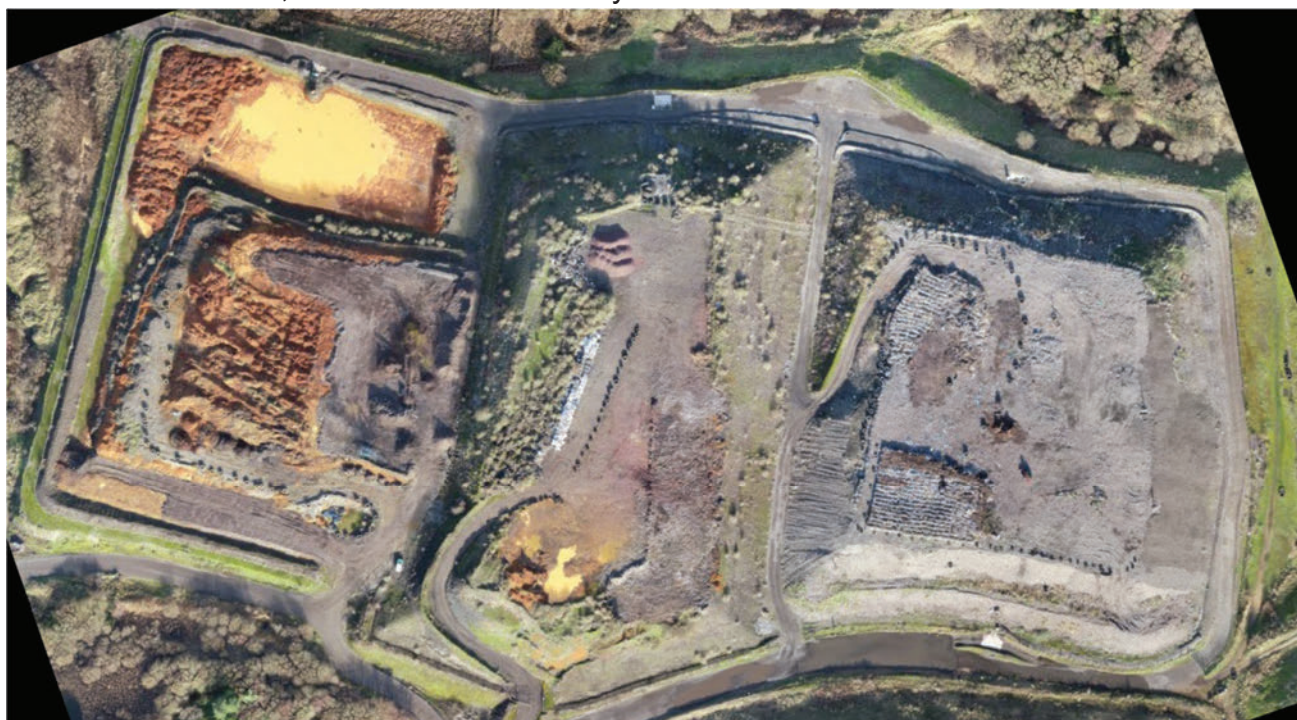
Figure 1: Aerial photograph (Dec 2019) showing from left to right: cell 2 (operational), cell 1 (full) and the bio-cells.

- Surface water ponding was not observed in any of the areas within the landfill, that I inspected.
- No issues relating to malodourous emissions, pests, visible dust or any other amenity related condition was observed during my inspection.
- No evidence of any banned<sup>1</sup> or prohibited wastes were observed during the inspection.

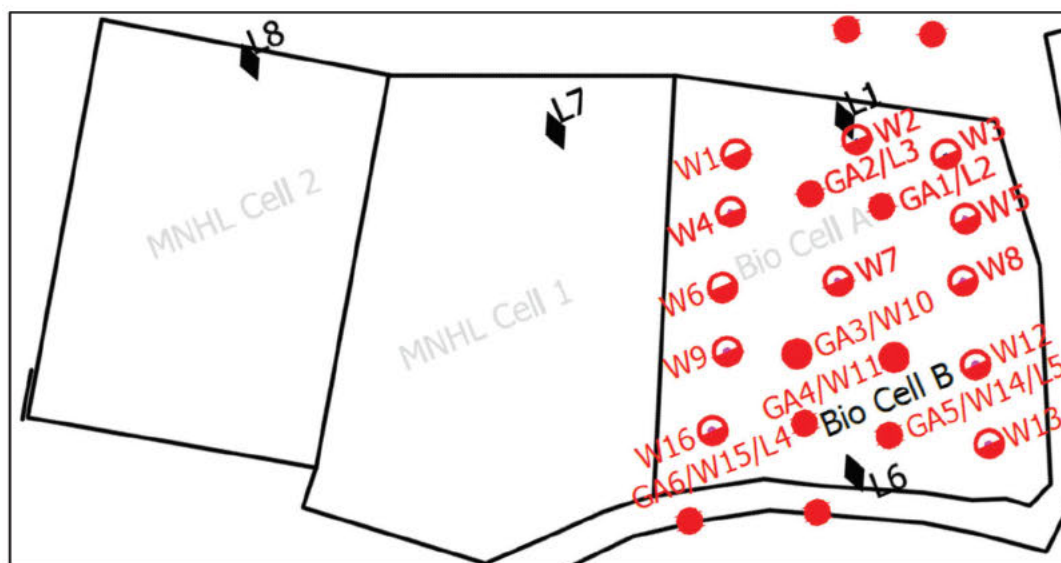
Figure 2: drawing showing location of primary<sup>2</sup> leachate monitoring points: L1; L6; L7 & L8. The Bio-cells also has additional dual purpose wells that function as leachate level monitoring points L2; L3; L4; L5; W10 & W11.

- Leachate level compliance has been problematic at the site over the last number of years, however this year the operator has succeeded in bringing all the cells within the landfill back into compliance<sup>3</sup>. This improvement is welcomed and is in part based on the operator's new leachate pumping system which was commissioned last year (see further details below).
- A check of the leachate levels in a random sample of the wells at the landfill was conducted by JD in my presence. Leachate levels were below the permit's compliance limits in all the monitoring wells that were dipped.

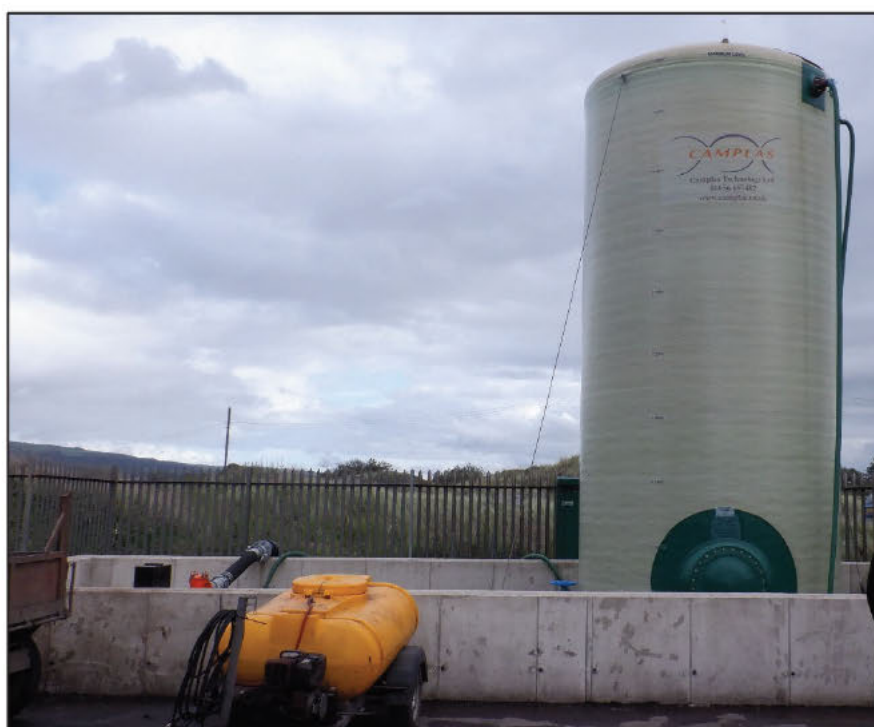
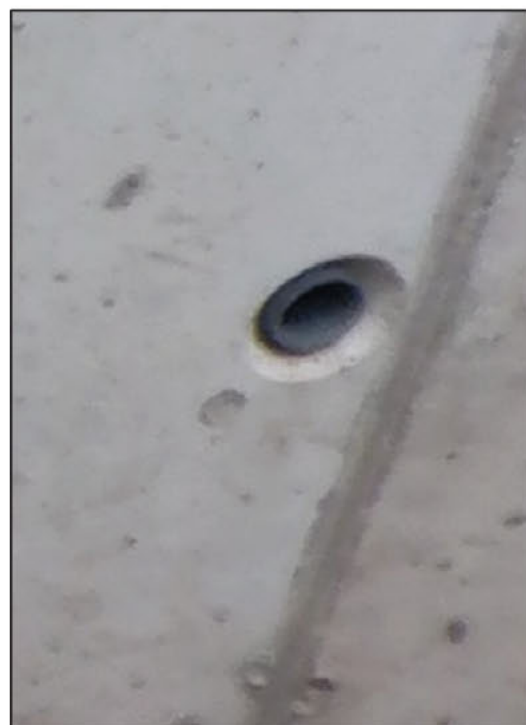
Figures 3 and 4:

- Leachate is pumped to a sealed holding tank sited within the landfill's transfer station compound. The tank is located within an engineered concrete containment bund which was designed to provide the required secondary containment (i.e. providing a containment capacity equivalent to 110% of the tank – should a tank failure occur). The tank is fitted with a vented lid in the event of gas build up. No malodorous emission was detected in or near the tank during the visit.

- A concrete sump (fitted with a pump) has been built into in the bund floor and this keeps the bund free from rainwater build up. The bund has been constructed with no pipe penetrations through the bund wall, the leachate pipework passes over the bund. The bund appeared free of standing water with no visual evidence of leaks noted.
- An inspection of the bund wall surface reveals several penetrations, these appear to have been sealed to some degree. It is unclear whether these penetrations pass through the entire bund wall or only partially (plastic caps conceal the aperture on the inside surface). Eitherway the operator needs to check these carefully to ensure that they are properly sealed. Any holes, even partial<sup>5</sup> ones should be sealed with suitable waterproof grout (flexible sealant or plastic caps are not normally considered suitable as they degrade). **ACTION**

Photograph showing leachate storage tank and bunding. Close-up photograph showing suspected partial penetration through the bund wall (operator to check).

<sup>5</sup> Penetration points are considered potential weak points in any bunding system and can, over time, progress to cause failure.

| Criteria | Action needed | Complete by |
|---|---|---|
| B4 | <b>Ref: 0037068.3</b> <ul style="list-style-type: none"> <li>Tata to check and seal all penetrations in the leachate tank's containment bund.</li> </ul> | 31 <sup>st</sup> Jan 2021 |

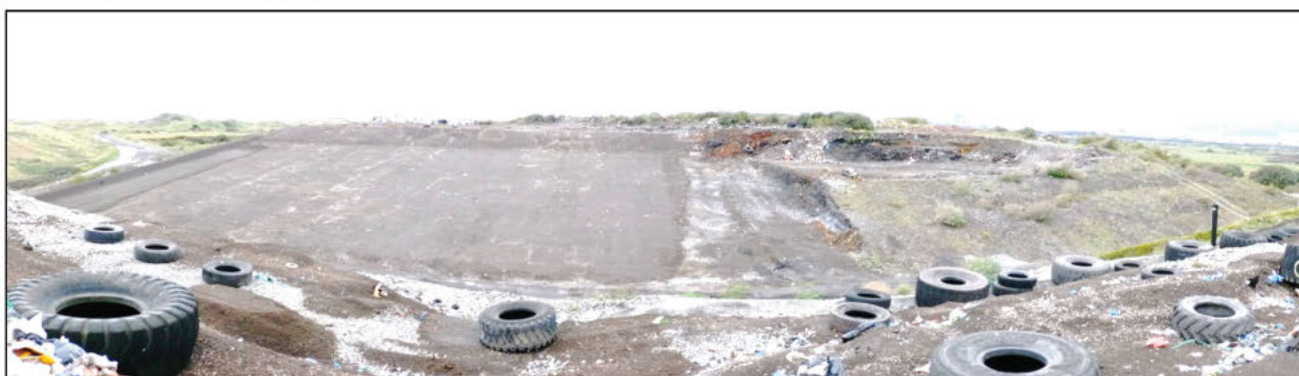
- My inspection of this cell was limited to a leachate level check (compliant) and a visual check of some of the flanks (satisfactory).
- This cell is full, although the eastern flank is being re-profiled as part of the void space extension project for the bio-cells (see later discussion). This re-profiling operation is presently suspended. However, about half of the work on the flank appears to have been completed (see figure 5). This prepared surface will form the formation layer for the barrier system which, once installed, will be used to separate the Biocell wastes.

Figure 5 Photograph showing eastern flank of cell 1. Left hand side shows area of flank already re-profiled.

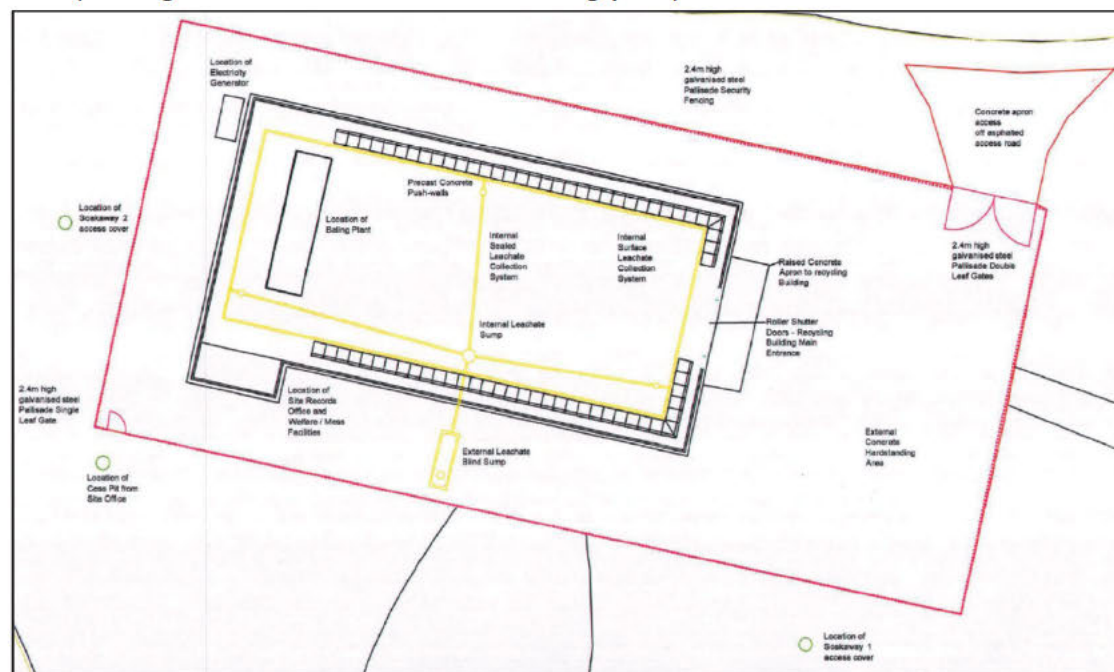
- Clean water from the yard and roofed areas is meant to be discharged into stone drains situated outside the site. It appears that water should also drain to a third French drain near the access gate. The drainage plan should be updated to reflect this (see figure 6 - taken from the working plan).

Figure 6. Working Plan drawing of site drainage

- Note: this suspected third drain requires some maintenance as water is not draining freely from the yard. It should further be noted that the daily inspection records indicate that no issues with the surface water drainage system was identified during the daily inspection. This is not likely and staff should be reminded of the requirement to keep accurate records.
