**MORFA NON-  
HAZARDOUS LANDFILL,  
PORT TALBOT**

**PERMIT BV7311IE**

**2020 Annual Review of  
Environmental  
Monitoring**

*Report Number 2092r1v1d0221*

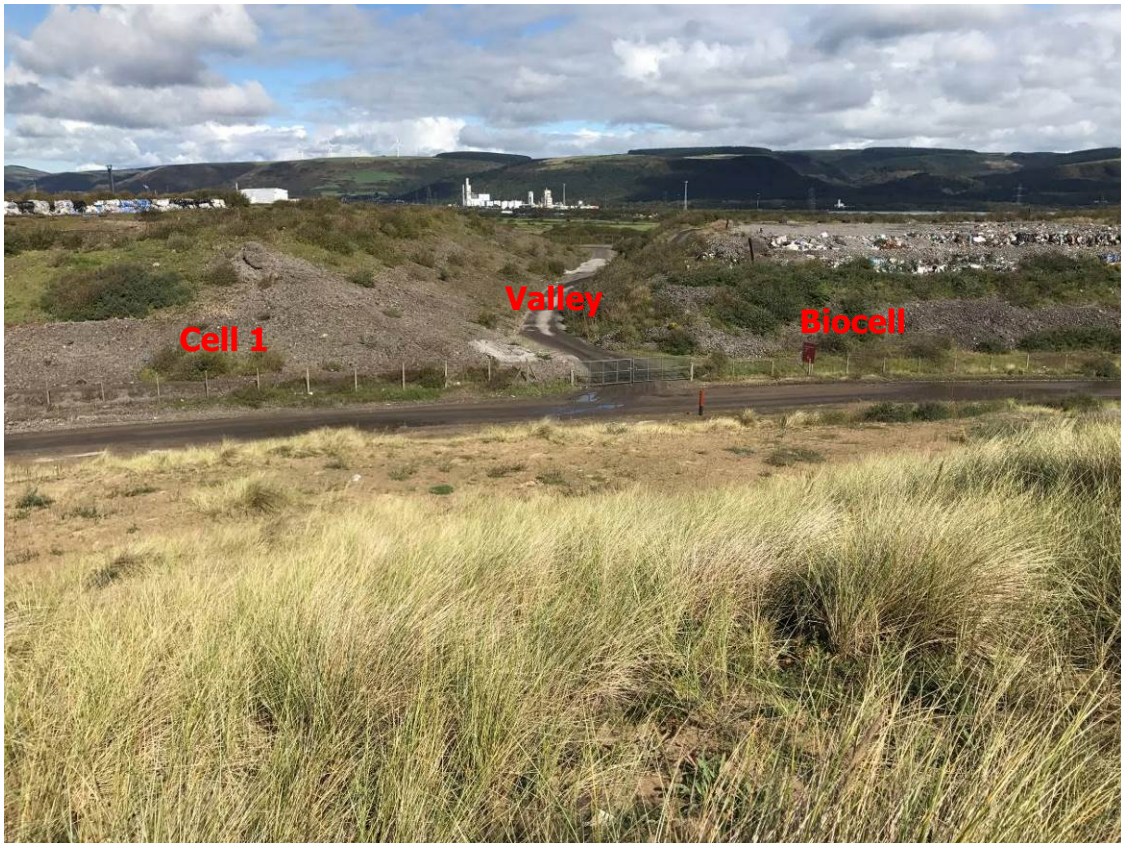
The existing Biocell is separated from non-hazardous Cell 1 by a deep narrow valley where the opposing south flank of Cell 1 meets the north flank of the Biocell, as shown in Plate 6-1. The approved restoration contours for the landfill require that this valley is infilled to produce a single elevated landform. To secure additional biodegradable void space, NRW has approved a cut into the upper part of the southern flank of Cell 1 and extension of the biodegradable waste cell lining system into the void to provide sufficient biodegradable waste capacity to 2028. Once the new cell area is available for waste disposal, the completed areas of the Biocell must then be restored by December 2021. At the time of writing, approximately 50% of the biocell extension has been completed. This is referred to as cell Ci.

**Plate 6-1 View north towards Non-hazardous Cell 1, valley feature and Biocell**

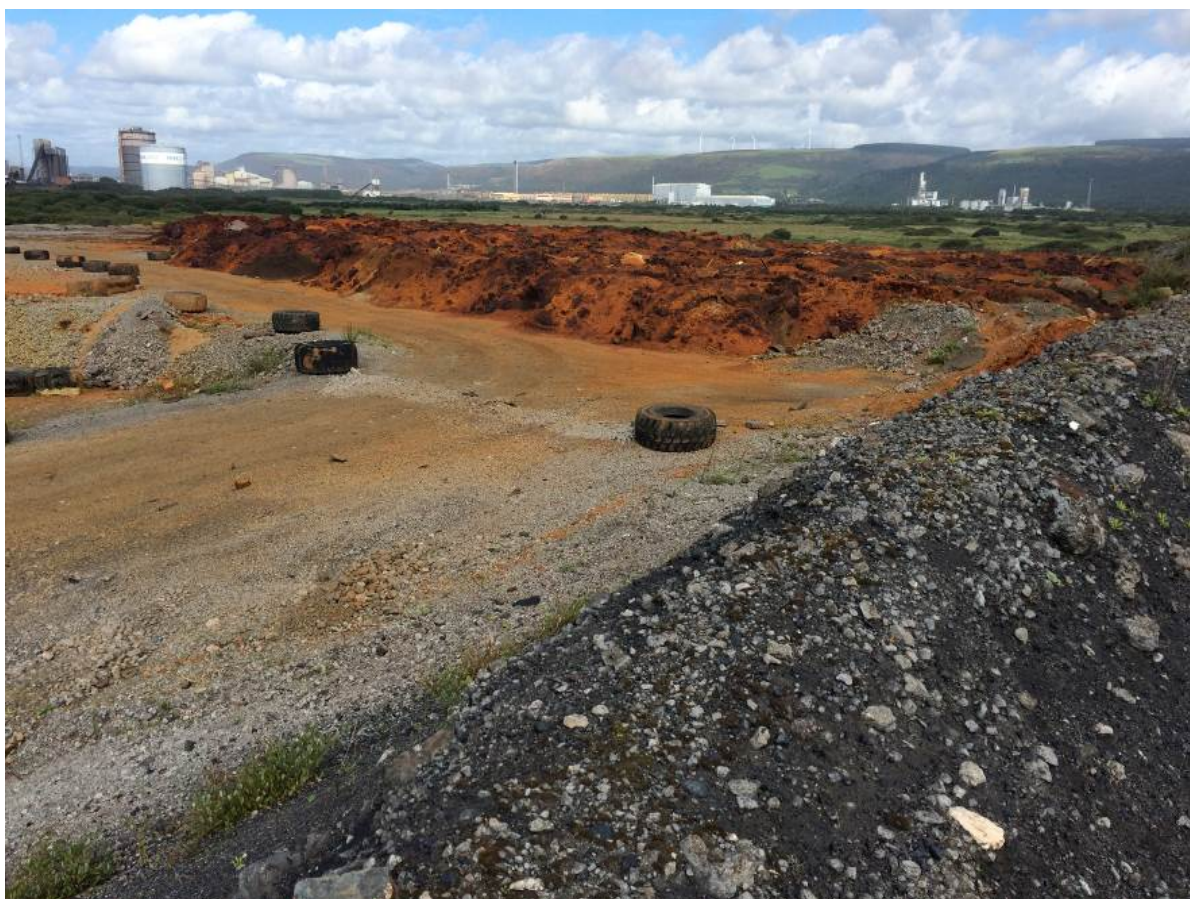
Since October 2008, hot mill sludge (HMS) filter cake generated by the steelworks has been landfilled in Bio Cell B. This process has subsequently continued at a rate of approximately 500-700 tonnes/month. In accordance with Improvement Condition 1 of the Variation Notice this prompted the monthly monitoring of Benzo(a)pyrene (BaP) on samples collected from sump L6. In September 2010, this data was reviewed by Geotechnology to establish whether BaP control levels were required (see report 993r1v1d0910). As the data showed that BaP was not detected in the leachate, control levels were not considered to provide additional environmental protection. Benzo(a)pyrene has continued to be present in leachate below the analytical detection limit.

**Plate 6-2 View North over MNHL Cell 2. Note dominance of iron rich filter cake**

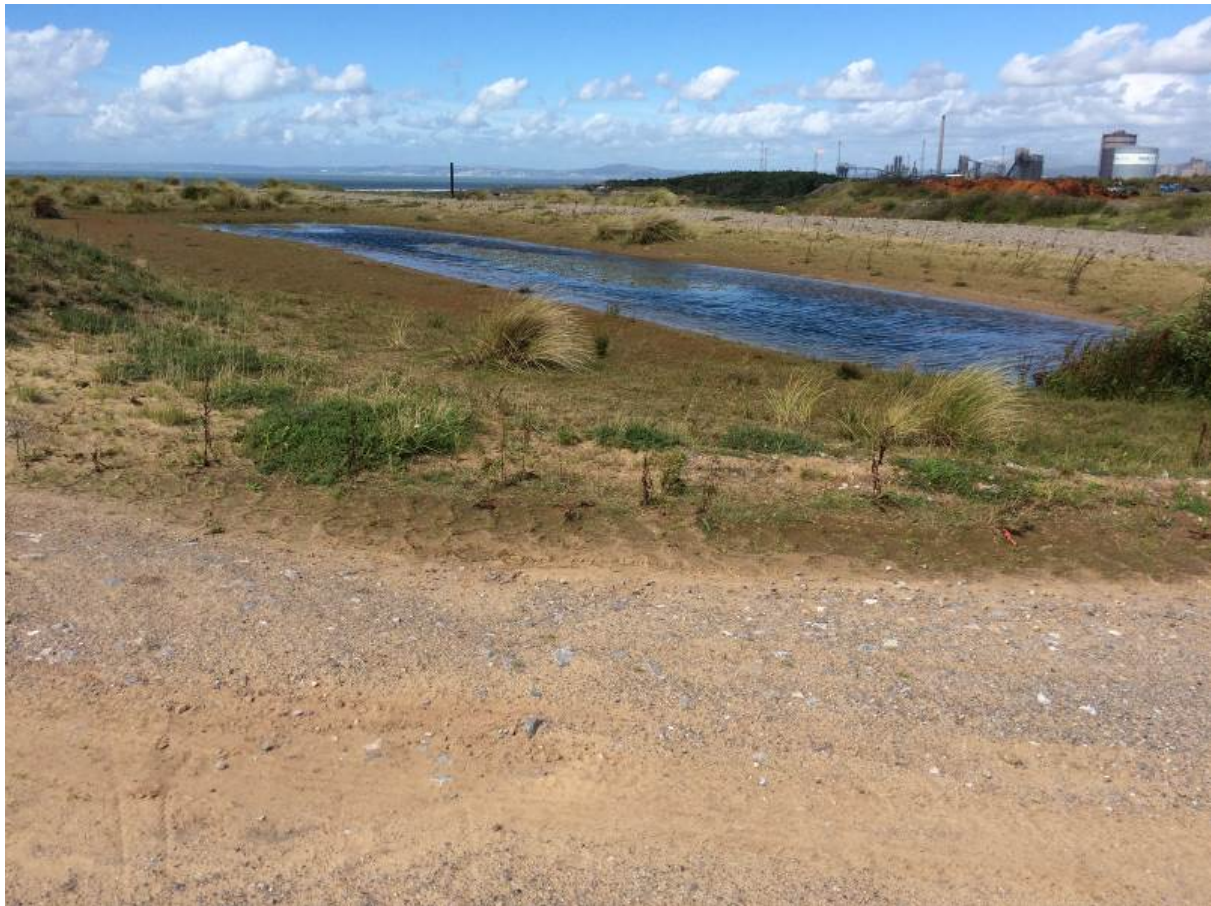
Phased restoration of unlined MCL was undertaken between 2004 and 2013. The restoration involved the placement of site won dune sand over the plateau and parts of the re-profiled slopes. Below the sand, the restoration scheme involved placement of geomembranes which, in combination, provide gas and surface water management as well as providing barriers to precipitation ingress and gas egress. The sympathetic restoration also involves the placement of sand on top of the geomembranes, creating dune morphology like the surrounding land.

**Plate 6-3 Typical restoration profile on surface of MCL**

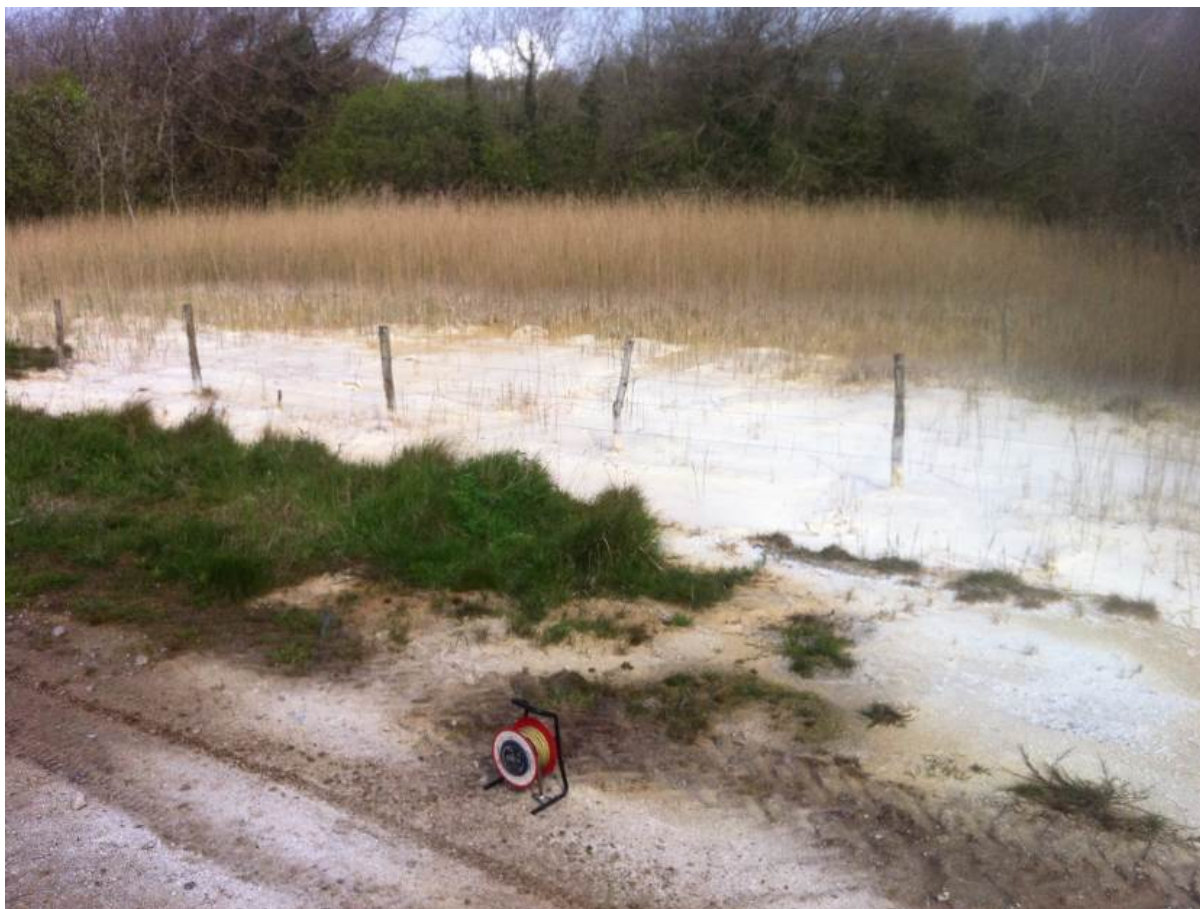
has been previously observed in response to changes in shallow groundwater levels. NRW has approved the covering of these areas with site won sand to limit direct access.

**Plate 6-4 Accumulation of secondary precipitates adjacent to MCL  
(between BH17 and P12)**

NRW has also provided support in principle for a new way of operating the recharge trench system. This new approach, involving a more passive system, is currently being designed.

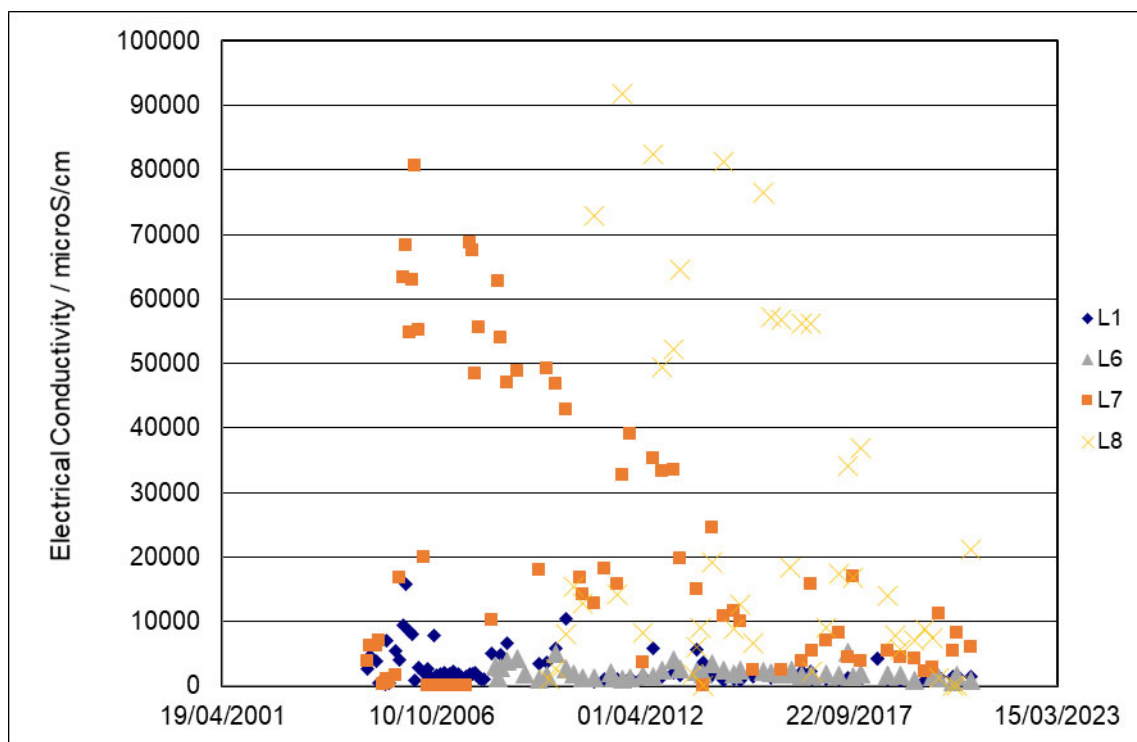
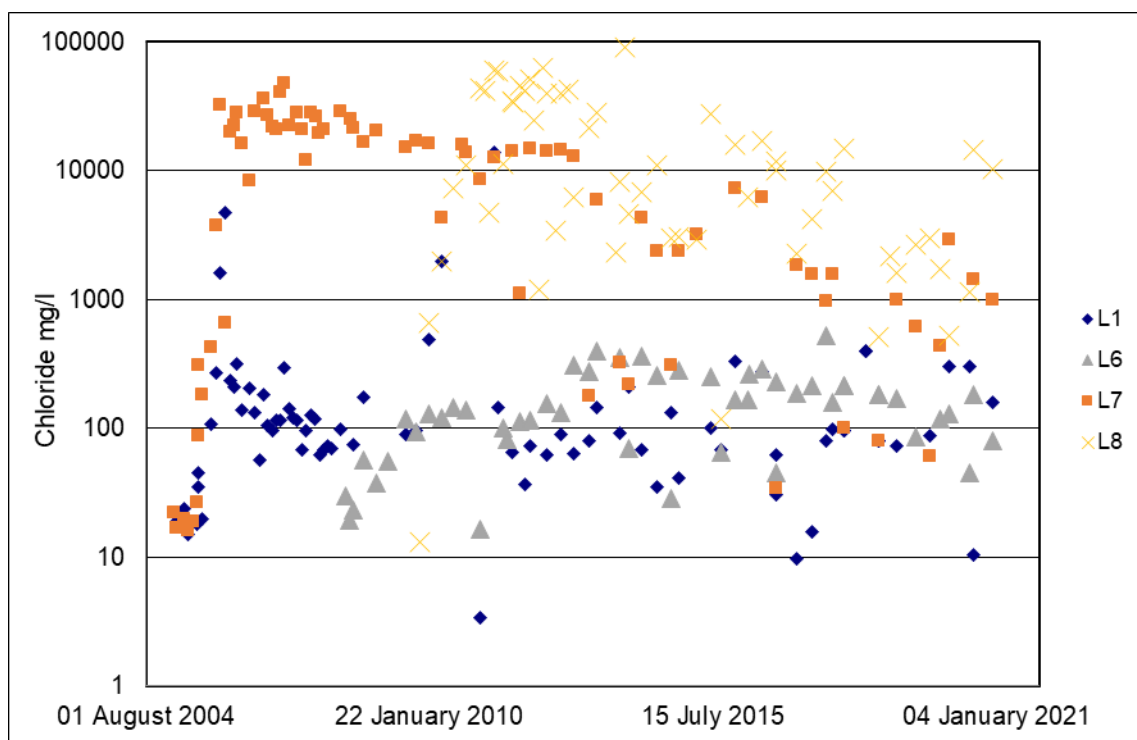
As noted previously, the leachate has continued to become more dilute with the electrical conductivity declining, most likely because of dilution due to high rainfall and previously persistent high leachate levels. The lower mineralisation is characterised by lower levels of ammonia, calcium, alkalinity and most notably chloride (see charts below of selected chemistry).

**Chart 8-2 Comparison of leachate chemistry**

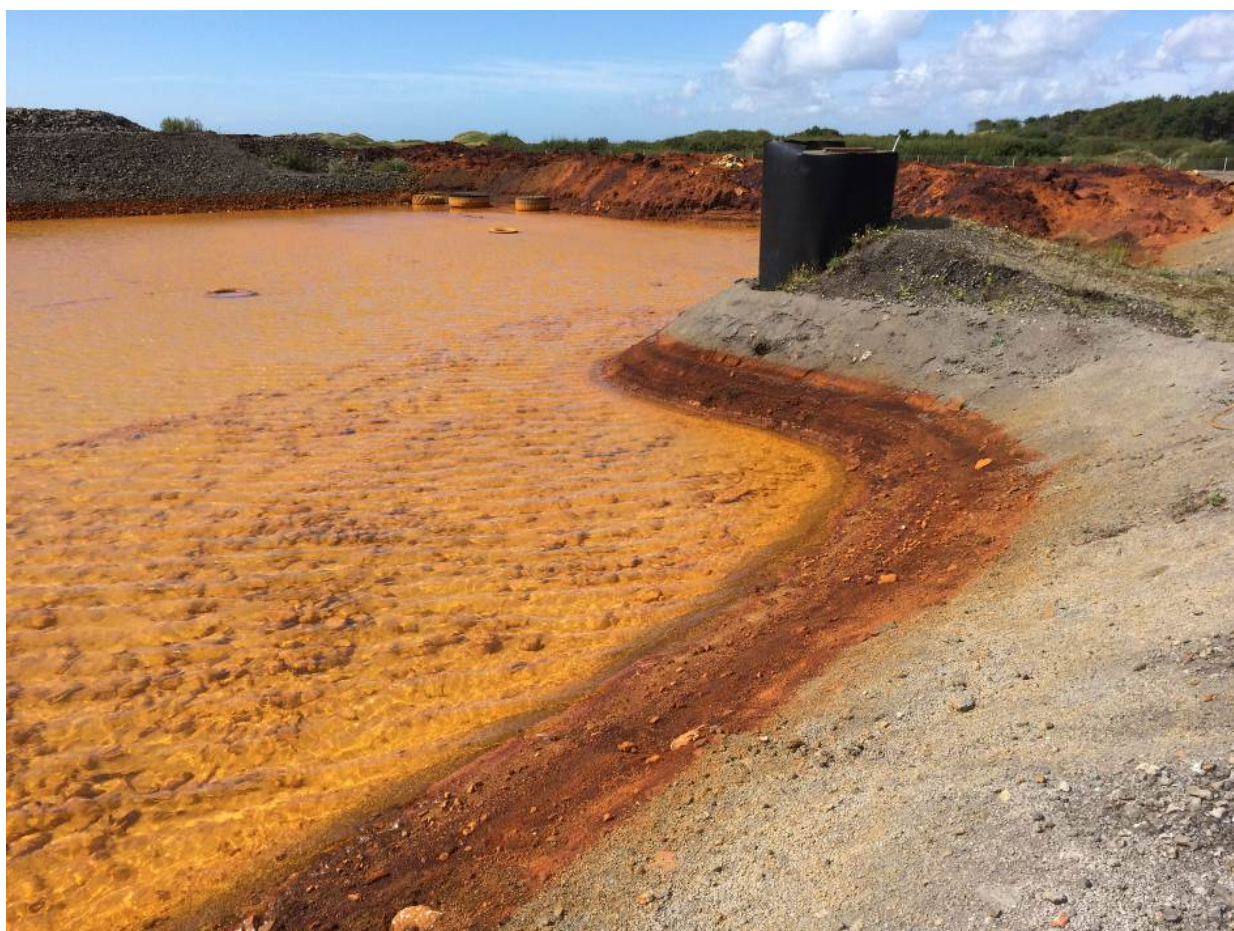
Filter cake (EWC code 11 01 10) has been placed into Cells 1 and 2 (with leachate draining to sumps L7 and L8) at a rate of approximately 500 - 800t/month since the start of monitoring. Produced by the lime neutralisation of acidic ferrous chloride and pickling solutions at the cold mill effluent treatment plant, the waste principally comprises iron oxyhydroxide chloride phases, calcium chloride, iron chloride and mixed oxides. Within the landfill, the soluble components of the waste are leached by infiltration. This process is suspected to be the main source of the elevated levels of chloride and calcium. As the waste becomes buried and less oxygenated, the oxyhydroxide iron phases may also start to undergo changes. Some may start to age and crystallise, forming more stable iron oxide phases and some may undergo reductive dissolution in anaerobic conditions that may be present in parts of the landfill. This latter process could potentially release iron into the leachate along with other trace metals adsorbed to the iron precipitates.

**Plate 8-1 Cell 2 leachate sump L8. Note staining due to iron.**

This latter process was previously considered to be occurring within Cell 2 at L8, as iron significantly increased in concentration from <1mg/l to over 1000 mg/l during the latter part of 2012 and was elevated on several occasions during 2013. At the same time, the leachate sampled at sump L8 was found to be green in colour and the laboratory measured pH variable over a relatively brief time i.e. dropping from over pH 11 to pH 4 and then returning to pH 11 within 12 weeks (see chart below). Similar patterns were observed during 2014, 2015 and 2016. During 2019 and 2020, these variations were less pronounced.

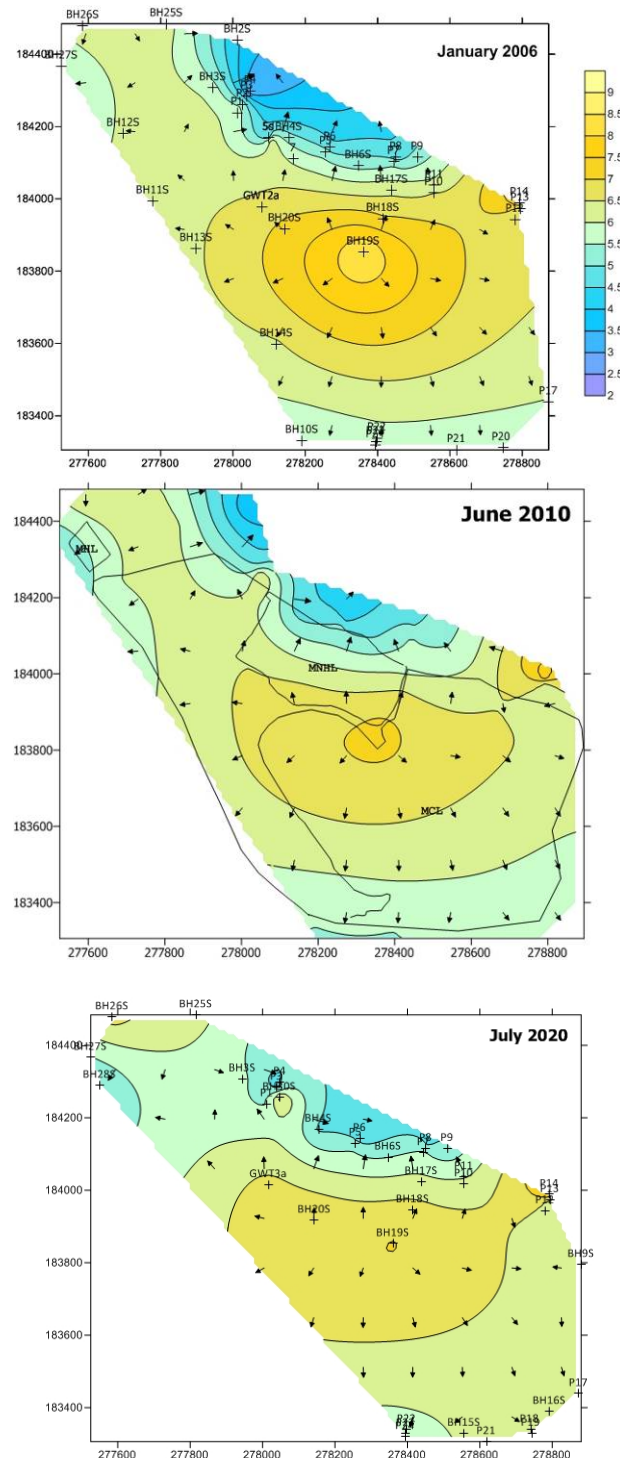
Groundwater levels in the shallow and deep aquifer are presented in Appendix 5 and Plate 9-1. The patterns of groundwater flow encountered during 2020 are very similar to those observed previously.

**Plate 9-1 Shallow Groundwater Level Contours**

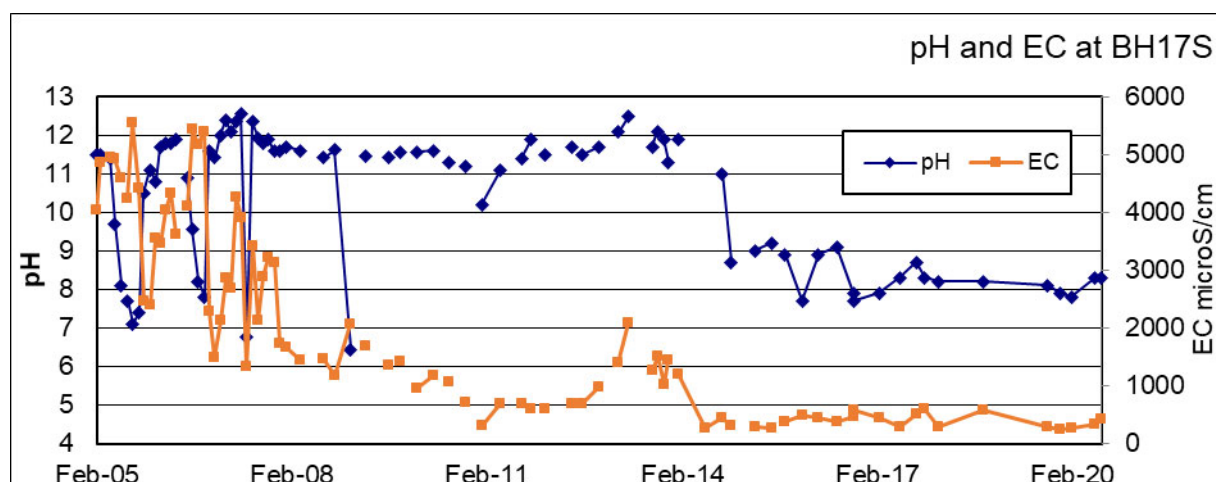
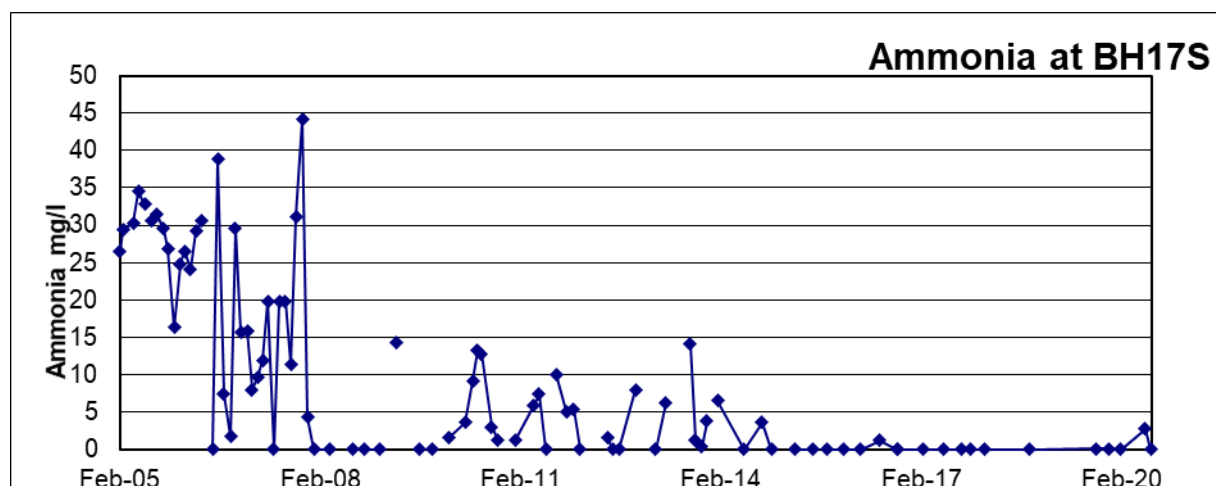
The monitoring programme continues to confirm the diminishing impact of leachate from the adjacent unlined but capped MCL on groundwater directly upgradient of MNHL. Over the past few years, upgradient groundwater along the northern boundary of MCL has shown a sustained decrease in mineralisation, suggesting an overall change and improvement in water quality, most likely due to capping. This is most obvious at monitoring positions BH17S-BH20S which are directly upgradient of MNHL and downgradient of MCL. More recently, similar changes have started to be observed to the south of MCL, as shown in Charts 9-1 and 9-2. At these positions, there have been sustained decreases in the concentration of several parameters including pH, Electrical Conductivity, ammonia, chloride, calcium, alkalinity and Chemical Oxygen Demand (COD) in the shallow aquifer as shown by the time series charts in Appendix 6 and selected charts below. With time, the water quality is likely to become less alkaline as less slag-based waste is exposed. As the water quality changes, trace metals may potentially become slightly more mobile and this may explain some of the impersistent variations in trace metal concentrations.

**Chart 9-1 Temporal variation of water chemistry at BH17S**

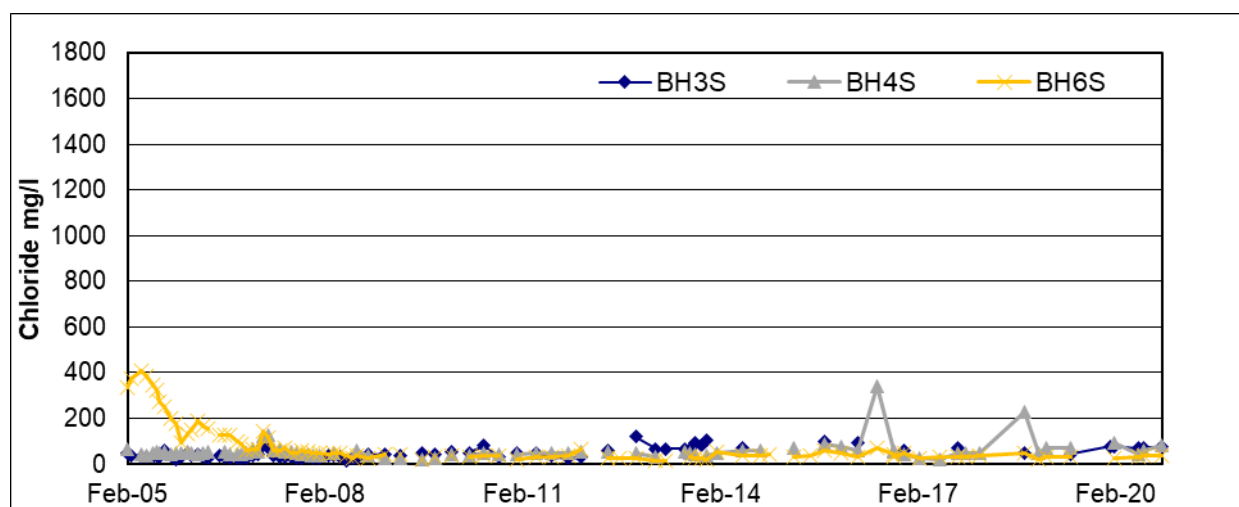
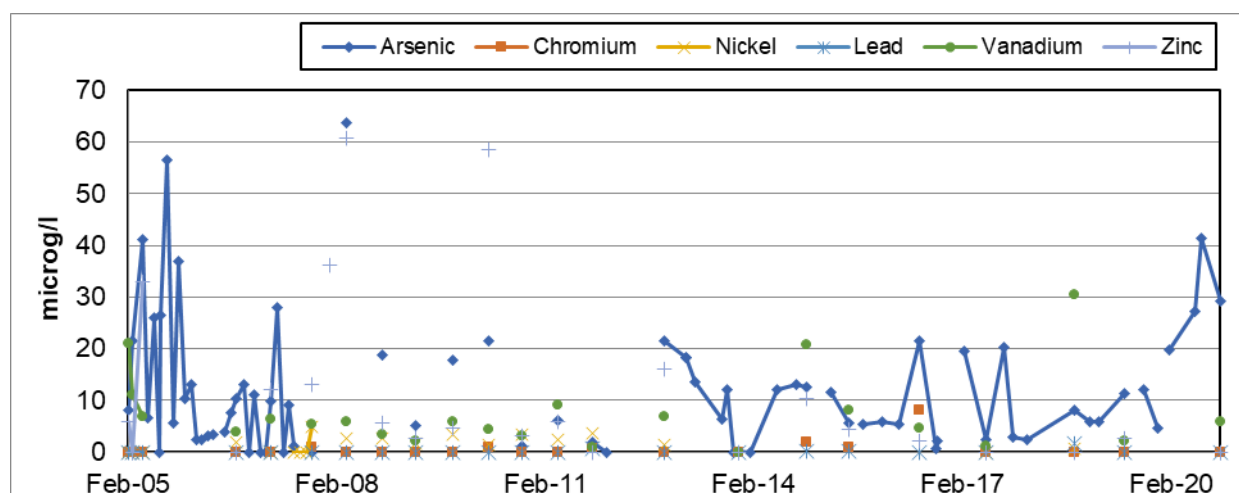
**Chart 9-2 Temporal variation of water chemistry around edge of site**

In the shallow aquifer downgradient of the active cells, samples of groundwater have for some time revealed relatively short-term increases in alkalinity. These are considered to be related to the leaching of alkaline components from MCL, other areas of unlined waste and variations in shallow groundwater levels. Short-term variations in the concentration of ammonia and calcium may also be due to the same processes. There is no evidence to suggest seepage from MNHL is the cause as chloride, a key indicator of leachate is not sustainably increased. Groundwater quality downgradient of MNHL, along the boundary with Margam Moors SSSI (BH3, BH30, BH4 and BH6) is like the upgradient chemistry observed at GWT3A and BH17S – BH20S. At BH30 and BH4, the groundwater is less mineralised than groundwater to the west at BH3 and to the east at BH6. This may be indicative of variations in shallow groundwater quality caused by the occurrence of the springline to the west and historical seepage from MCL to the east.
