**This form will report compliance with your permit as determined by an NRW officer**

| Site | Port Talbot Steelworks | Permit Ref | BL7108IM |
| Assessment type | Check Monitoring | | |
| Parts of the permit assessed | 2019 BF Bleeder Events root cause & 2019 PCDD Monitoring deficiencies. | | |

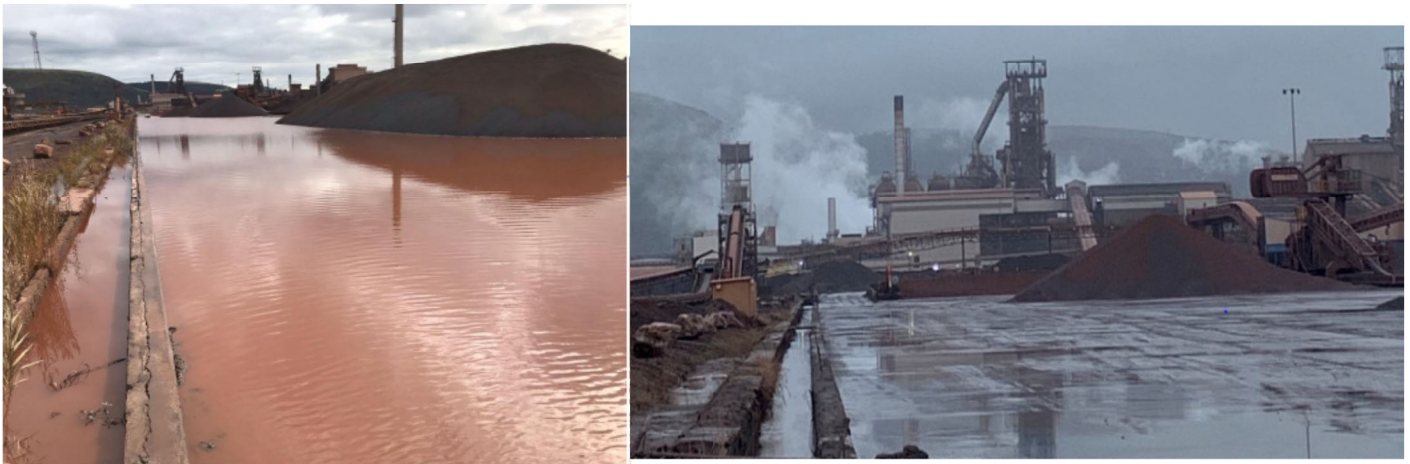
Note: the improvements to the drainage system were tested earlier in 2020 following a period of heavy rain (Storm Dennis). The heavy rain over this period did not overwhelm the newly cleaned drainage system. This is illustrated in the following photographs.

*Photographs showing before and after improvements to drainage systems*

There should have been a regular and robust inspection/ maintenance regime in place to ensure efficacy of the site's drainage system. This failure is considered contrary to **conditions 1.1.1a and 2.3.1a** of the permit. As this is only one of several contributory factors that caused the bleeder events, we have categorised this failure as a minor breach. A compliance classification score (ccs) of 3 has been attributed to this breach (against the b3 compliance heading).

- The stockyards drainage system has now been subject to an extensive deep clean and it is understood that all blockages have been cleared.
- Some drainage infrastructure has been replaced or upgraded (e.g. French drain cleaning and manhole cover repair).
- A revised procedure has been developed and a task placed on TATA's 'SAP' plant maintenance system to ensure thorough inspections of the drainage system will be undertaken on a regular basis (quarterly).
- TATA is in a stronger position to react to future heavy rainfall events and can call on the provision of extra emergency pumps should the need arise.
