## Compliance Assessment Report

Report ID:  
CAR\_NRW0036724

| Site | PB Gelatins EPR/DP3030ZC | Permit Ref | DP3030ZC | | |
| Date of assessment | 29/05/2020 | Time in | 10:19 | Out | 11:55 |

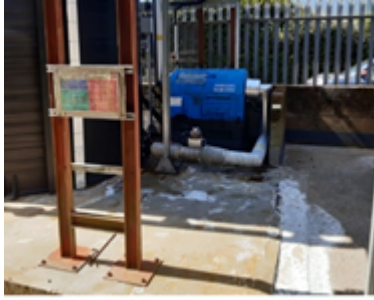
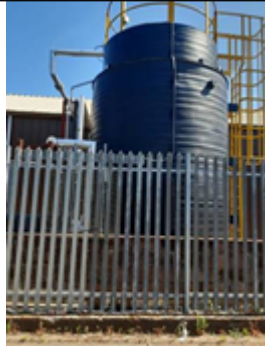
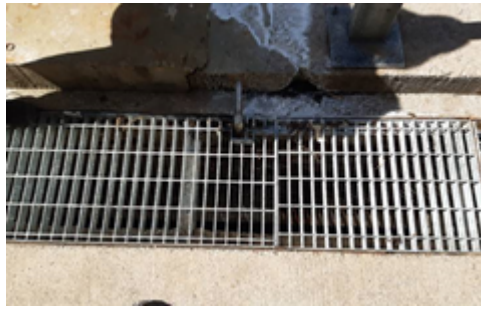
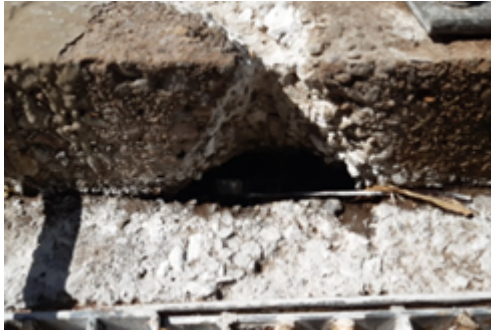
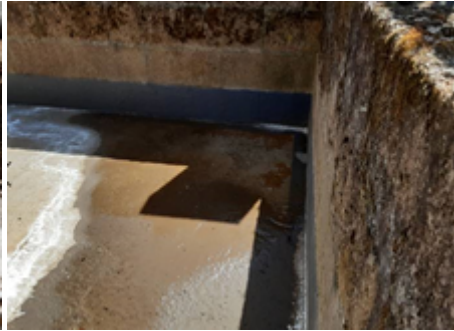
I arrived at the site in Treforest at 10:20 on Friday 29<sup>th</sup> May and met Julie Campbell and Mauricio Caetano Ramos at reception. We walked over to the area of the site where the incident occurred (The Farm). The area consisted of three large double skinned tanks adjacent to the site's perimeter fence. The area cannot be accessed by the public and is secured behind a locked gate. The middle tank, designated for caustic storage, is where the incident took place. The tank itself is a double bunded HDPE internally bunded tank with auto-dosing and above ground delivery pipework. The secondary containment is provided by an integrated HDPE bund attached to the primary tank and concrete hardstanding below the pipework. There are 900mm high concrete block masonry walls to three sides of the tank with large channel drainage which discharges to the industrial effluent sewer to the fourth side. The bund drain is piped to the effluent channel drain, which could be used if a spillage within the bund was to be detected. According to PB Leiners permit application, the masonry walls and channel drainage provide a degree of tertiary containment which would contain minor spillages outside of the main bund. The corresponding pipework and Chem Guard (Housing the valves and pumps) are located adjacent to the Caustic Tank and within the tertiary containment.

The remnants of the spill were obvious upon reaching the area. A white trail of dried Caustic could be seen from the Chem Guard to the Effluent Drain. Within this area several significant cracks and holes in the concrete floor could be seen. Additionally, dry residue and liquid could be seen around the whole of the tank, with a pool of liquid located adjacent to the tertiary wall mentioned above.

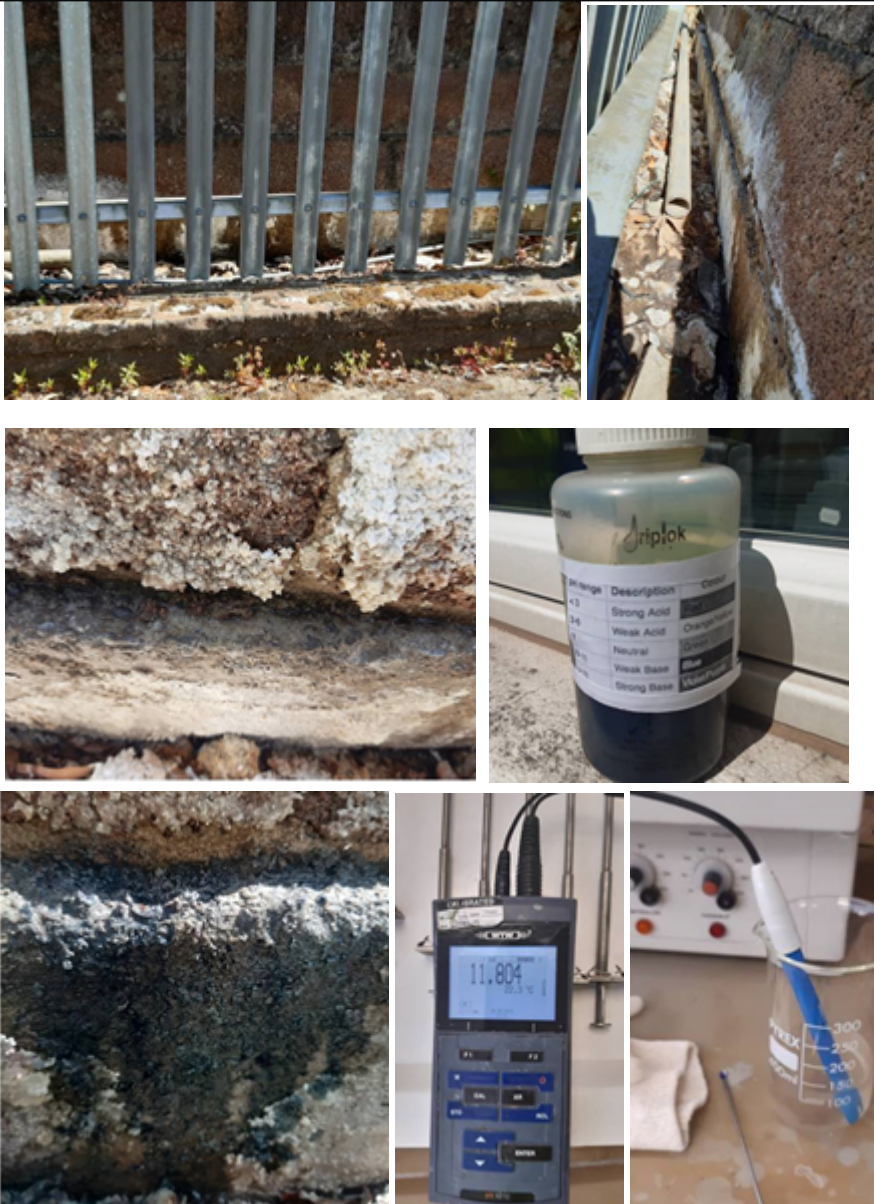
Finally, we walked out onto the public path located on the opposite side of the 900mm high concrete block masonry walls mentioned above. Upon close inspection, damp and dry patches of white residue were evident over a several metre expanse of the wall and soil at the base of the wall. These patches were located at the same height as the floor on the opposite side of the wall (the floor where the caustic had spilt). Since the other sections of the wall either side of the caustic tank were free from these patches it was thought prudent to test the liquid and the white solid to see if they were a result of the caustic spill. Julie Campbell was able to retrieve a pH indicator solution from PB Leiner's Laboratory. We sprayed a damp patch of the wall with the indicator and waited for the colour change. Within a few seconds the colour changed from green to dark blue/purple indicating a high pH. Following this Julie removed a portion of the white solid and took it to the Laboratory for a pH test. The chemist at the lab dissolved the solids in deionised water and used a pH meter to analyse the solution. The result of which was a pH of 11.8 indicating a strong alkaline solution. These results had indicated that the 900mm high concrete block masonry walls used for tertiary containment had failed.

Although the area of contamination was relatively small and confined, the soil at the base of the wall was highlighted as a pathway for the contamination to reach the subsoil and groundwater within the local environment. Even though there was no evidence of caustic on the public footpath or road, given the extremely close proximity of the public footpath, had it been raining there would have been a significant chance that highly alkaline liquid may be created and spilt onto the public footpath and neighbouring surface water drains. Consequently Public Health Wales were informed of the incident.

**Action 6:** Remediate the cracks and holes within the impermeable concrete surface and the brick wall with immediate effect. Look into the use of chemically resistant products for both areas. Within the area there are tanks that contain Caustics and acids. Identify a product that can withstand both chemicals.
