Appendix C: Geomorphology Photo Survey (3rd November 2020)

Table C-1 Geomorphology Photo Survey

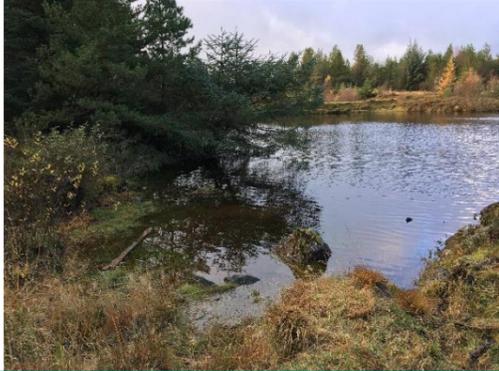
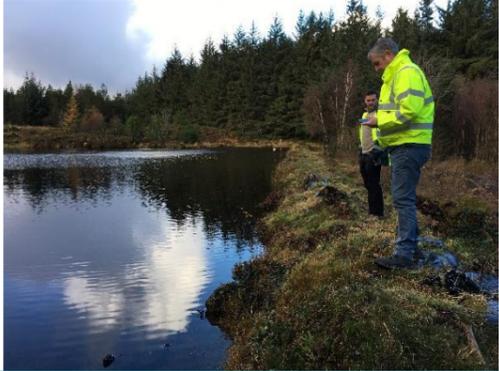
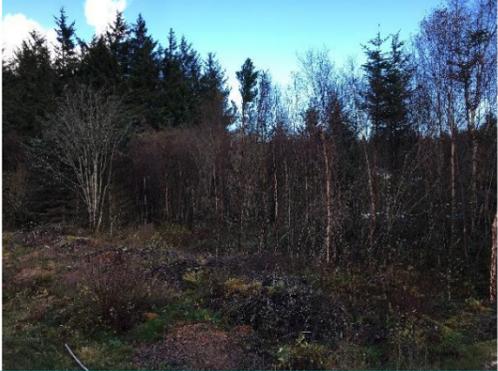
Location and Description	what3words reference	Orientation of Photo			Observations
		Upstream	Cross-Stream	Downstream	
1 – Pen y Gwaith Reservoir – existing spillway	///shady.filer.throat

<ul style="list-style-type: none"> • The reservoir water was noted to be particularly clear with vegetation growth along the water margins. • Mixed sediment sizes were noted on the bed of the reservoir, ranging from fine sediment to small boulders. • The existing spillway was extensively overgrown with established vegetation. • The dam embankment was vegetated and spongy underfoot.
2 – Pen y Gwaith Reservoir - North East Dam	///erupts.drifter.airbase

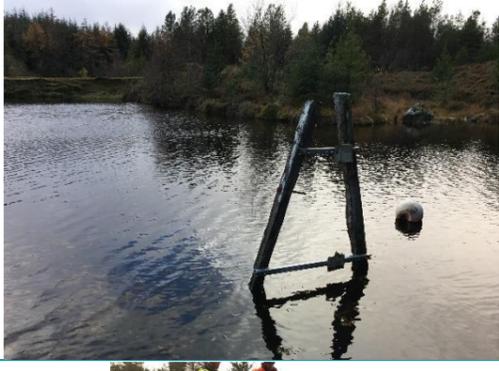
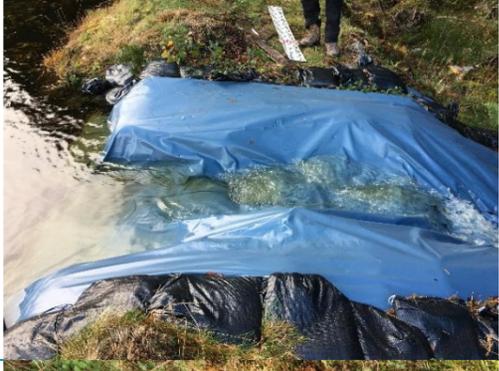
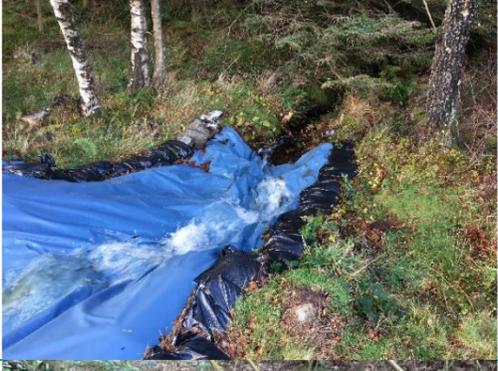
<ul style="list-style-type: none"> • The temporary spillway erected on the North East Dam appeared in relatively good condition with some minor scour noted at the base of the temporary spillway. • The dam was also vegetated and spongy underfoot in this location.

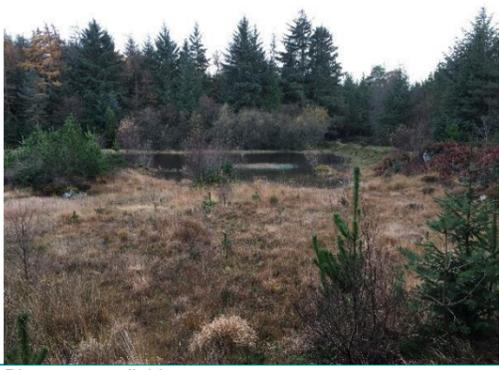
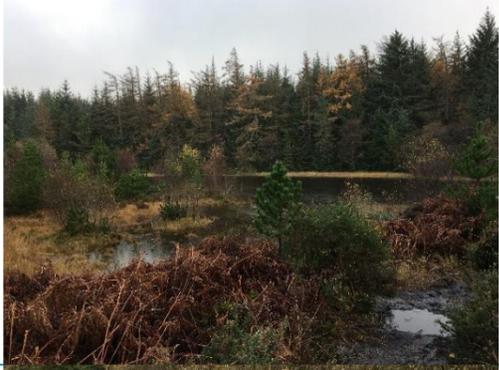
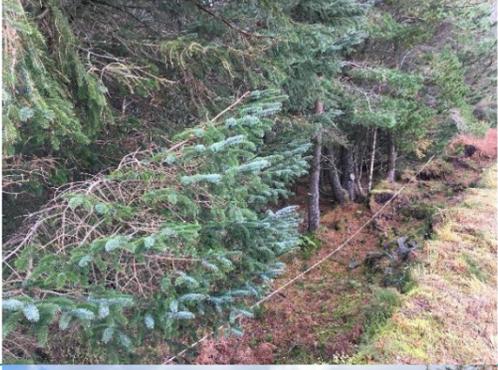
<ul style="list-style-type: none"> • Extensive vegetation was observed within reservoir from the embankment including trees. • No obvious in flow to the reservoir was observed. • The embankment was vegetated. In comparison to the North East Dam, the embankment felt firm underfoot.
6 – Pen y Gwaith – Embankment A	///emulated.chemistry.petrified	Photo not available

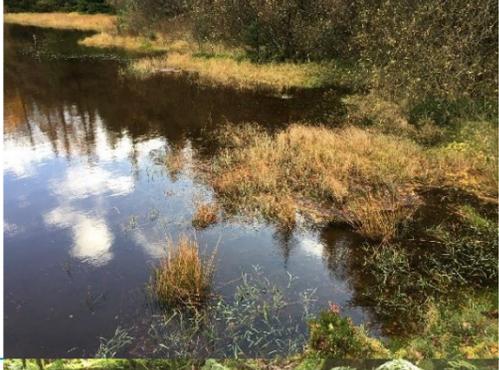
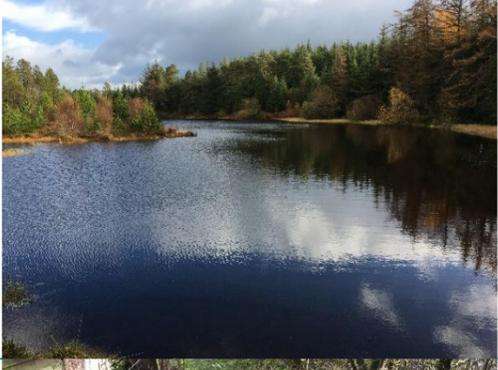
<ul style="list-style-type: none"> • Vegetation was observed within reservoir from Embankment A but significantly less established than observed from Embankment B. • No obvious in flow to the reservoir was observed. • Embankment A appeared in a similar condition to Embankment B. In comparison to the North East Dam, the embankment felt firm underfoot.

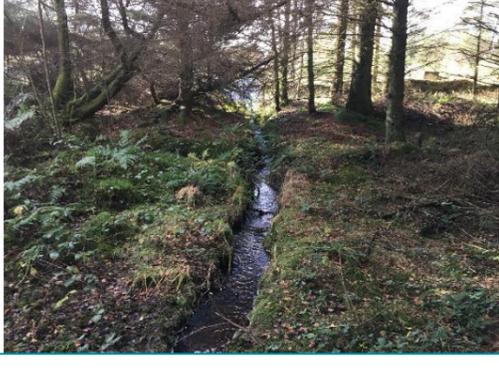
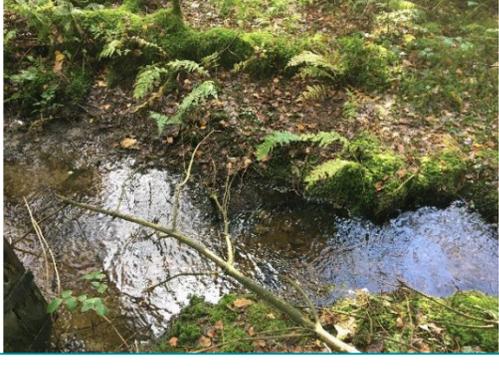
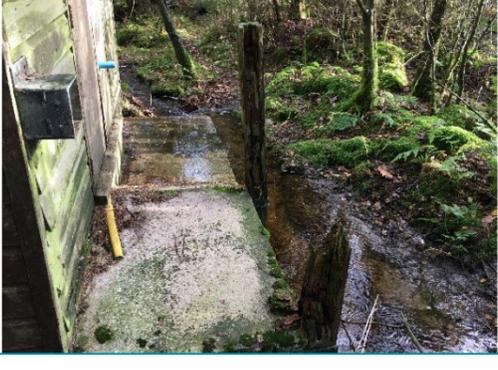
7 – Watercourse – downstream of reservoir, upstream of abstraction point	///snails.reflector.discouraged

<ul style="list-style-type: none"> • The watercourse bankfull width was ~ 1m width downstream of the reservoir, widening downstream of the abstraction point ~1m. • The substrate predominately comprised fine to coarse gravel • The former spillway confluence was noted in this location, established vegetation suggested no recent flow of water down this channel. • Disturbance of the bed suggested the presence of an armoured gravel layer protecting a layer of finer material. • Abstraction outbuilding was in current operation.

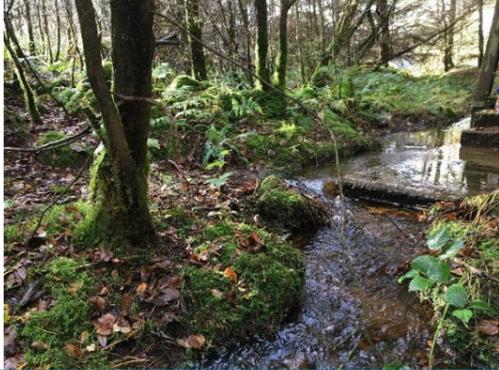
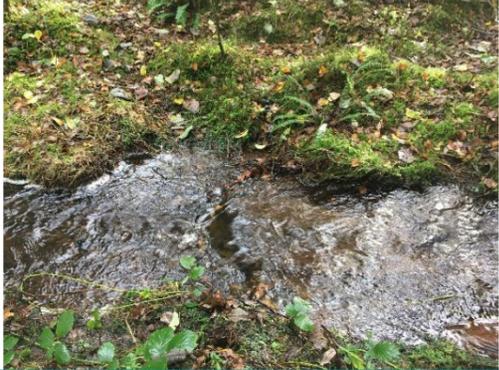
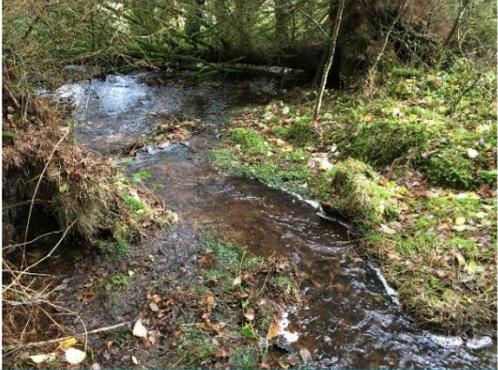
Location and Description	what3words reference	Orientation of Photo			Observations
		Upstream	Cross-Stream	Downstream	
9 – Watercourse – downstream of reservoir, downstream of abstraction point	//irritate.beakers.uniform

<ul style="list-style-type: none"> • Minor scour noted around the base of the outbuilding. • Fallen trees and leaf litter providing hydraulic complexity and localised widening. • See notes for Location 7.
10 – Watercourse – downstream of reservoir, culvert on access track	//quietest.dampen.gathers

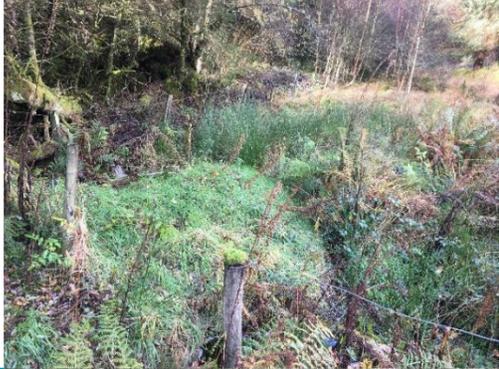
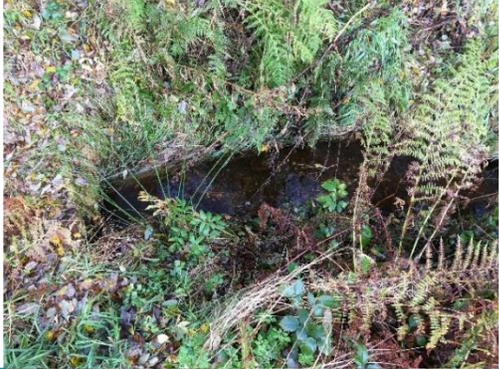
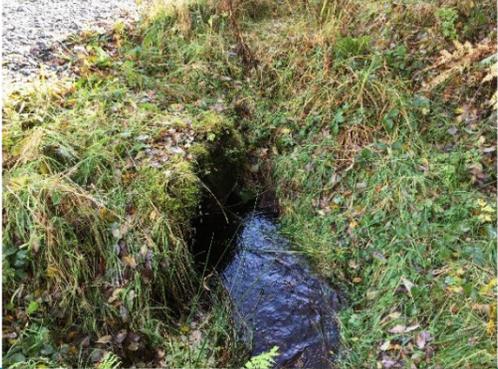
<ul style="list-style-type: none"> • The channel narrowed in this location. • Similar substrate size and structure noted in this location to the upstream sections of the watercourse.
11 – Watercourse – downstream of access track	//building.spoiled.owned

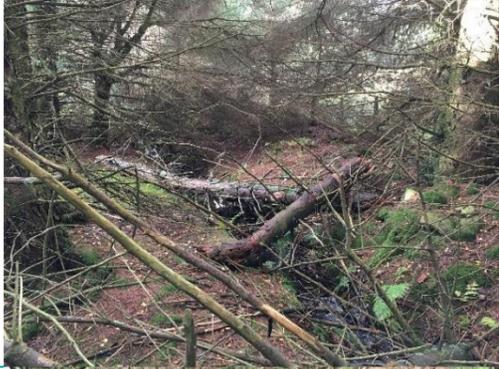
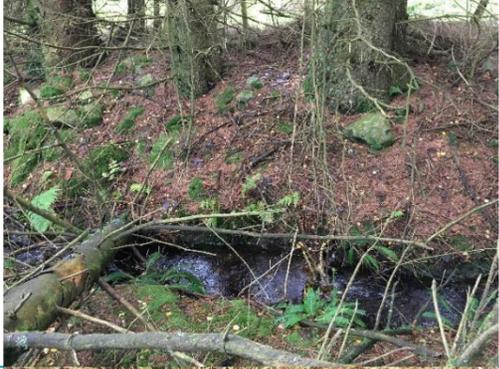
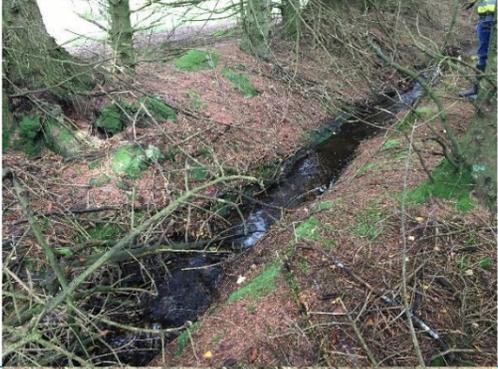
<ul style="list-style-type: none"> • The channel was ~1m wide in this location and appeared incised in comparison to the upper sections of the watercourse. • Channel planform exhibited as unnaturally straight with evidence of bank resectioning and embanked. • Fallen trees encouraging step pool sequences. • Disturbance of the bed suggested the presence of an armoured gravel layer protecting a layer of finer material. • The watercourse was heavily shaded by mature trees and challenging to access through trees.

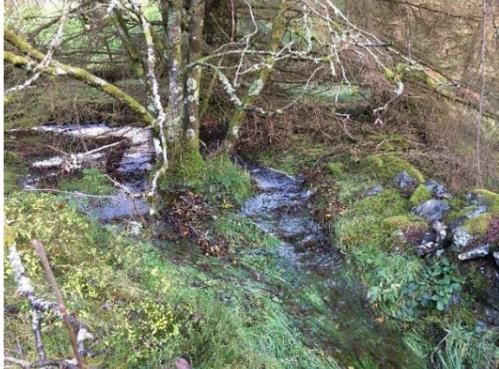
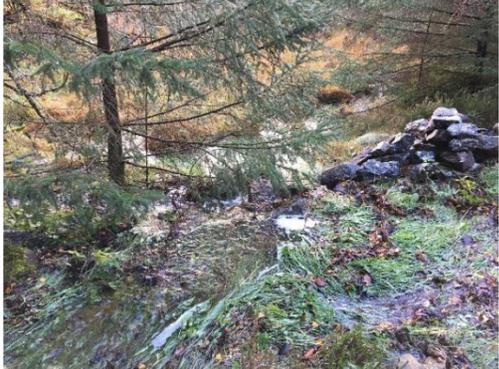
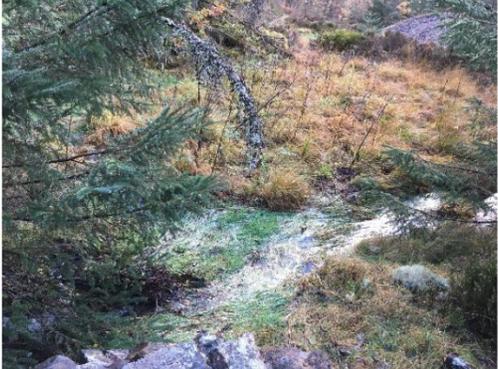
<ul style="list-style-type: none"> An informal weir structure was noted in this location ~ 1.5m in height constructed from small boulders and in dilapidated condition. Sediment accumulation notes upstream of the structure with tree established within the channel.

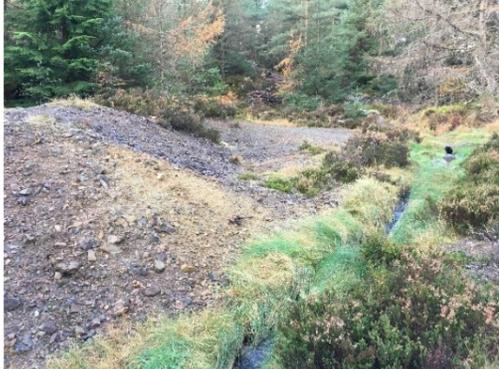
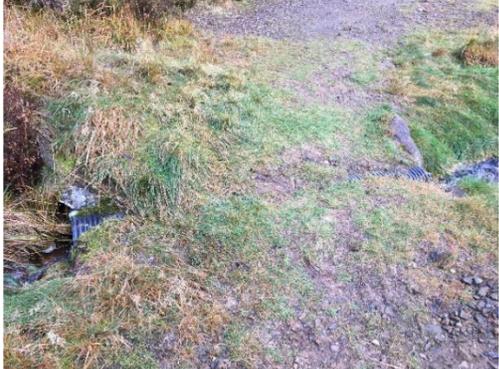
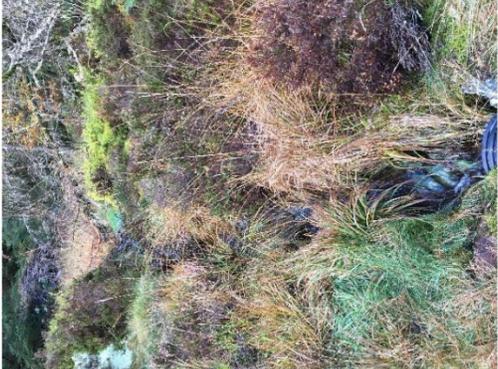
15 – Watercourse – near mine spoil heaps and pipe culvert	///encodes.oils.cupboards

<ul style="list-style-type: none"> The stream narrowed downstream of the weir structure as it flowed past mine spoil heaps No active erosion of the spoil heaps was noted by the stream. Rilling of the spoil heaps may suggest runoff from the spoil heaps into the stream following rainfall. Small informal pipe culverts were noted to allow the river to flow under a foot path. The channel margins were vegetated with grass-like plants.
15 – continued	///encodes.oils.cupboards	N/A

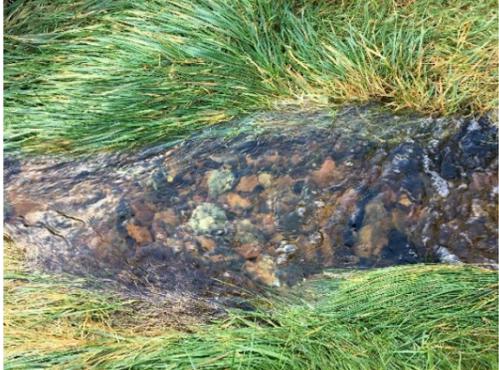
N/A	<ul style="list-style-type: none"> Similar substrate noted upstream and downstream of the informal weir structure.

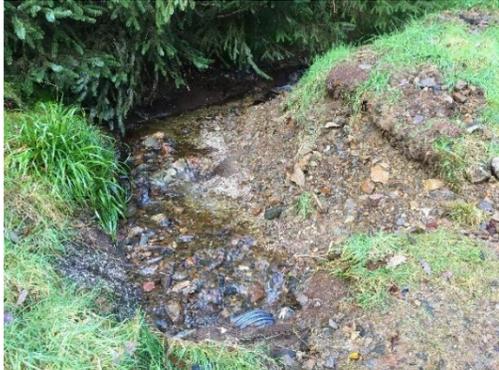
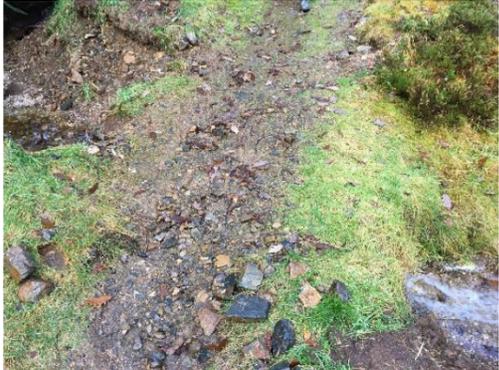
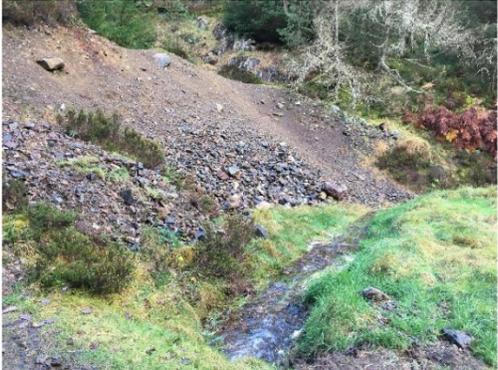
Location and Description	what3words reference	Orientation of Photo			Observations
		Upstream	Cross-Stream	Downstream	
16 – Watercourse – upstream of lower access track and spoil heaps	///those.mourner.worker

<ul style="list-style-type: none"> Following a very steep section of channel, the stream flowed past more spoil heaps from Hafna mine. The channel was ~1.2m wide in this location and evidence of historical erosion of the spoil heaps. A small pipe culvert ~300m in diameter was observed under the footpath,
17 – Watercourse – downstream of lower access track	///rash.leaky.available

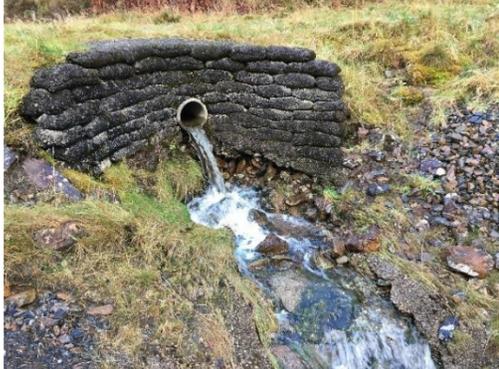
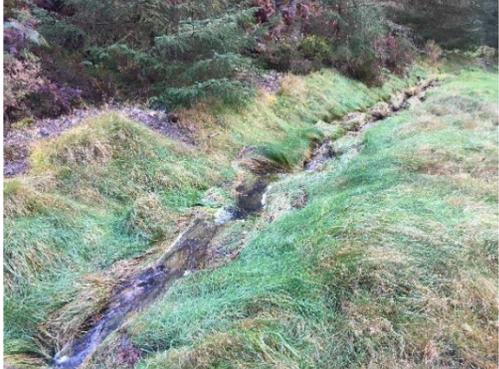
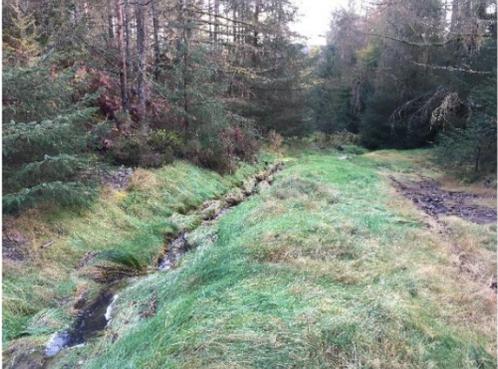
<ul style="list-style-type: none"> The stream flowed through a pipe culvert ~300m pipe in diameter under an access track. Downstream of the culvert outfall, there was clear evidence of an eroded structure. This may have been installed as an erosion protection measure to protect the track. Whilst still flowing through woodland, the trees were set back from the stream allowing light to reach the stream. The stream was notably steeper downstream of the culvert.

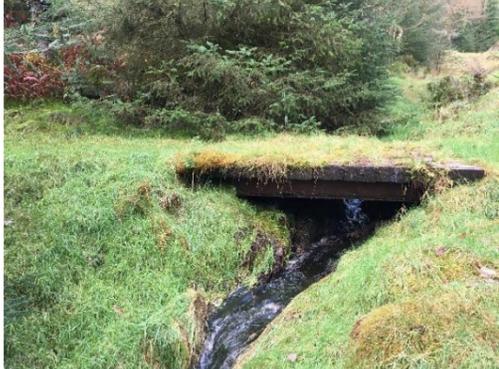
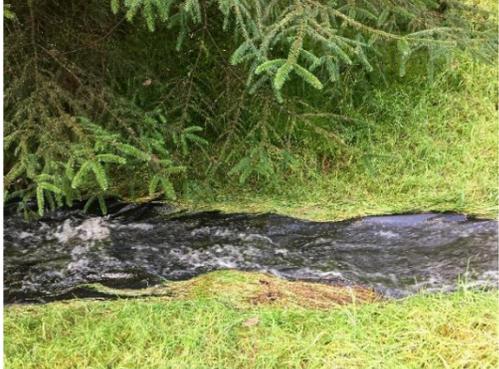
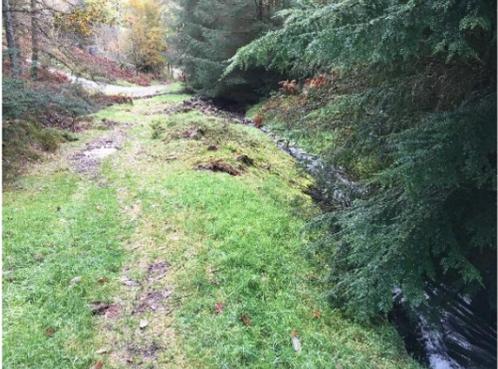
18 – Watercourse – downstream of lower access track (potential remediation site)	///woes.opts.model

<ul style="list-style-type: none"> Downstream of the culvert, plastic sheeting had been installed presumably as a form of former mine remediation works. No records of these works were known by the walkover participants. Inspection of the sheeting indicated that water was flowing above and below the plastic sheeting. No substrate was observed above the plastic sheeting, suggesting sediment transport had supply.
19- Watercourse – downstream of lower access track (potential remediation site - failed)	///munch.wishes.dating

Further investigation of opportunities to remove these redundant structures is recommended, particularly for the areas of the plastic sheeting which may be an active source of plastic pollution. Connectivity between the mine heaps was evident, raising a concern of these areas as a source of zinc and lead contamination to the Conwy water body.

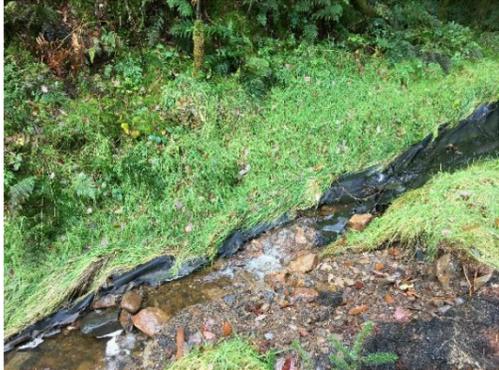
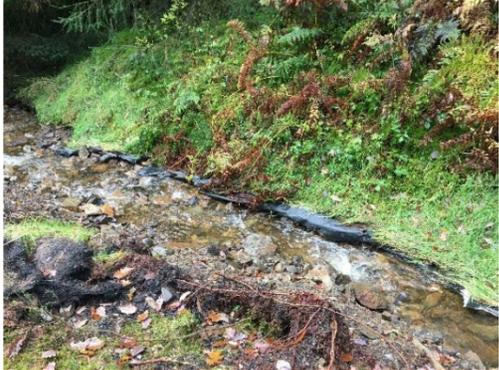
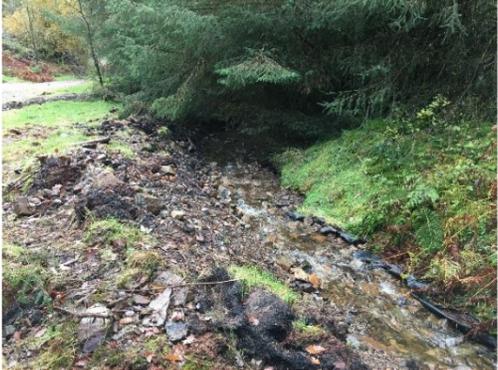
<ul style="list-style-type: none"> Further downstream, the plastic sheeting had failed with water flowing above and below the sheeting. Active bank erosion was noted on the left bank, a bankfull width of ~2m was observed. Coarser substrates were noted in this location, with a dominance of larger gravels, cobbles and small boulders.

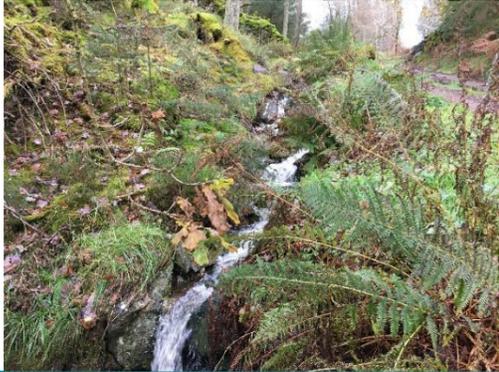
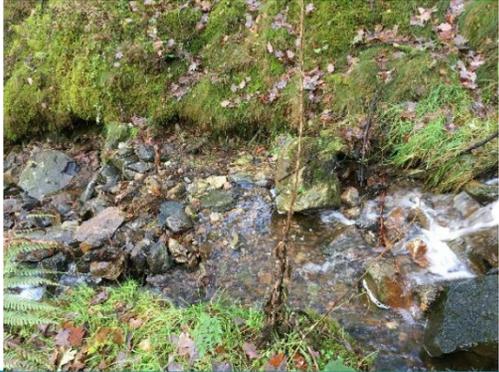
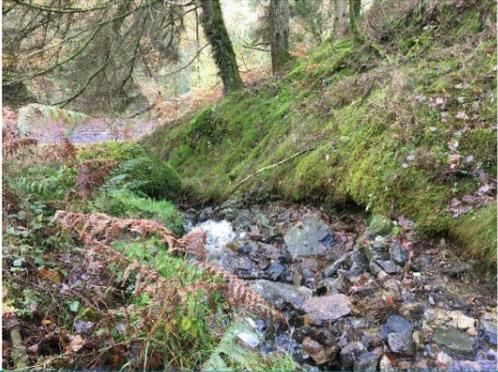
Location and Description	what3words reference	Orientation of Photo			Observations
		Upstream	Cross-Stream	Downstream	
20- Watercourse – along lower access track	//chap.bravest.groomed

<ul style="list-style-type: none"> As the stream followed the route of the access track, the channel notably steepened. The stream flowed through a series of steep cascades, and pipe culverts.
21 – Cascade near Mill	//hammocks.lampost.chip

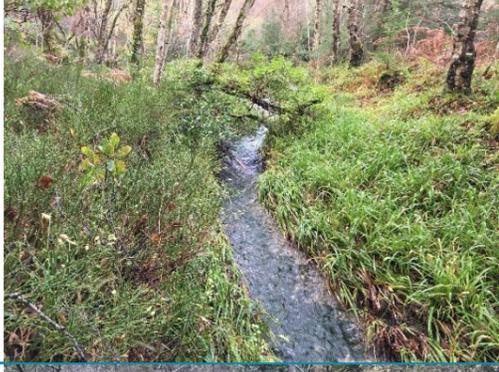
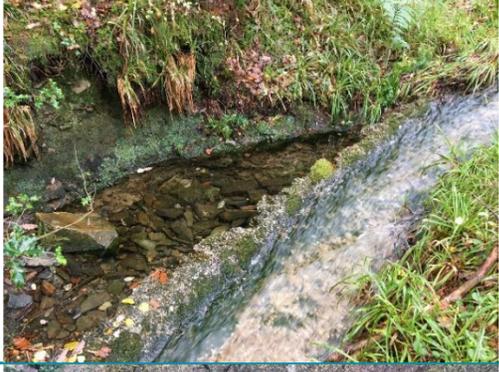
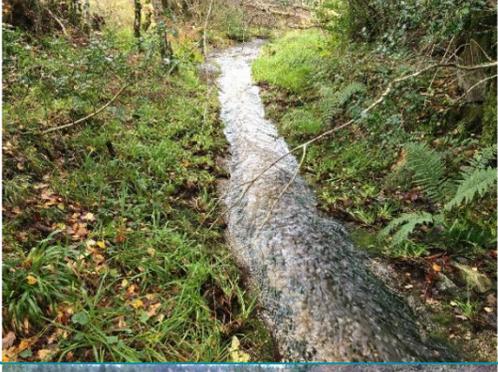
<ul style="list-style-type: none"> Downstream of the mill, further evidence of erosion projection was observed potential to protect road infrastructure. This channel appeared to be lined with concrete, and functioned similar to a long smooth flume. A point of failure was noted in the concrete flume adjacent to a section of bank erosion and localised widening. No substrate was observed on the channel bed, indicating that sediment transport capacity exceeded the sediment supply.

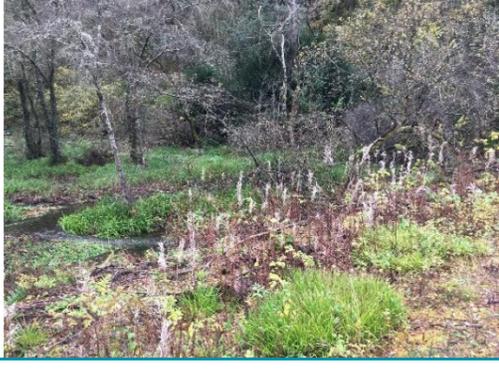
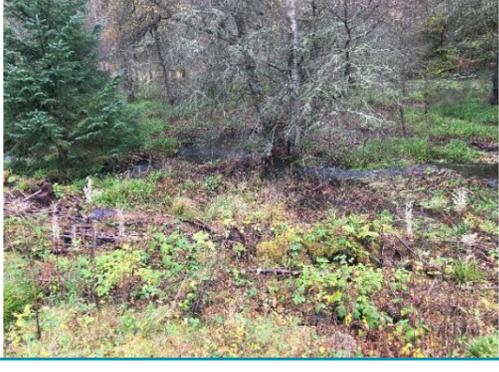
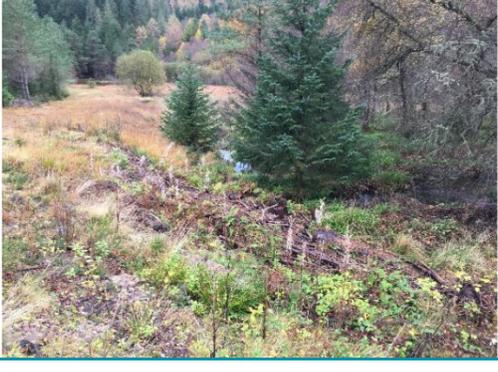
23 - Llyn Fuches Las	//woodstove.sweated.binder

<ul style="list-style-type: none"> Visibility of the channel was challenging as it flowed into Llyn Fuches Las. From the viewpoints available, the stream appeared to flow through multiple channels surrounded by established vegetation and mature trees.

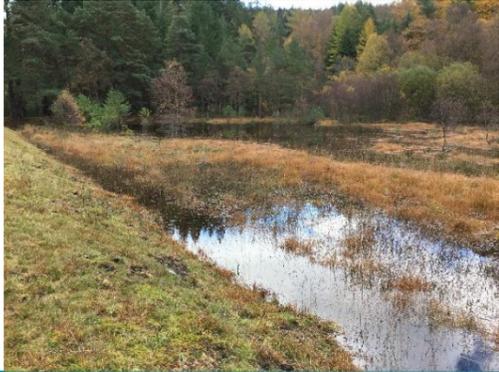
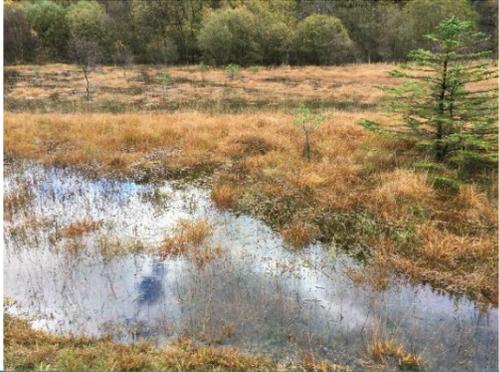
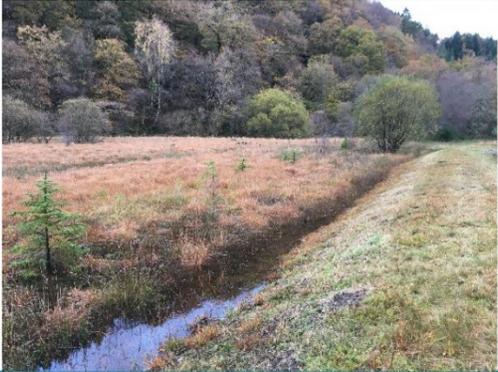
Location and Description	what3words reference	Orientation of Photo			Observations
		Upstream	Cross-Stream	Downstream	
24 - Llyn Fuches Las	//constrain.closed.info

<ul style="list-style-type: none"> • Extensive vegetation in Llyn Fuches Las was noted, the bed was not visible.
25 - Llyn Fuches Las Embankment and Spillway	//submits.occupations.peachy

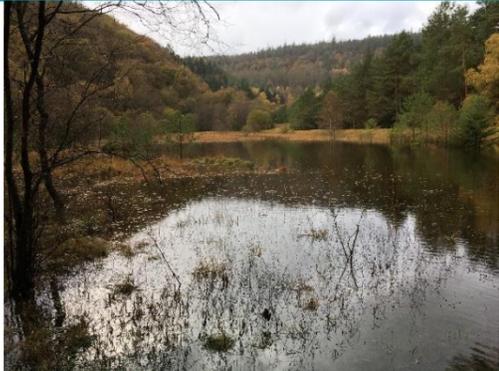
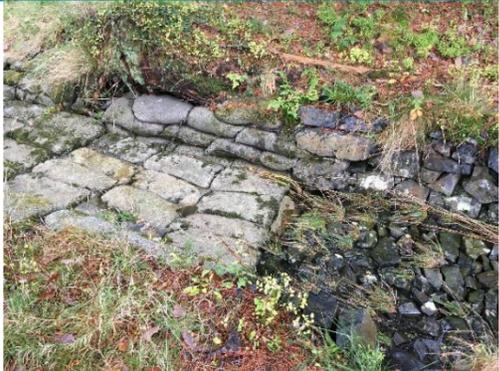
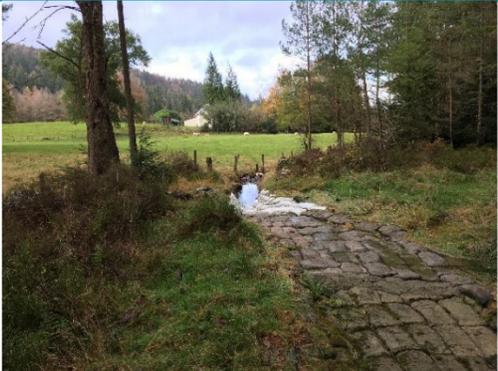
<ul style="list-style-type: none"> • Erosion of the Llyn Fuches Las spillway was noted, and temporary erosion protection measures has been installed by NRW to prevent further erosion. • Several sandbags were disturbed during the walkover which were replaced, suggesting recent high flows were experienced down the spillway.
