Arla, Llaandyrnog

Final site inspection 16.04.2021

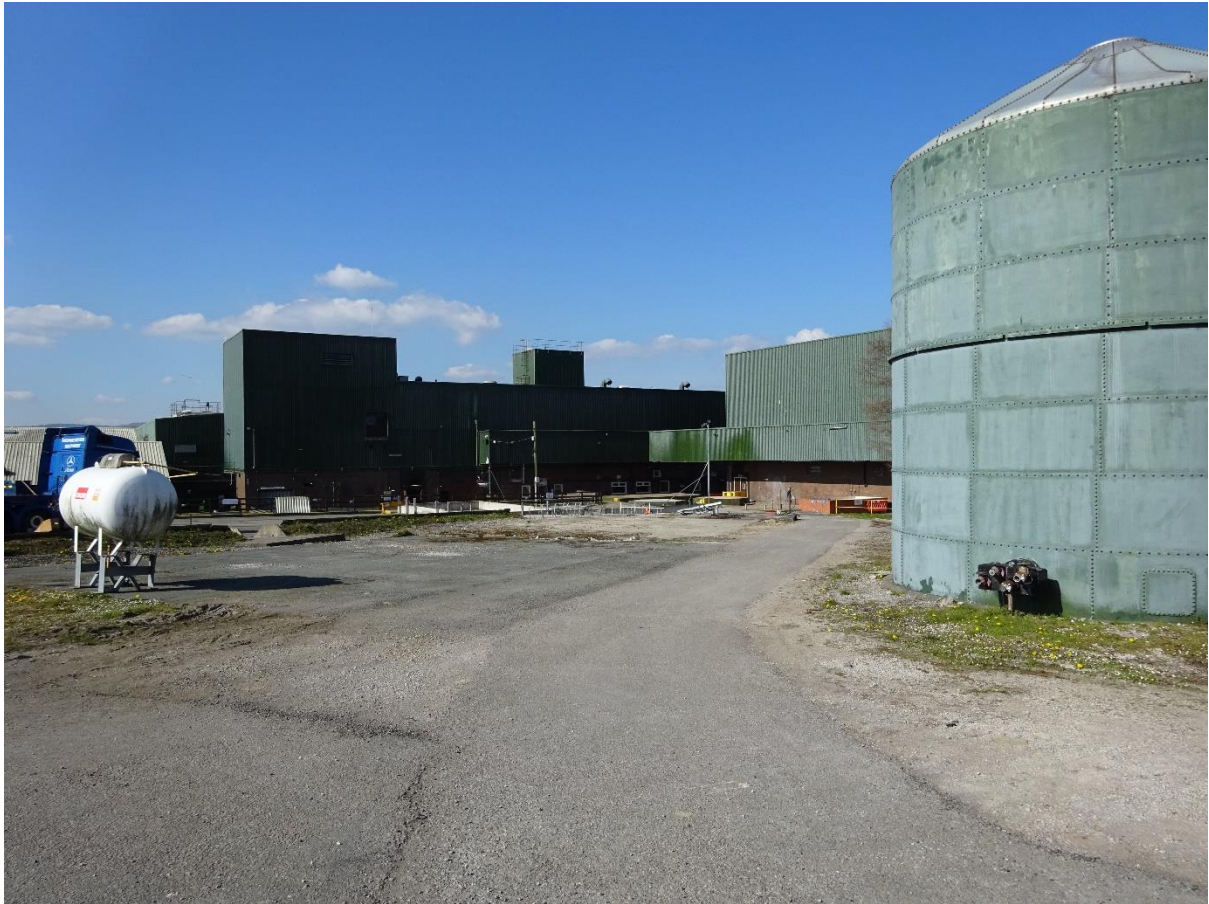
Photo 1 & 2 – top yard and bulk tank area now empty. Green firewater tank remains.

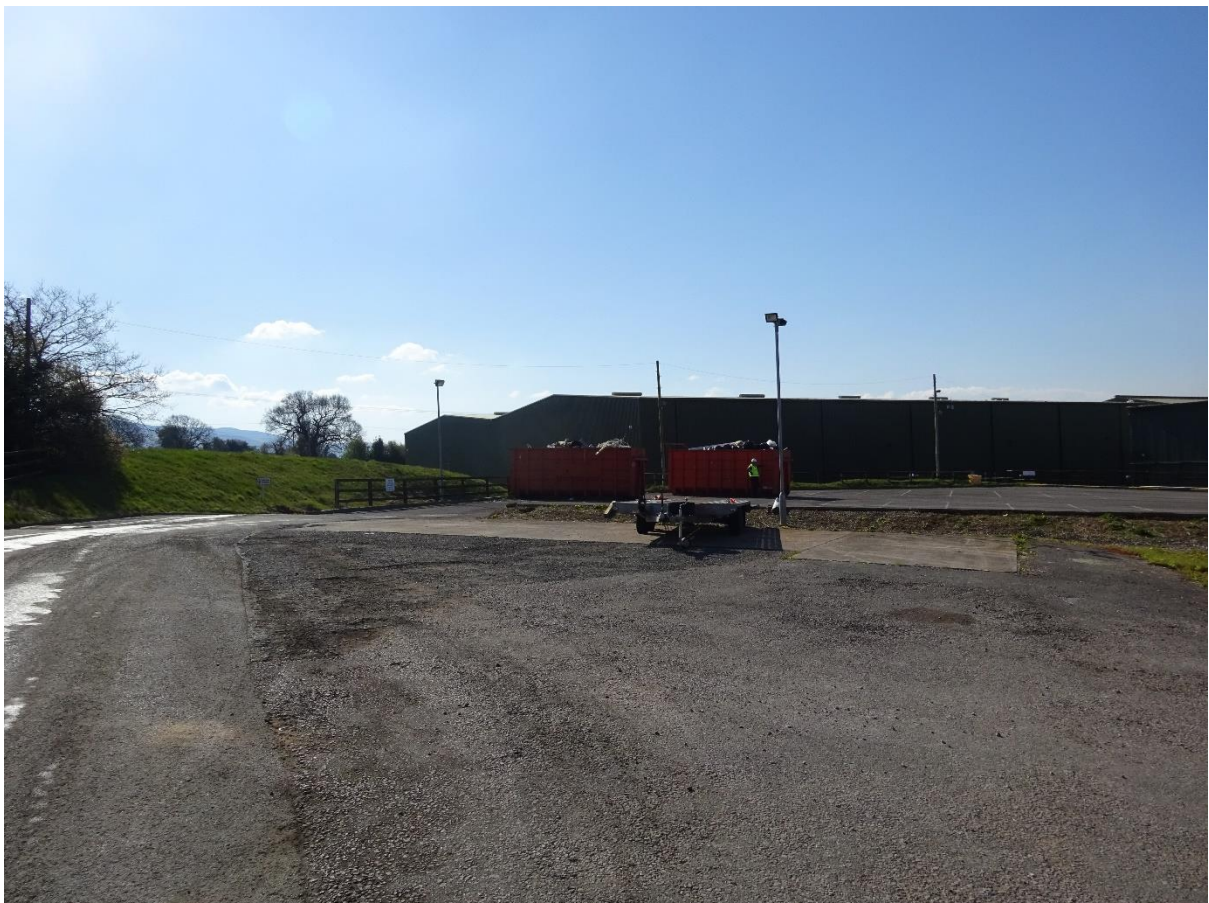
Photo 2 – two general waste skips remain as part of final site tidy-up

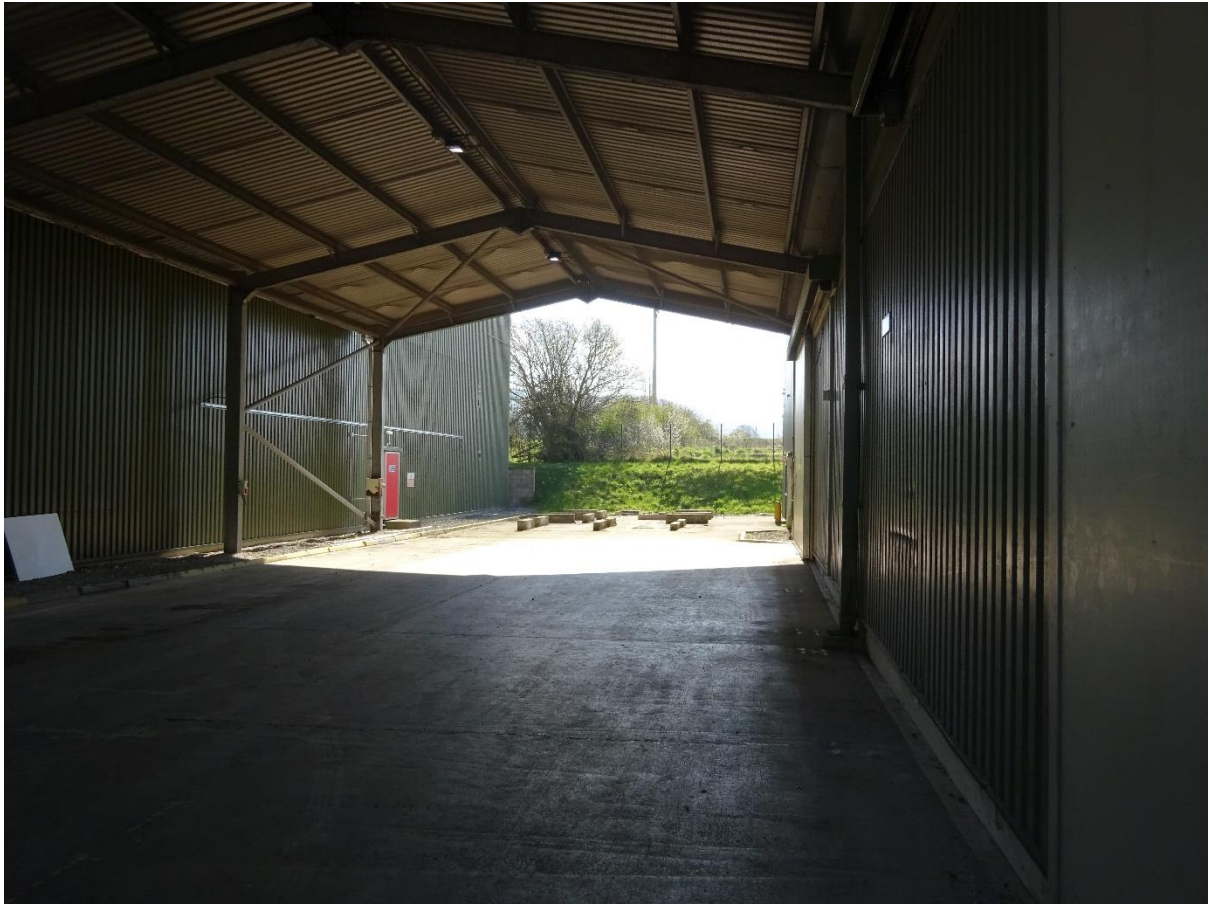
Photo 3 – Cold store area, all refrigeration equipment removed

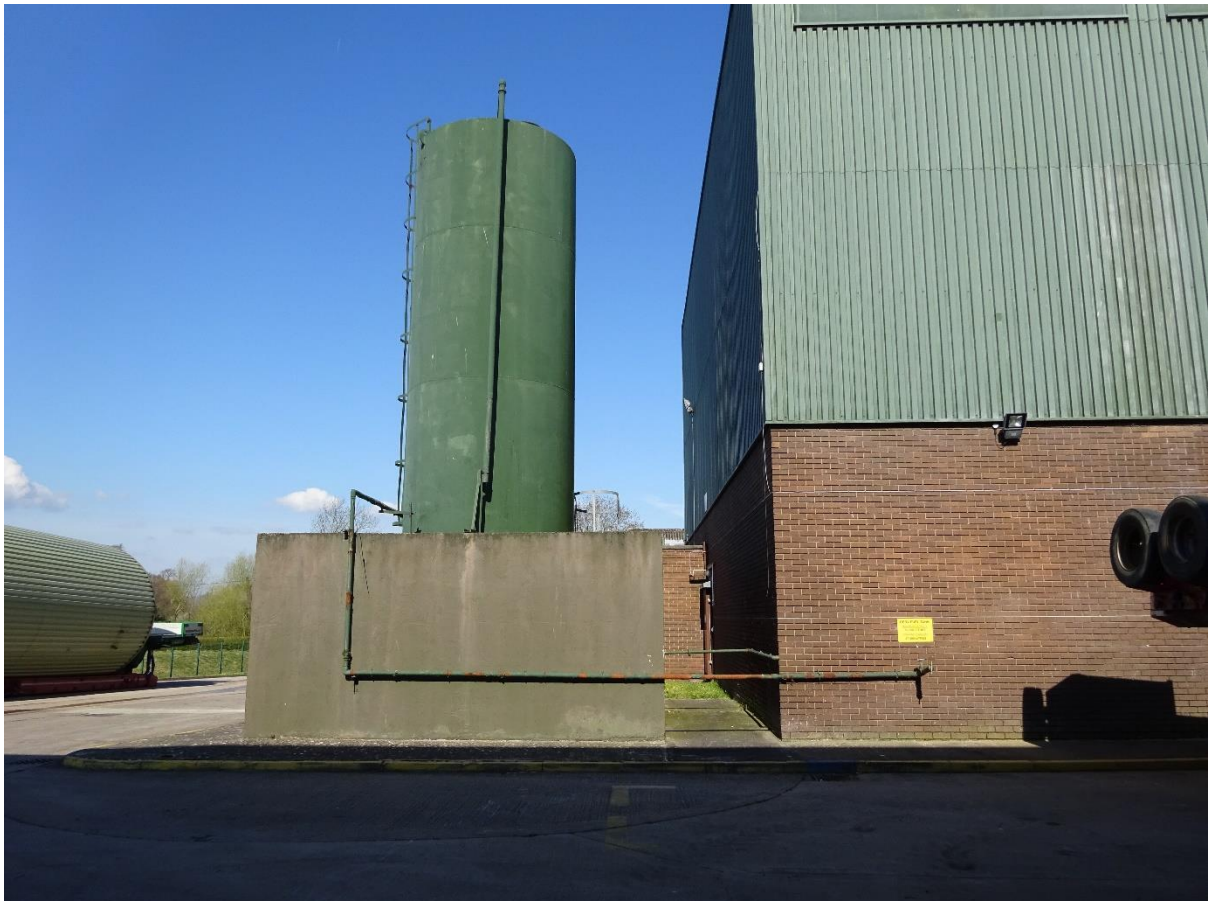
Photo 4 – old DERV tank, empty and cleaned.

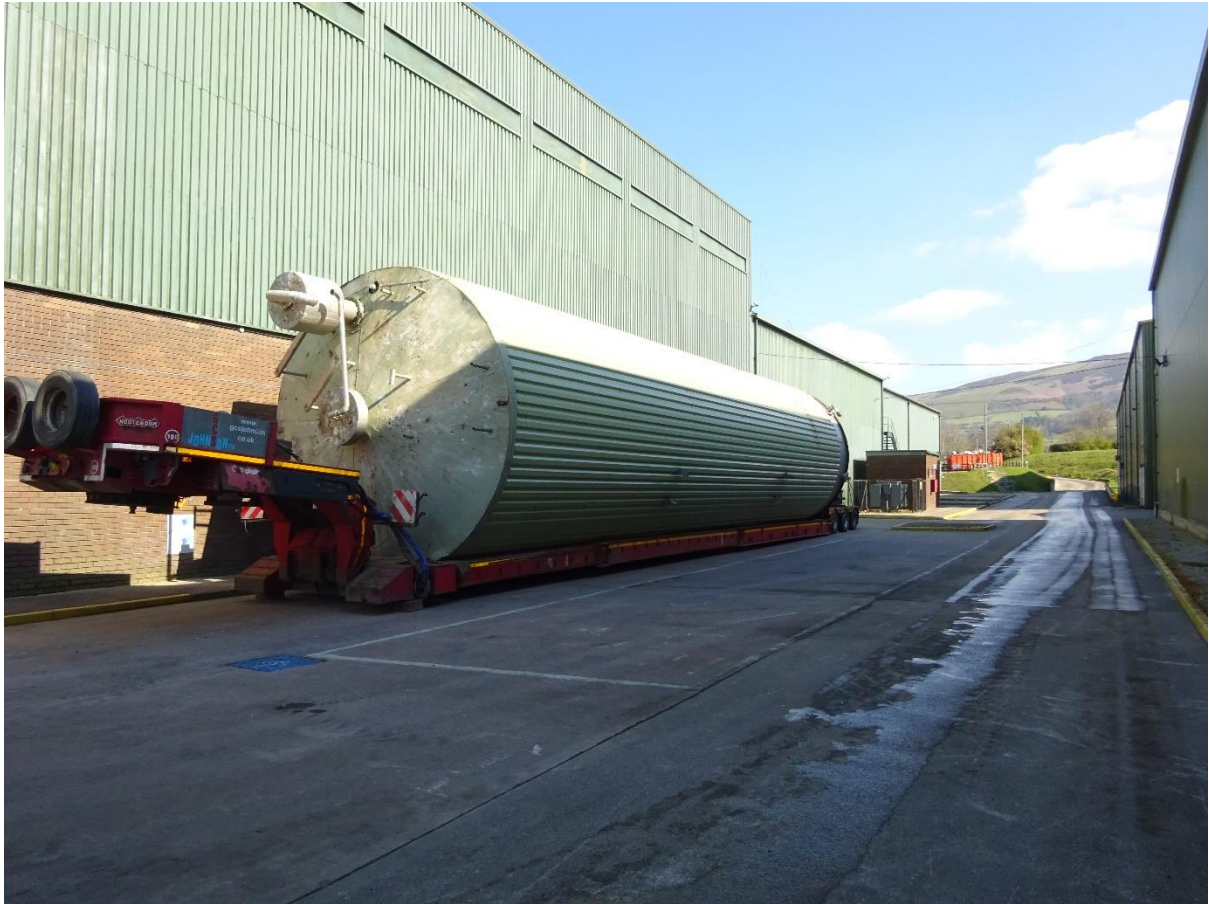
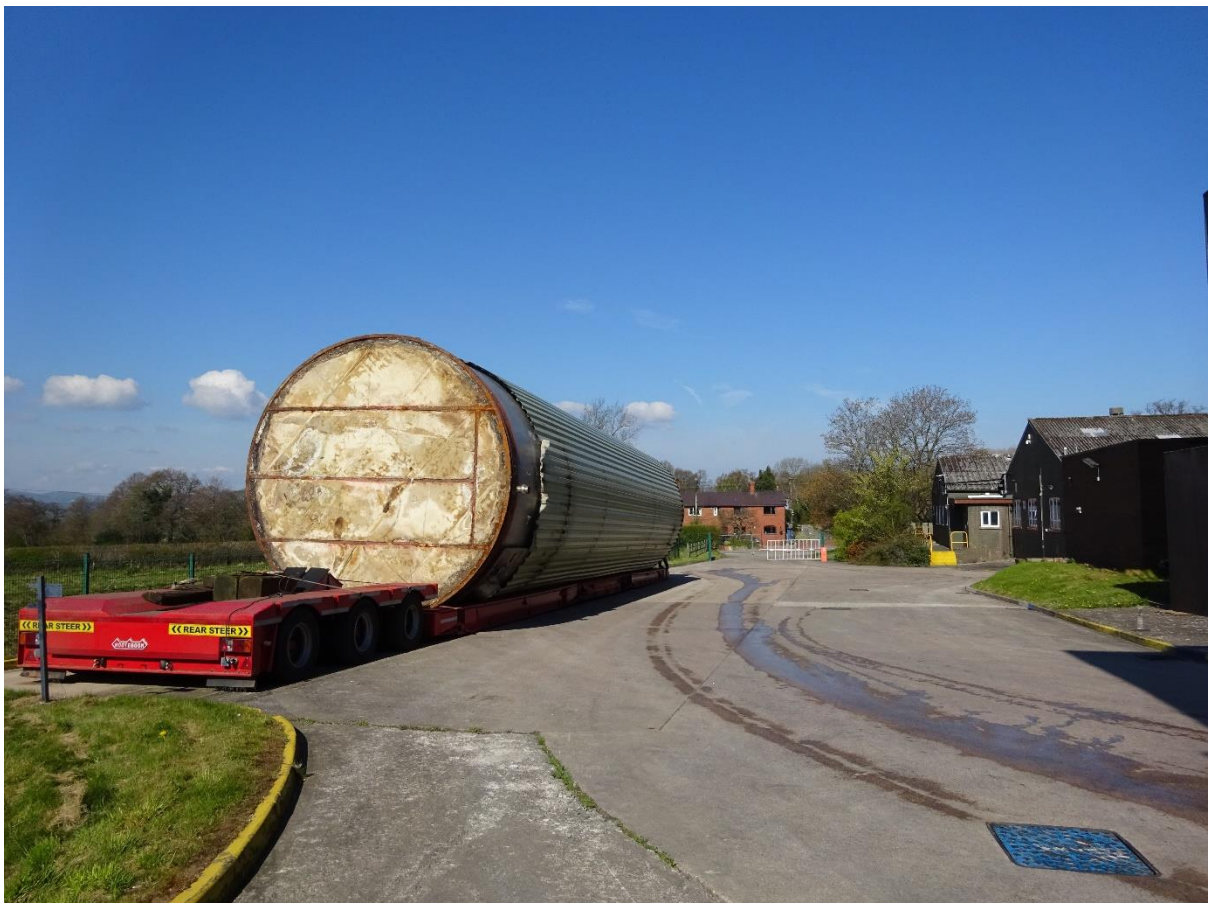
Photo 5 & 6- Final two silos removed, awaiting transport off site

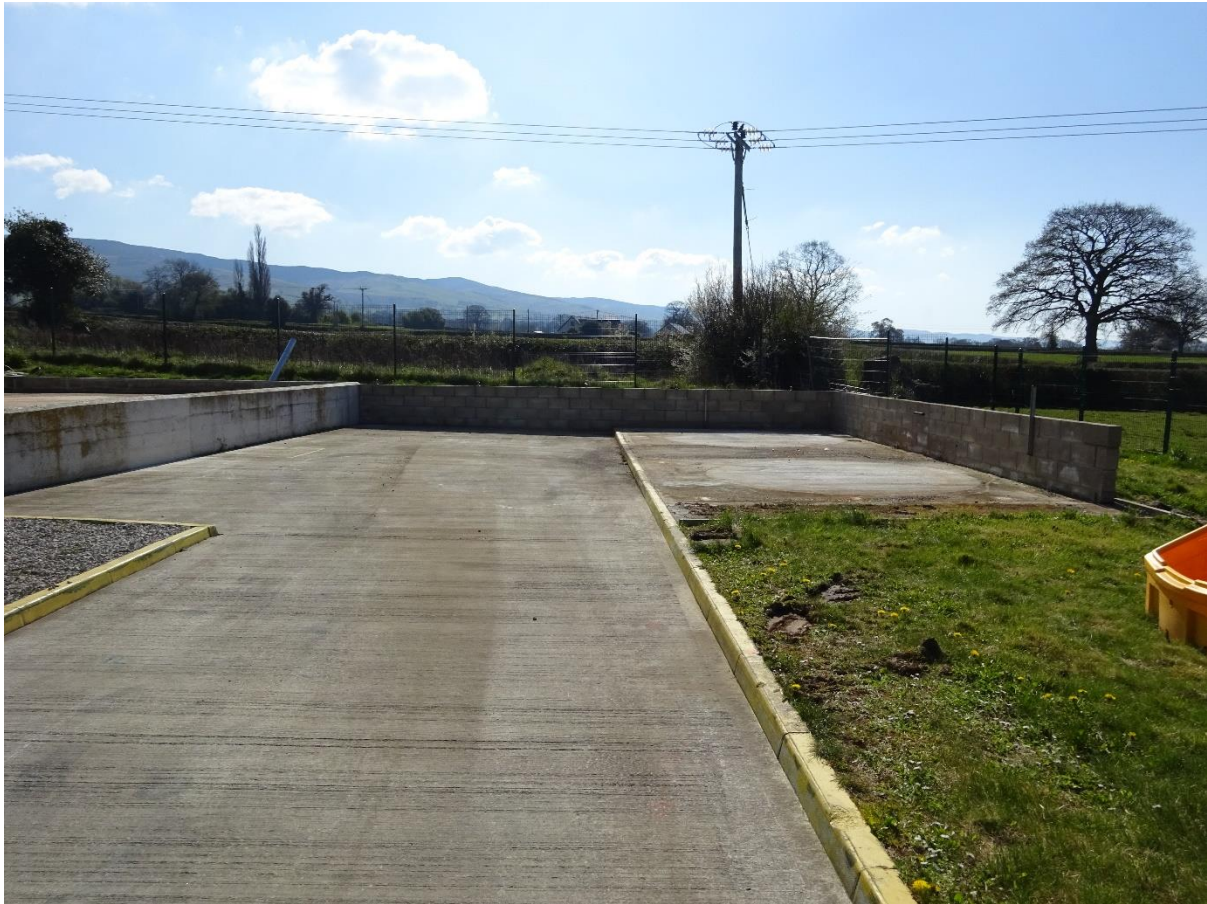
Arla, Llaandyrnog  
Final site inspection 16.04.2021  
Photo 7 – ETP and bulk chemical tanks access road

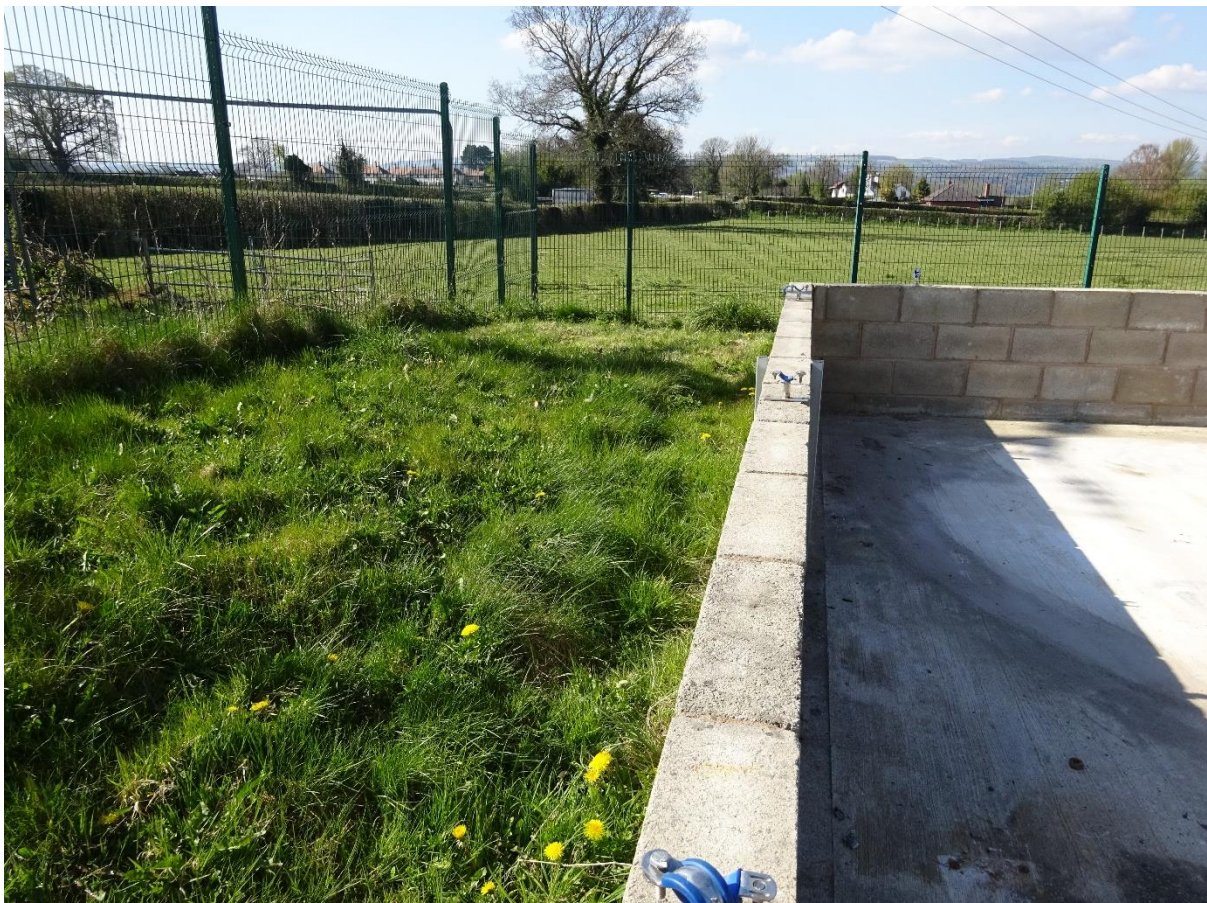
Photo 8 – grassed area behind ETP bund wall

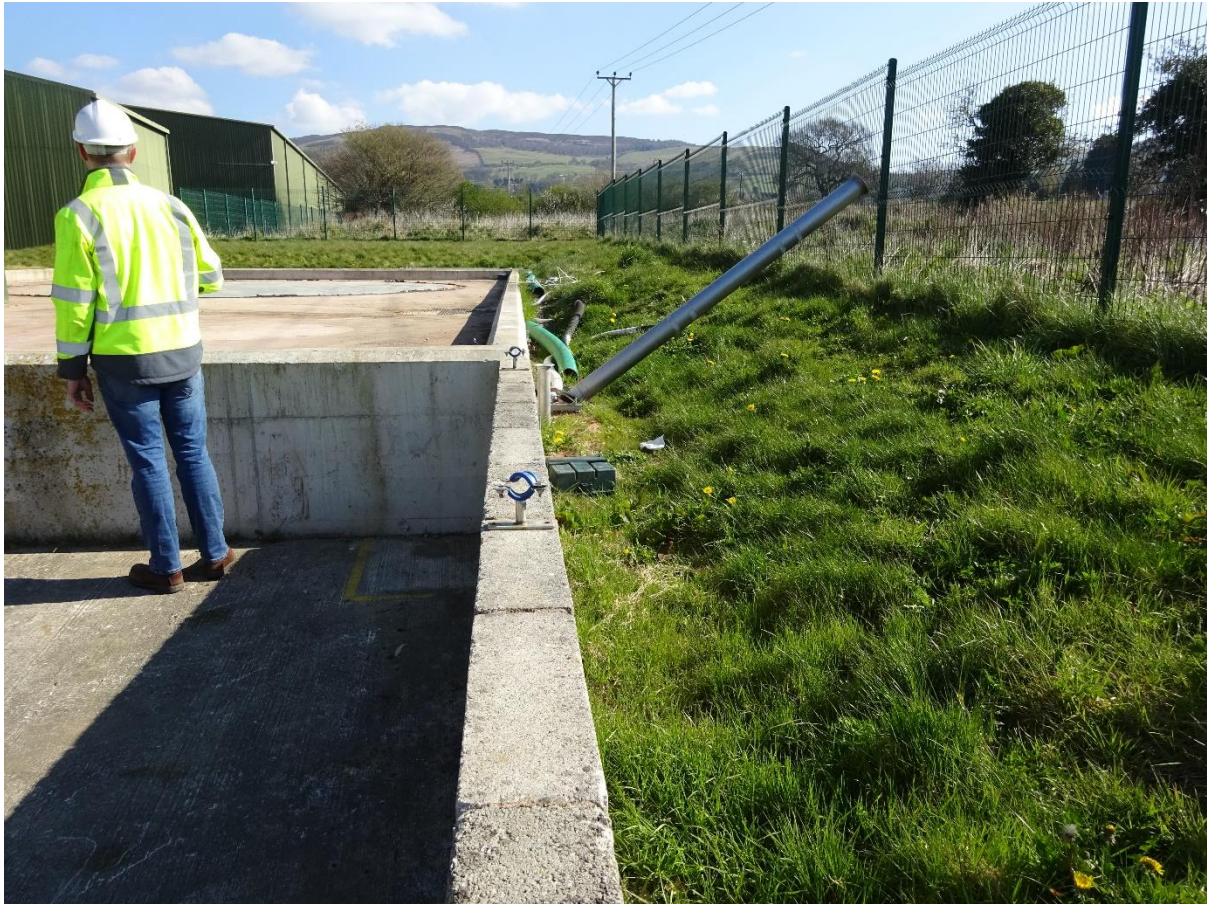
Arla, Llaandyrnog  
Final site inspection 16.04.2021  
Photo 9 – ETP bund and adjacent grassland

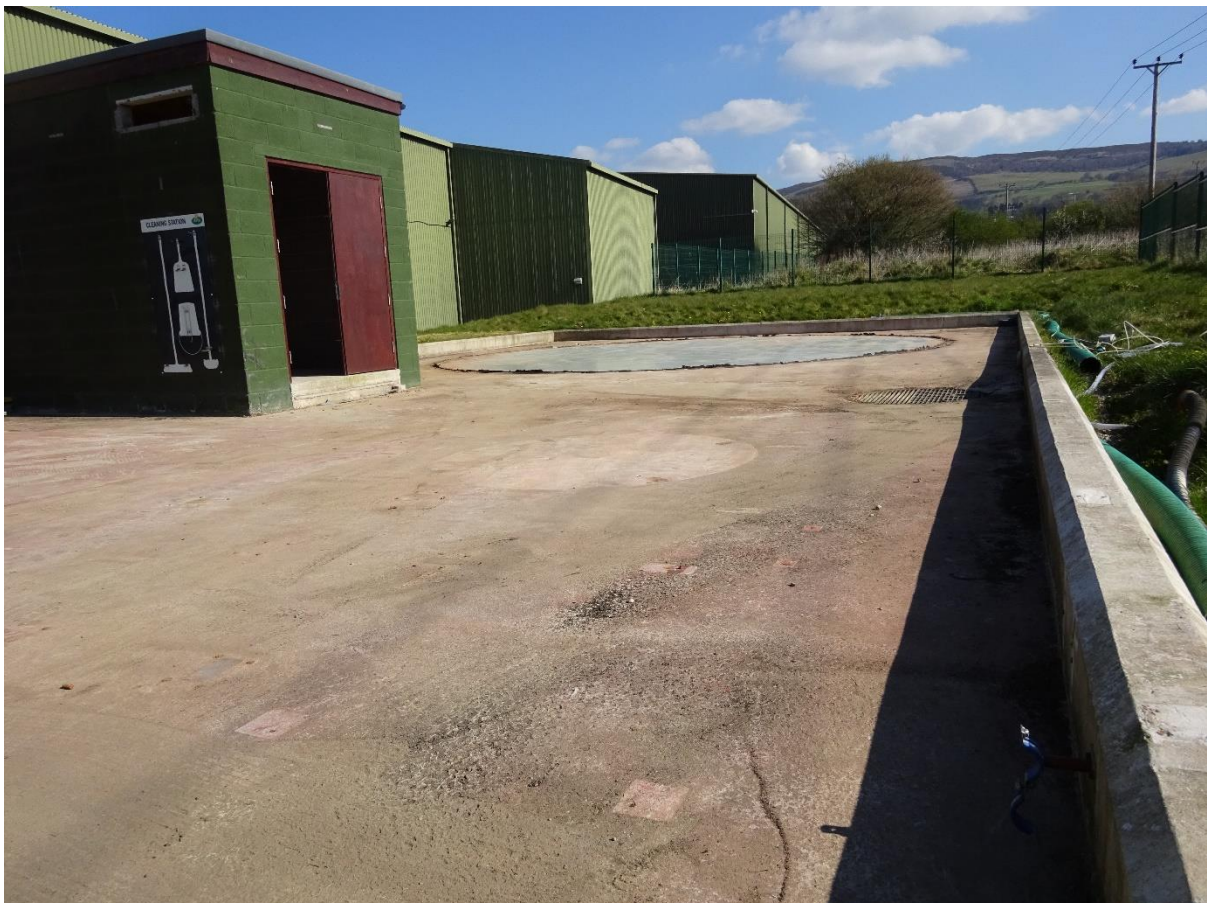
Photo 10 – ETP control cabin, control units removed

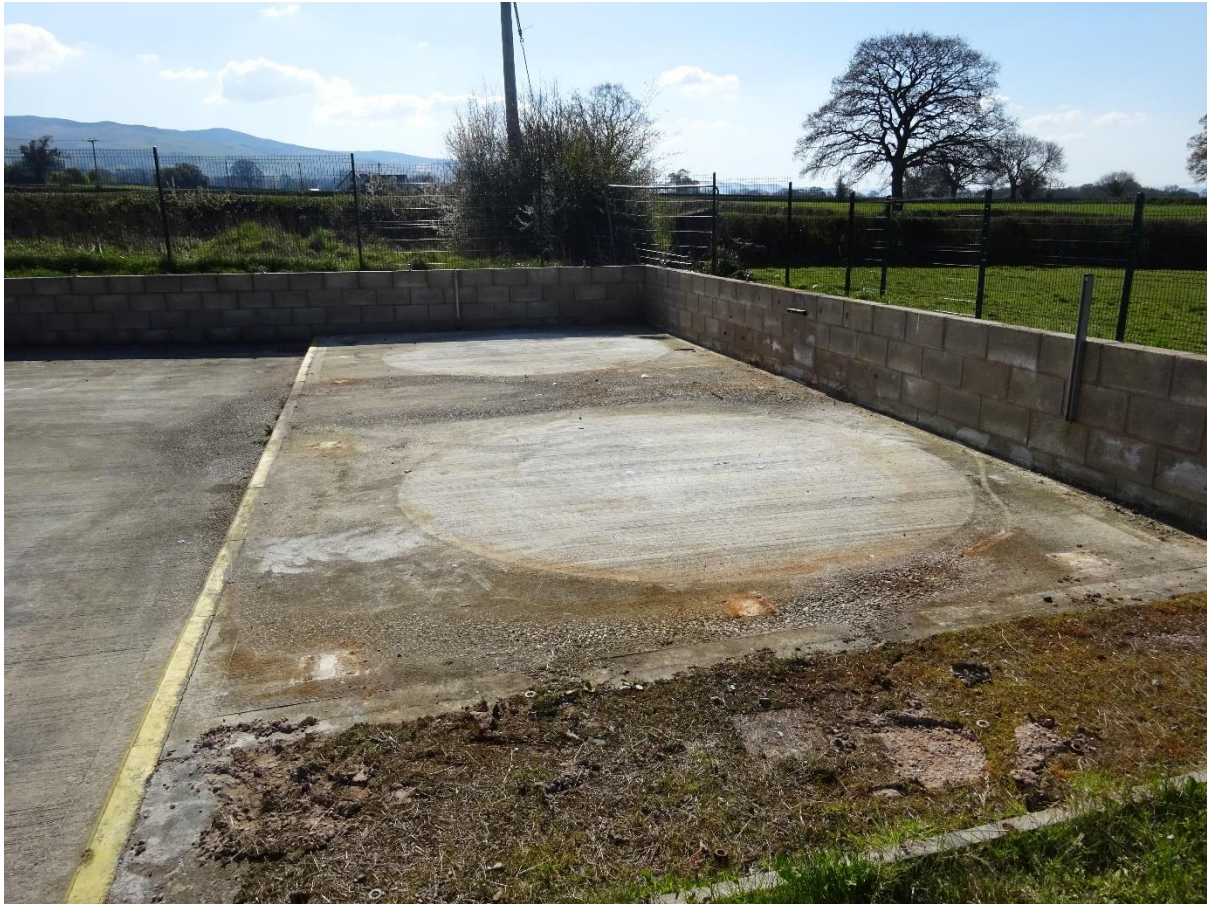
Arla, Llaandyrnog  
Final site inspection 16.04.2021  
Photo 11 – concrete base below chemical tanks area

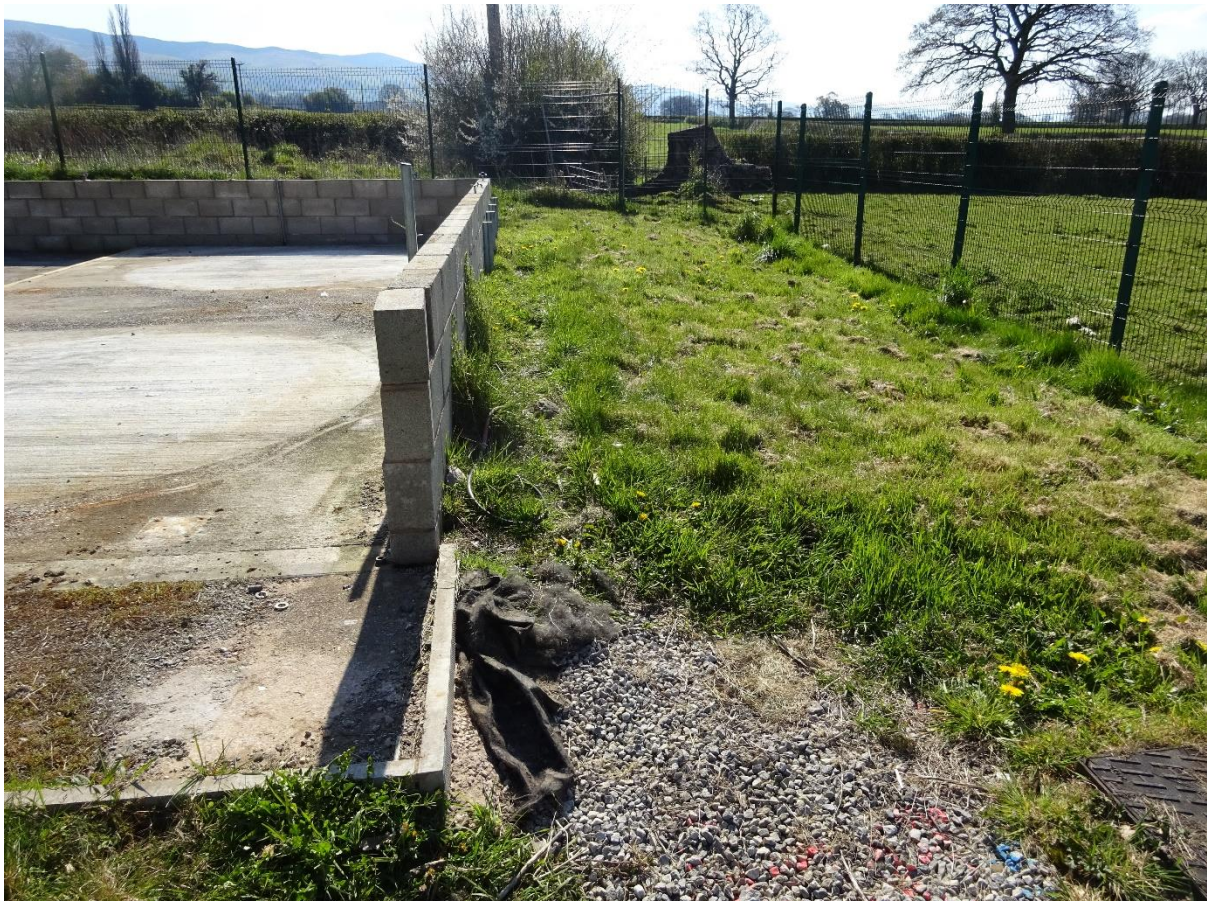
Photo 12 – grassed area outside ETP chemical tank

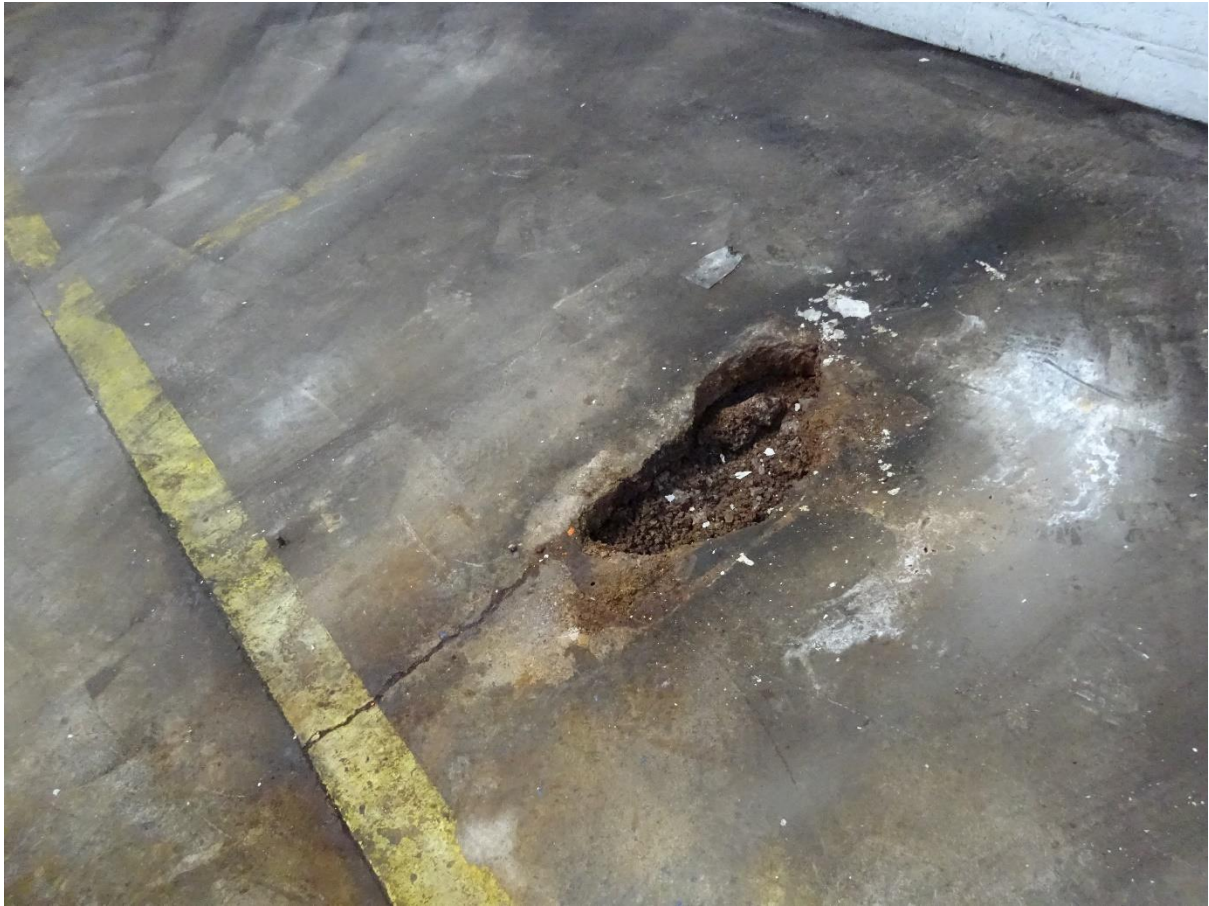
Photo 13 – damaged flooring in the indoor checmicals storage area, further detail supplied following visit.

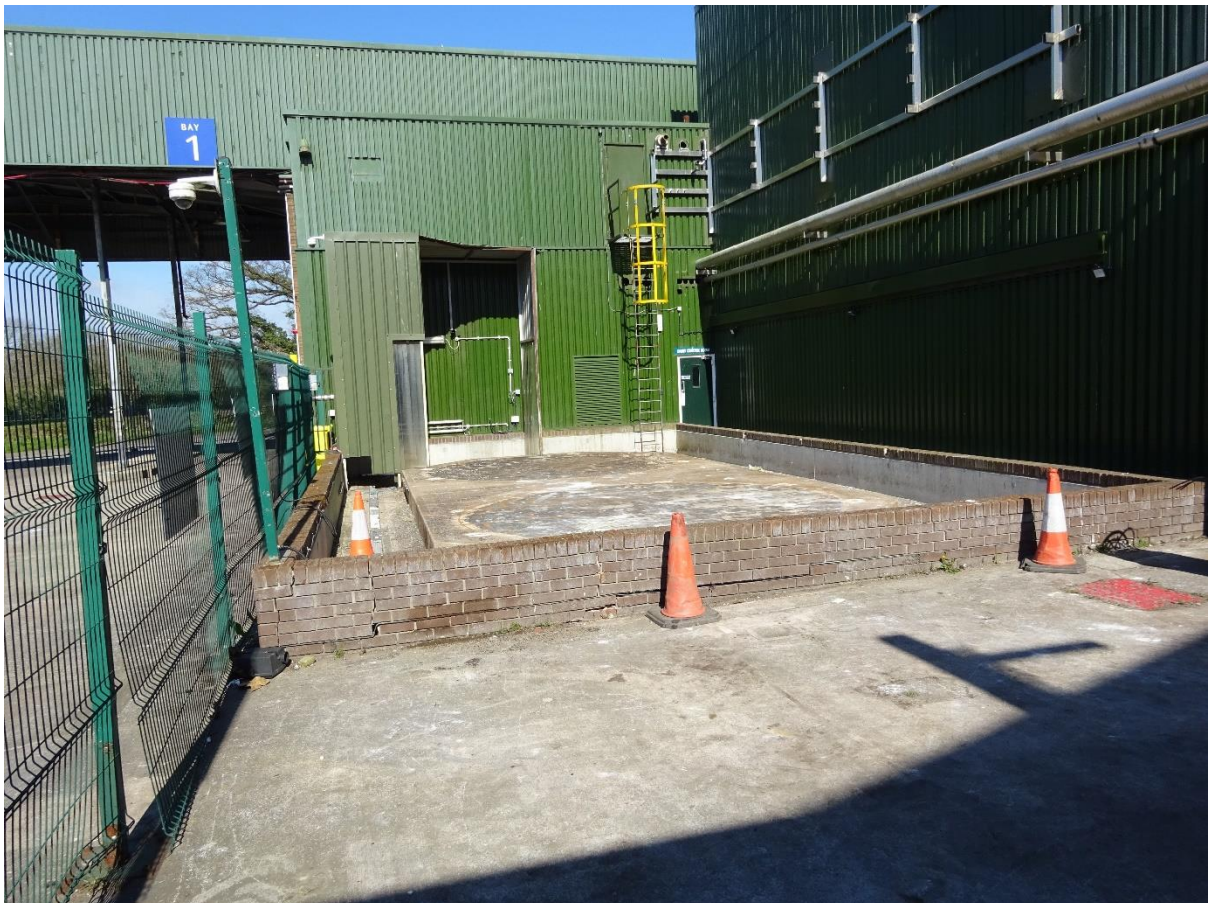
Photo 14 – tanks and ancillary pipework removed adjacent to site entryway

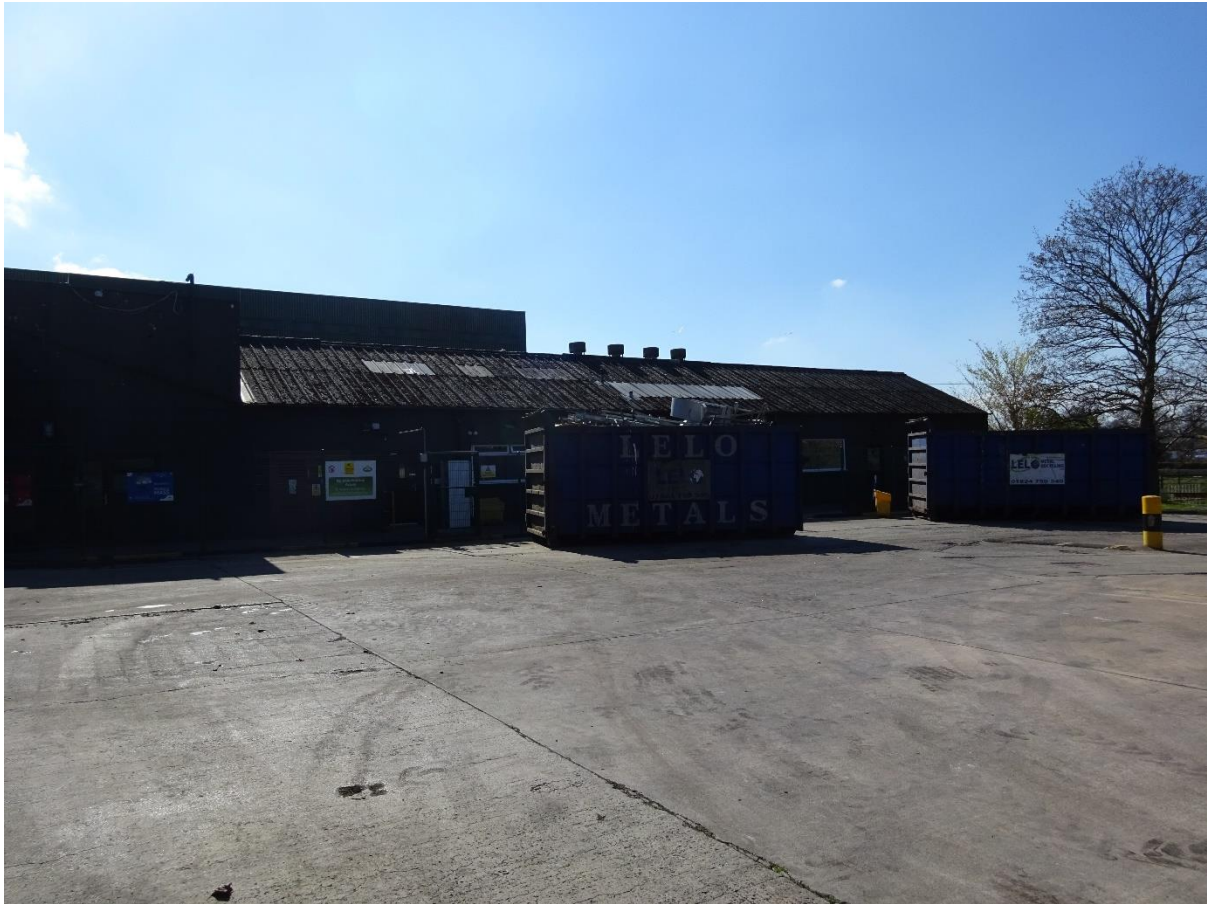
Arla, Llaandyrnog  
Final site inspection 16.04.2021  
Photo 15 – scrap metal skip from site clearance

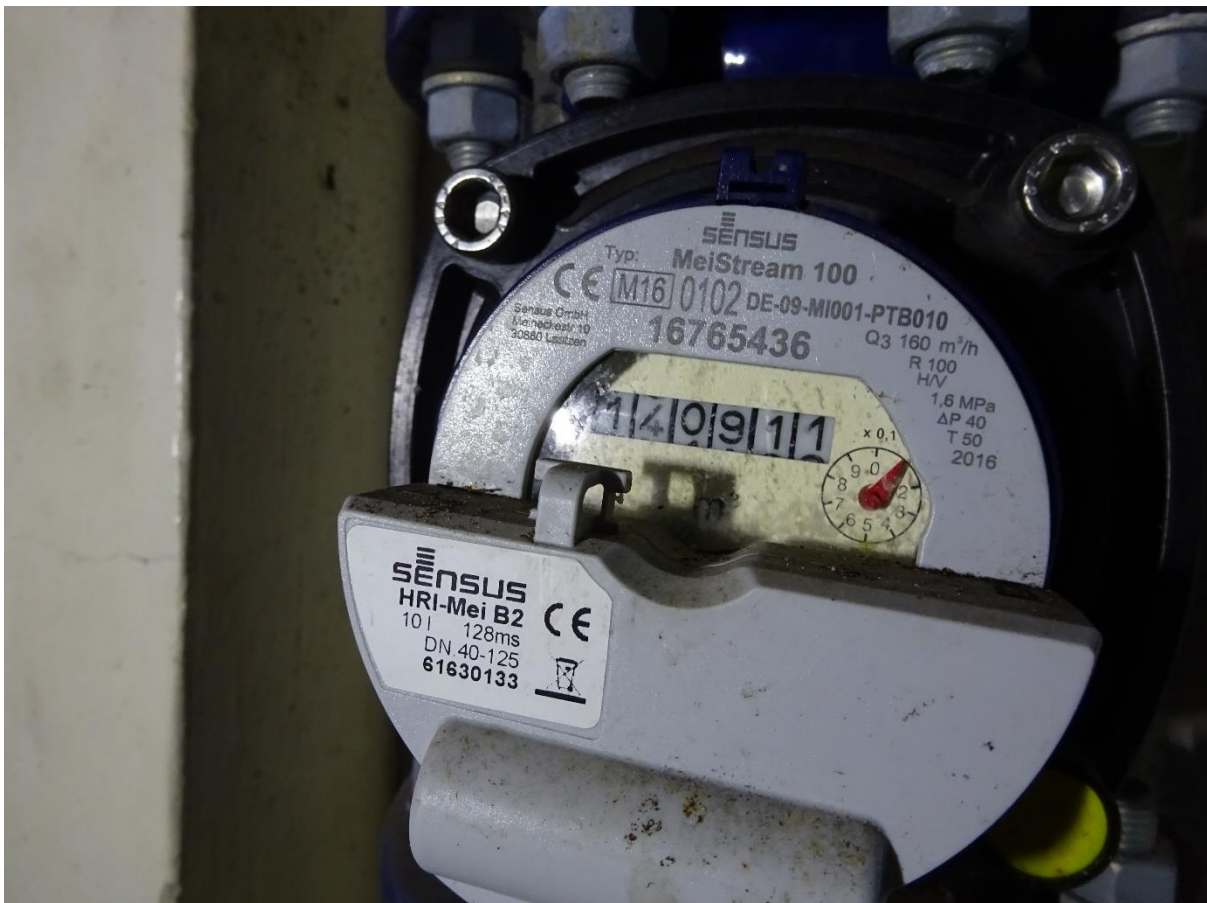
Photo 16 – Borehole meter – Point A, Abstraction Licence 24/66/1/0047

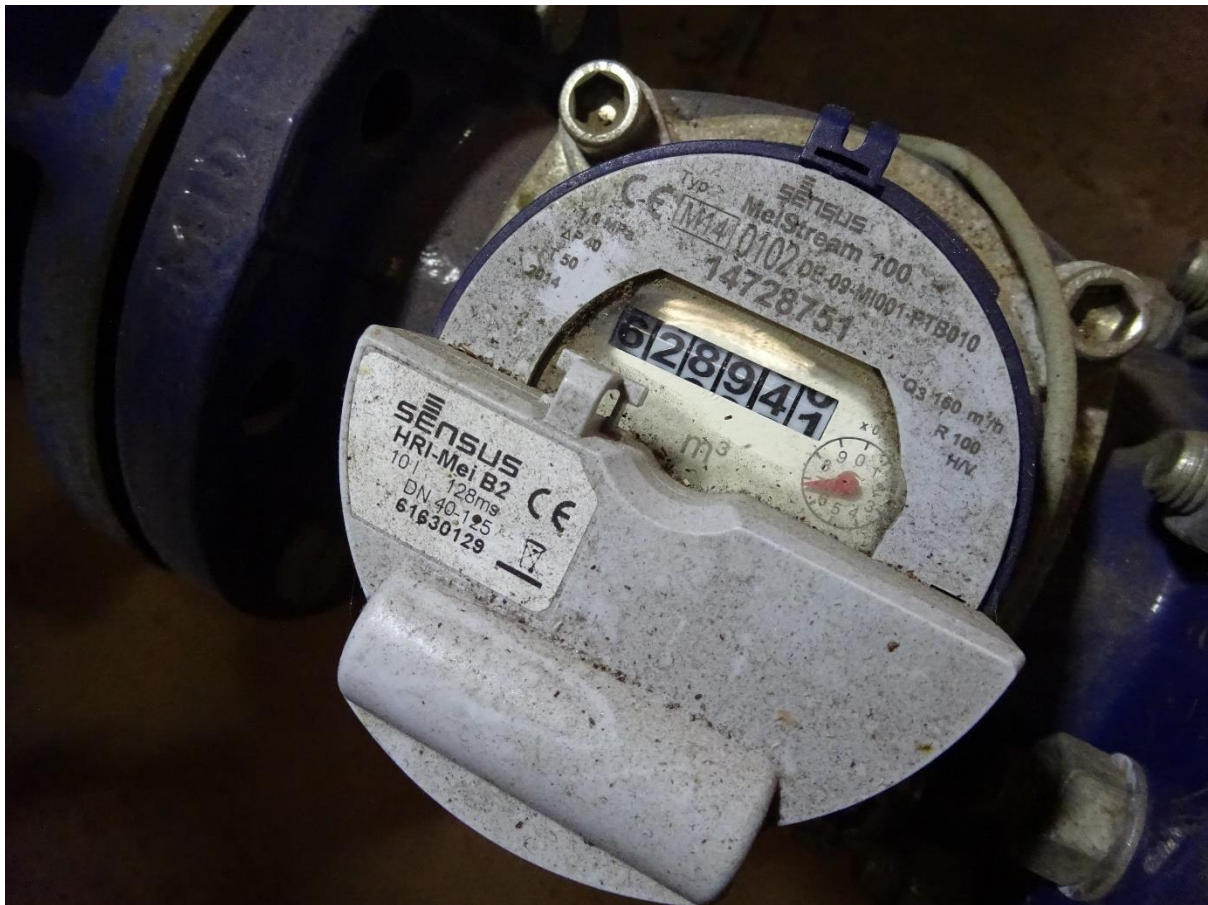
Photo 17 – Borehole meter – Point B, Abstraction Licence 24/66/1/0047

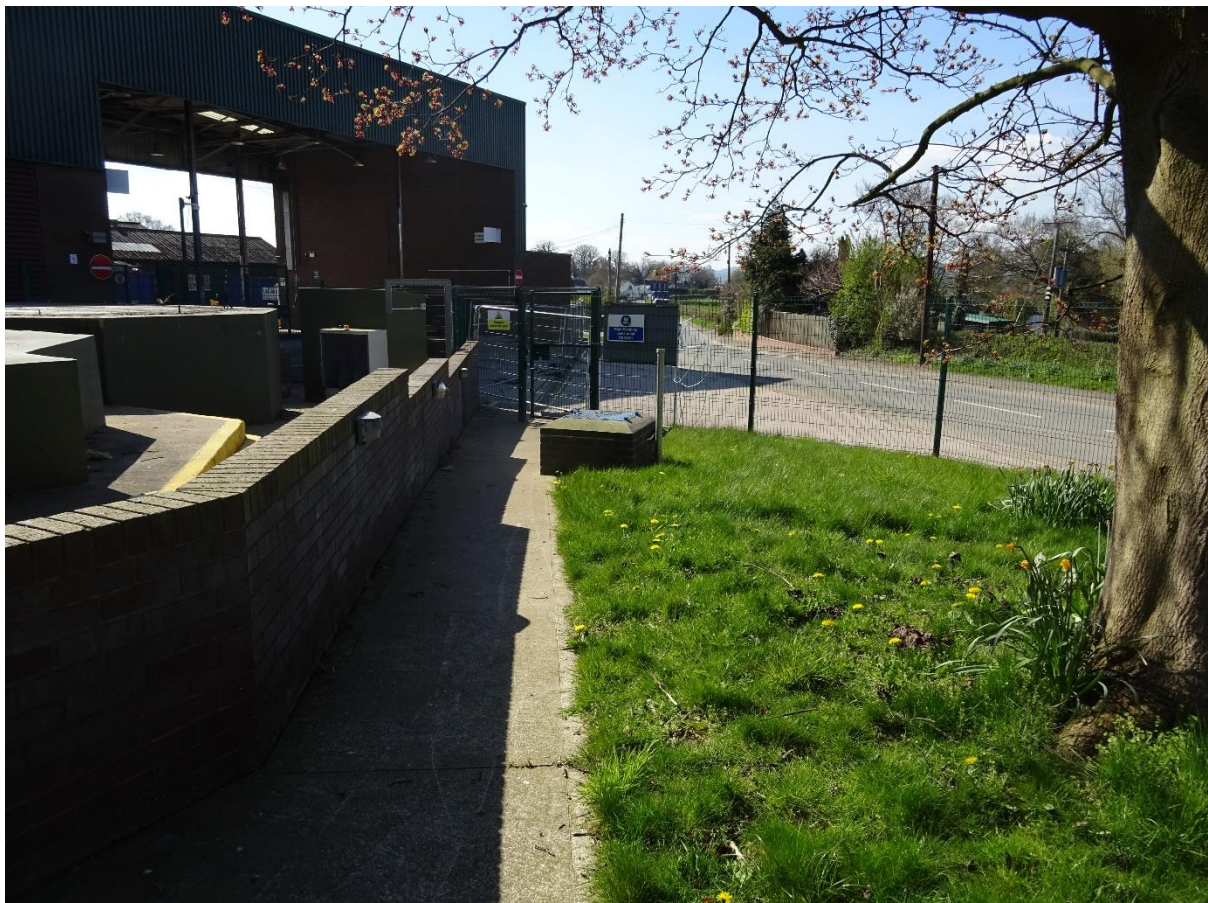
Photo 18 – Site entryway and bund with tanks removed. Penstock manhole.

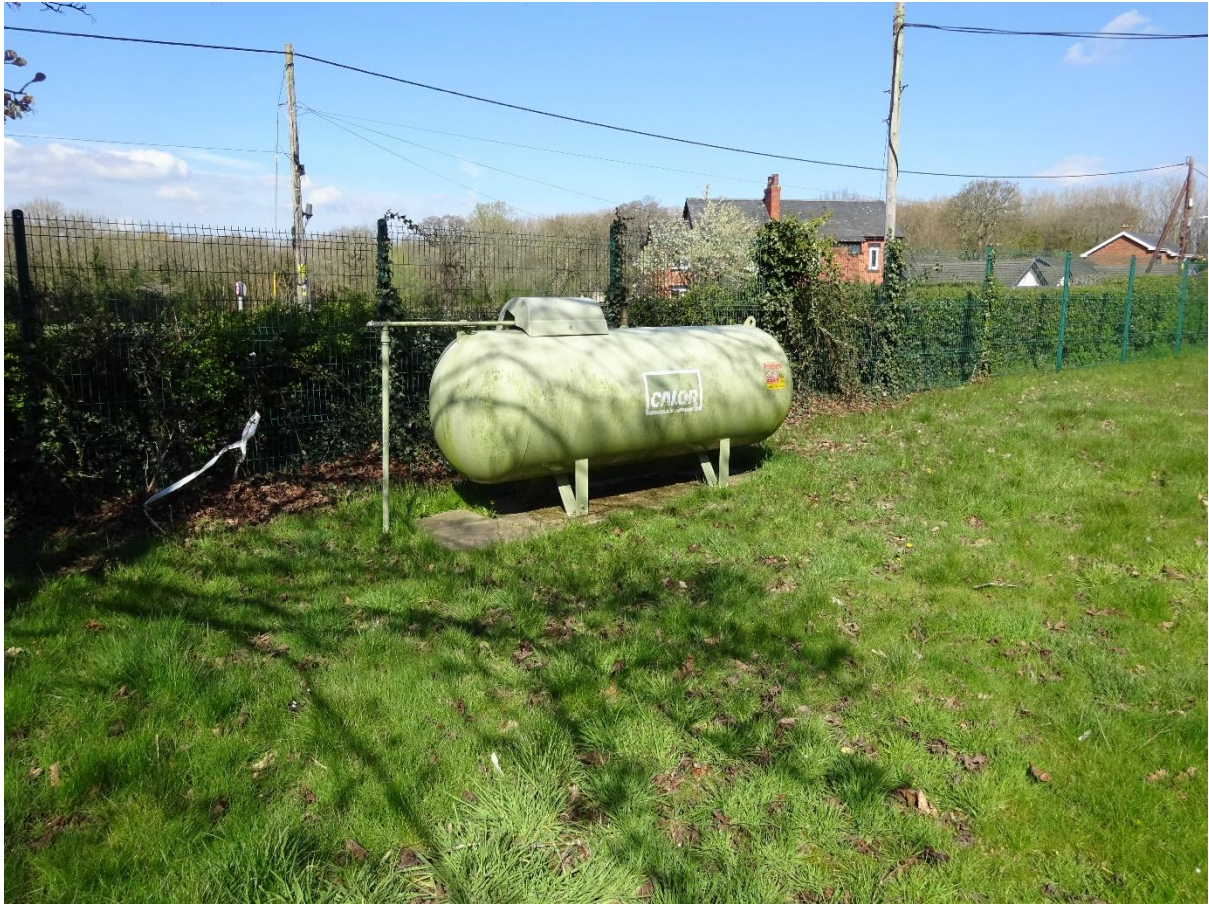
Arla, Llaandyrnog  
Final site inspection 16.04.2021  
Photo 19 – Calor Gas tank remaining

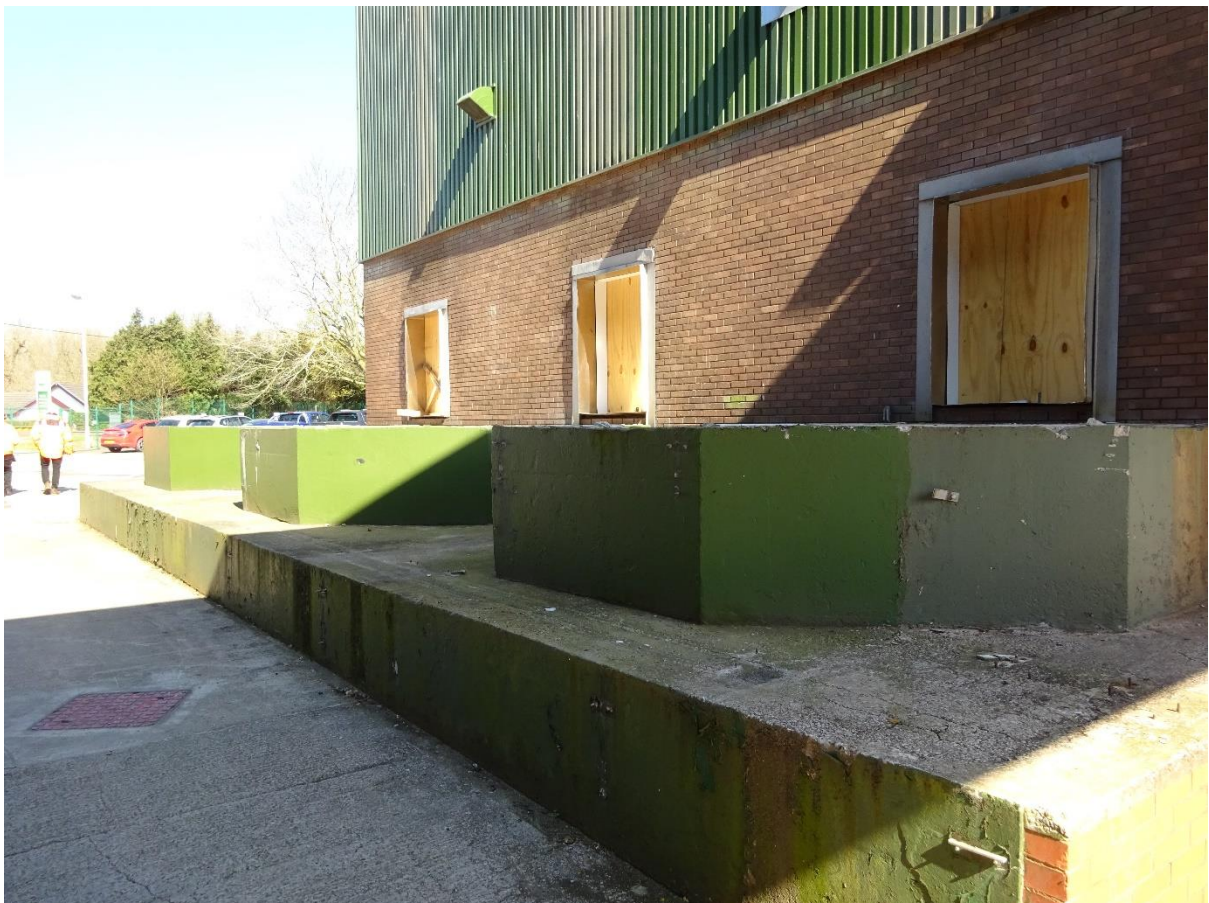
Photo 20 – Milk intake area, silos removed

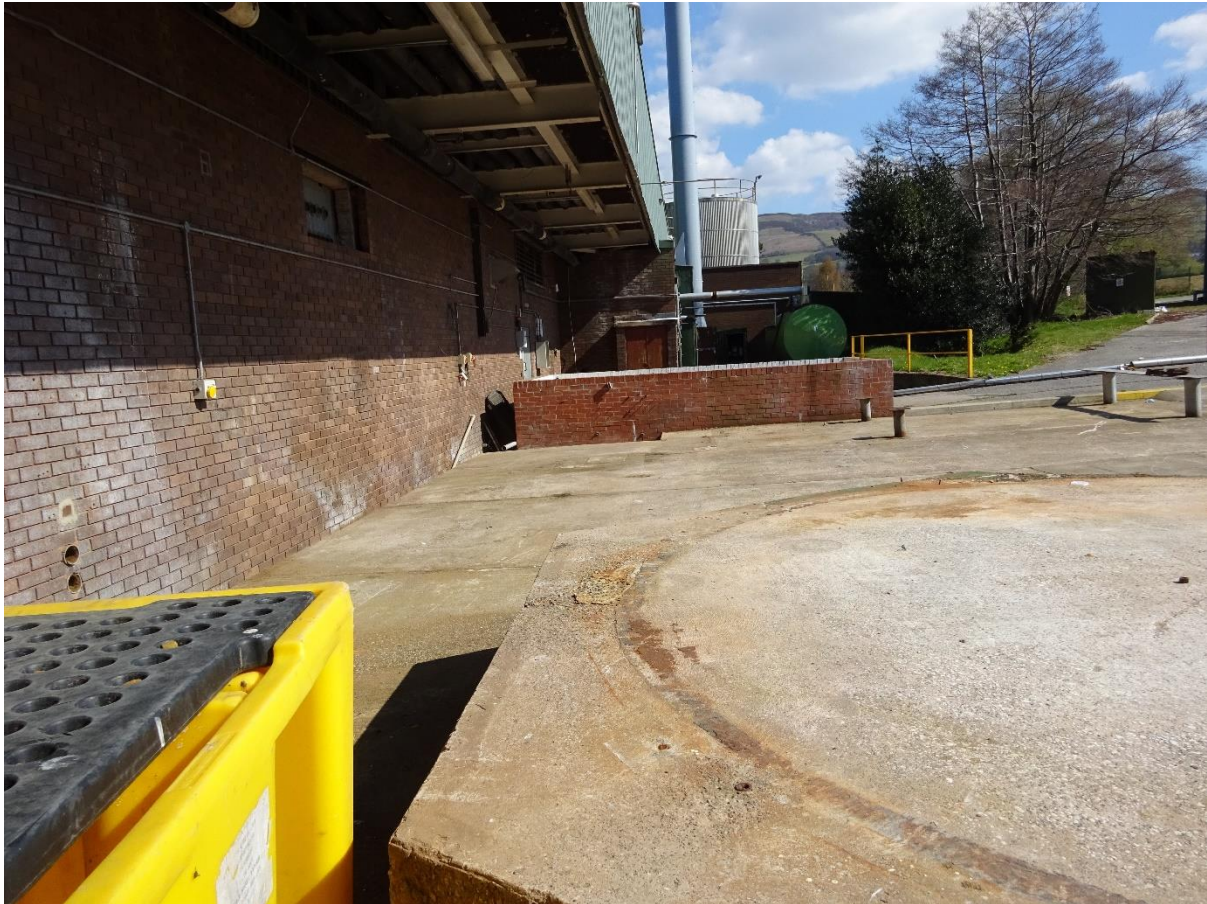
Photo 21 – Dosing chemicals bund adjacent to boiler house, ancillary pipework removed. Bund tray in foreground is empty
