Arla, Llaandyrnog

Final site inspection 16.04.2021

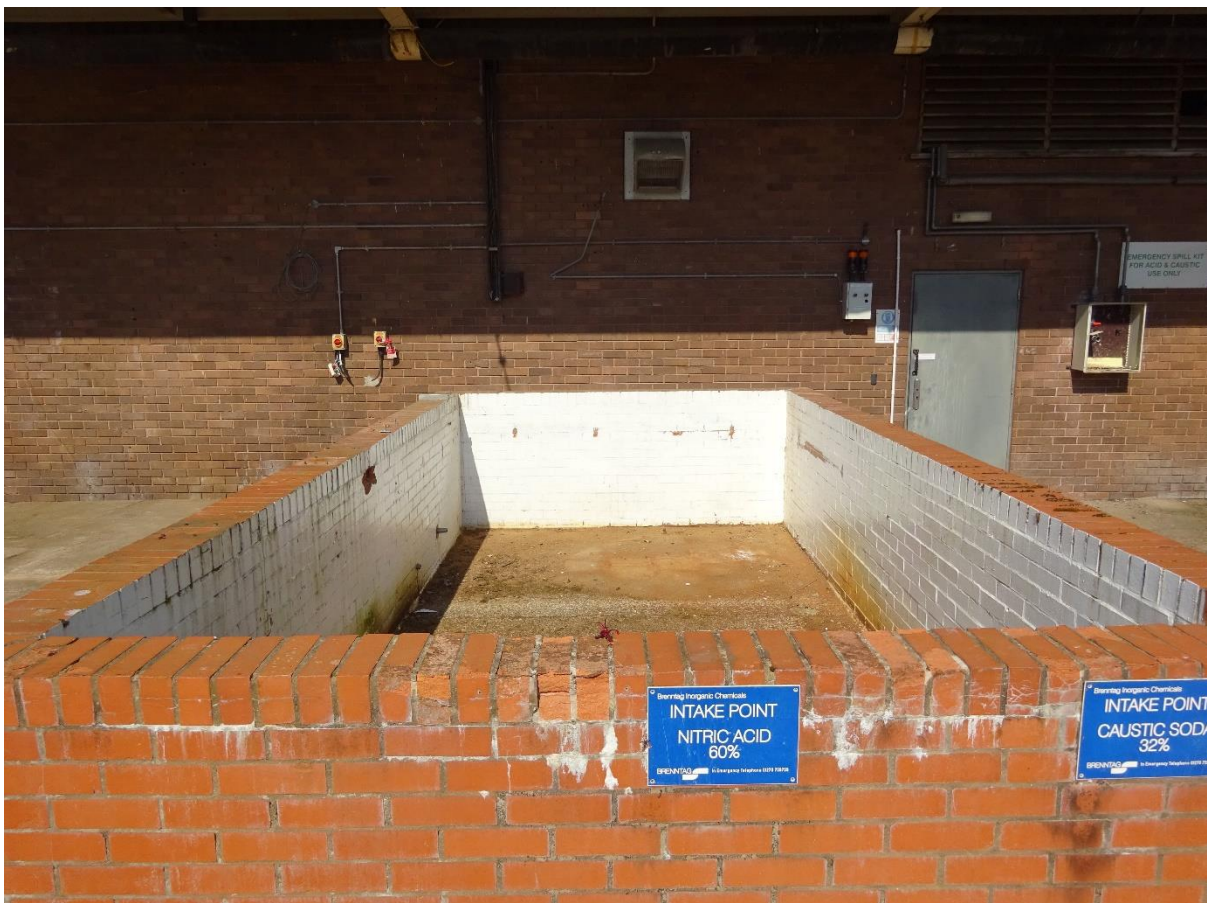
Photo 22 – Dosing chemicals bund – detached pipework breaches the wall on the left side

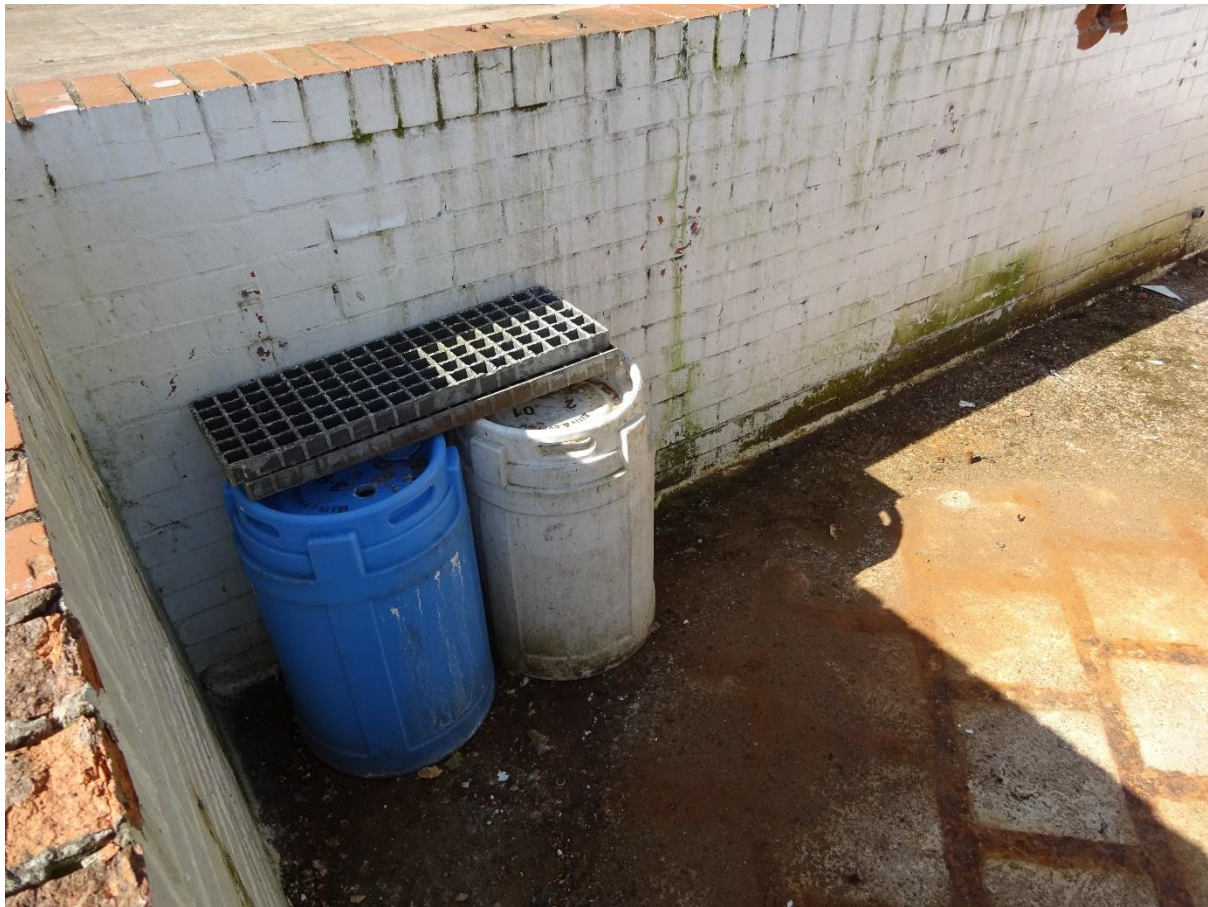
Photo 23 – Dosing chemicals bund, two empty containers remain. Photos following removal after the visit supplied

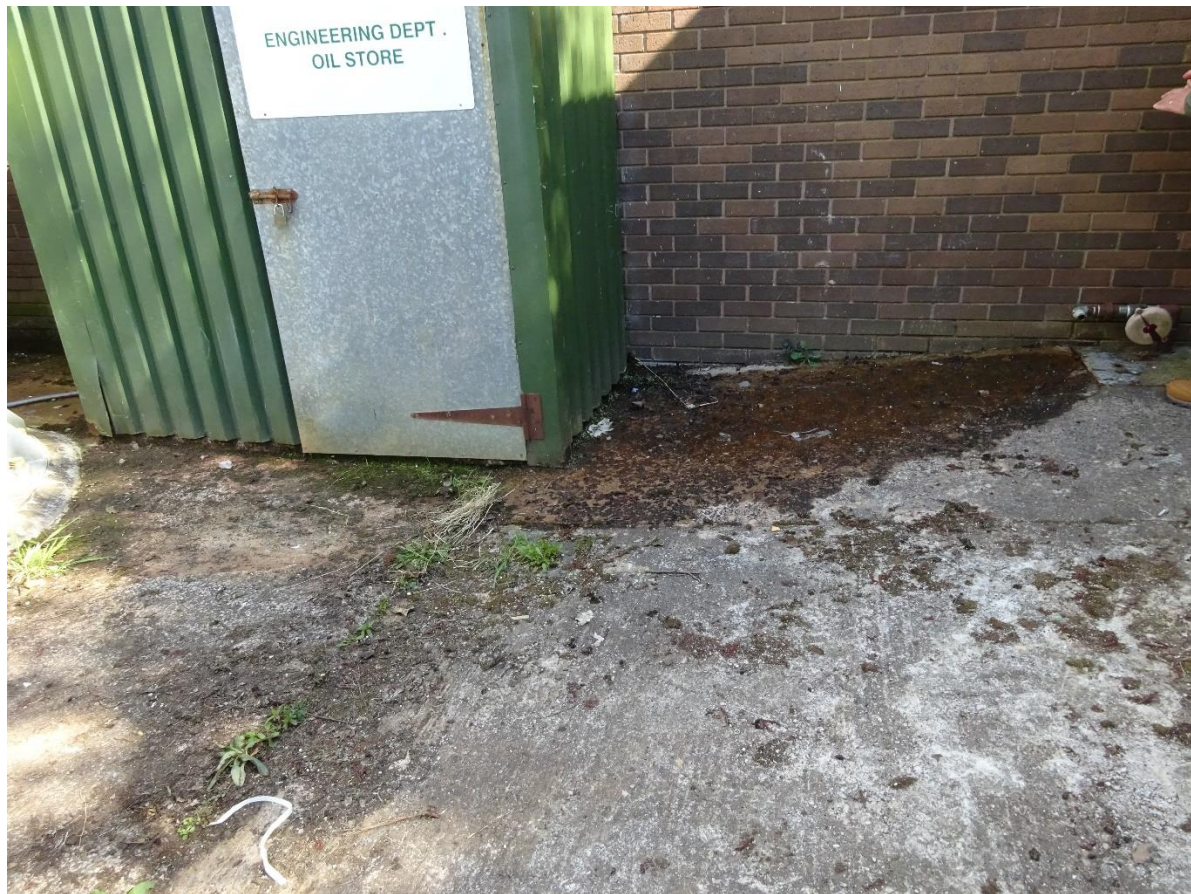
Photo 26 – small container storage, few very small capacity (<2.5l) nominally empty containers remained and would be removed during the clearance. Water staining from the fire hydrant pipe to the right.

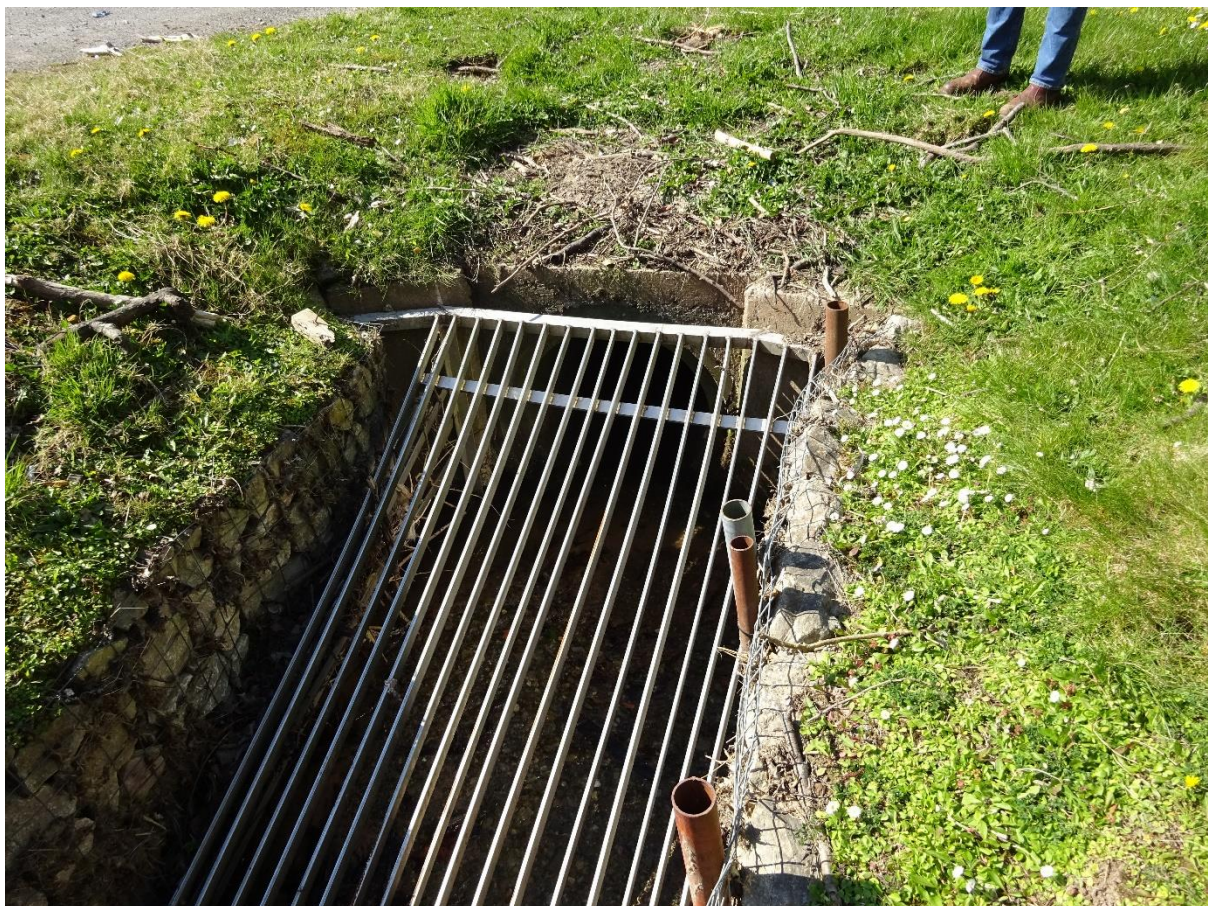
Photo 27 – trash screen at the upstream end of the Nant Simon culvert was clear.

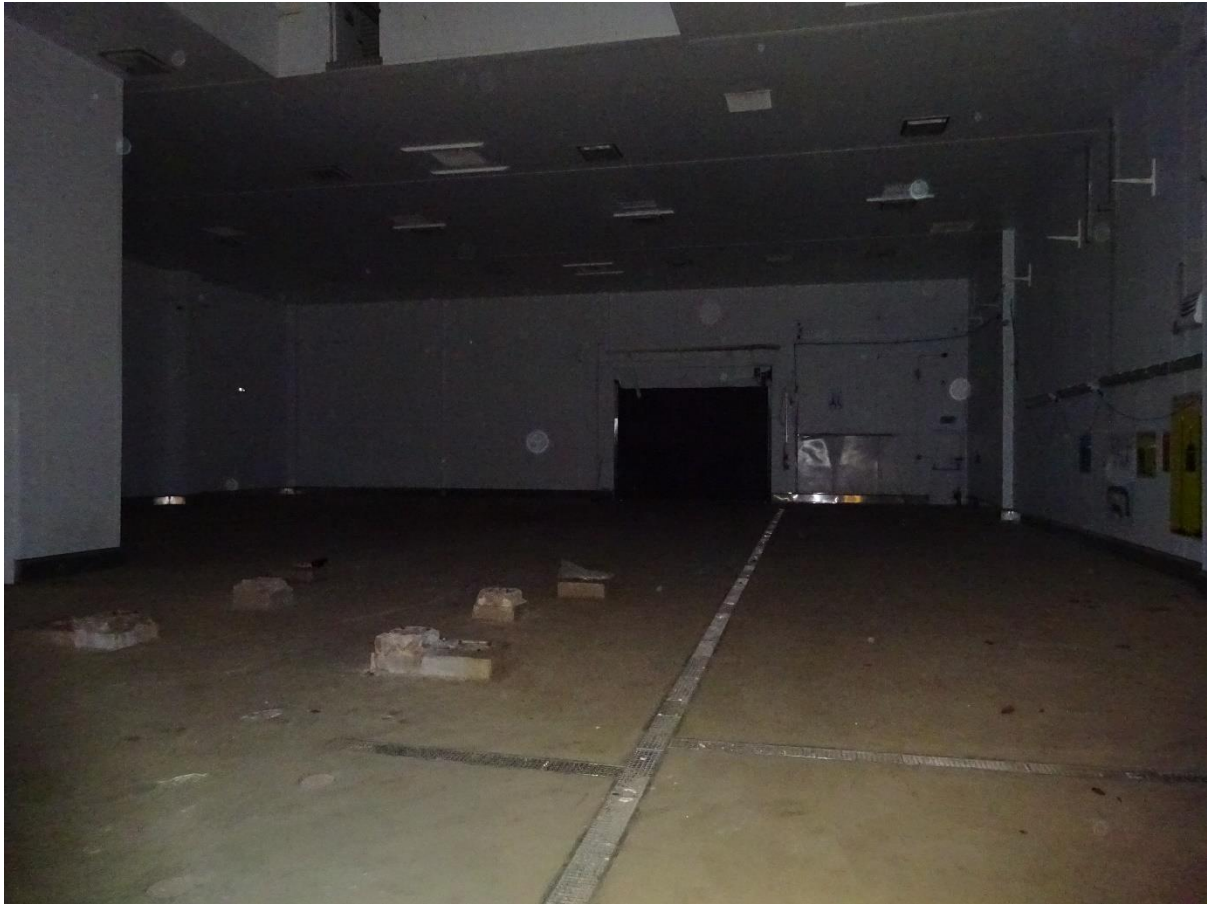
Arla, Llaandyrnog  
Final site inspection 16.04.2021  
Photo 28 – internal plant and equipment removed

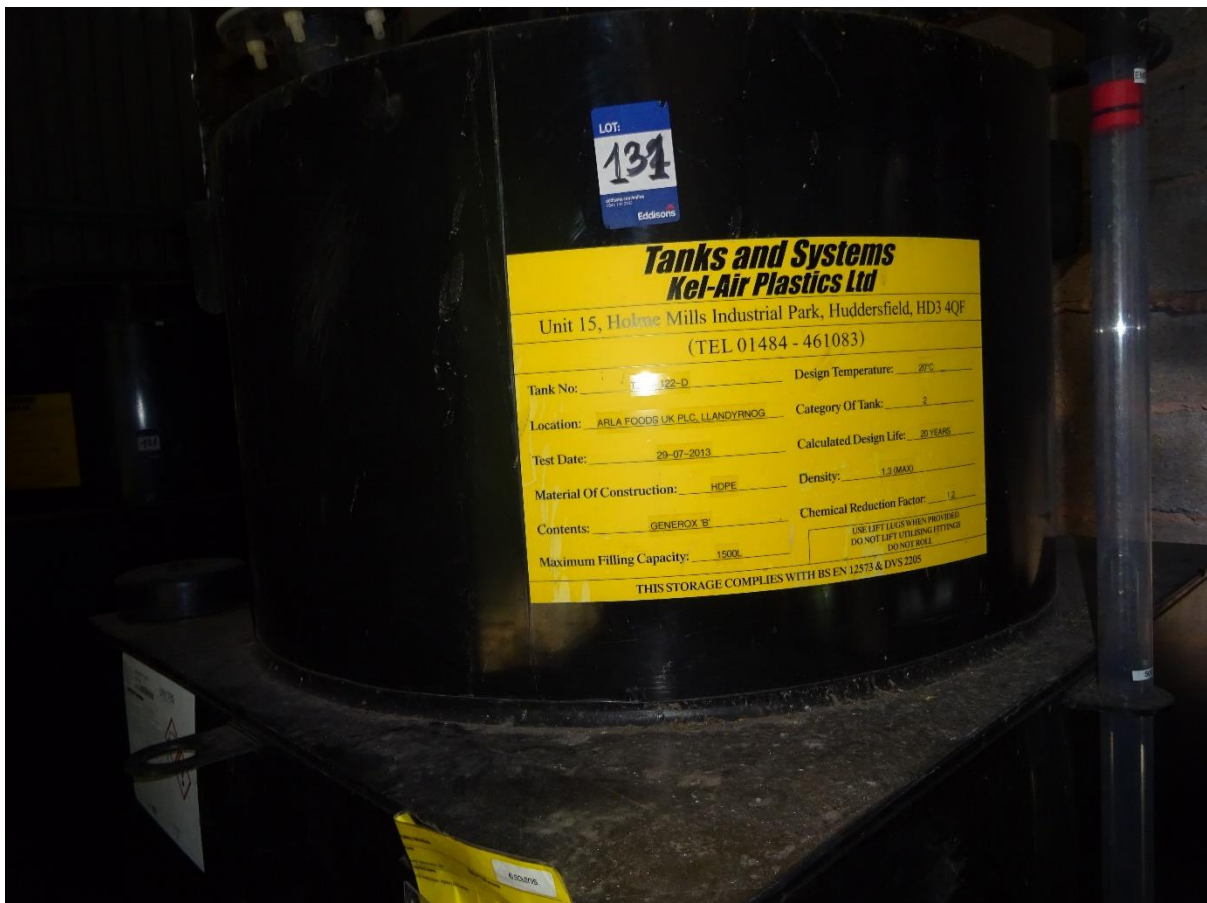
Photo 29 – empty chemical tanks inside factory. Evidence of contractor cleaning sent with surrender application.

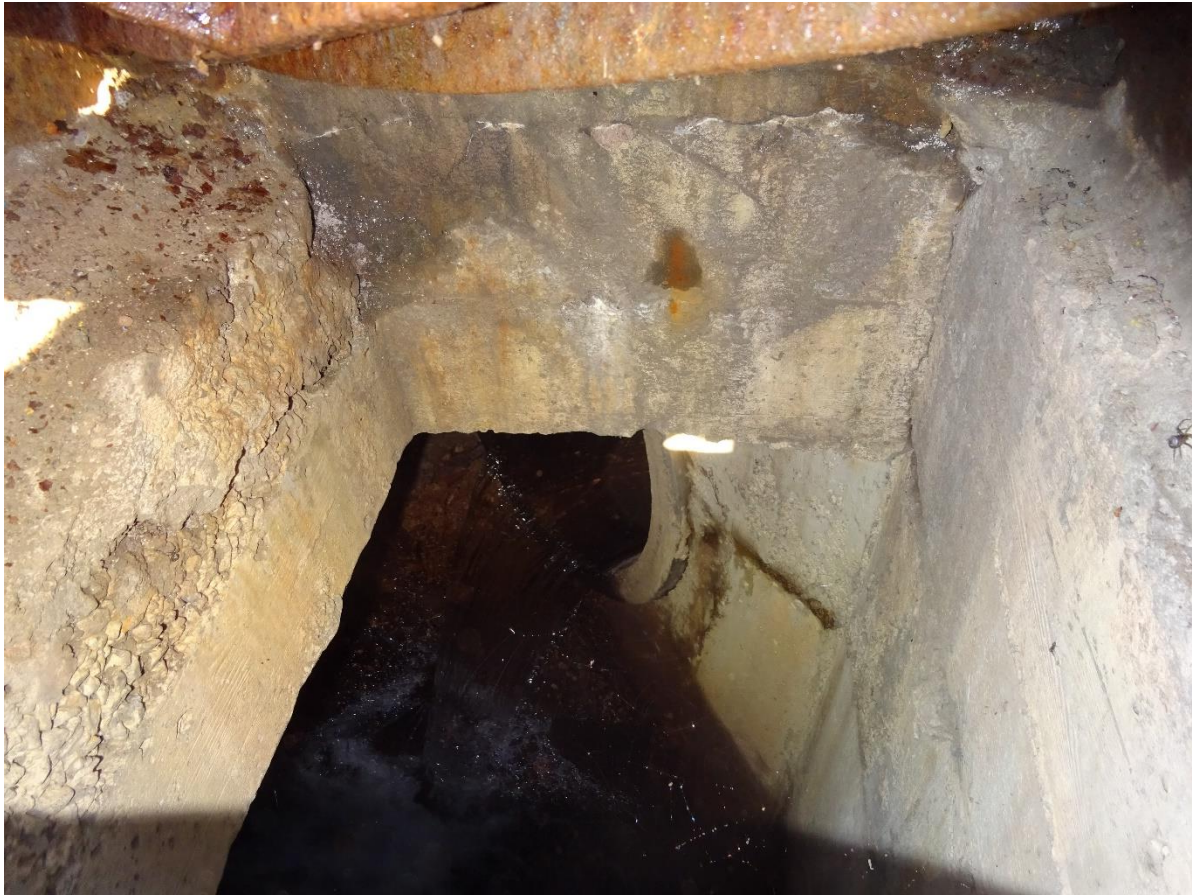
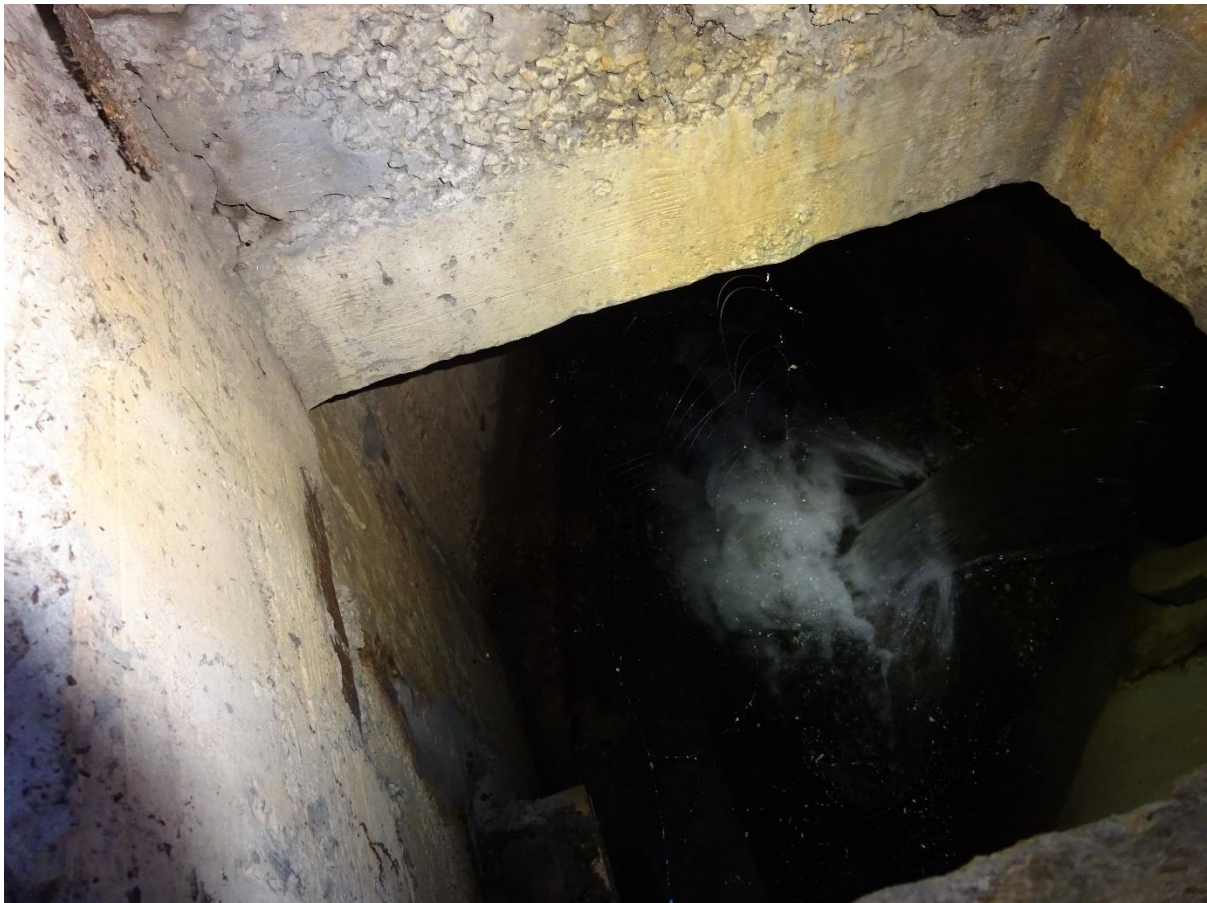
Photos 30 & 31 – final manhole collecting site surface drainage and culverted Nant Simon in site entryway. Running water is clear and no evidence of fungus or discolouration in the chamber.
