| Project: NEWPORT TRANSPORTER | | Status: PRELIMINARY | |
| Drg Title: PROPOSED REPAIR DETAILS | | Drawn By: SAM | Checked By: |
| B072084- CUR - ZZ - ZZ - SK - S - 27153 - | | | |

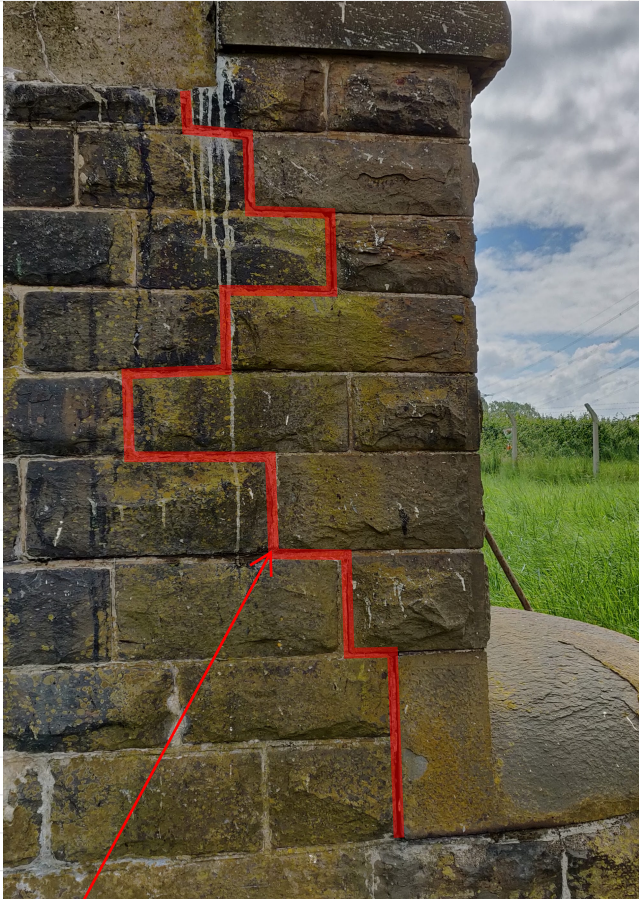
Cracked Masonry Example

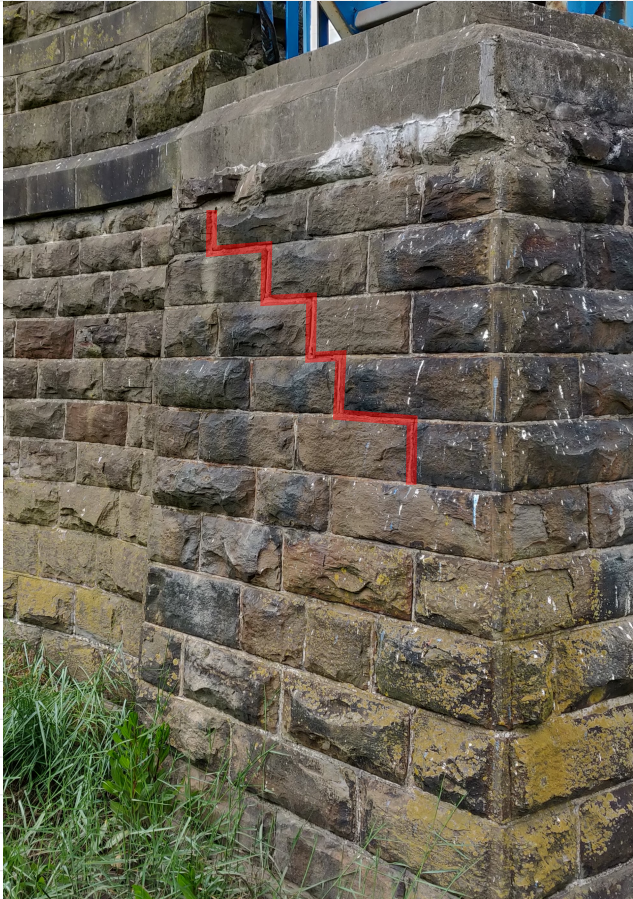
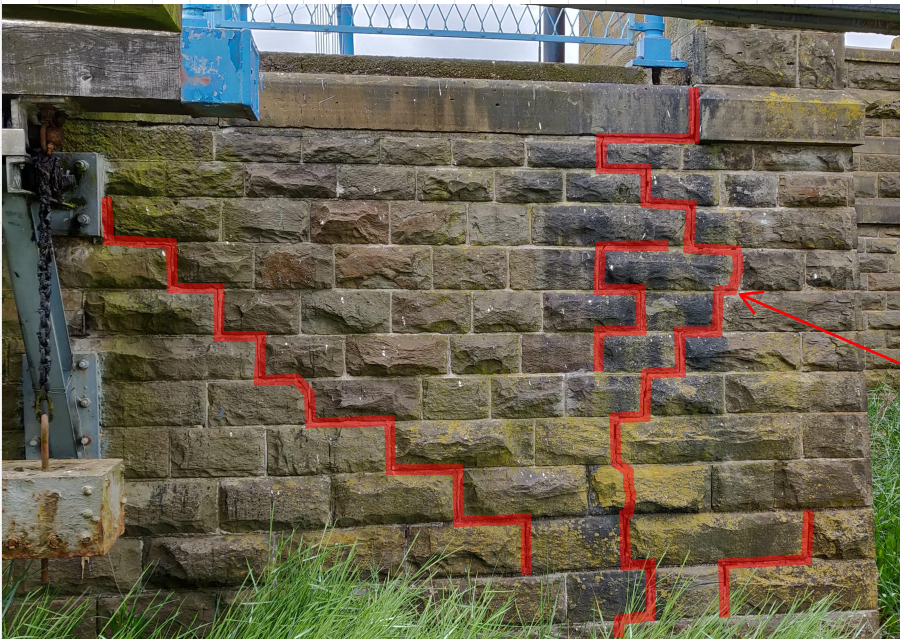
Cracked Masonry Example

**Repair Justification:** The masonry to the East and West approaches are as per the original construction and no major works have been carried out in their lifetime, although it is likely some repointing has occurred intermittently. A small degree of masonry has been subject to mortar loss, cracking within mortar beds and movement within the masonry units. The masonry extents are highly visible and accessible elements and one of the first points of interaction for visitors. Likewise, they are an important element in the long-term life of the structure, supporting the approaches to each bank for pedestrian and vehicle access and egress onto the bridge. As such they are high-risk elements which would benefit from refurbishment.

- Cracked mortar; Affected areas are to receive Helifix Helibars within mortar beds with existing mortar to be removed, followed by placement of Helibond cementitious grout and reinstatement of the facing mortar bed.

- Cracked masonry; Affected masonry units to be assessed on a case by cases basis. However, where a masonry unit is deemed to have degraded to a degree that is detrimental to the future of longevity of the construction this is to be removed repaired through the use of Cemtie reinforcement within single blocks. The masonry unit is then to the reinstatement to original position and orientation within wall.

- Repointing; Affected mortar beds and perpend joints are to be assessed on a zone by zone basis. However, where the mortar is deemed to have degraded to a degree that is detrimental to the future longevity of the construction this is to be removed and replaced with a mortar specification to suit existing, subject to testing of existing material.
