**Incident Summary Report**  
**Incident :2104374    Location : Crumlin**

ADDRESS / LOCATION OF INCIDENT Inc. ADDRESS / NGR / POSTCODE / ASSET No - Swffryd CSO, off Kendon Rd, Crumlin, NP11 3PA. ST2122998661

BRIEF DESCRIPTION OF INCIDENT - DCWW crew on site. Have identified blockage on asset causing minor discharge.

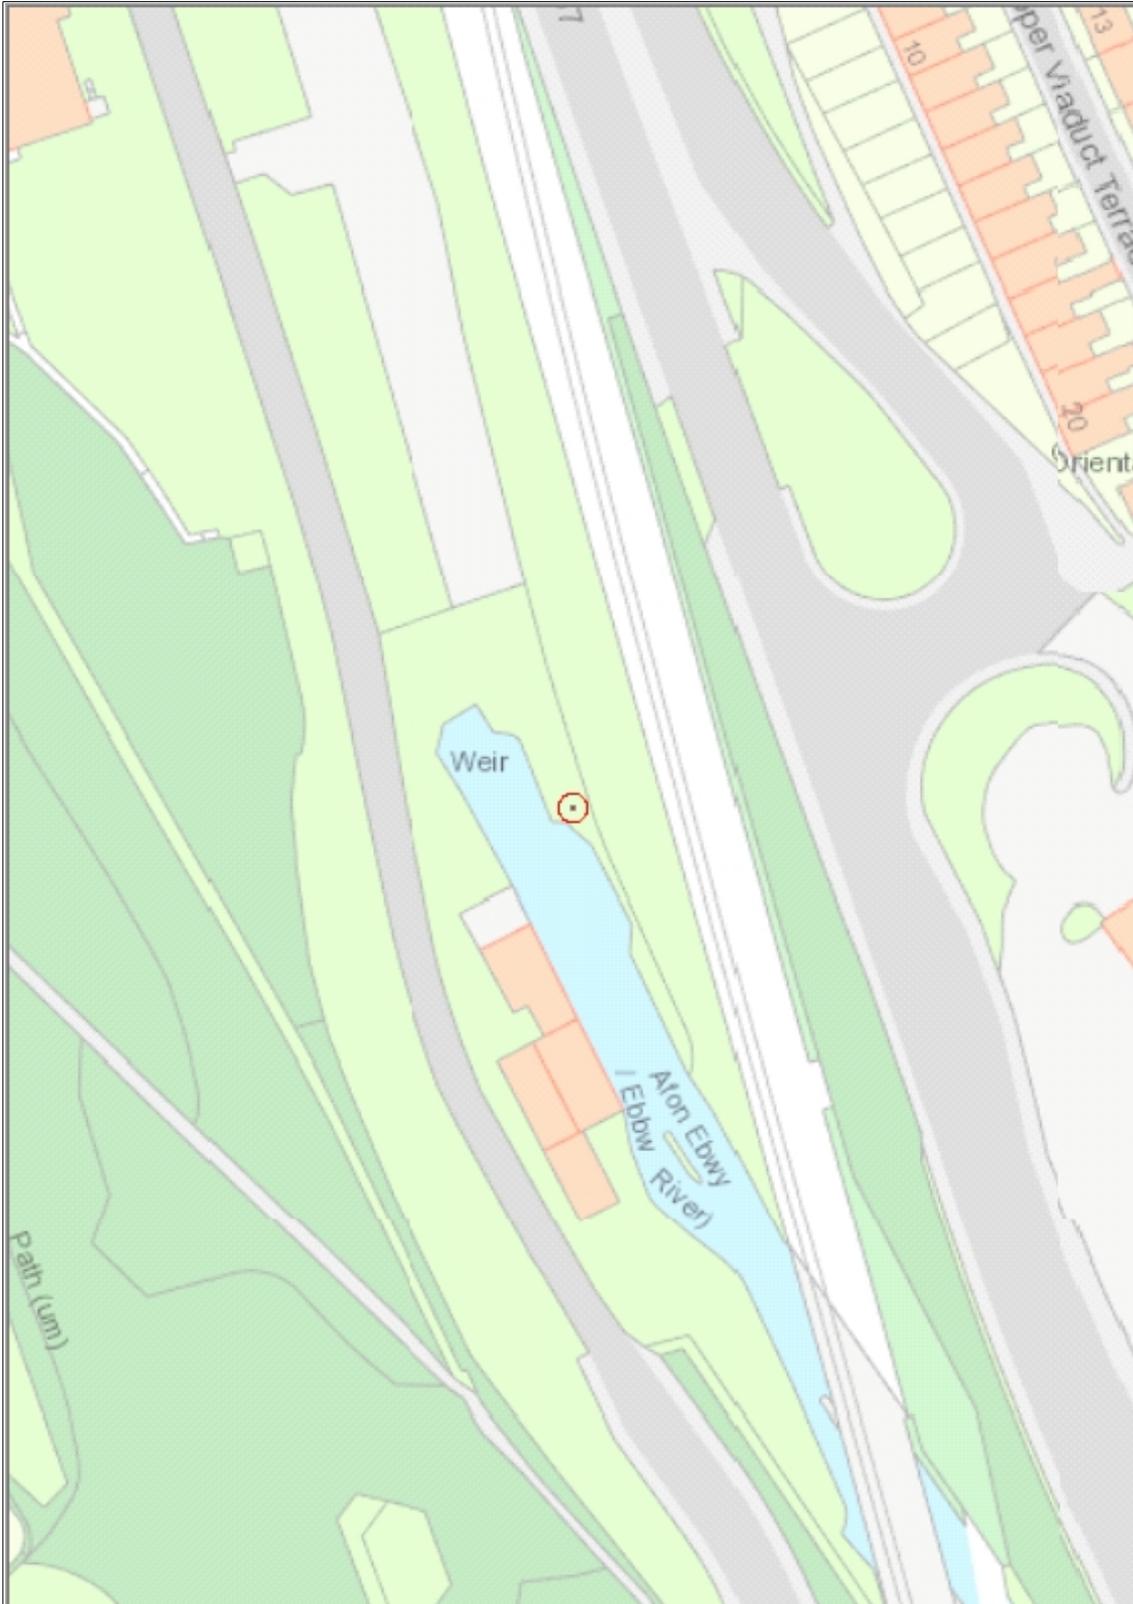
10/06/2021 14:31	Tamarind Falk	10/6/21 (14.30) DCWW Final: 'Extensive CCTV carried out, no structural issues identified. Cause appears to have been a build up of rag post-storm. Believed to have washed down from the upstream catchment. Discharge was screened and dilute with no discolouration. Review taking place W/c 14th June. Further detail to be shared with Tamarind Falk NRW. Final update.'
16/06/2021 14:45	Tamarind Falk	16/6/21 DCWW No Impact Claim received from Dan Humphreys with additional photos & info: Please find attached claim along with additional photos (these are 2017 ones but show width and speed of Ebbw at this location – hence the claim). NB 1st attachment is that which I sent over last week. Review held this morning, good to find no structural defects identified, but we will amend the maintenance tailored to this specific asset where we will look at the upstream chambers and undertake proactive flushing going forward. Always plenty of learnings from these type of events.

17/06/2021 12:40	Tamarind Falk	17/6/21 Dan confirmed that the photos taken on 19/5/21 at 14.39, were taken before the blockage had been cleared ie. at time of discharge. The discharge is barely visible, it is so minimal.
17/06/2021 12:43	Tamarind Falk	17/6/21 Emailed Dan Humphreys DCWW confirming No Impact Claim accepted, in line with guidance 16_02. Photos taken at time show discharge is barely visible if at all, it was so minimal.
17/06/2021 12:52	Tamarind Falk	Crumlin Swffryd CSO Caerphilly: Discharge permit AN0361101
17/06/2021 13:00	Tamarind Falk	All correspondence filed on DMS -Pollution file 2104374 and Incident Summary filed under permit AN0361101.
