## Newport Transporter Bridge – ECI Survey Works Report.

## The scope of the ECI Survey works are as follows:

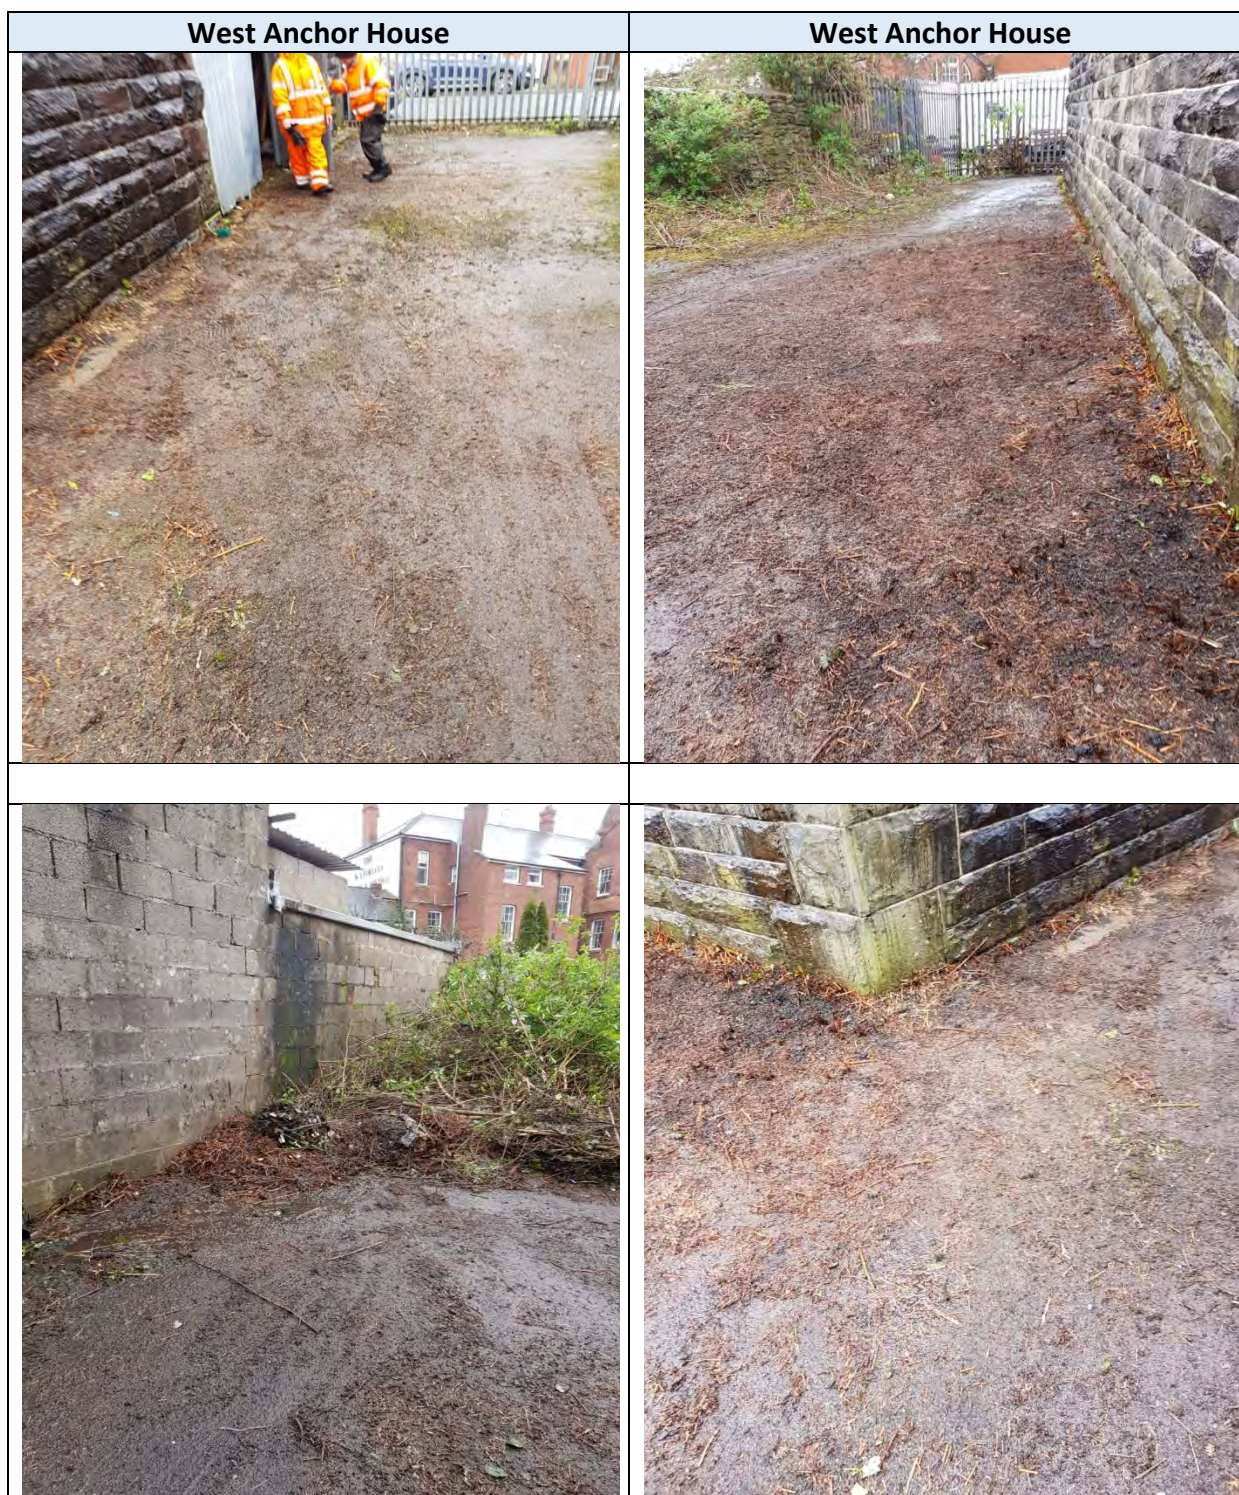
### Item 1. Removal of vegetation to anchor pits to see damp/corrosion.

Vegetation around the full perimeter of both Anchor Houses has been undertaken to facilitate a thorough inspection of the pits and associated buildings.

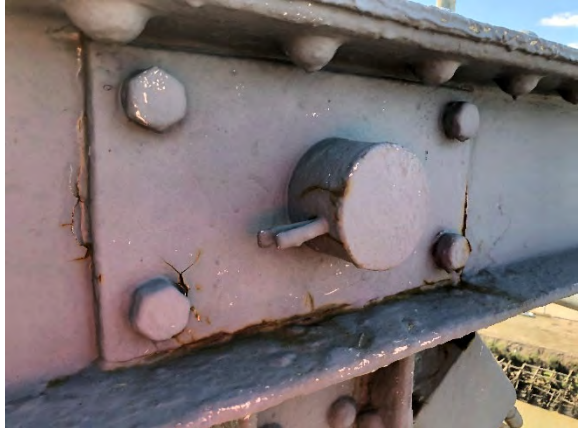
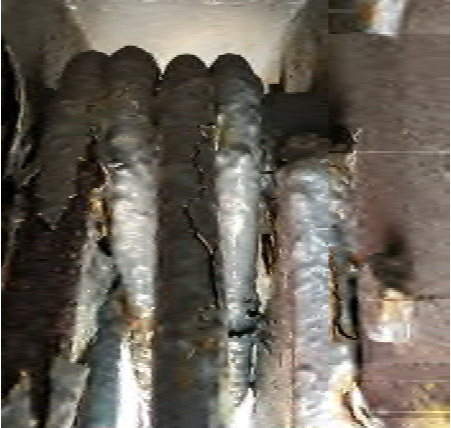
## Top Bracing Pin 44 (TBP44)

The Pin was firmly locked in position and wouldn't move despite various means being introduced to release it from its housing.

The existing strengthening cover plates affixed to the internal and external faces of the Top Chord Flanges were removed to free up the pin. However, this proved futile as the Pin remained firmly locked in place. *Please Note: The existing bolted connections in each corner of the strengthening plates were all hand loose after removal of the paint, prior to us undertaking any structural works, it is not known how these have all worked loose?*

It became apparent through observation that the Vertical Primary Steelwork (VPS44) was transferring all the weight from the Bottom Chord directly onto the Pin Connection and therefore removal of the pin was unattainable without releasing the applied force.

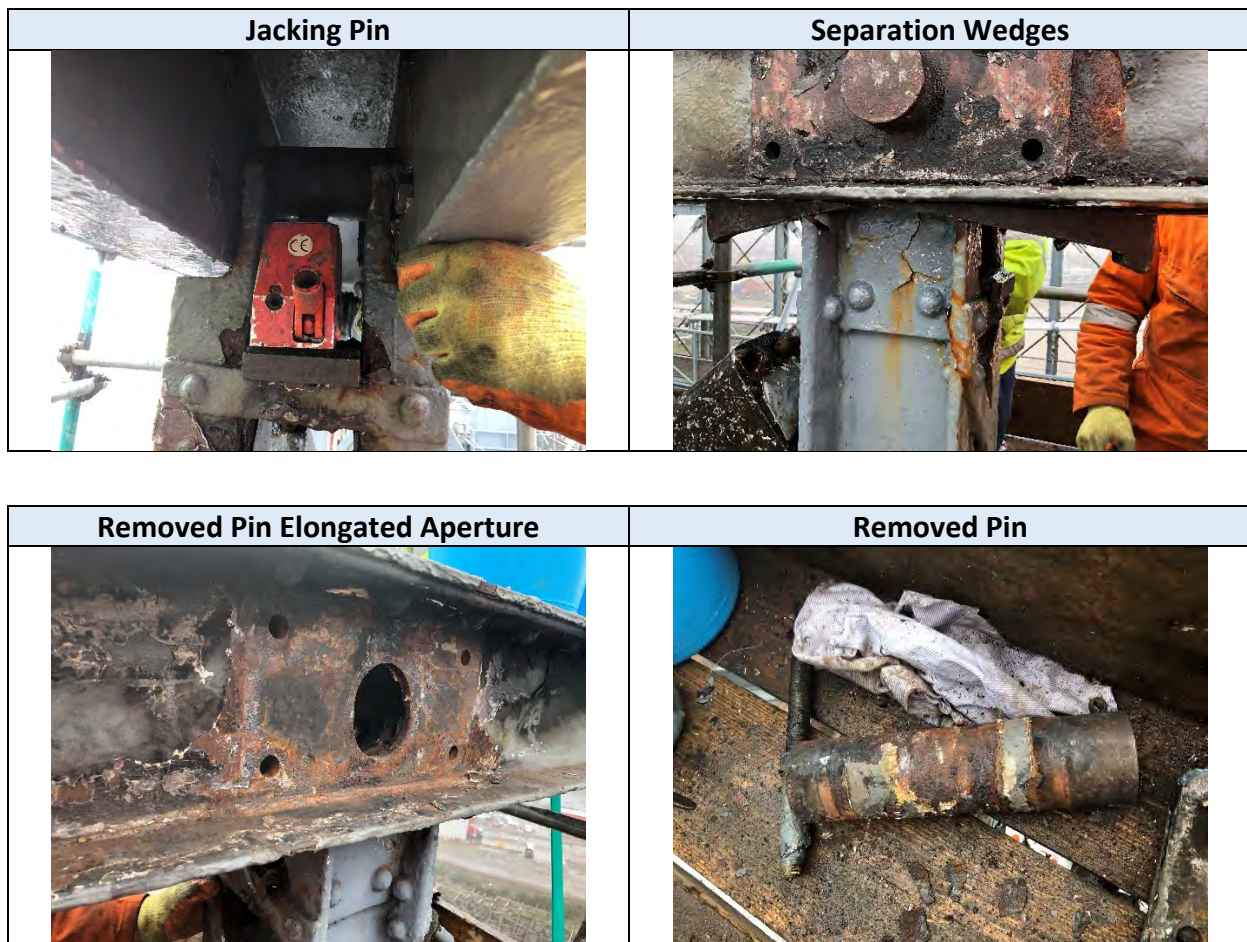
On removal of the pin it became more apparent that the inside face of the VPS (at the connection to the pin) was heavily corroded/ delaminated and in need of repair. A design will need to be produced to allow such repairs to be undertaken during the core works to ensure a robust connection between the Pin and VPS.

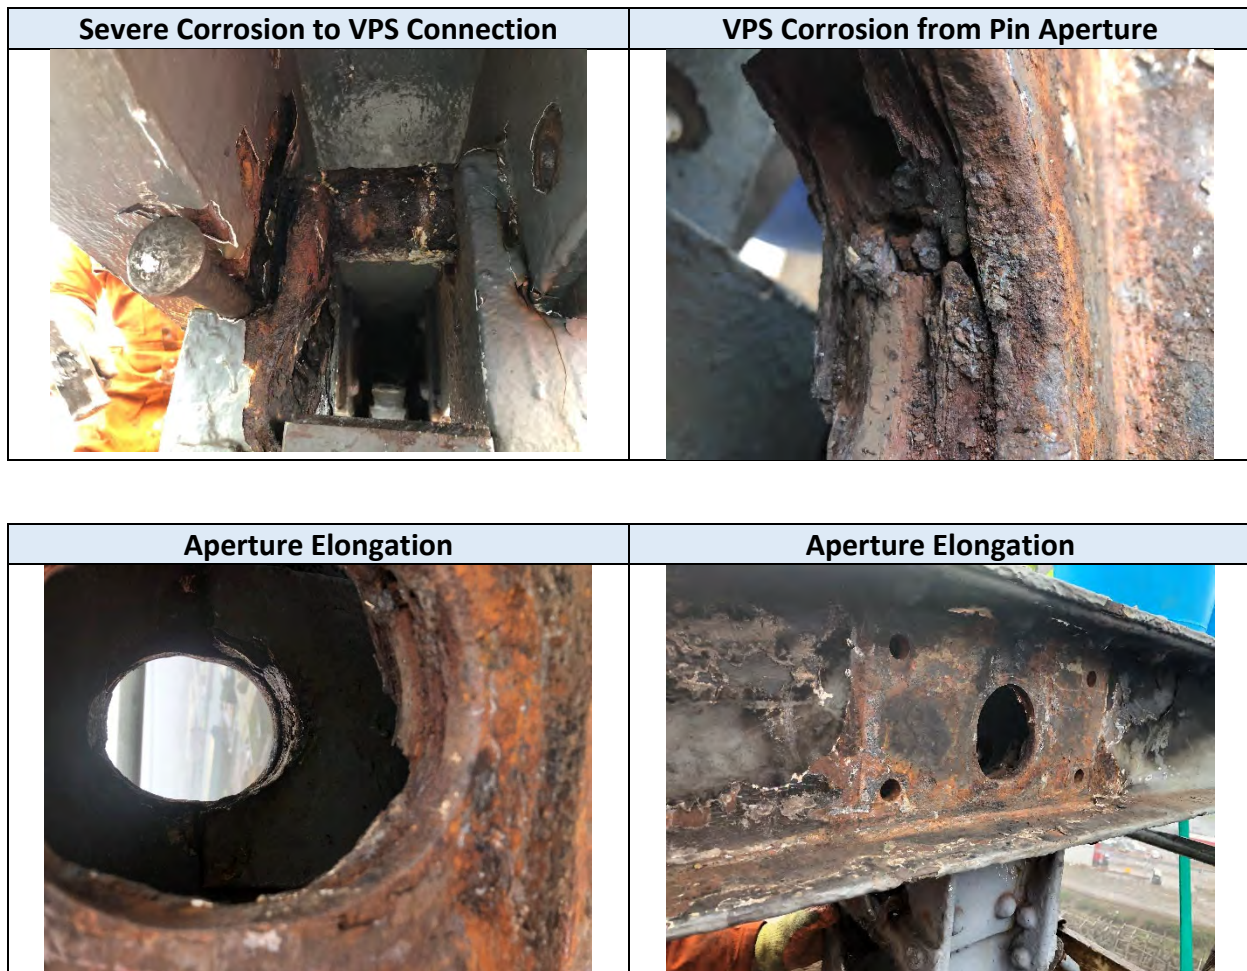
There was also evidence of prior elongation of the aperture on the Top Chord Flanges, adding credence to the historical installation of the cover plates.

After removal the new Strengthening plates were installed to the external faces and bolted into position.

The periphery of the existing aperture was dressed using an acorn grinder to remove any stress fractures, prior to insertion of the new pin, which was easily slid in by hand.

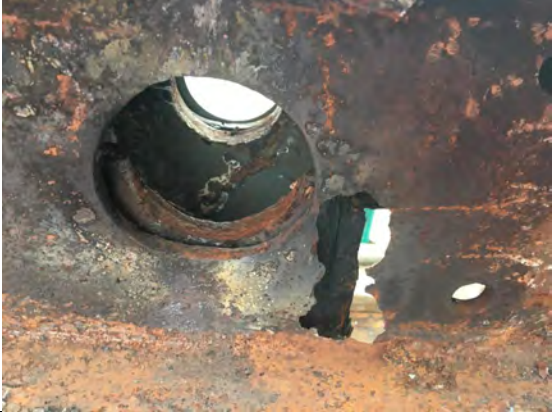
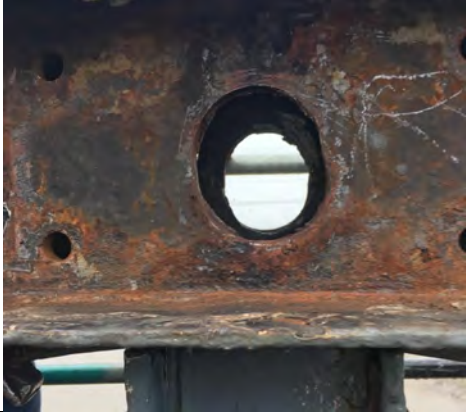
| Internal Face of TBP48 | Elongation of External Face of TBP48 |

The main difference with this location, was the significant corrosion discovered to the inside face of the Top Chord.

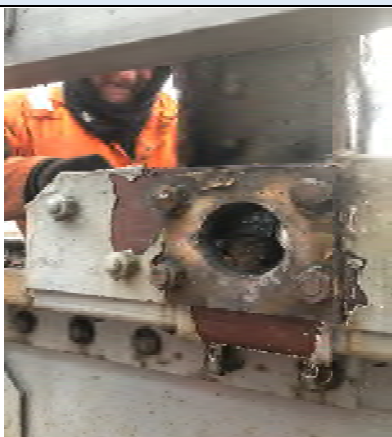
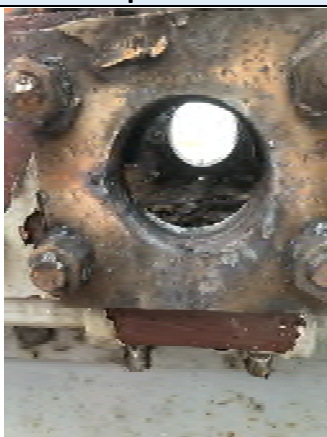
| Removed Pin | Aperture |

On examination of the Bottom Chord and VPS, they both appeared in good condition with limited corrosion and no visible elongation of the apertures.

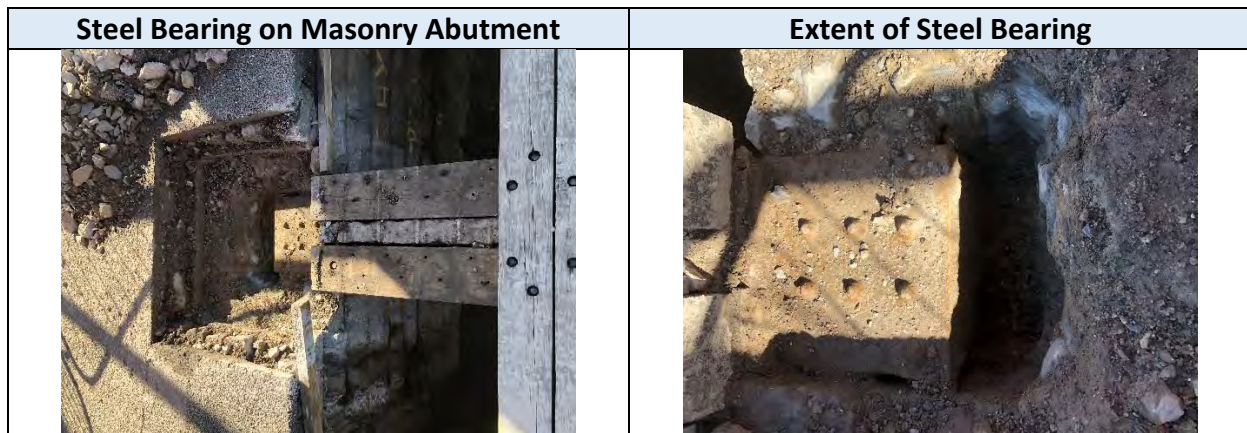
The ground was made up of 100mm of Tarmacadam and then 200mm of Cobbled Setts then general fill around the steelwork to the rear of the stone abutment wall.

Once inspected the timbers were re-affixed and the excavation re-filled, setts reset and a new hot tarmacadam surfacing applied.

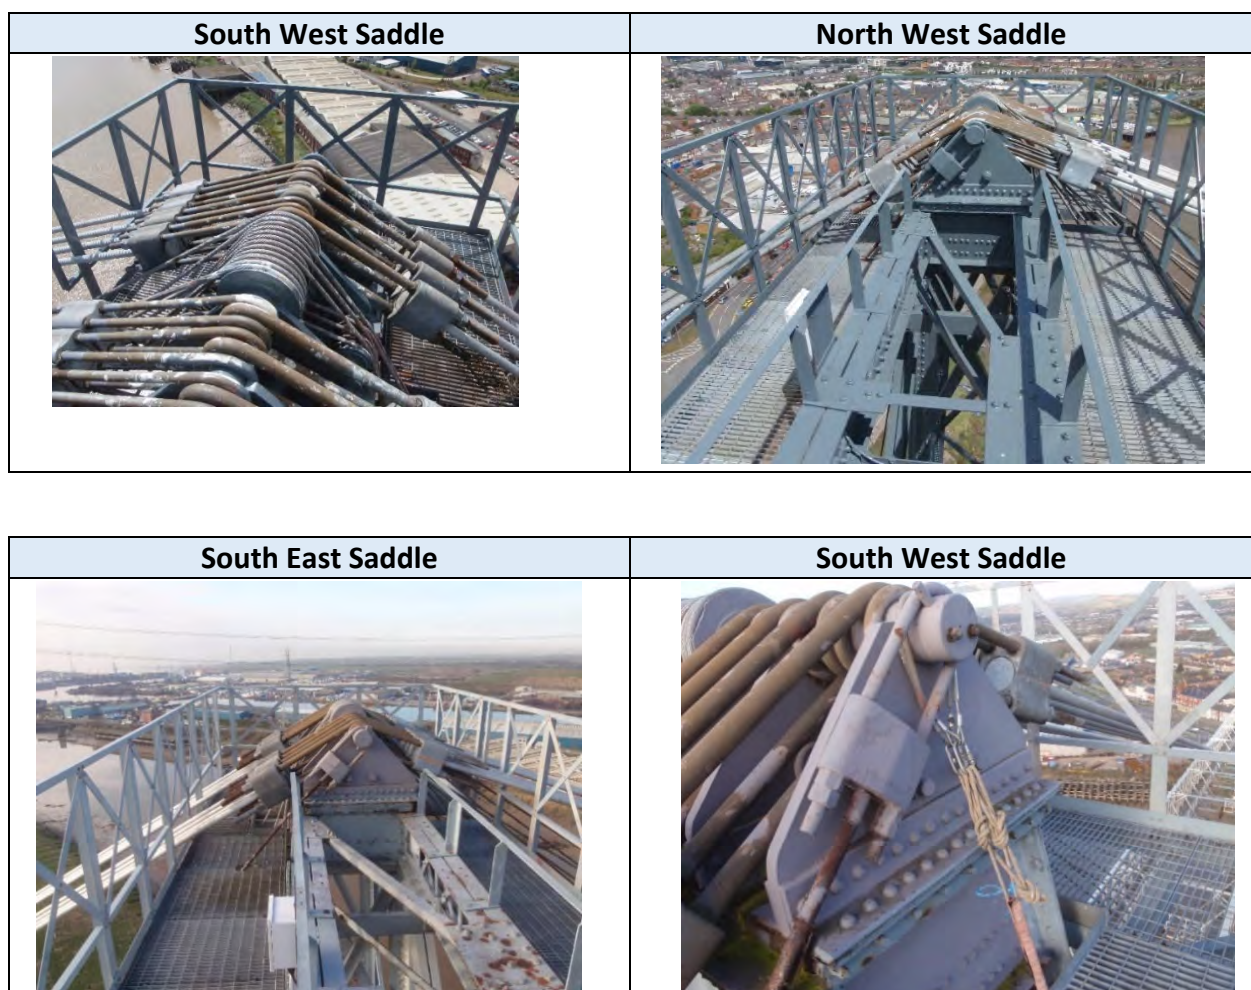
## Item 8. Detailed bearing / anchorage inspection (saddles on top of piers)

On visual Inspection of the Saddle Anchorages, there does not appear to be any deformation or cracking to the Main Cable U-Bars or the Cable Sockets.

It is difficult to assess the actual saddle and roller arrangements, as these are covered by all the U-Bars, however from the small areas visible under the U-Bars, there does not appear to be any fractures or significant corrosion.

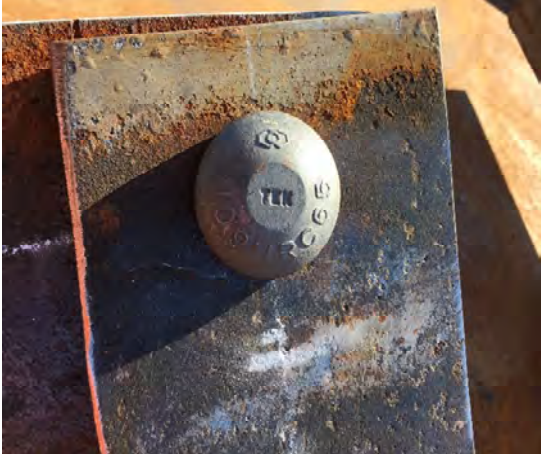
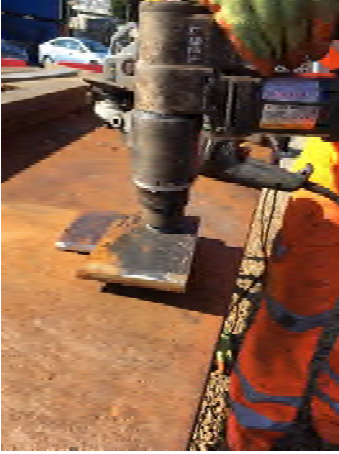
No deformation of the parent metal was observed and as the correct preload was reached.
