| <b>Paint Inspection Ltd</b><br>61 High Street<br>Fareham<br>PO16 7BG | | <b>Client</b> | Curtins |
| <b>Project Name</b> | Newport Transporter Bridge | <b>Historical Information</b> | No |

## 1: Survey Details

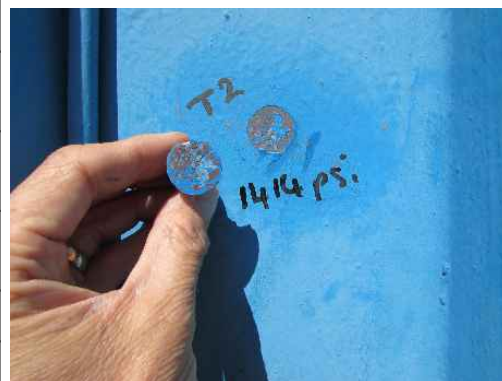
| Date | Test Area | Standard | Result | Fracture Strength |
|---|---|---|---|---|
| 24-07-2019 | T2 Gondola Above Deck | ISO 16276-1 | Pass | 1414 PSI |
| <b>Adhesion Failure</b> | m/n - adhesive failure between mth coat and nth coat of a multicoat system | | | 100% |

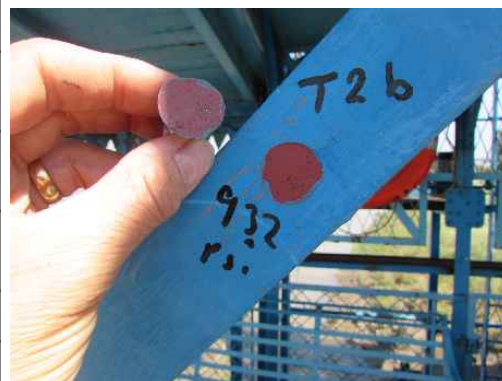
| Date | Test Area | Standard | Result | Fracture Strength |
|---|---|---|---|---|
| 24-07-2019 | T2b Gondola Above Deck | ISO 16276-1 | Pass | 932 PSI |
| <b>Adhesion Failure</b> | B/C - adhesive failure between 1st and 2nd coat | | | 100% |

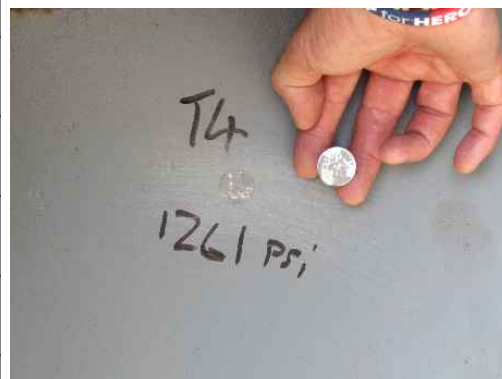
| Date | Test Area | Standard | Result | Fracture Strength |
|---|---|---|---|---|
| 24-07-2019 | T4 Motor house | ISO 16276-1 | Pass | 1261 PSI |
| <b>Adhesion Failure</b> | m/n - adhesive failure between mth coat and nth coat of a multicoat system | | | 50% |
| <b>Glue Failure</b> | Y/Z adhesive failure between adhesive and dolly | | | 50% |

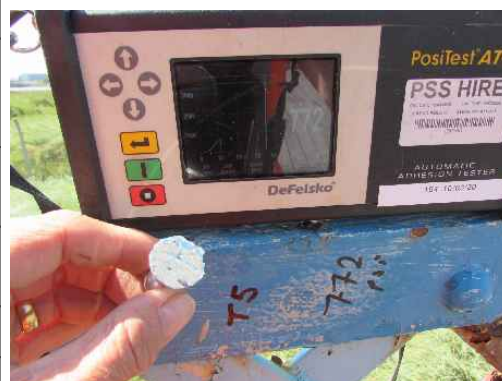
| Date | Test Area | Standard | Result | Fracture Strength |
|---|---|---|---|---|
| 24-07-2019 | T5 Eastern Approach lattice topside | ISO 16276-1 | Pass | 772 PSI |
| <b>Adhesion Failure</b> | C/m - adhesive failure between 2nd coat and mth coat of a multicoat system | | | 100% |

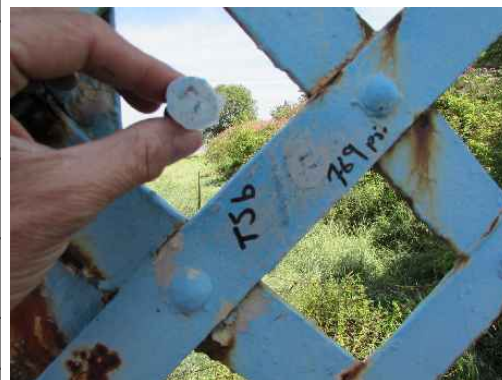
| Date | Test Area | Standard | Result | Fracture Strength |
|---|---|---|---|---|
| 24-07-2019 | T5b Eastern Approach lattice steelwork | ISO 16276-1 | Pass | 769 PSI |
| <b>Adhesion Failure</b> | m/n - adhesive failure between mth coat and nth coat of a multicoat system | | | 100% |

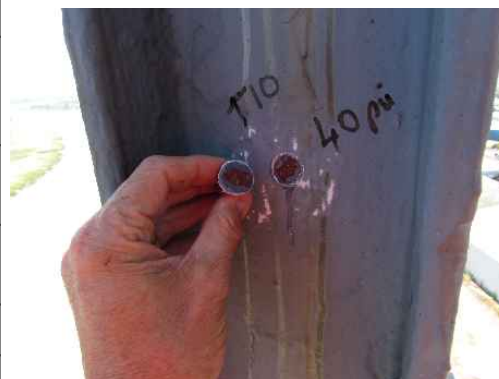
| Date | Test Area | Standard | Result | Fracture Strength |
|---|---|---|---|---|
| 24-07-2019 | T10 Main boom vertical steelwork | ISO 16276-1 | Fail | 40 PSI |
| <b>Adhesion Failure</b> | m/n - adhesive failure between mth coat and nth coat of a multicoat system | | | 100% |

the client confirmed that they have a major maintenance repainting programme over the next 2 years. The plan is to fully blast clean and application of a new coating system to all Main Boom members. From the data collected i.e poor adhesion and multi paint layers etc, our recommendation would be inline with the clients current scope.

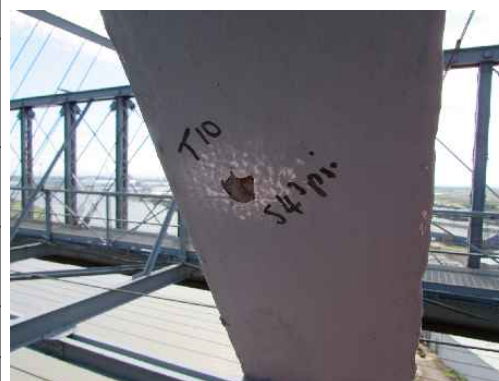
| Date | Test Area | Standard | Result | Fracture Strength |
|---|---|---|---|---|
| 24-07-2019 | T10 Main boom vertical steelwork | ISO 16276-1 | Fail | 543 PSI |
| <b>Adhesion Failure</b> | B/C - adhesive failure between 1st and 2nd coat | | | 100% |

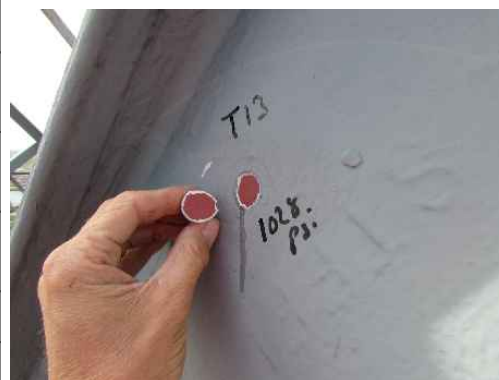
| Date | Test Area | Standard | Result | Fracture Strength |
|---|---|---|---|---|
| 24-07-2019 | T13 Pylon (west) | ISO 16276-1 | Pass | 1028 PSI |
| <b>Cohesion Failure</b> | B - cohesive failure of 1st coat | | | 100% |

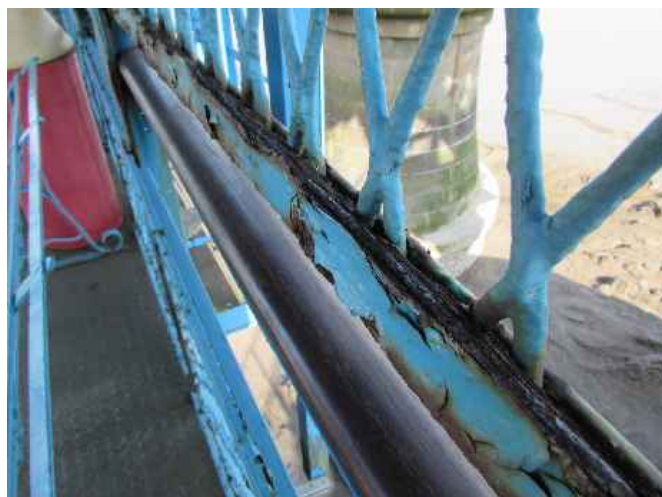
**Gondola Topside**  
Heavy corrosion and breakdown.

The coated steelwork topside, has good adhesion and average paint thickness. Whilst there is approx 20% corrosion, the coating can be repaired and overcoated. Some corrosion locations are heavy and will either require replacement of the steel members, or further assessment on treatment to provide ongoing durability.

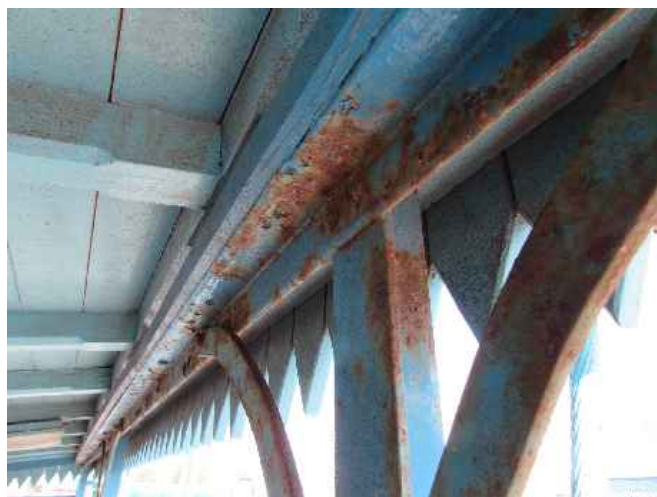
**Gondola Topside**  
Corrosion to framework members.

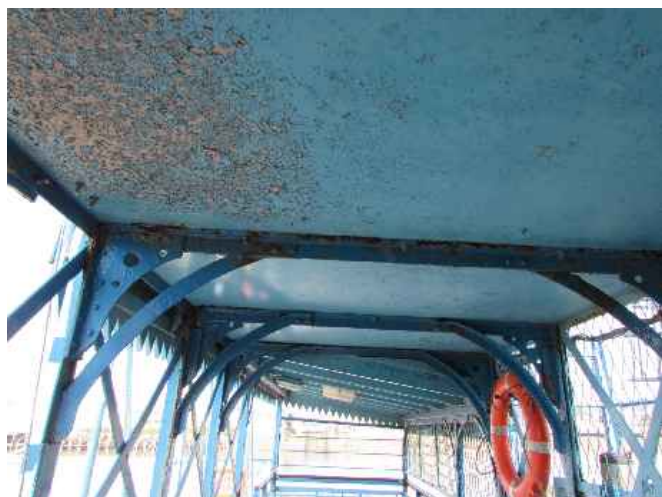
**Gondola Topside**  
Covered seating, deck plate showing coating delamination and flaking.

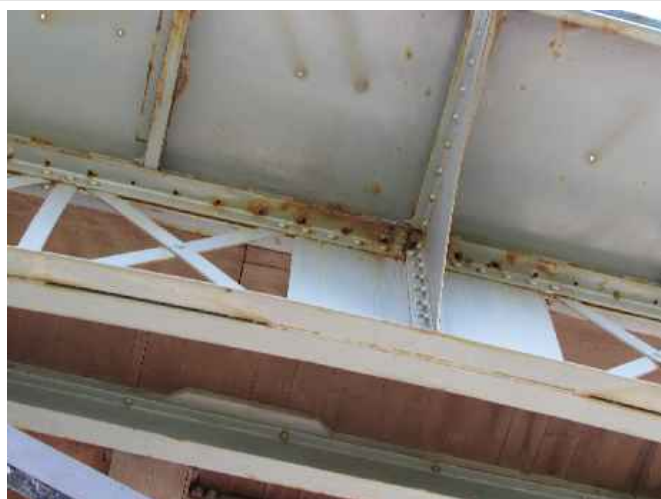
**Motor House**

Corrosion to edges and fixings.

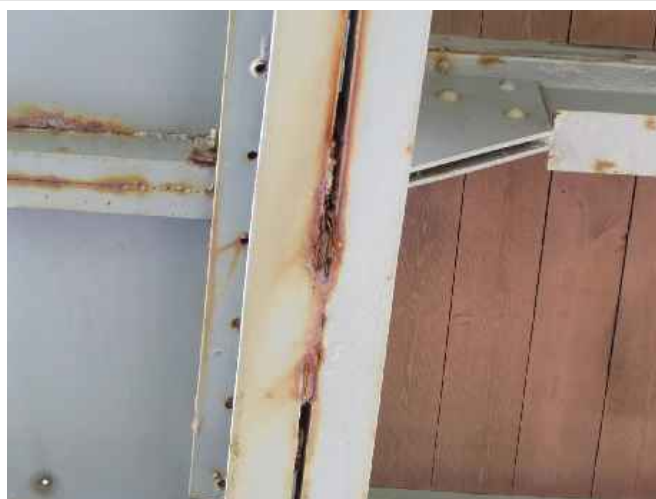
**Motor House**

Photo showing corrosion on the edges and joints, along with crevice corrosion.

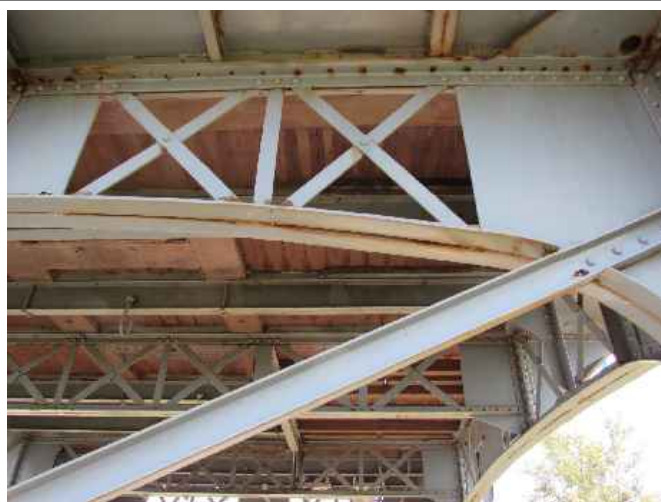
**Motor House**

Overview photo, corrosion is consistent on edges, joints along with crevice corrosion.

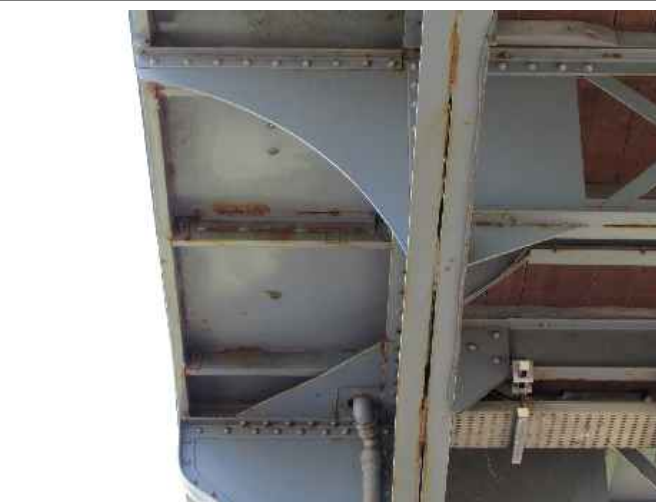
**Motor House**

General view of underside showing corrosion to edges and joints.

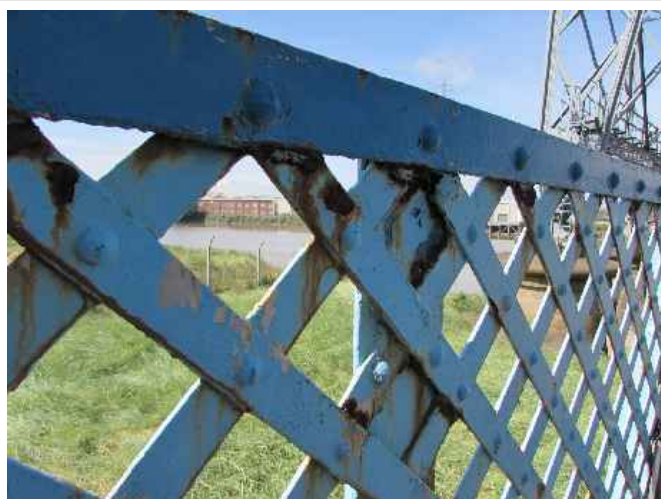
**Eastern Approach Topside Lattice**

Photo showing corrosion on cross members.

Due to the corrosion levels, the coated steelwork topside and underside will require major maintenance, by fully blast cleaning and application of a coating system to provide long term durability and corrosion protection.

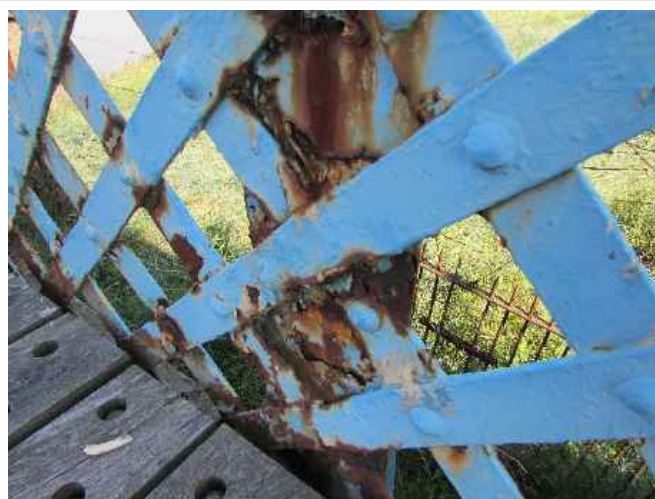
**Eastern Approach Topside Lattice**

Photo showing heavy corrosion at interface with cross members and upright.

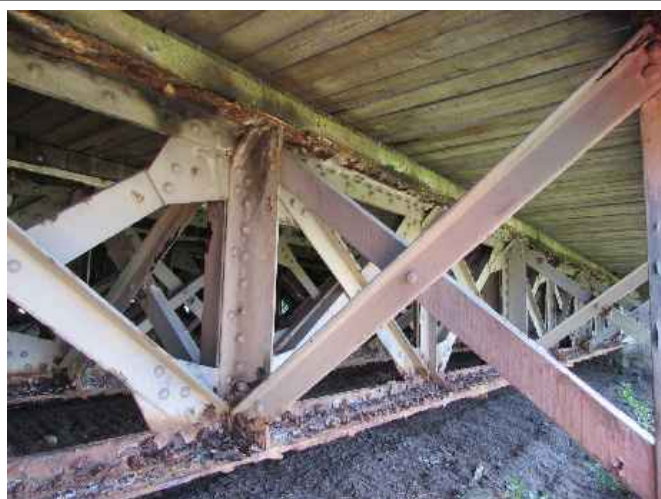
**Eastern Approach Underside**

Overview of steelwork underside, heavy corrosion on members.

We do not recommend patch repair.

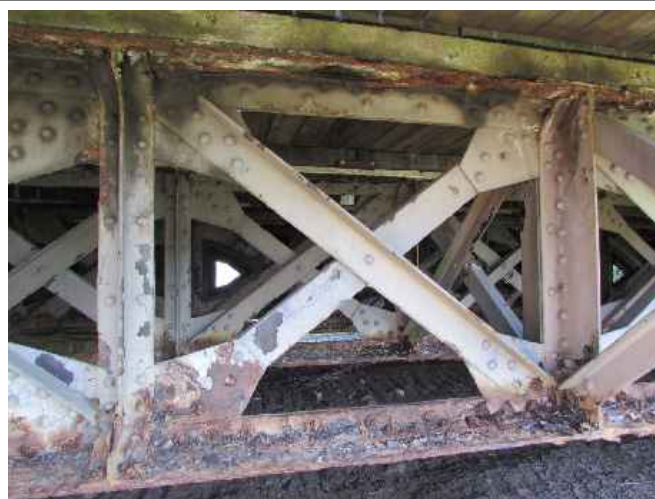
**Eastern Approach Underside**

Heavy corrosion and breakdown on underside members.

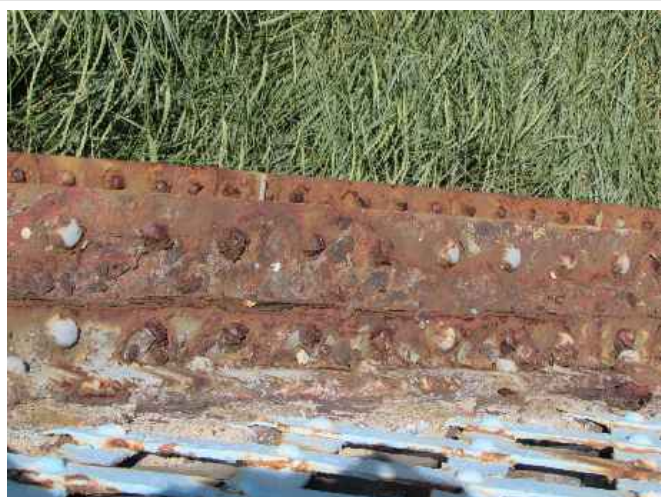
**Eastern Approach Underside**

Underside, bottom flange, heavy corrosion and total breakdown of the coating system.

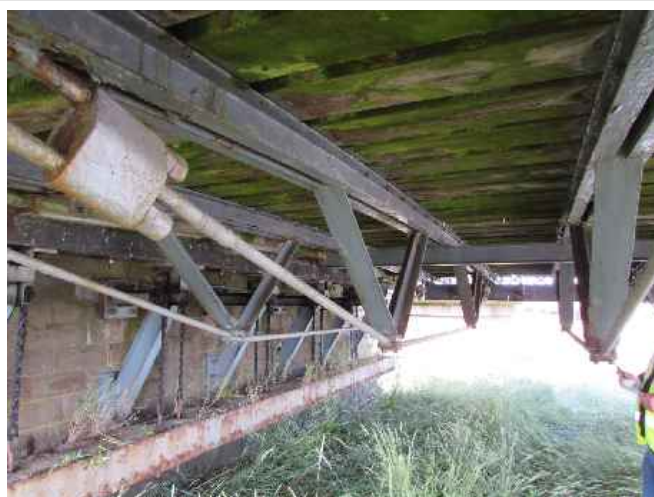
**Gondola Underside**

General view of the steelwork showing corrosion on members.

The coating system underside will require to be removed (preferable by blast cleaning) back to the bare steelwork and a major repainting programme put into place to reinstate the coating to provide long term durability and protection from corrosion. We do not recommend carrying out patch repair.

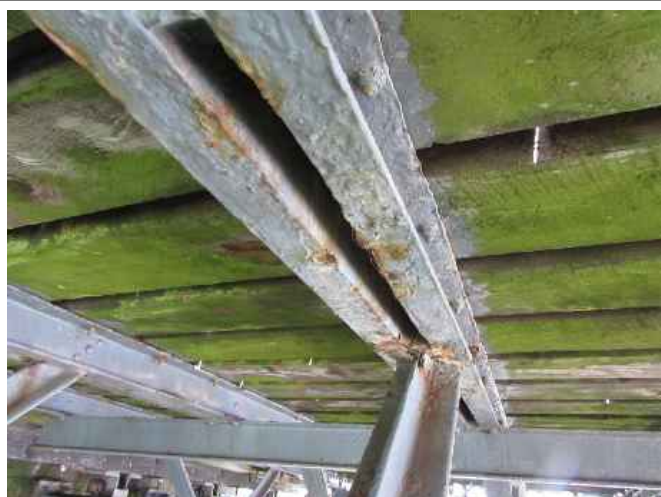
**Gondola Underside**

Photo showing corrosion to supporting members.

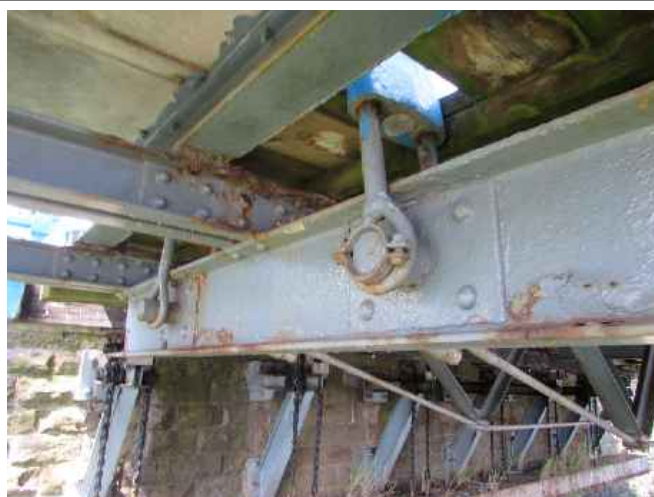
**Gondola Underside**

Photo showing corrosion to all supporting members.

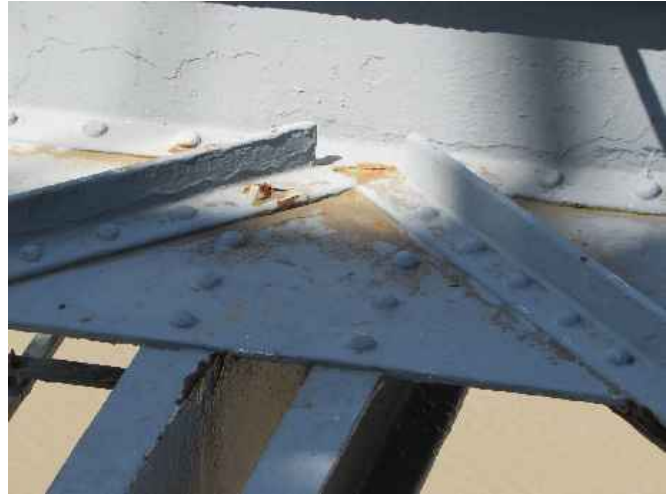
**Main Boom Traveller Steelwork**  
Overview of corrosion.

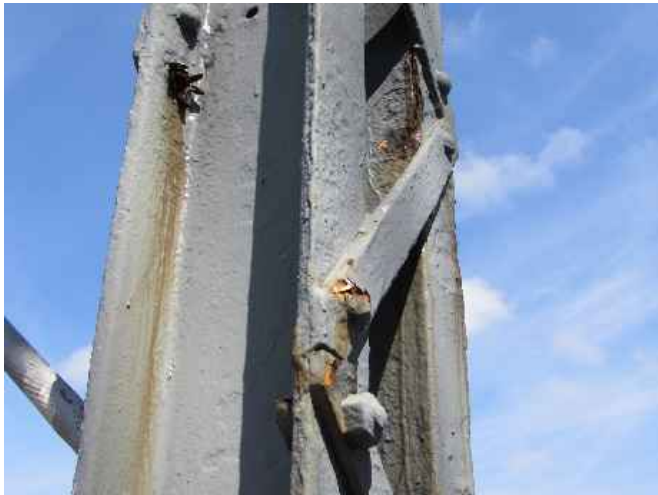
**Main Boom Vertical Steelwork**  
Corrosion and breakdown.

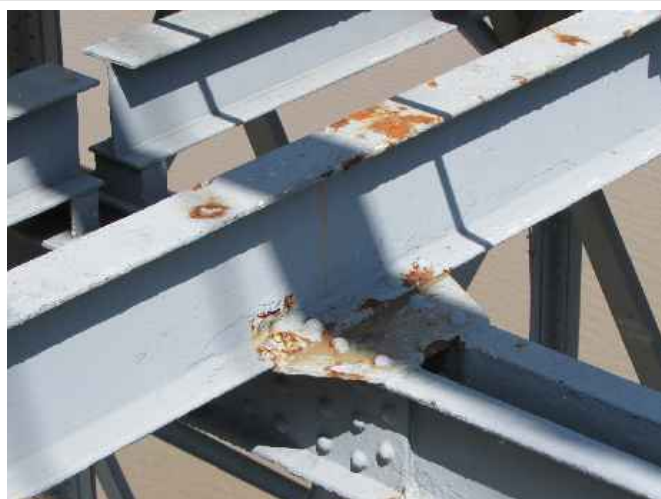
**Main Boom Primary Steelwork**  
Corrosion at interface between steel members.

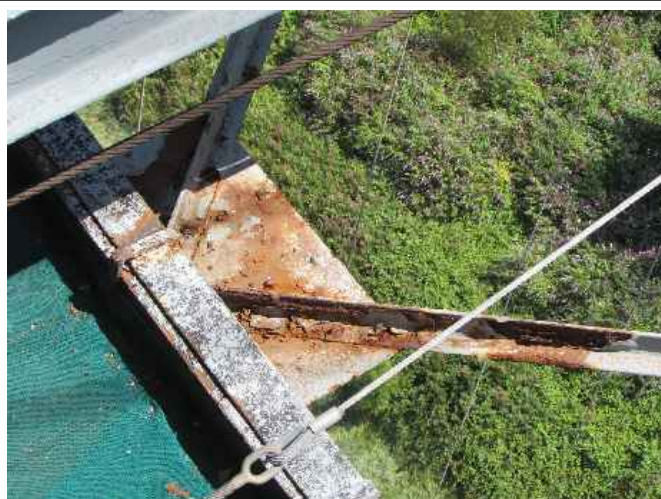
**Main Boom Primary Steelwork**  
Heavy Corrosion on main boom steelwork.

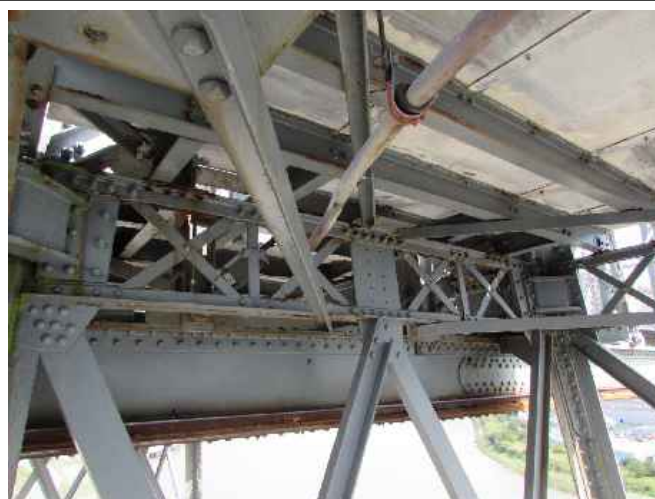
**West Pylon**  
Overview of underside, corrosion on edges, joints and fixings.

The coating system to the pylons is in a repairable condition, but the amount of delamination of the top coats will require a high level of preparation to remove all the loose and flaking paint back to sound coating. The flaking topcoats were only observed on the west (staircase) pylon so further assessment will be required on the other pylons to provide a detailed scope of work.

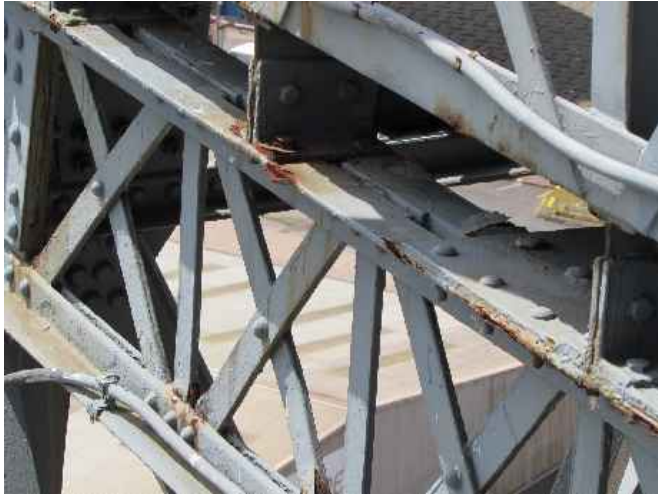
**West Pylon**

Corrosion on edges of cross member.

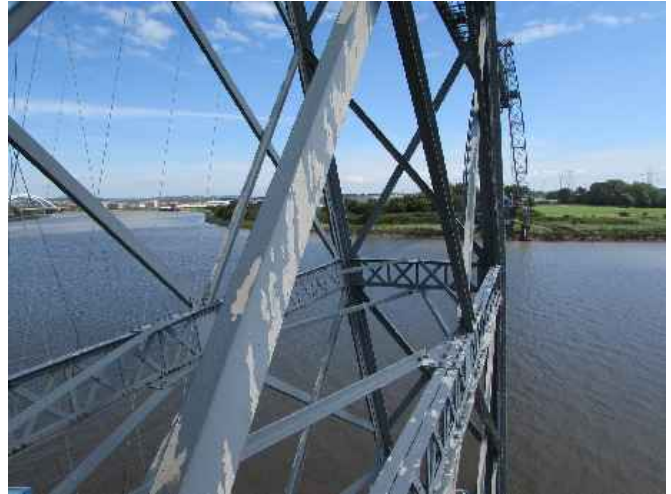
**West Pylon**

The west pylon was inspected and tested. Overall there is approx 5% moderate corrosion which once again is mainly on the edges, in corners, fixings. It was noted on the west pylon that there is widespread delamination/flaking paint, from the location of inspection it would seem that the top layer(s) is delaminating from the undercoats. The likely cause of failure is from the previous painting programme, where either the surface was not sufficiently cleaned/abraded, paint applied out of specification, or the overcoating times were not adhered to.

Photo shows the extent of the delamination of the top coats.
