# LEACHATE TREATMENT REPORT 2020 NANTYCAWS LANDFILL

Prepared for: **Carmarthenshire County Council**

Date: **March 2021**

| <b>TITLE:</b> | Leachate Treatment Report |

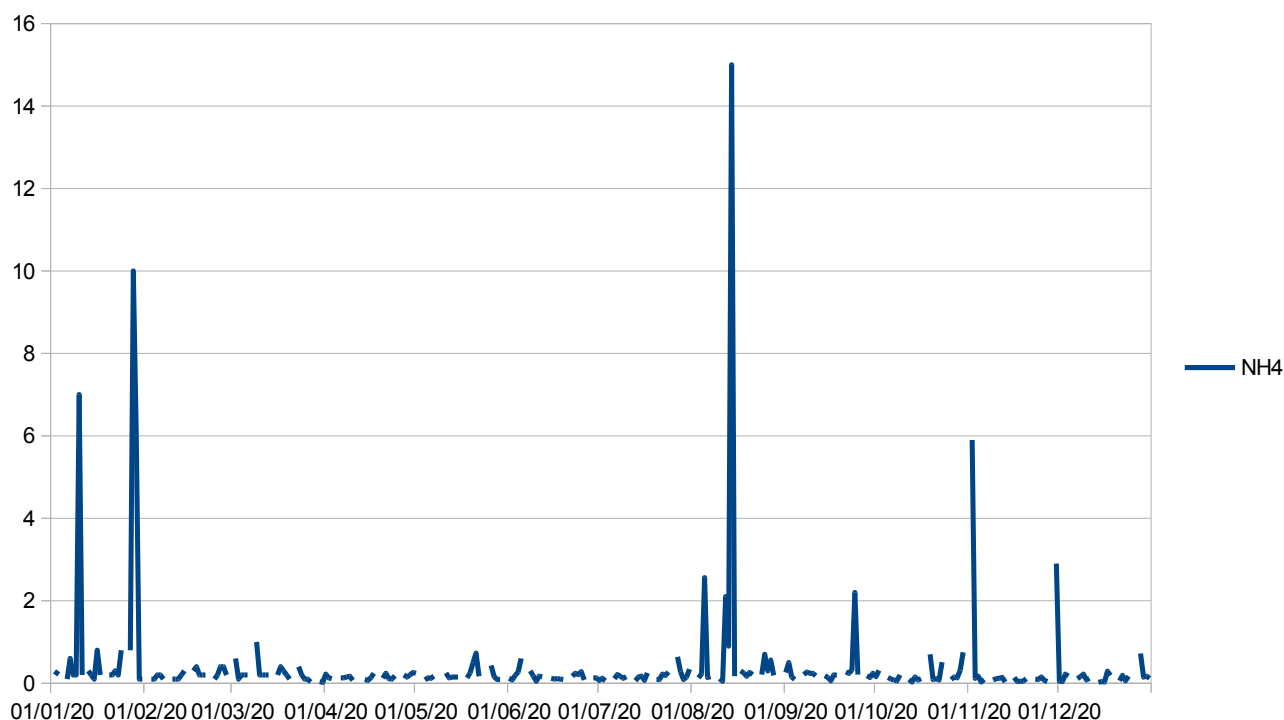
**Graph 1. Ammonia, Final Discharge**

The daily discharge was kept at an average of roughly 90 m<sup>3</sup> until the latter quarter of the year when issues with the treatment process were discovered and the plants throughput reduced to compensate. The throughput, as depicted in the following graph shows that in order to maintain the consent discharge level of up to 4mg/L NH4, the throughput had to be reduced. At the beginning of the year a couple of power cuts resulted in the pumps running at full speed with resulting loss of treatment. Upon discovering these events the discharge was sent to the lagoon and the pumps set back to their desired pump rate. The situation was then monitored through the day until treatment was back to satisfactory levels before discharge was commenced. Blower or aerator failures can cause a loss in treatment as there is not enough oxygen in the water for the conversion process, this happened twice, the event in May (see notable events) was caught in time before any treatment was lost and the event in August caused a loss of treatment whereby the discharge was diverted to the lagoon until treatment was regained.

September proved to be the beginning of a loss of treatment that was discovered to be an infestation of life forms, possibly due to the hot summer. The life forms were proved to have eaten the media to which the bacteria reside; therefore a loss of ammonia treatment resulted. The matter is further discussed in conclusions.

The various spikes in the following months were dealt with in the same manner as a power-cut event, detailed above.

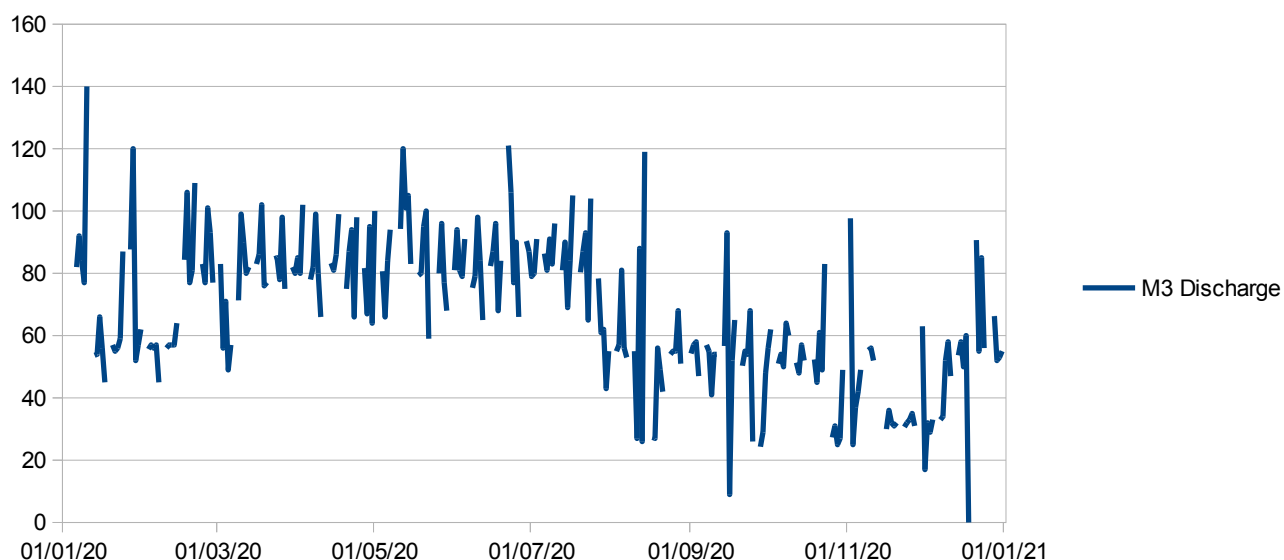
**Graph 2. Daily Flow, Final Discharge**

The daily flow levels to the discharge point are low during the summer and higher during the wet and stormy conditions. The lagoon is used to hold water during wet periods to keep discharge levels below the consent level of 400 m<sup>3</sup>/day. During the year the smallest discharge was roughly an average of 20 m<sup>3</sup> and this, as discussed later in conclusions, is due to the lowering of throughput in order to maintain the conversion of ammonia to nitrate. The spikes depicted on the graph are due to either power cuts whereby the plants reverts back to full throughput or due to attempts at increasing the throughput to monitor the plants operation.

As can be observed in graph 2 that depicts the total discharge from the main treatment plant, the pump rates had to be set ever lower to keep the ammonia levels at acceptable levels. A couple of power cuts and blower faults resulted in unacceptable treatment levels and during these events the discharge was diverted to the lagoon until the correct treatment levels returned.

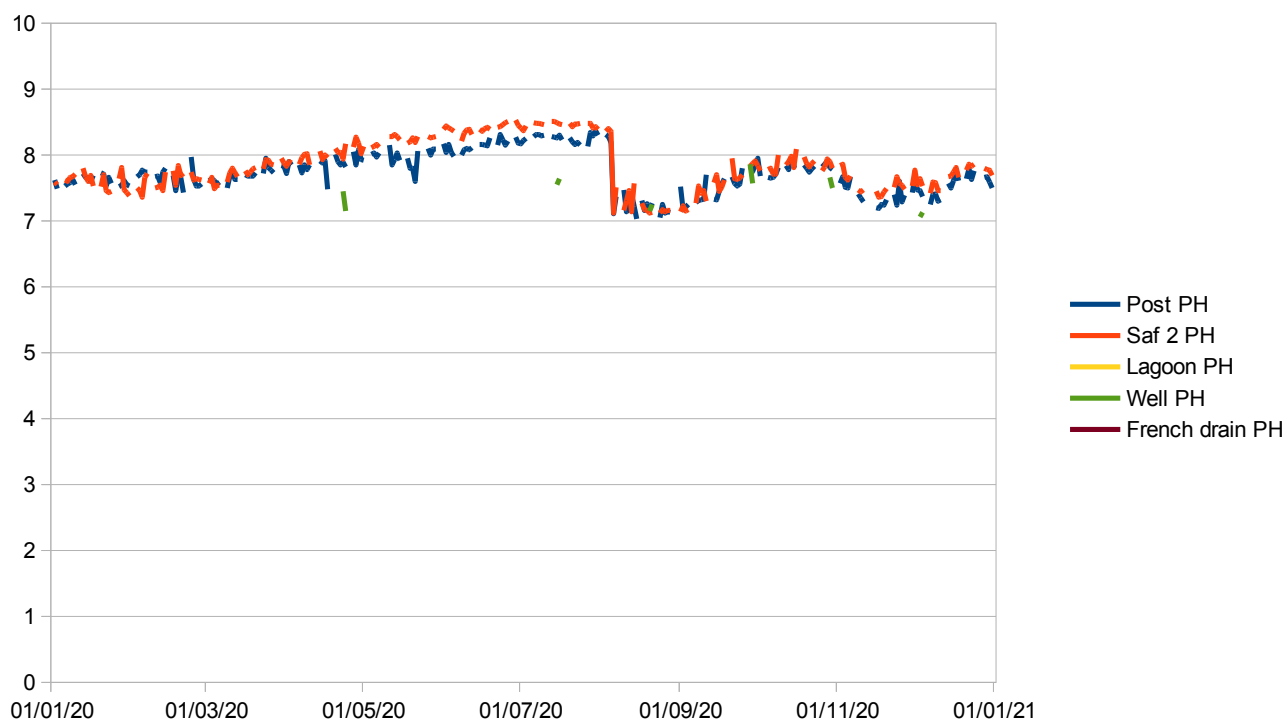
Graph 4. pH levels

The acidity and alkalinity levels or pH levels of the recorded media are in concert with each other with no serious deviations from the average. The consent levels for discharge are a range of 6 to 9 pH units. The French drain is normally rainwater and therefore shows the lowest value on occasion. The trend upward of pH levels is due to the probe drifting out of calibration. The sharp decrease shows that the calibration has been performed and further into the year it is observed that the levels fluctuate due to the plant failing in treatment. This event coincides with the end of summer.

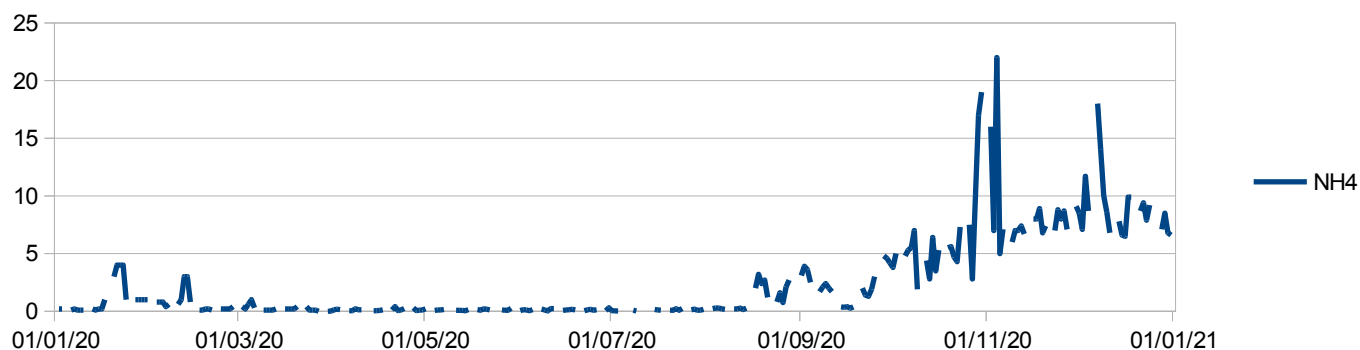
**Graph 5. SAF2 Ammonia Levels**

SAF 2 treats the water from the holding lagoon and is normally discharged to the reed bed and then the stream when the ammonia levels are acceptable. The lagoon was taking increasing volumes of well water during the latter part of the year due to the loss of complete treatment in the main plant. This increased the ammonia level of the lagoon water beyond the treatment capability of the SAF2 unit and the discharge was therefore sent back to the lagoon. Further details can be found in the conclusions.

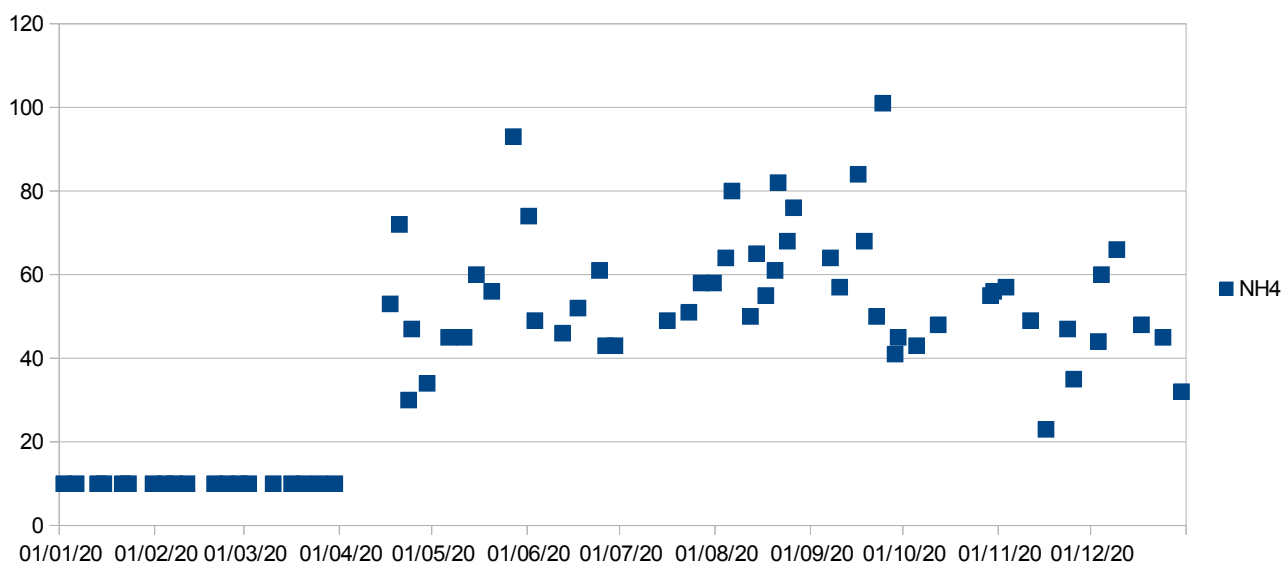
**Graph 6. Well Ammonia Levels**

The field data was taken with colour indicator tests in the first quarter of the year and the maximum reading obtainable was 10 mg/L. The field data was then gathered with a Palintest Photometer 7500 that allowed accurate data to become obtainable in the field. The ammonia levels of the well vary and can be observed to be 100 mg/L on occasion and sometimes as low as 20 mg/L. The well reacts quickly to inclement weather and this is thought to dilute the water with regard to ammonia.

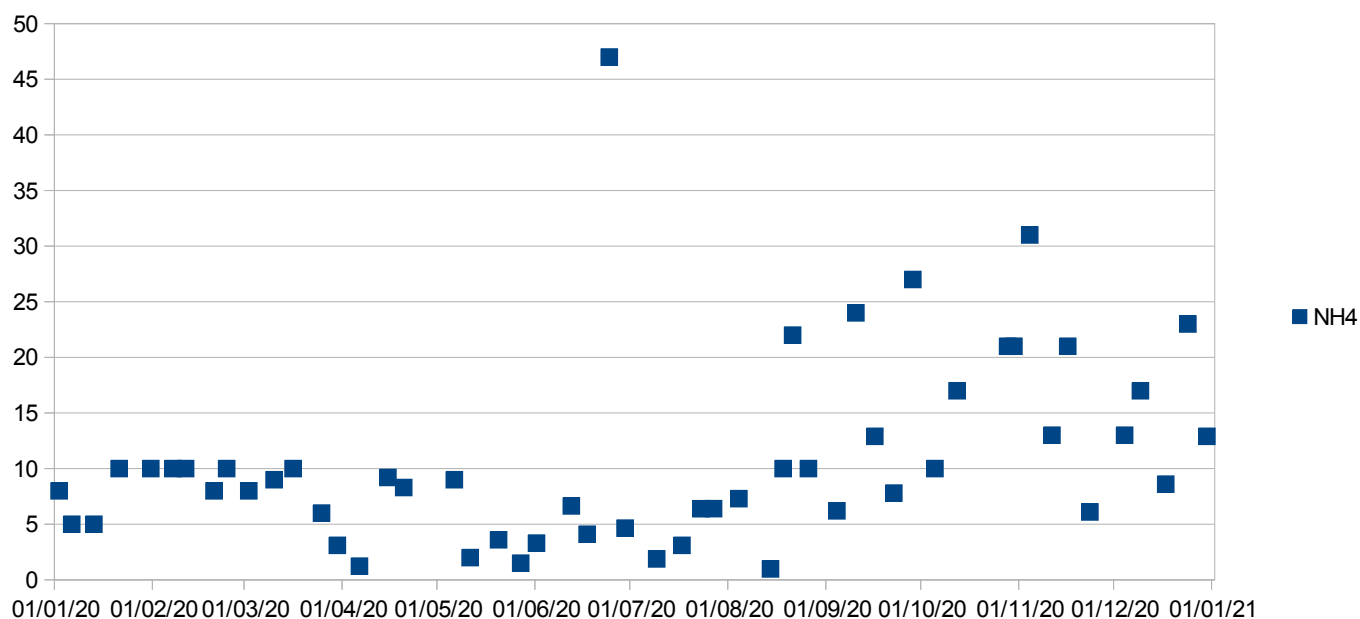
### Graph 7. Lagoon Ammonia Levels

An anomalous reading of over 45 mg/l was observed mid-year and is likely due to bad timing with regard to sampling time. If the sample is taken after a fresh discharge of well overflow then one is essentially sampling the well. The ammonia levels in the lagoon are recorded as up to 10 mg/l during the first part of the year using the colour indicator tests. Once the switch to the Palintest was made the observed ammonia levels remained consistent until the plant failure and the concentration of the lagoon steadily increased. This had an adverse effect on the SAF2 unit.

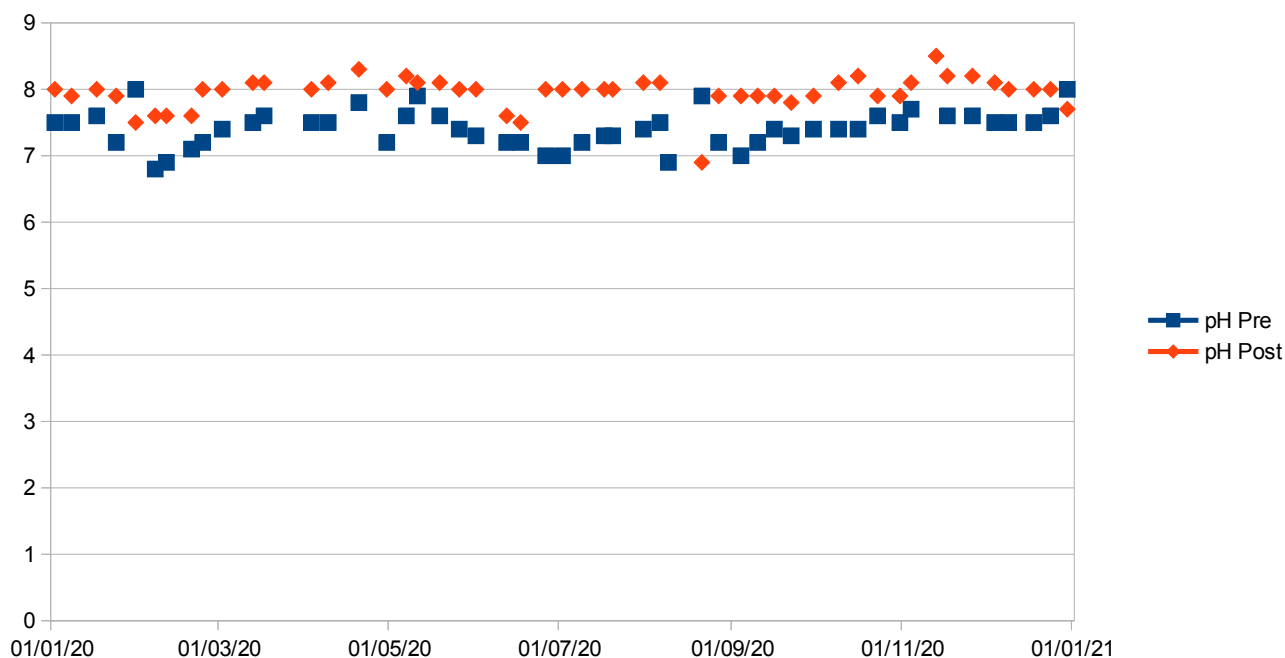
**Graph 9. pH Pre and Post Treatment Comparison**

The results remained consistent through the year with a slight dip below the normal levels mid-summer and a slight rise above normal levels in November during the plant malfunction, detailed in conclusions.

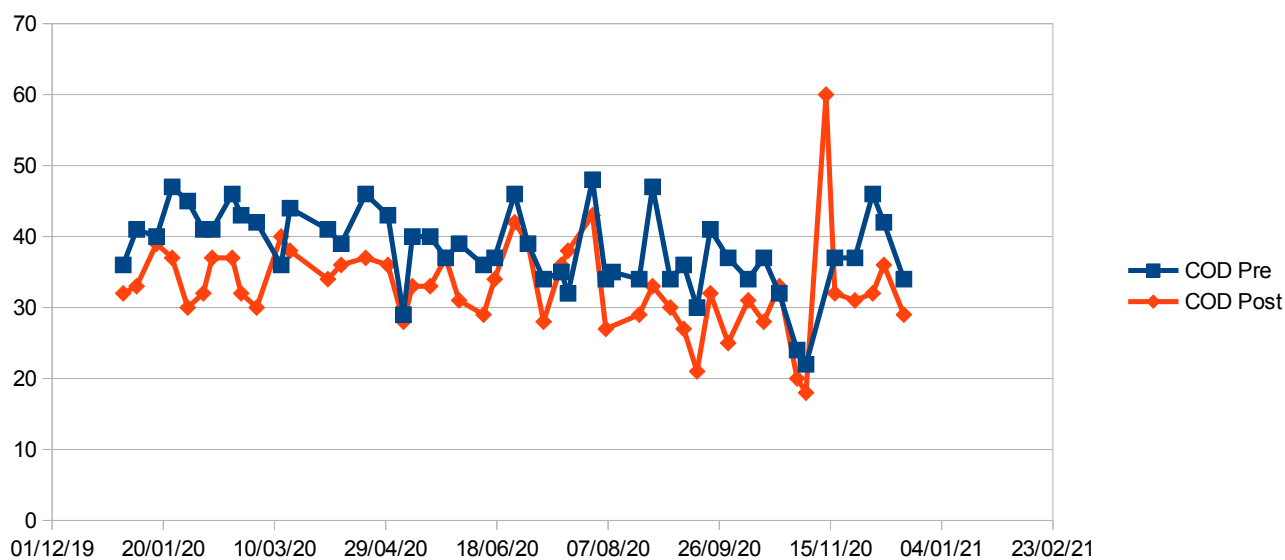
**Graph 11. COD Pre and Post Comparison**

The chemical oxygen demand (COD) levels remained consistent through the year except for a spike in COD during November that is due to the plant recovery process that is further explained in the conclusions.

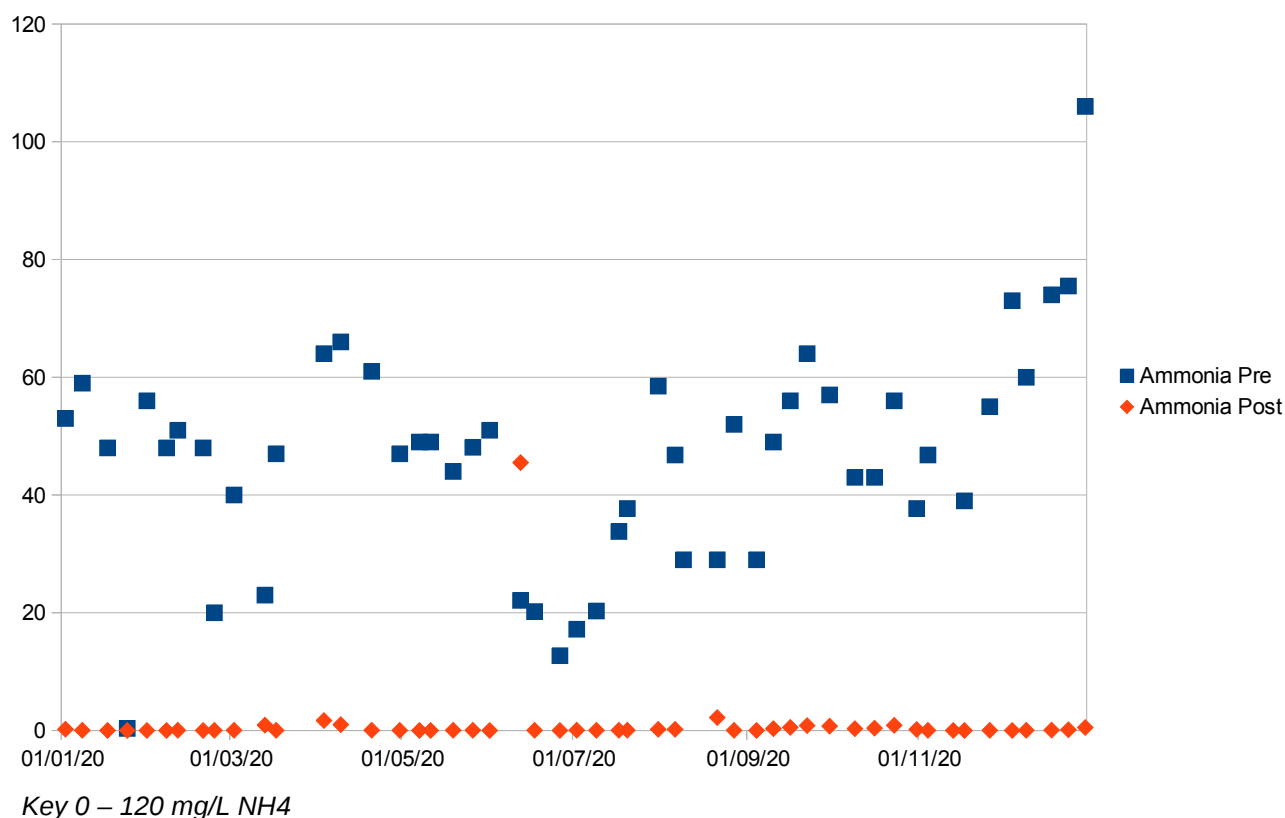
**Graph 12. Ammonia Pre and Post Comparison**

There was one event during the year which caused the Ammonia to breach the permitted 4mg/L NH<sub>4</sub>.

The value was exceptionally high and the corresponding data for nitrite and nitrate levels show normal levels indicating an anomalous reading with regard to the ammonia level. The ammonia level is higher in concentration than the well water giving further evidence of an anomalous reading. A possibility is that some organic material entered the sample container and was able to breakdown in the hot weather period prior to analysis.

The rest of the year saw the discharge kept under the allowable limit, this was achieved by careful management of the retention time of the treatment water.

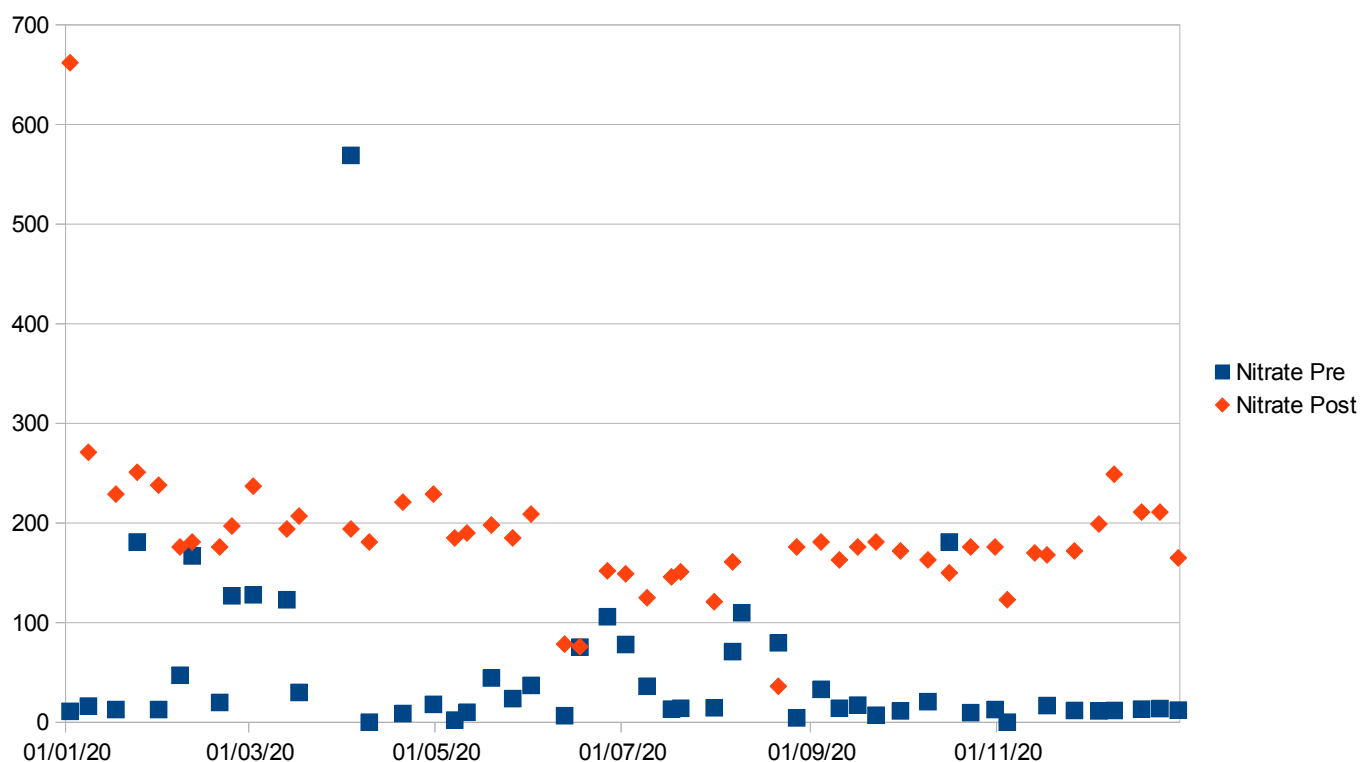
Graph 13. Nitrate Pre and Post Comparison

The treatment process utilizes bacteria (*Nitrosomonas* and *nitrosolobus* for example) to oxidize ammonia to nitrite. The second stage utilises another group of bacteria (*Nitrobacter* and *nitrococcus* for example) to oxidise the nitrite to nitrate, and this whole treatment process is seen to work by observing the rise in nitrate levels and the drop in ammonia levels at the discharge point. Some elevated levels of nitrate are seen in the pre-treatment and the beginning of the year the discharge nitrate levels were observed to be higher than normal.

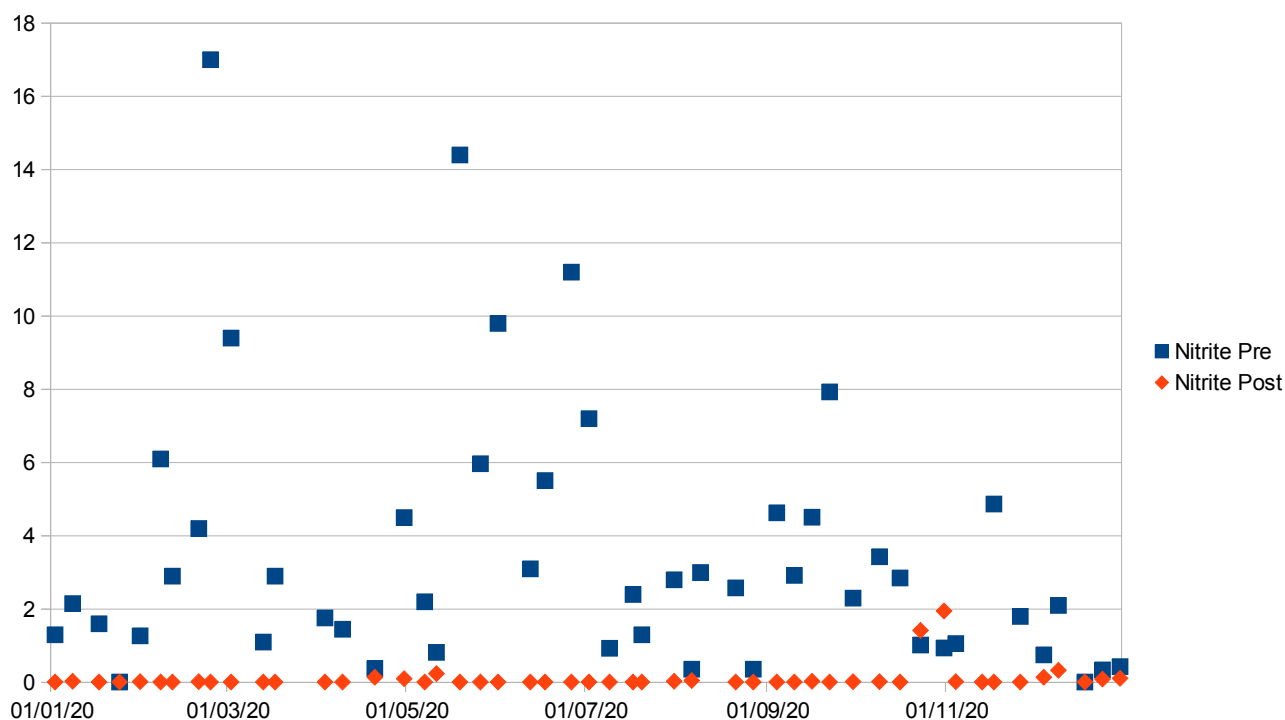
**Graph 14. Nitrite Pre and Post Comparison**

The intermediate stage sees bacteria oxidise the ammonia to nitrite that will be finally converted to nitrate. Therefore, the successful treatment of ammonia rich effluent should show close to zero nitrite.

Only during the plant recovery process did the nitrate levels increase, showing an inability to treat the water due to the deliberate de-oxygenation procedure as further explained in the conclusions.

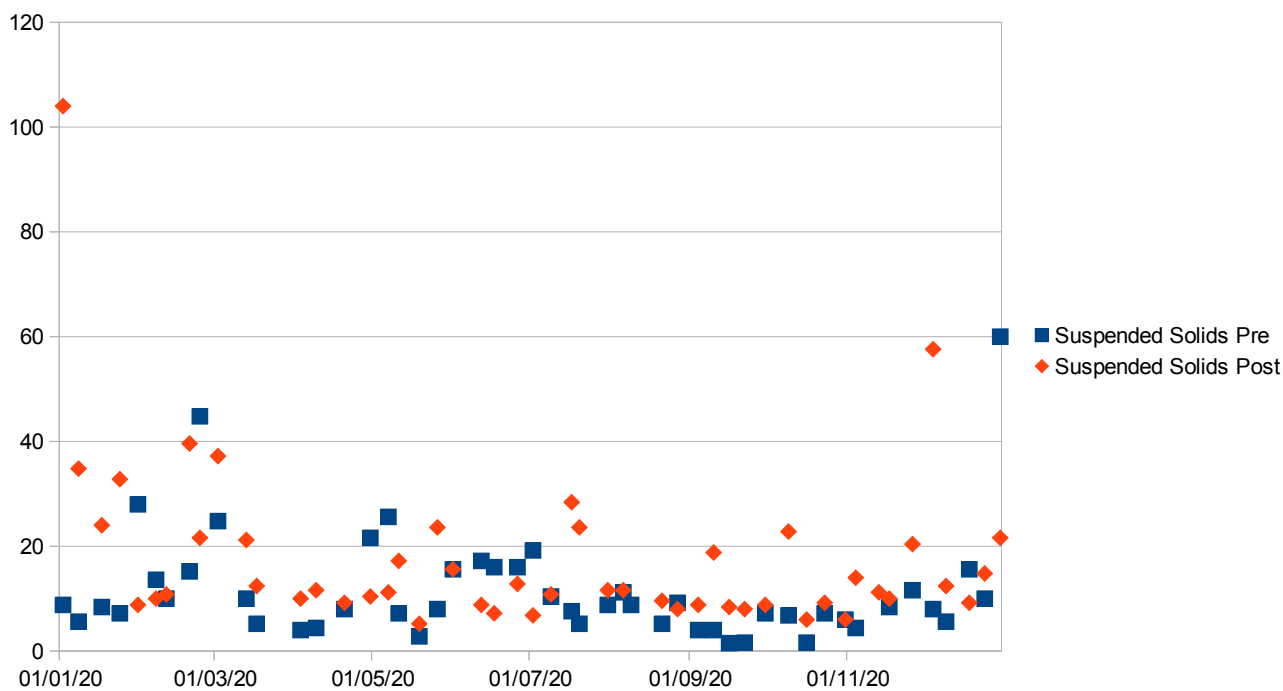
**Graph 15. Suspended Solids Pre and Post Comparison**

There were a few instances of the 30mg/L permitted level being breached. The breach in November occurred during the plant recovery process. During January through to March there were a series of power cuts and this resulted in the pumps coming back online at full throughput resulting in media being washed through the system.

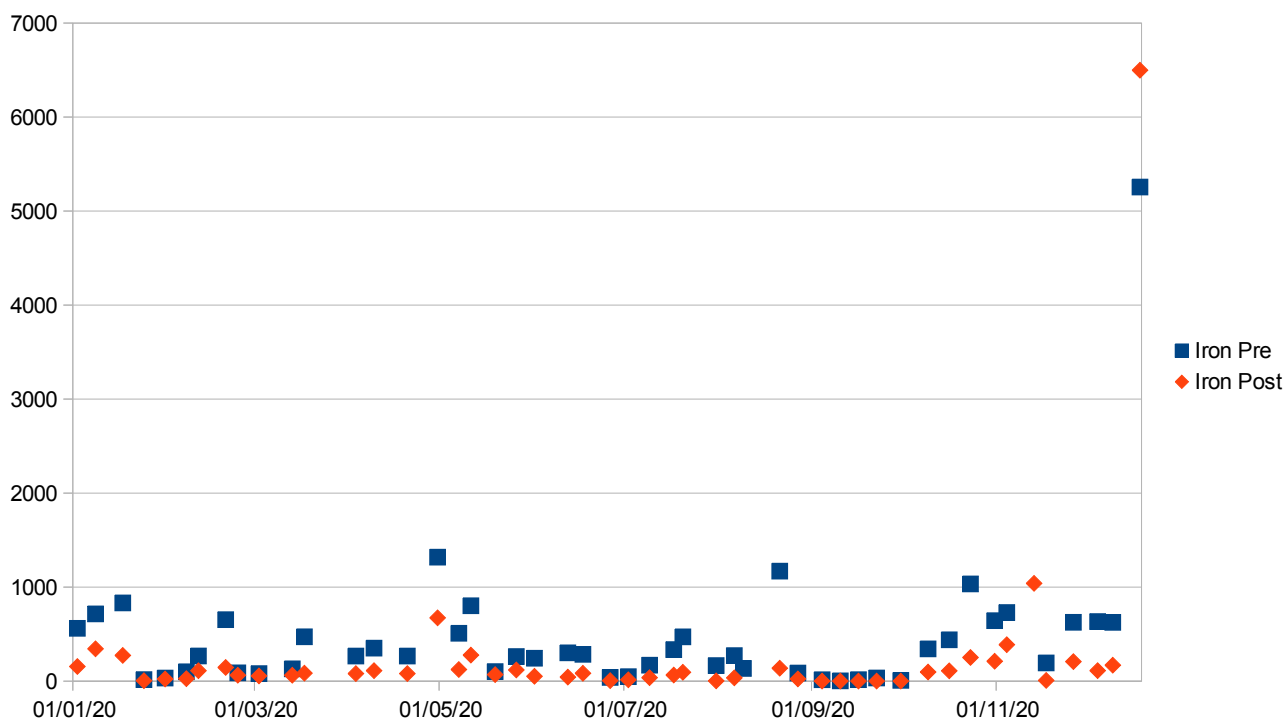
**Graph 16. Iron Pre and Post Comparison**

The iron is found to be present in the sediment sludge that is found on the media balls and also within various settling tanks. During power cuts and cleaning processes this sediment can become disturbed and cloud the water. If a discharge (post) sample is taken during this time or shortly afterwards then elevated iron levels will be observed as may be the case with the three discharge samples found to be over 1000 ug/L. The discharge consent is 0.75 mg/L or 750 ug/L. The substantial spike in iron at the end of the year seems to indicate an influx of iron rich water from the landfill. There is also a big spike in ammonia from landfill during this time, further indicating an event within the landfill or within the landfill water catchment.

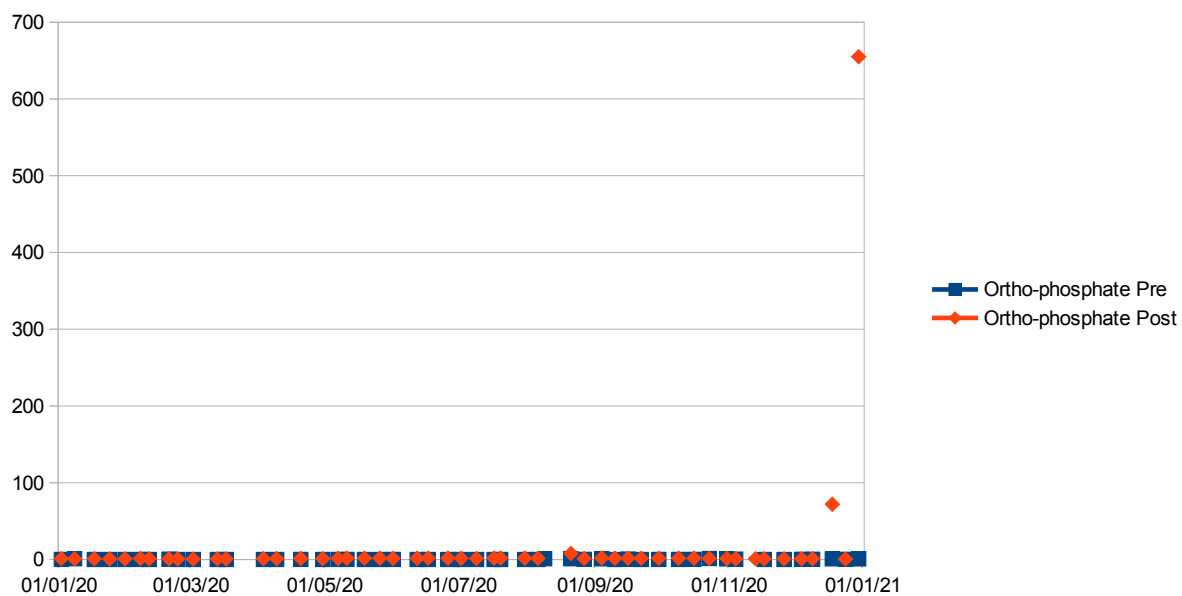
**Graph 17. Orthophosphate**

The orthophosphate levels remained constant through the year except for an exceptional spike in levels in December. This spike corresponds with a spike in iron and ammonia levels.

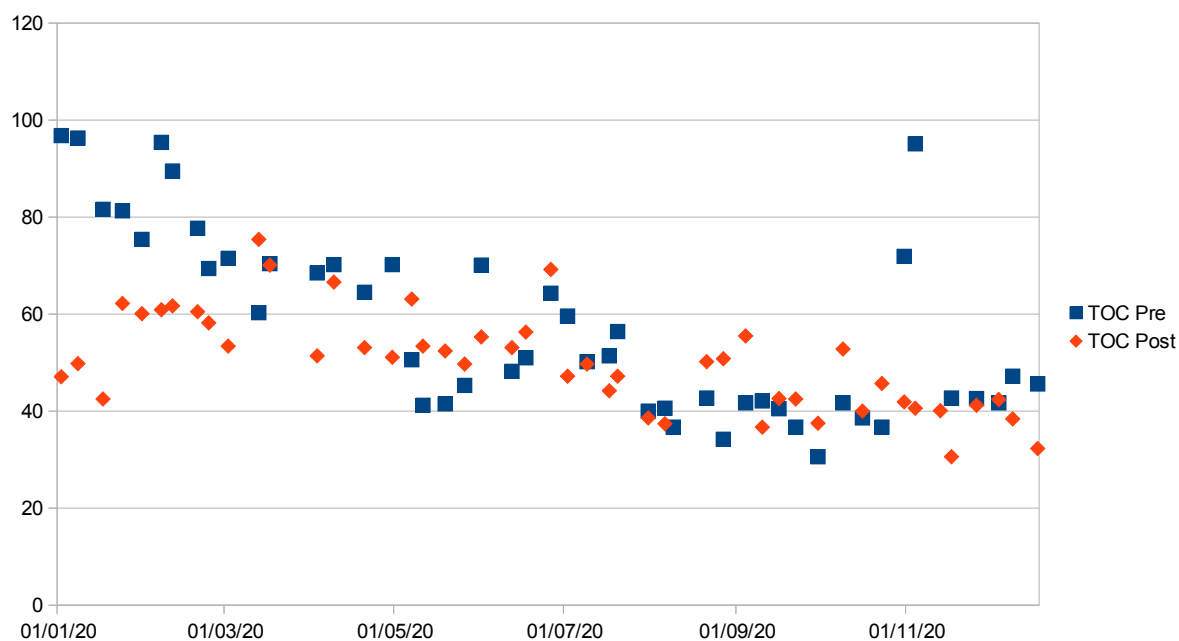
**Graph 18. TOC, Total Organic Carbon**

The total organic carbon (TOC) measurement is a measure of the organic carbon in the water pre and post treatment. The levels detected are consistent through the year with no major deviations from the mean observed. The spike observed in October, for example, appears high, but is still less than the levels seen in the January.
