**SOUTH SIDE  
QUEENSWAY WASTE  
MANAGEMENT SITE,  
LLANWERN STEELWORKS**

**2020 Annual Review of  
Environmental  
Monitoring**

*Report Number 2116r2v1d0221*

**February 2021**

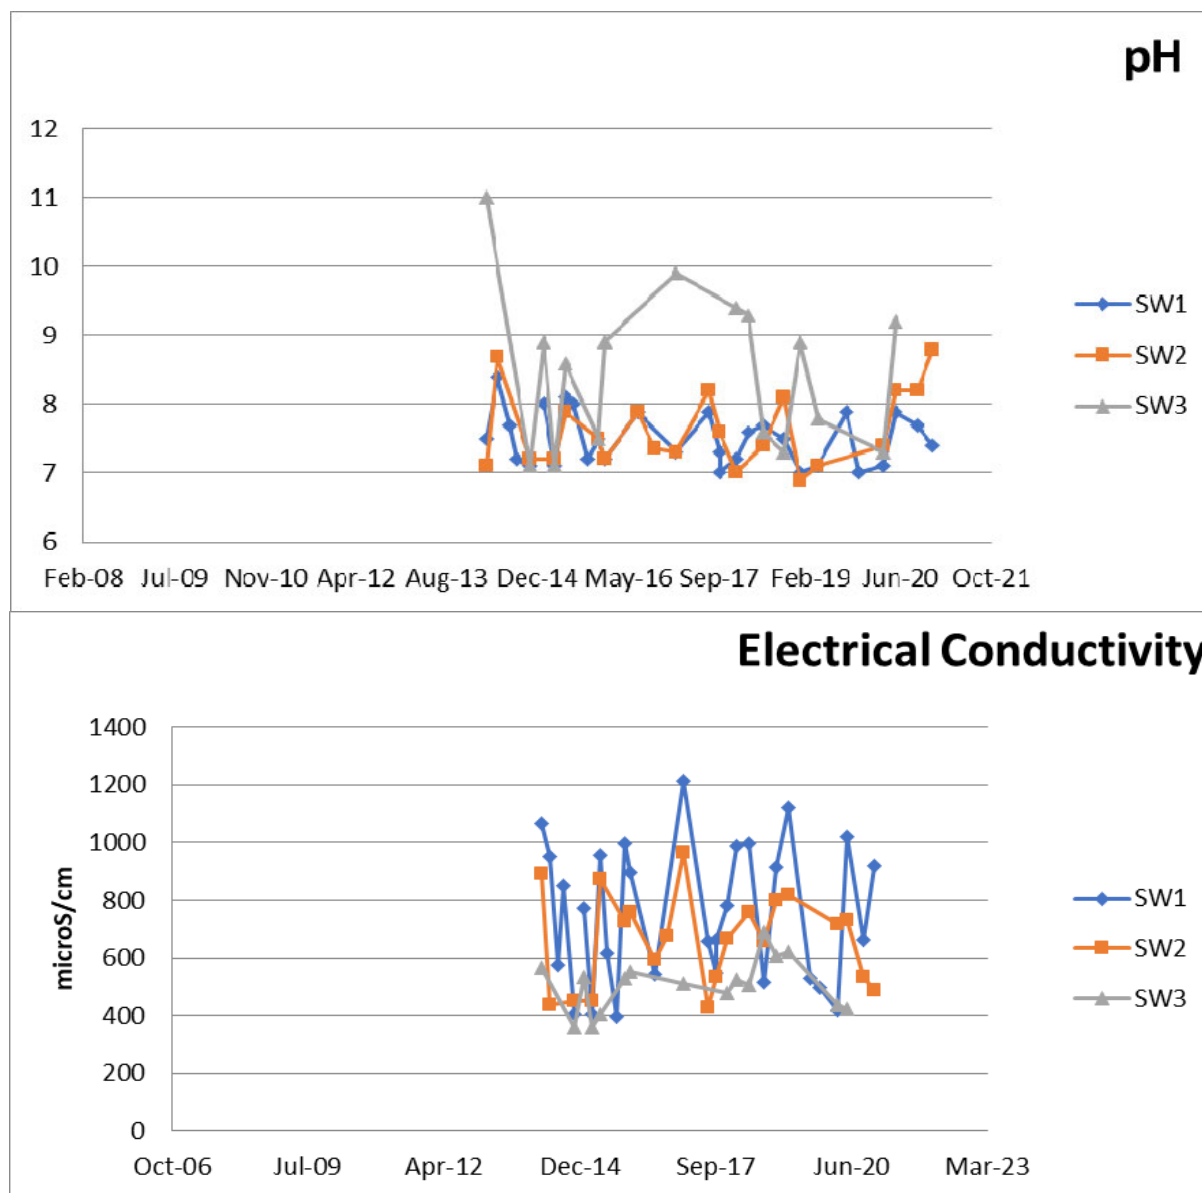
**Plate 6-1 Variations in surface water chemistry**

Surface water is typically circumneutral, moderately mineralised with low levels of non-hazardous and hazardous substances. As surface water progresses from east to west, the mineralisation decreases from ~ 800 microS/cm to less than 600 microS/cm. The main reason for this change is decreasing alkalinity although most parameters are lower downgradient of SW1.

As shown in Plate 6-1, sample positions SW2 and SW3 were not always accessible in 2019 and 2020 due to dense vegetation growth. This should be routinely cleared or new sample points established with agreement from NRW.
