# HV / CHP Fire Investigation Summary

*Saturday 13th March 2021 20:32*

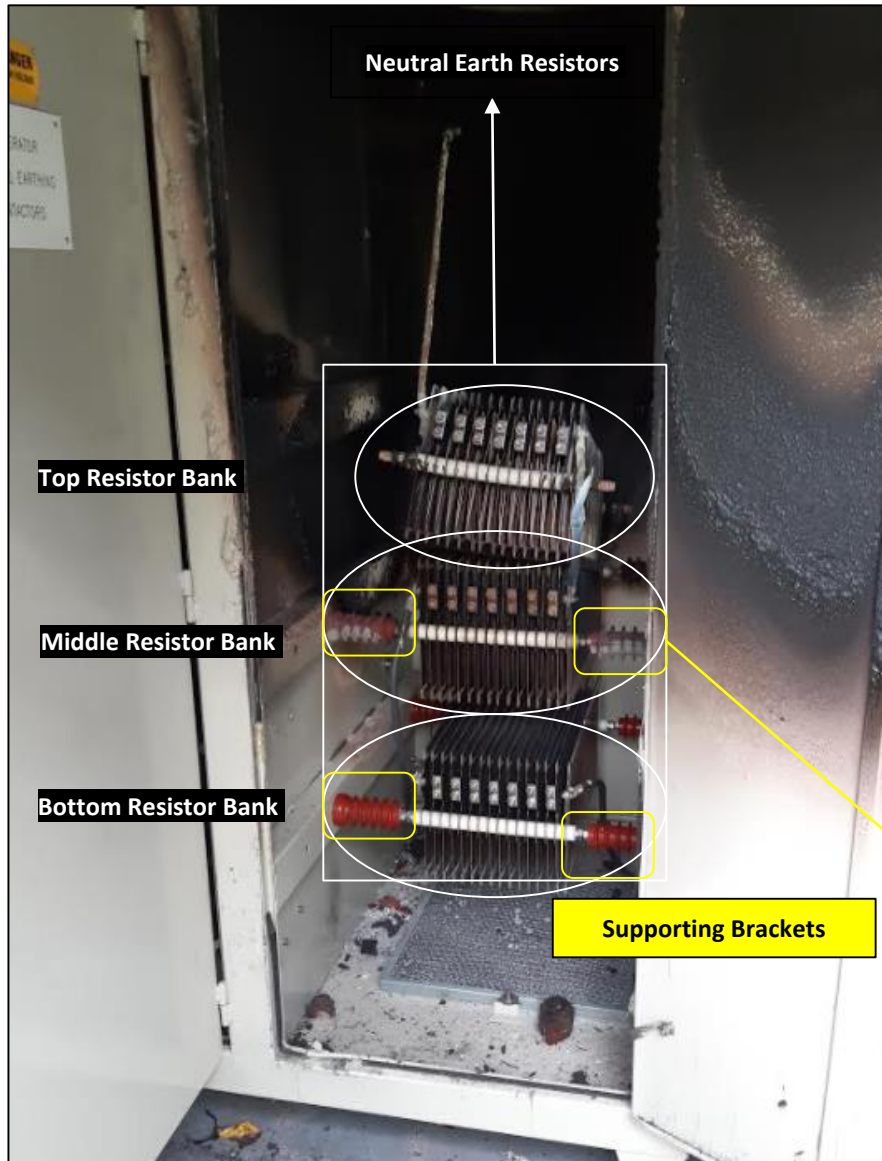
- The fire originated in the HV Switch panel compartments that houses a specific component, **Neutral Earth Resistors (NERs)**
    - *The NERs generate a current to measure the CHP generated electricity and ensure the frequencies match before connecting to the national grid.*

- The brackets of the top NER bank have failed & the top NER bank has fallen on the middle resistor bank.
  - There is a crack in the supporting brackets of the middle resistor bank > believed to have been caused by the incident.

- An extremely excessive number of operations on the circuit breaker have been recorded supporting that the CHP repeatedly tried to connect.
  - This likely overloaded the NER resistor and created excessive heat which could have affected the isolator supports for the resistor.

- Unable to withstand the heat the NER supporting bracket could have failed allowing the upper resistor to fall onto the middle resistor and cause an arc sufficient to initiate the fire.

- Appointment of EA Technology to carry out more detailed inspection and engineering assessment:
  - Detailed technical review of all information available to date.
  - Review relevant trip, alarm and operational status data.
  - Design review of the electrical system.
  - Design review of the protection system.
  - Establish adequacy of existing equipment and proposed changes to equipment / specification etc.
- Detailed review of CHP restart process with CBRE, amendments, training, validation.
- Review of Centrica appointment and 24/7 support moving forwards.
- Reinstatement of the unit is not a quick fix, current estimate is minimum 3 months (lead time confirmation and best commitments needed).

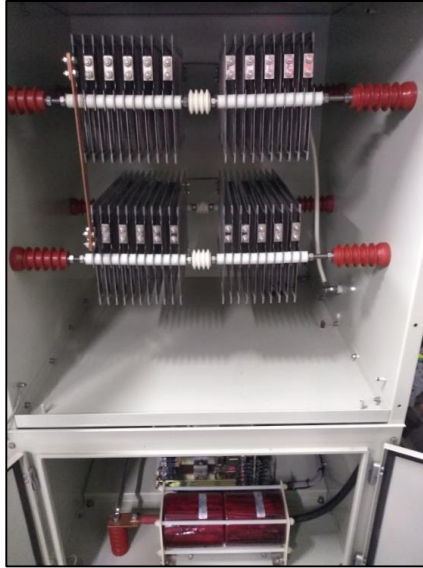
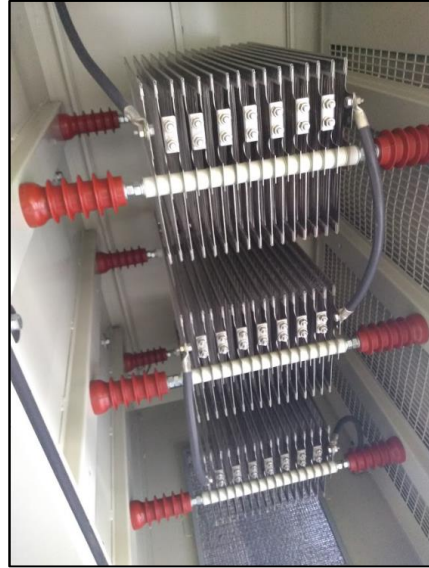
- Wide angle check complete on all other CHPs on site & we confirm this feature does **not** exist elsewhere.
  - The G59 event (very uncommon happening 2 or 3 times per year) occurred in the early hours on the same day of the fire and this powers down the CHPs.

**A380 NERs & Supporting Brackets - Defect Free**

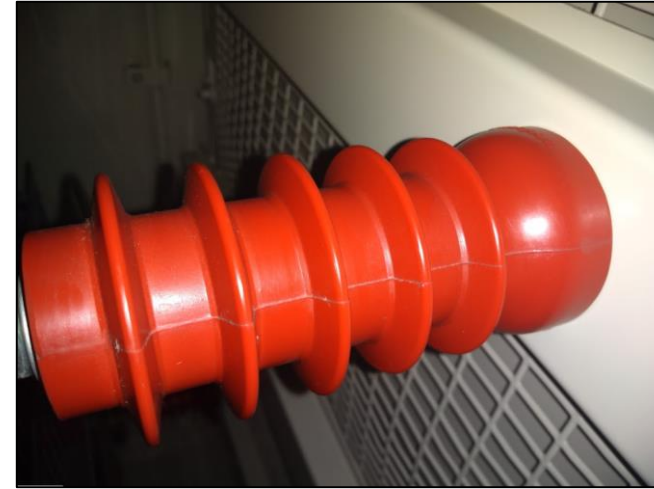
**Zoomed in view of A380 CHP Supporting Bracket - Defect Free**
