An ROV inspection of the breakwater bullnose structure identified several areas of possible structural damage for further investigation.

This report provides a summary of the survey methodologies employed, a description of the habitats encountered and a summary of notable features identified during the survey. An initial assessment of damage to the bullnose is also summarised following review of the ROV inspection imagery.

Holyhead Breakwater Refurbishment Scheme

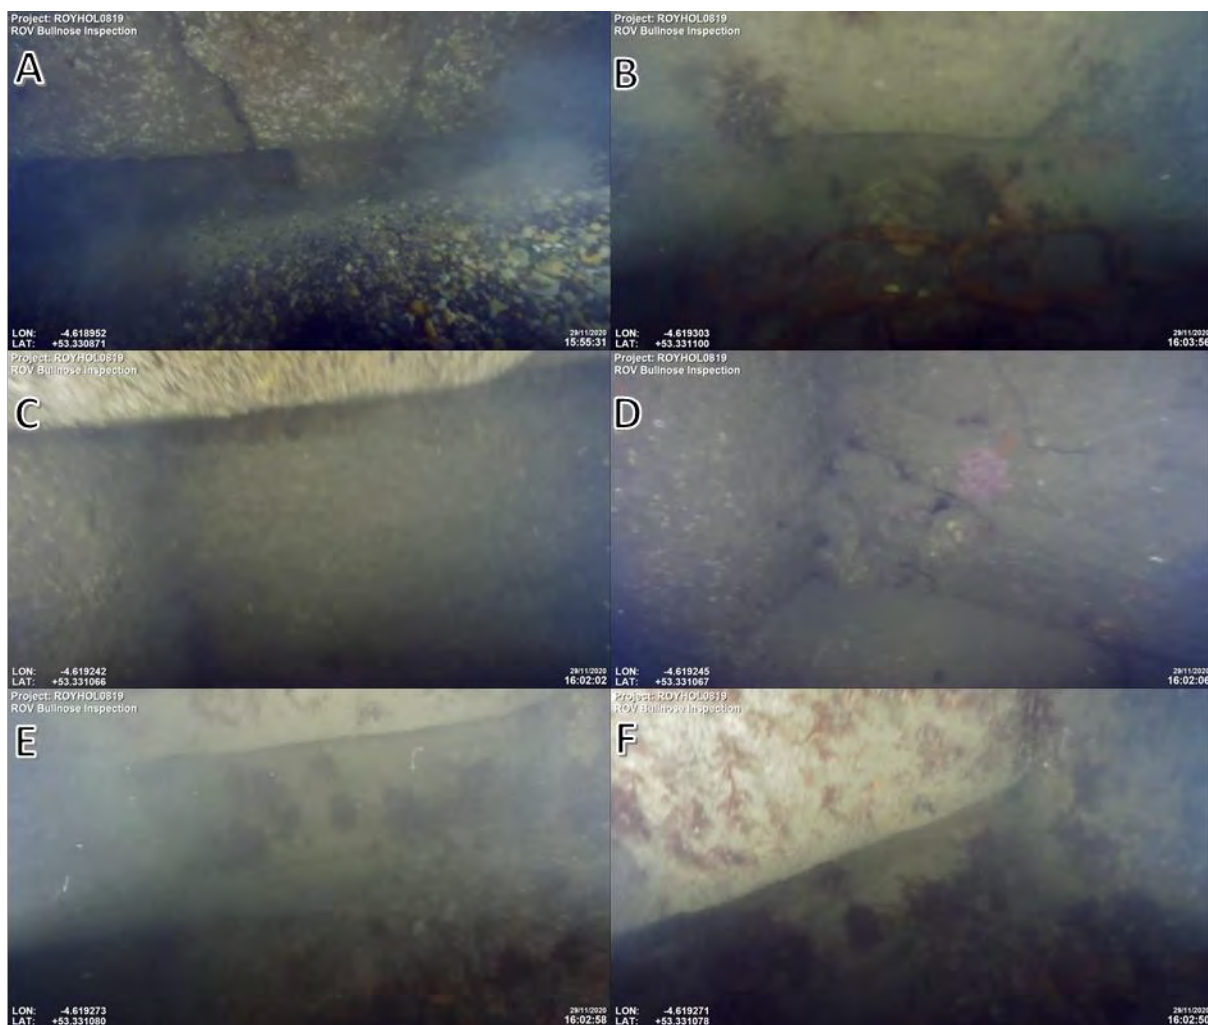
There were several observations of potential damage to the breakwater structure made during the inspection survey. Overall, the superficial condition of the structure appeared sound for large sections with the intersection between the breakwater footings and the seabed without damage however, some areas exhibited signs of possible scouring and undercutting where the lower block appeared to be unsupported in part (Plate 7 A – B). This was observed at several locations along the length of the bullnose structure but were restricted to small ~ 0.5m sections.

In addition, it appears that two of the bottom blocks have been dislodged from the main structure (Plate 7 C – D). These blocks appear to have been dislodged for some time as the exposed inner blocks are colonised with faunal turf communities. In both examples, a large, rusted chain matrix was observed to be laying scattered on the seabed, immediately adjacent to the location of the missing block sections.

Plate 7 Evidence of potential underwater degradation of the breakwater bullnose structure A & B) undercutting and scour of the footings C - D) evidence of two missing blocks in the lower block structure with associated chain matrix on seafloor.

undercutting and scour of the footings between the block structure and the rubble mound the breakwater sites as well as missing blocks. Further investigation of the ROV imagery by an experienced engineer is recommended to confirm and assess these areas of potential damage.

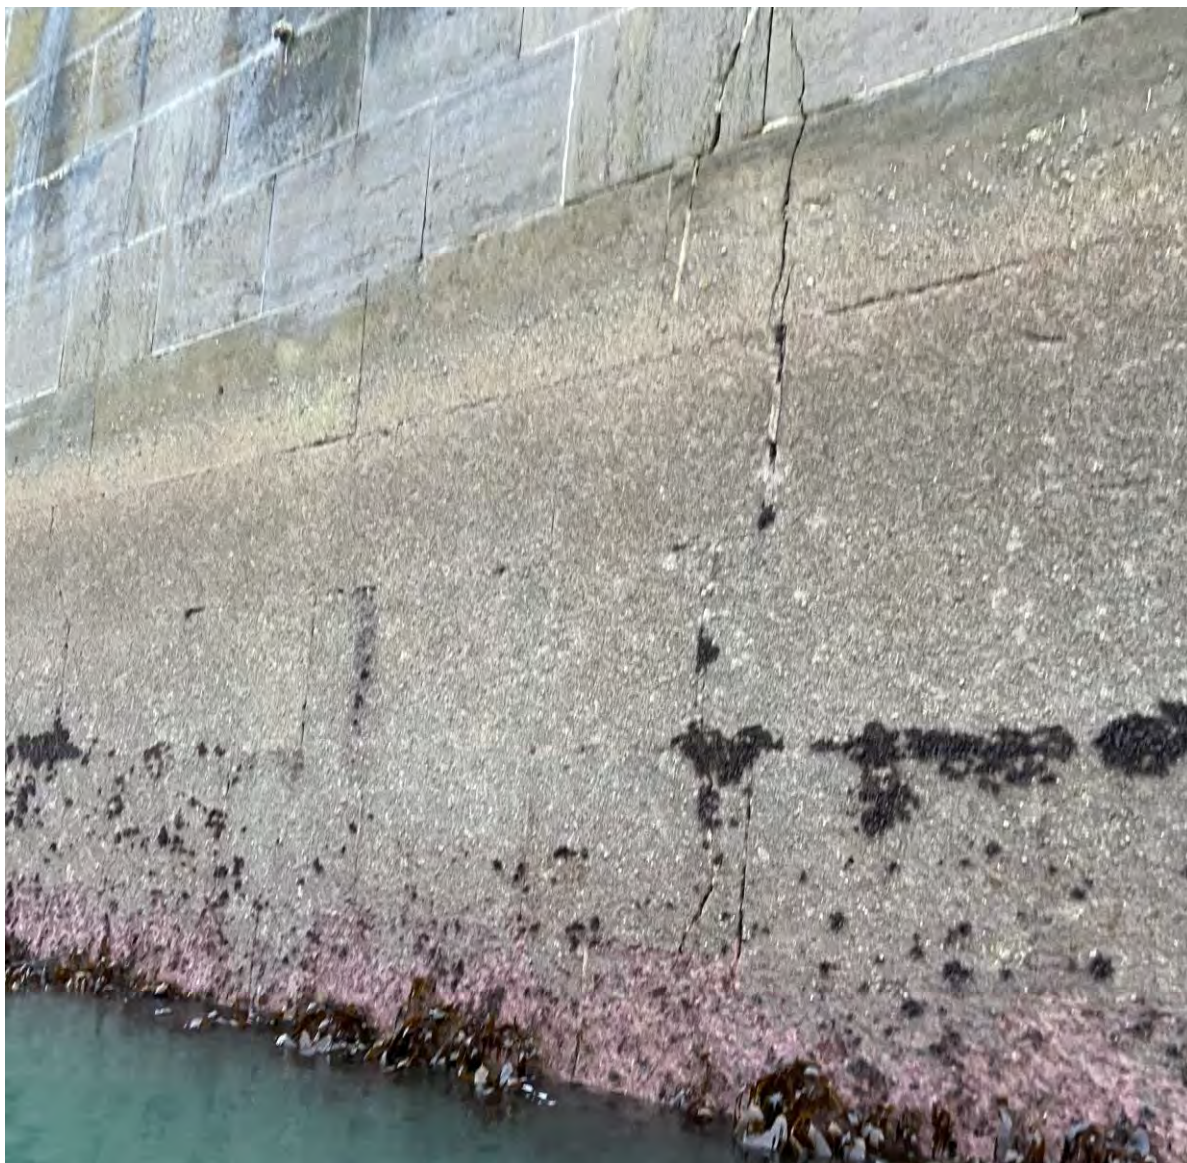
Evidence of significant cracking of the central section of the breakwater structure above the waterline was also observed from the vessel. This crack was running vertically through 5-6 blocks of the bullnose (Plate 8).

Plate 8 Evidence of cracking within the main bullnose structure above the waterline observed during ROV inspection transect.

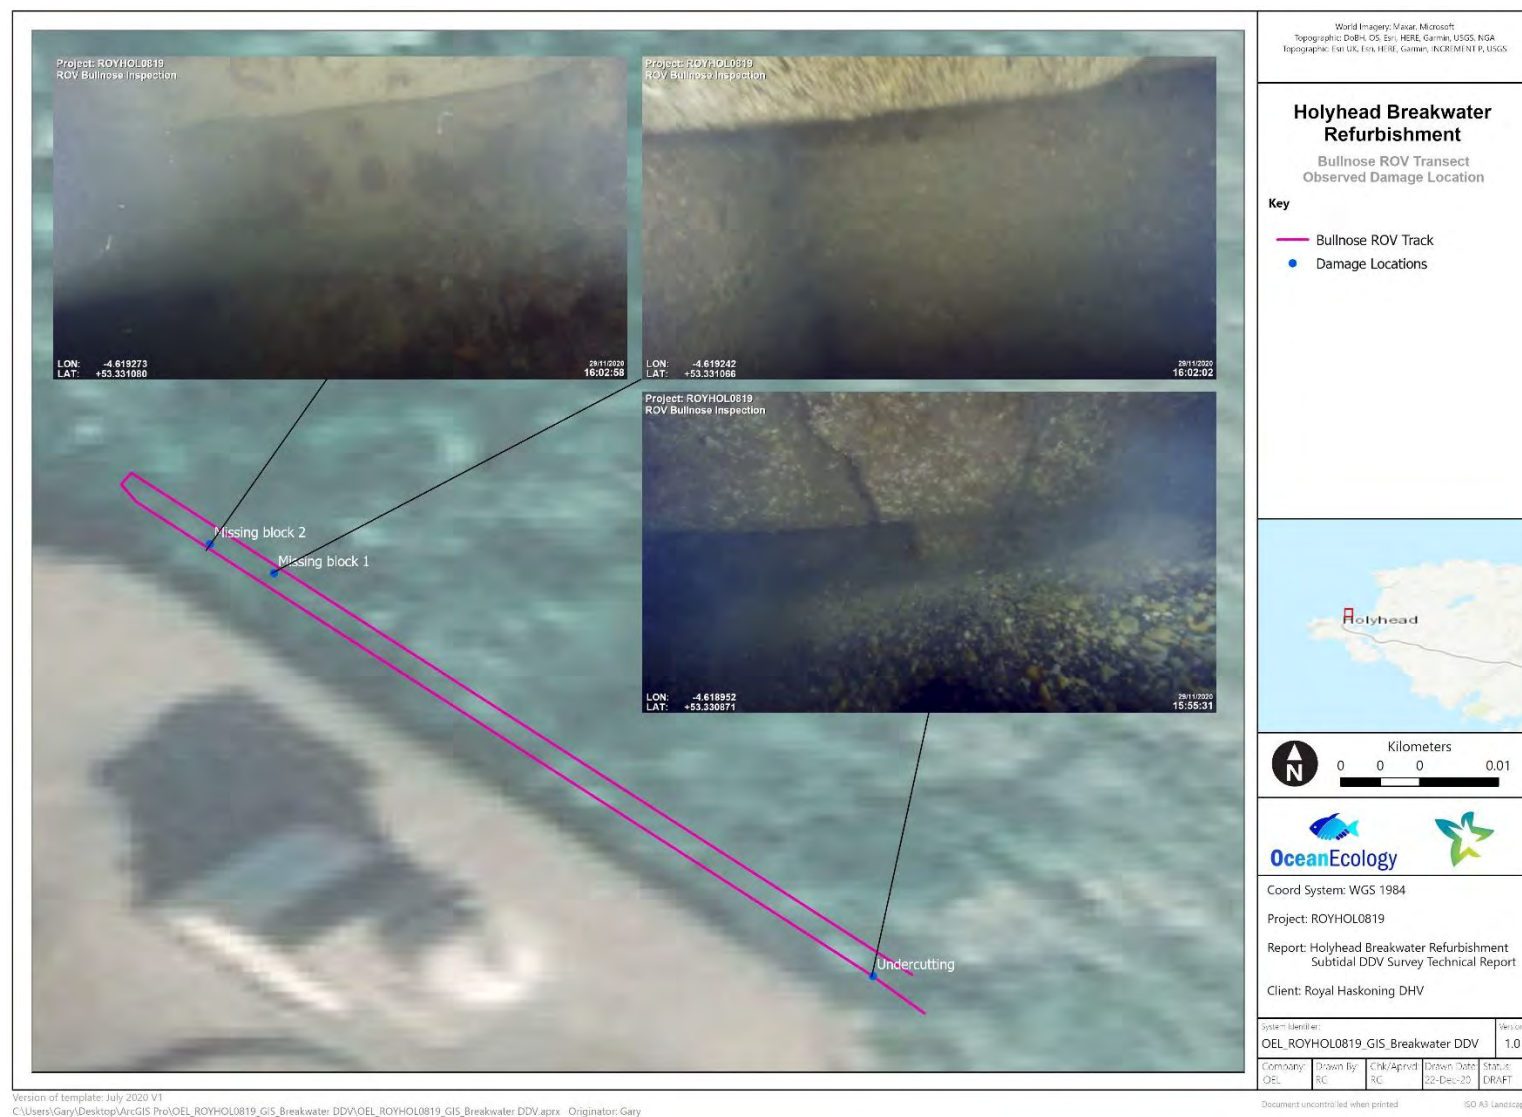
Figure 8 ROV Track and location of damage to breakwater structure observed during the Holyhead Breakwater Refurbishment survey, 2020.
