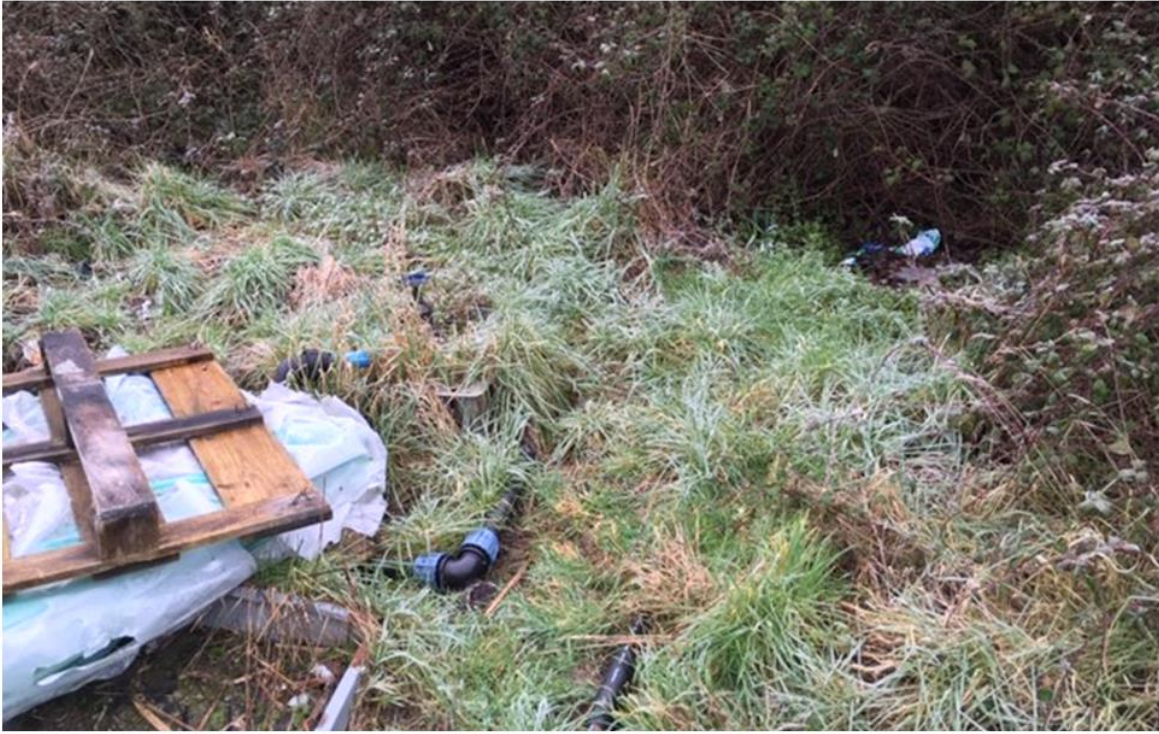
Photo 1: Primary Settlement Chamber (below grass) – Liquids pumped over to 2<sup>nd</sup> chamber (below grass) – Liquids pumped to Secondary Treatment System via over ground pipe network

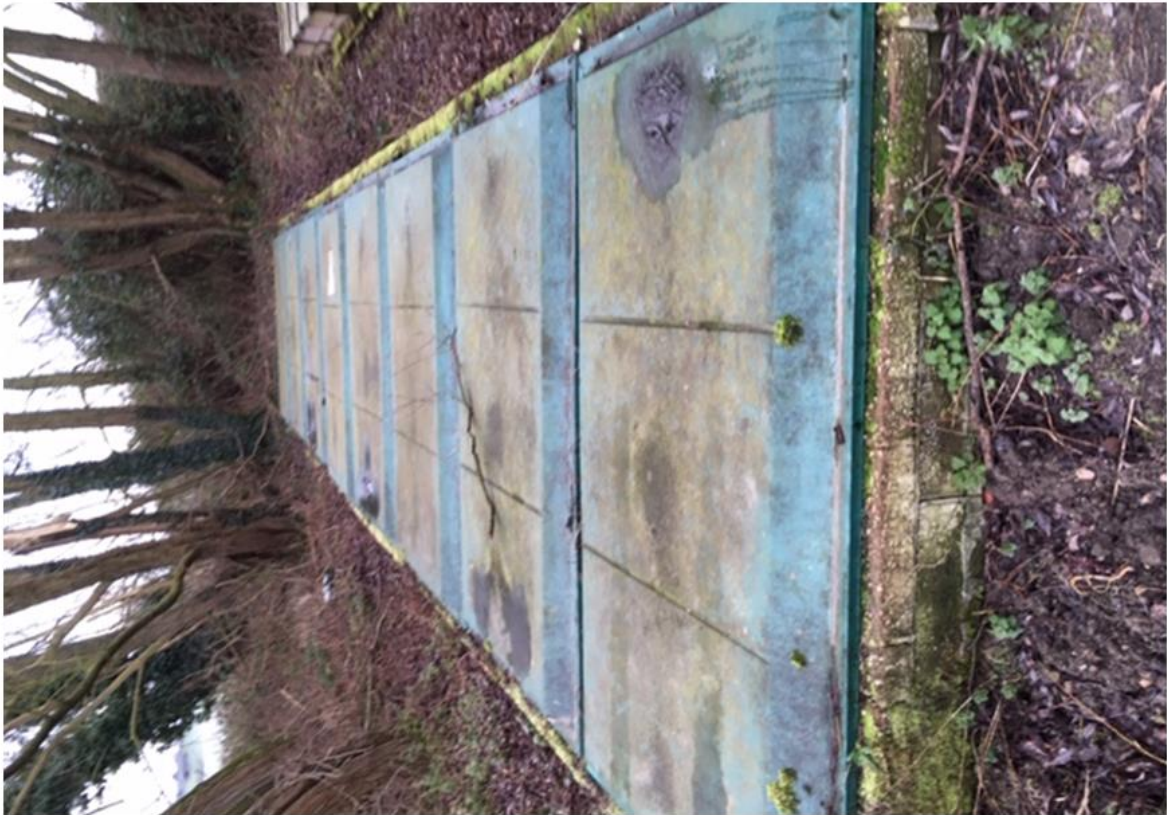
Photo 2: Secondary Treatment System (with 7 covers on)

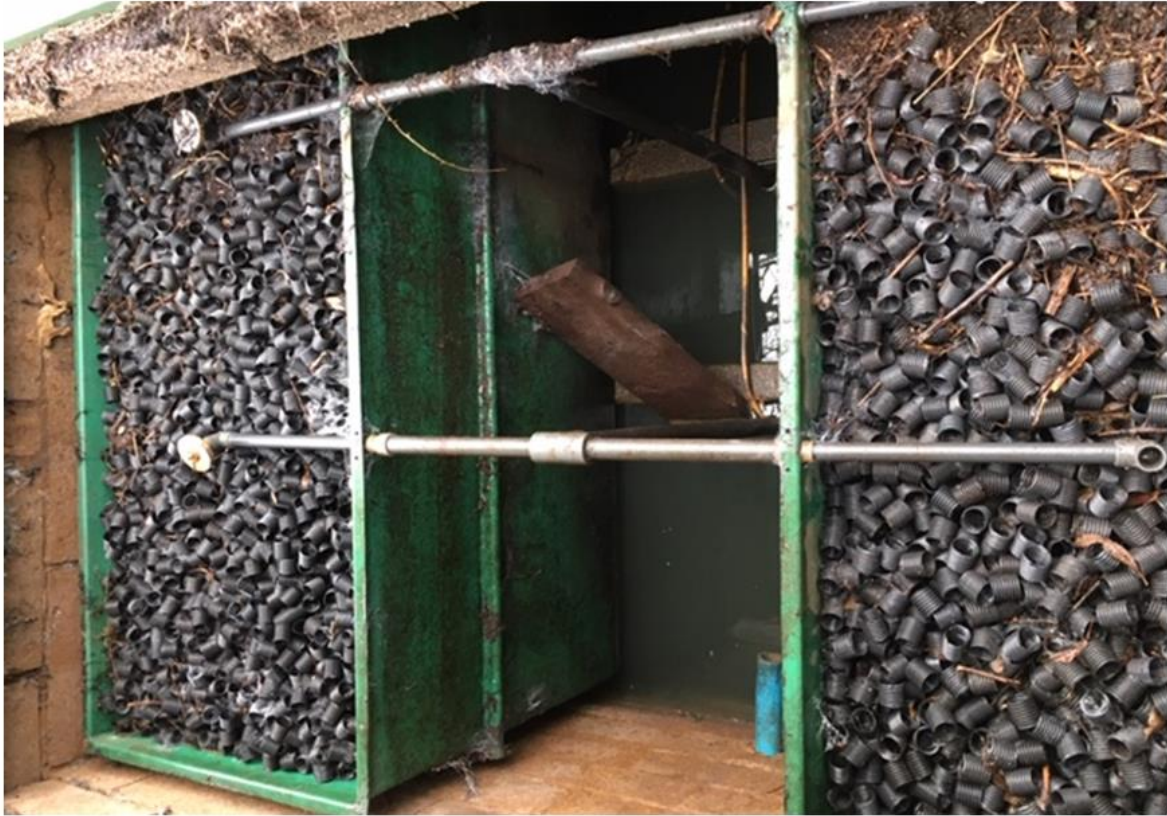
Photo 3: Trickling filters closest to inlet in Secondary Treatment System (covers removed)

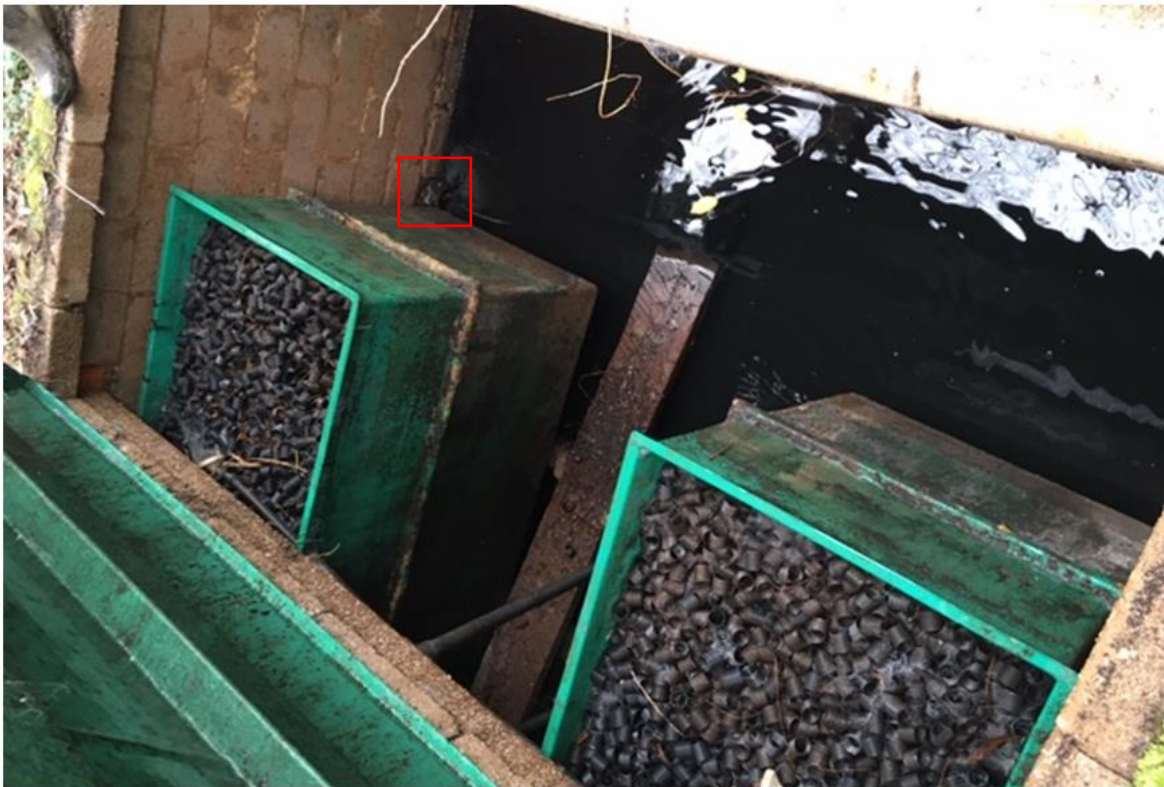
Photo 4: Trickling filters closest to outlet (in red) leading to discharge point in Secondary Treatment System (covers removed)

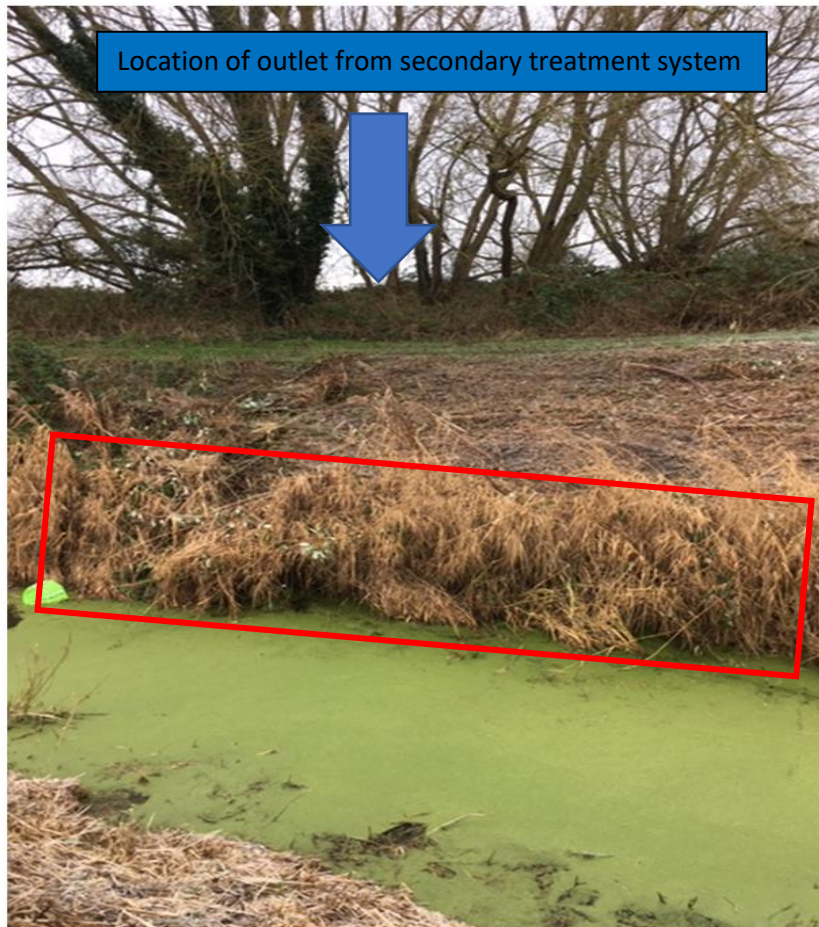
Location of outlet from secondary treatment system

Photo 5: Suspected discharge environment (reen). Discharge point somewhere in red box.

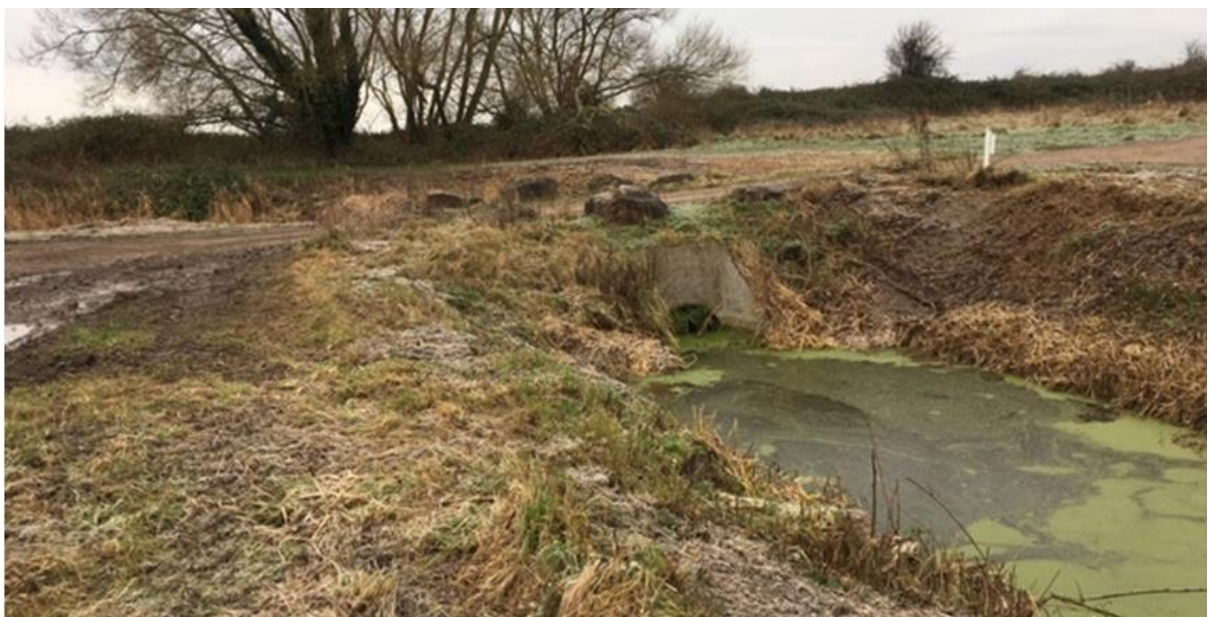
Photo 6: Reen connected to discharge reen. Reen smelt of sewage.
