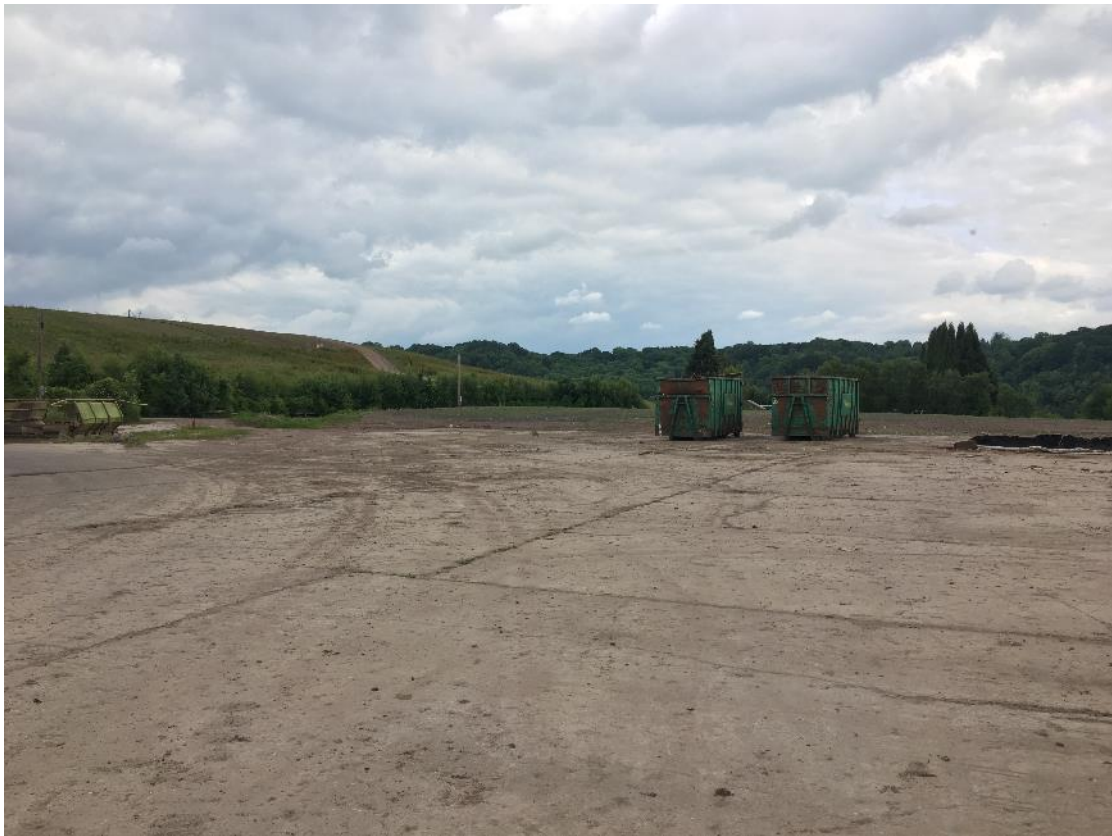
Photograph 1 – Photograph taken in the middle of the hardstanding area facing north towards environmental compound

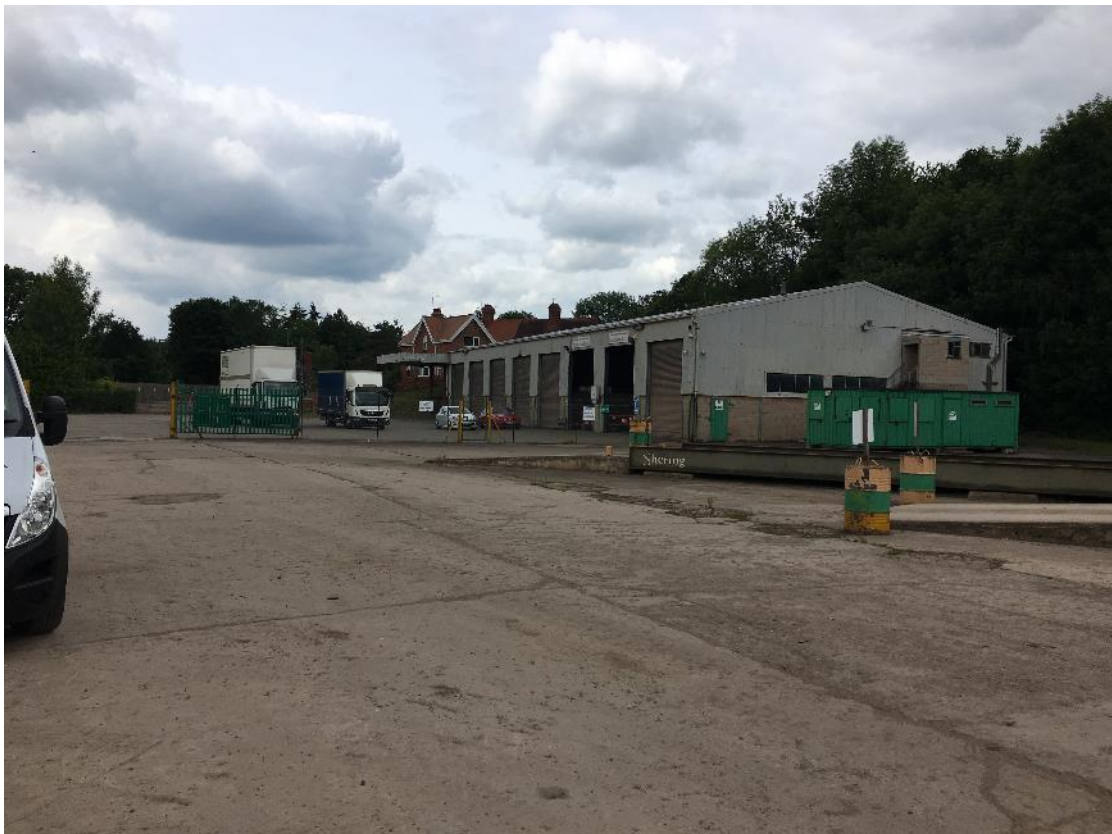
Photograph 2 – Photograph of the vehicle garages taken in the middle of the hardstanding area facing south

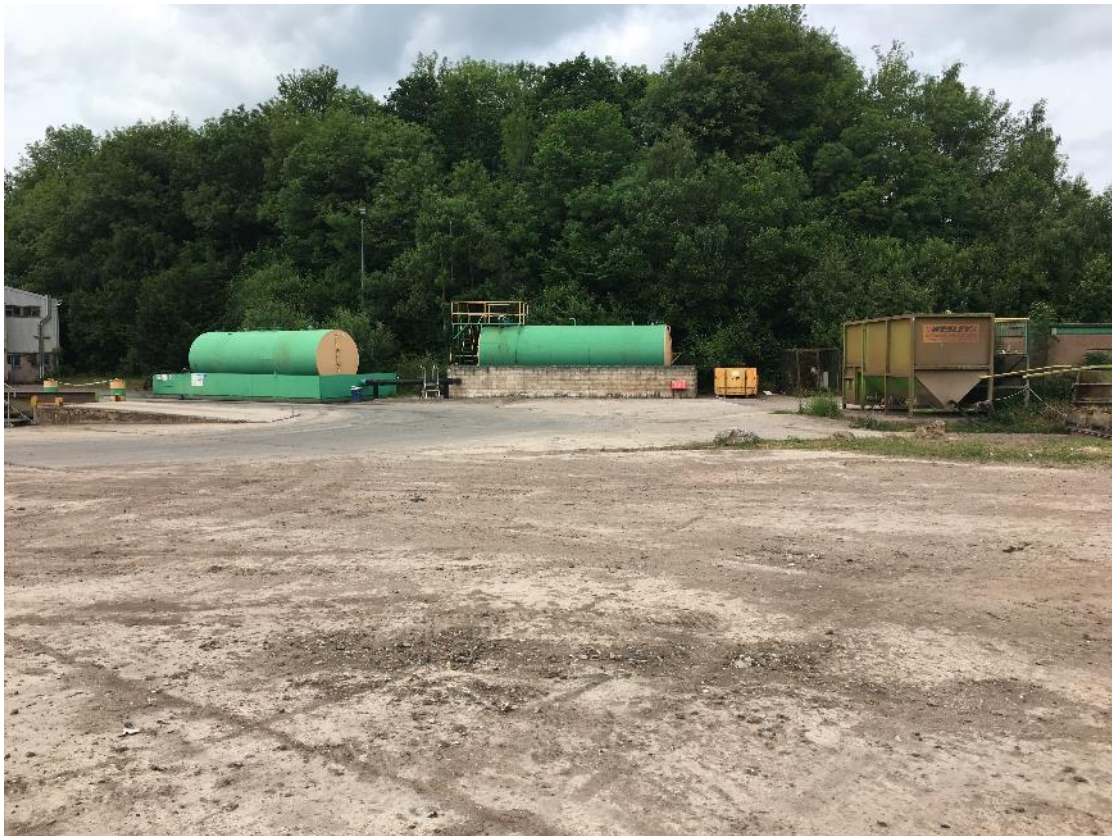
Photograph 3 – Photograph of the leachate storage tanks taken from the middle of the hardstanding looking west

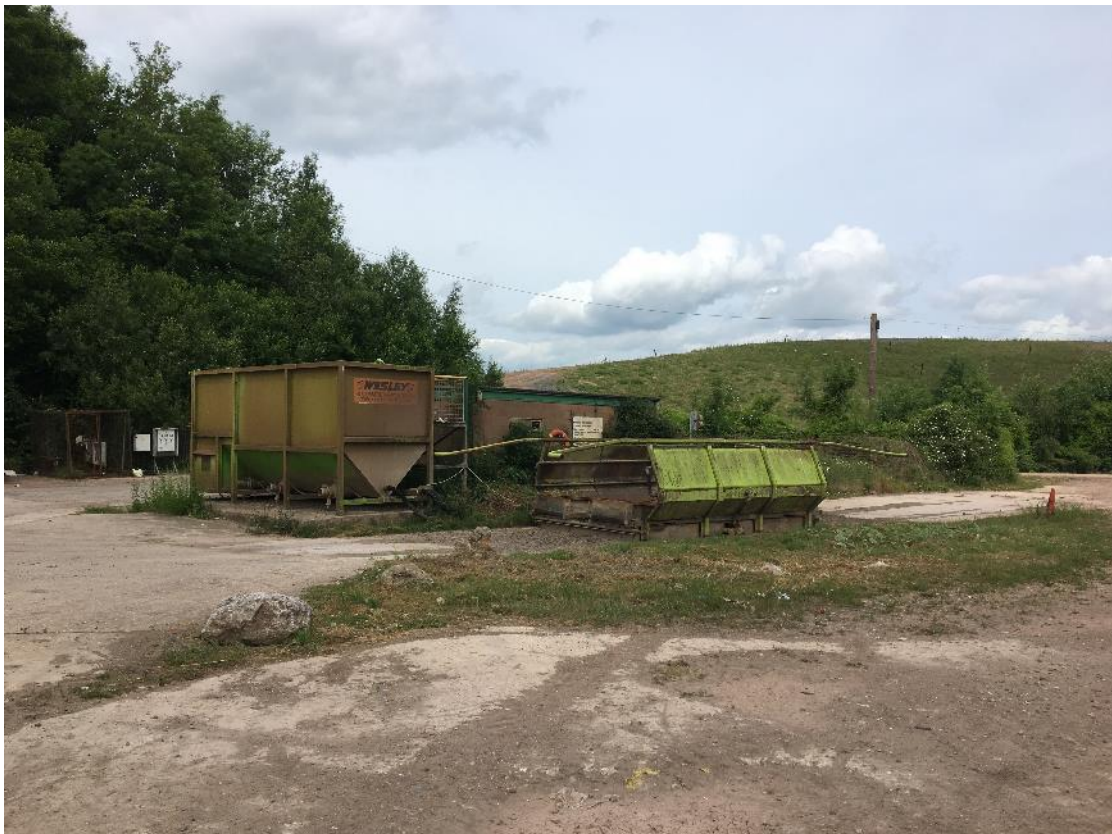
Photograph 4 - Photograph of the vehicle wheel wash taken from the middle of the hardstanding looking north west

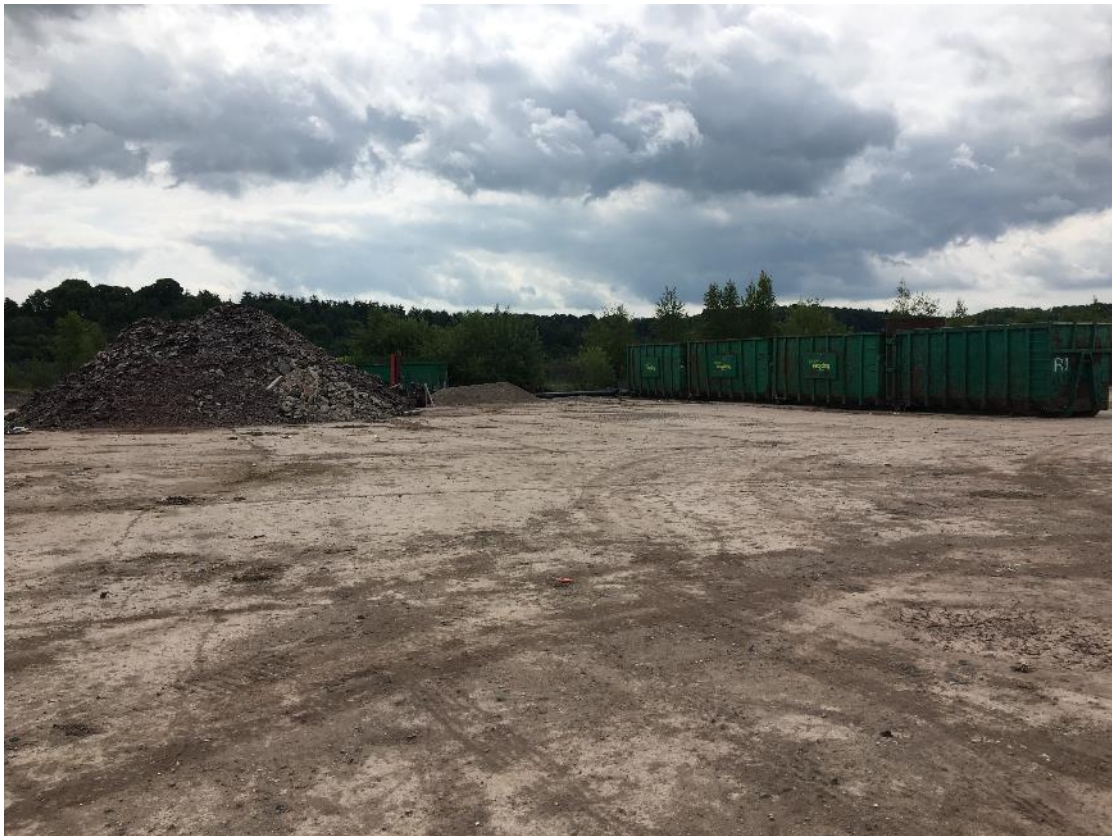
Photograph 5 - Photograph taken from the middle of the hardstanding facing east towards

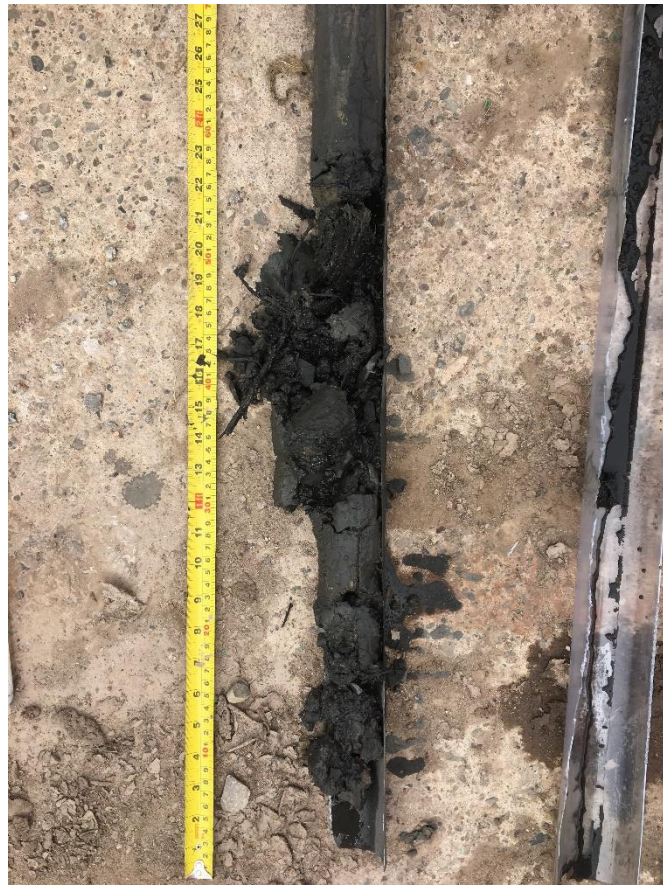
Photograph 6 - Photograph taken of the water saturated organic rich horizon identified at 4.60m within BH5

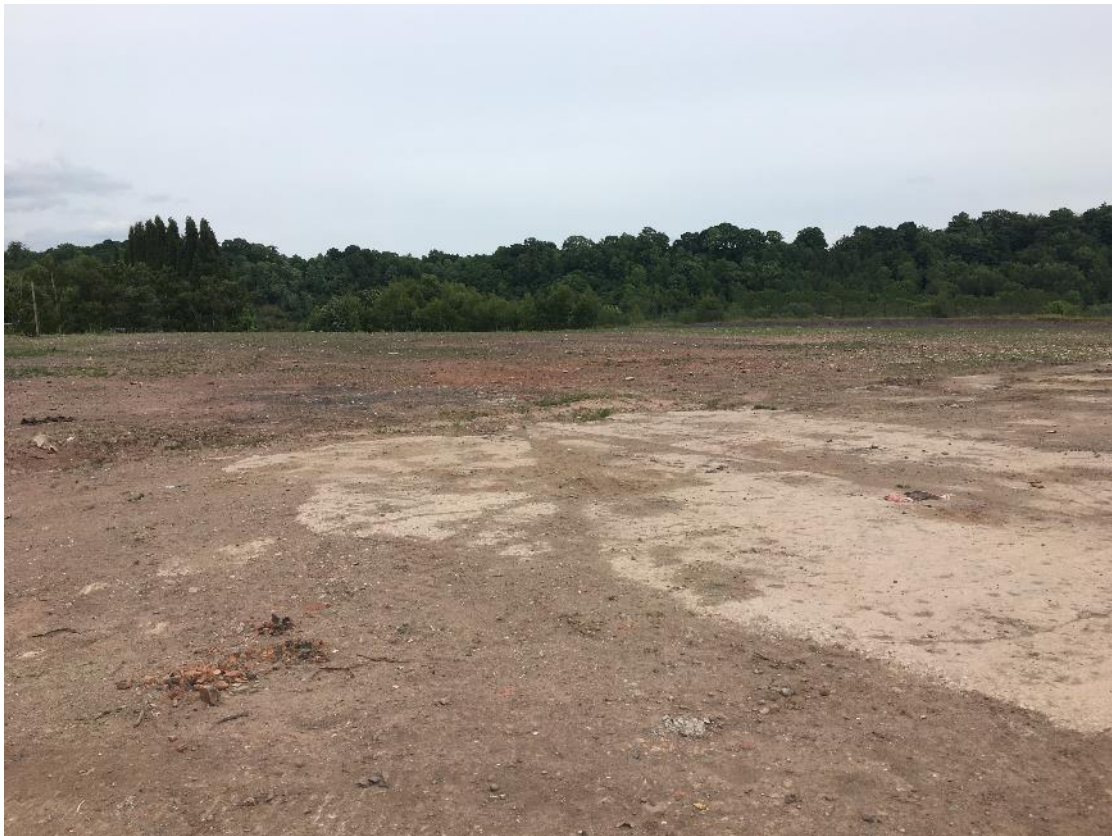
Photograph 7 – Photograph taken from the middle of the hardstanding facing north across the colliery spoil heap

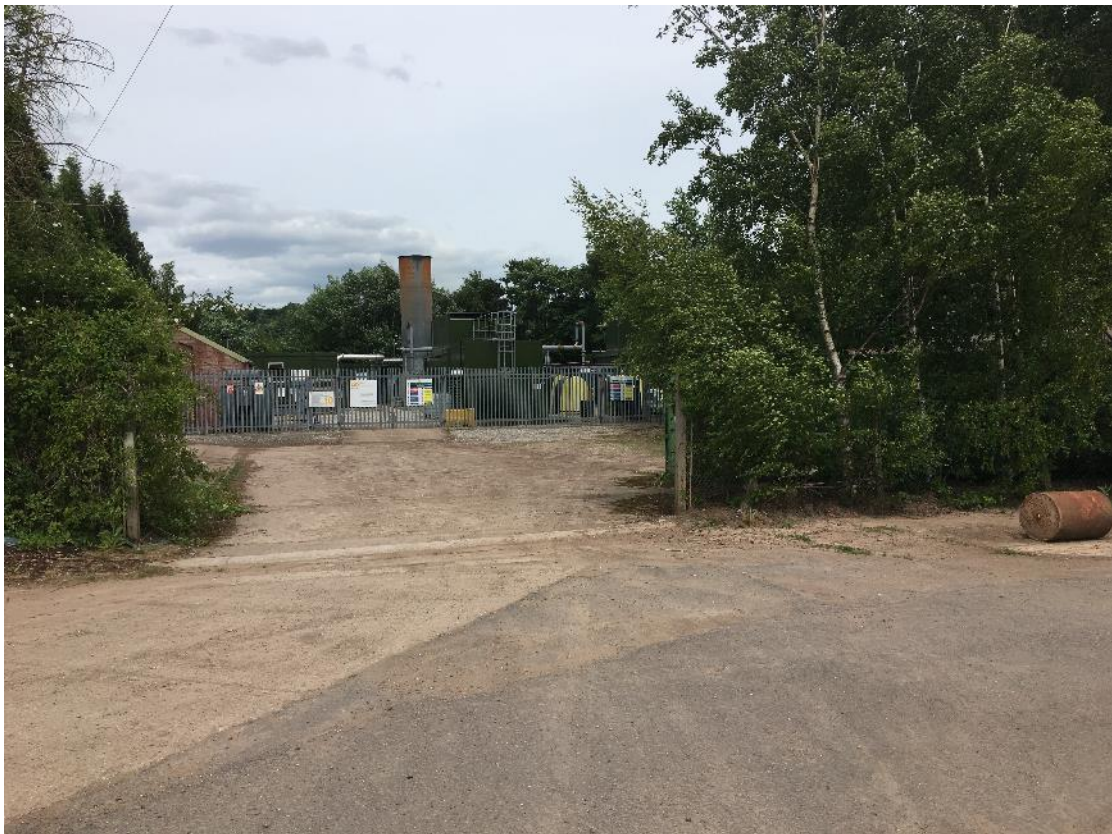
Photograph 8 – Photograph of the environmental compound taken from the northern edge of the colliery spoil heap facing north

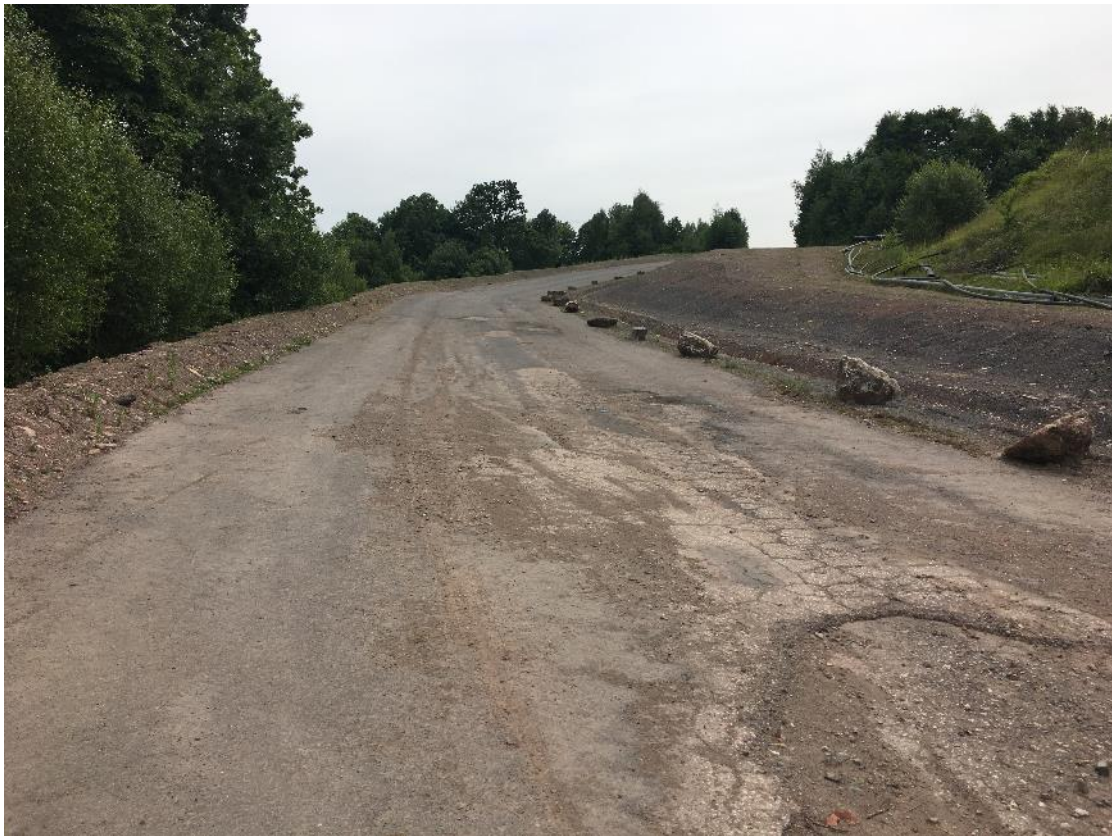
Photograph 9 – Photograph taken on the access road north of the environmental compound facing south

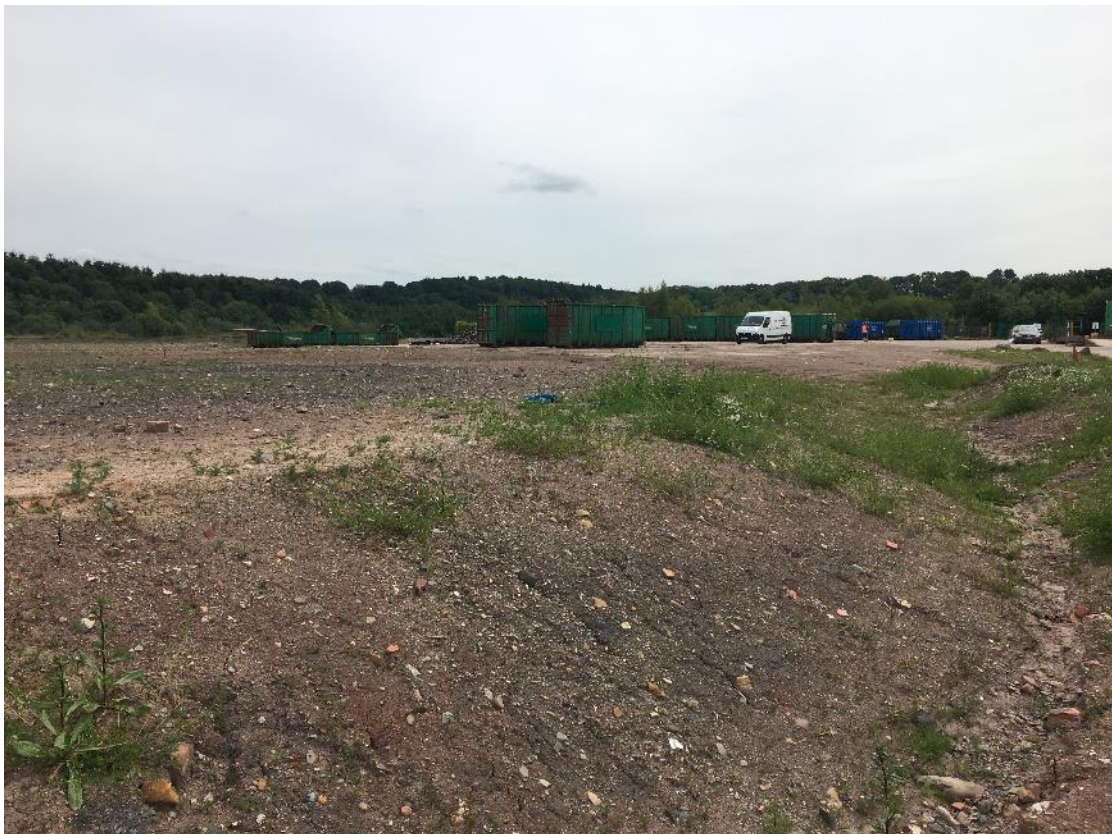
Photograph 10 – Photograph taken from the western edge of the colliery spoil heap facing south east towards the hardstanding

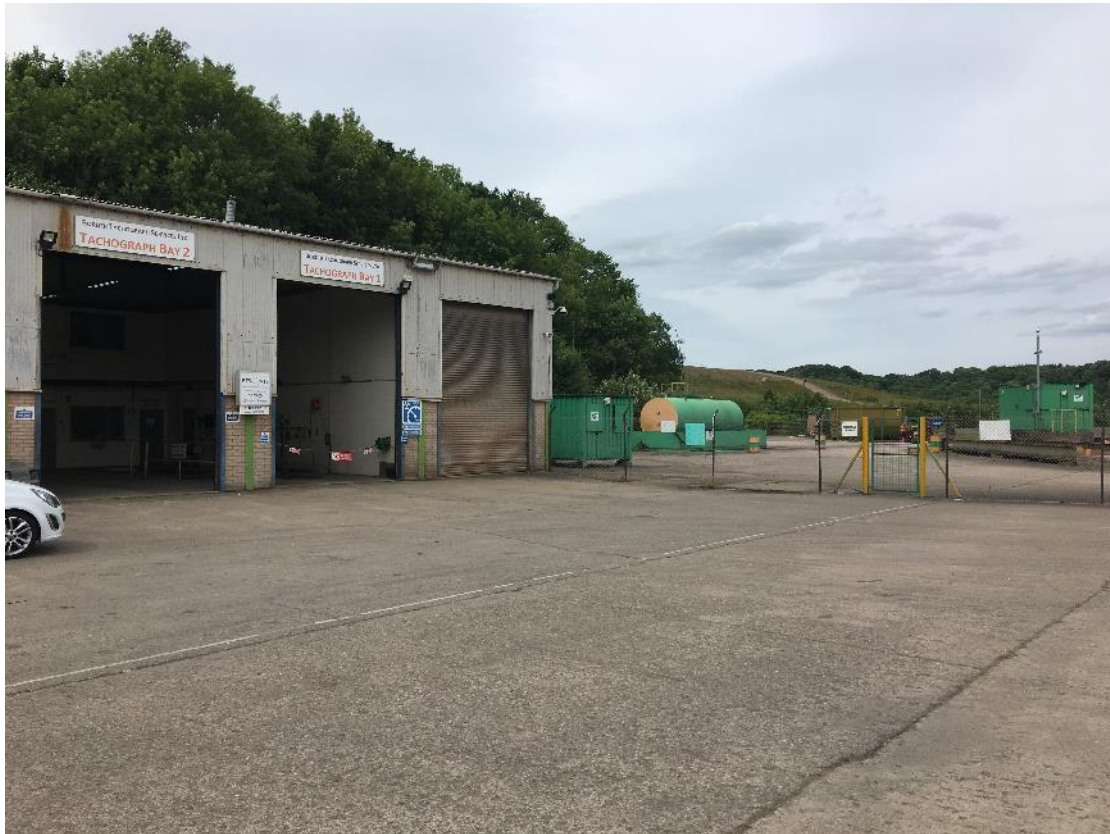
Photograph 11 – Photograph of the on-site vehicle garages, leachate storage tanks and weighbridge taken next to the vehicle garages facing north east towards

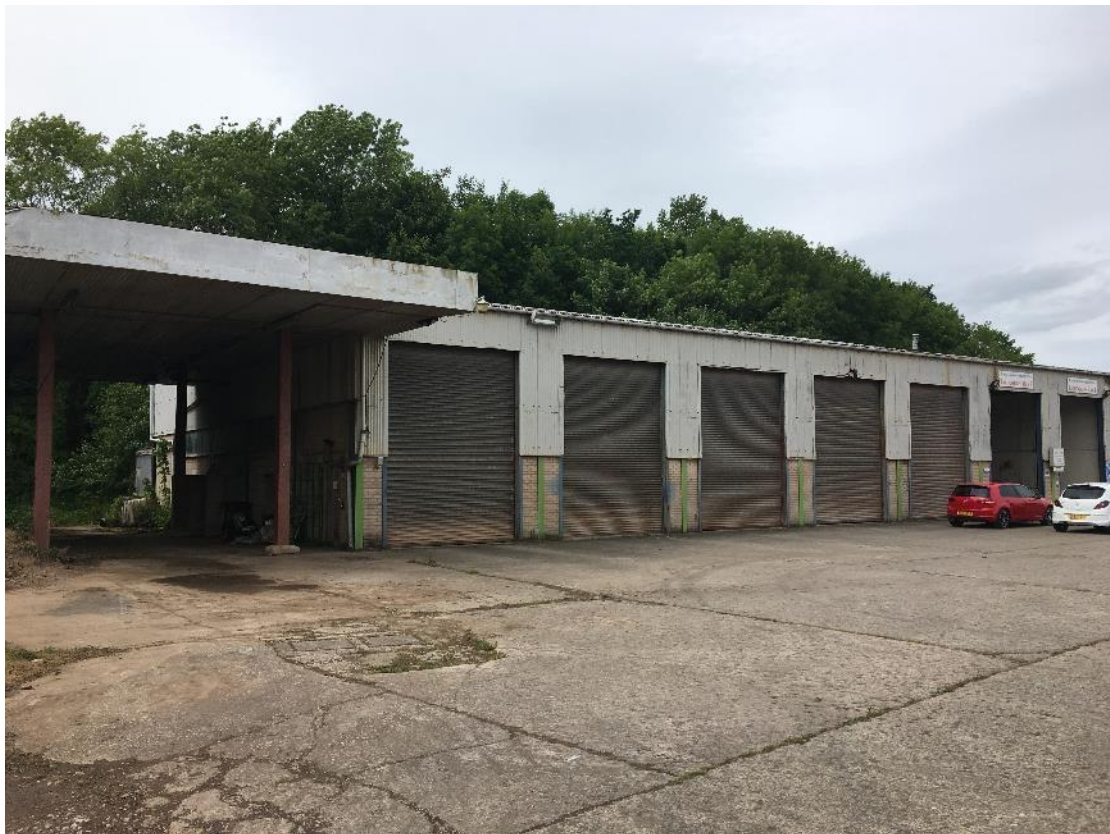
Photograph 12 – Photograph of the vehicle garages taken from the site office parking facing north east

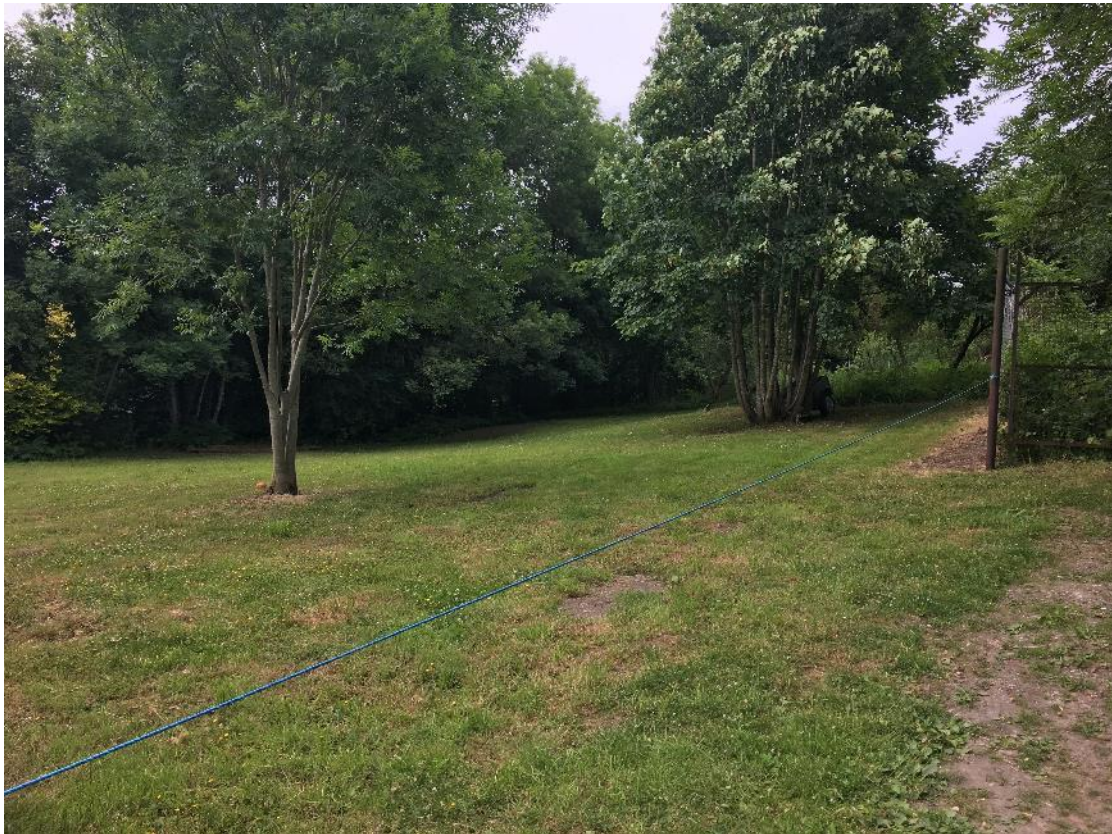
Photograph 13 – Photograph of the permitted land falling outside the landfill site's western ownership boundary facing north west

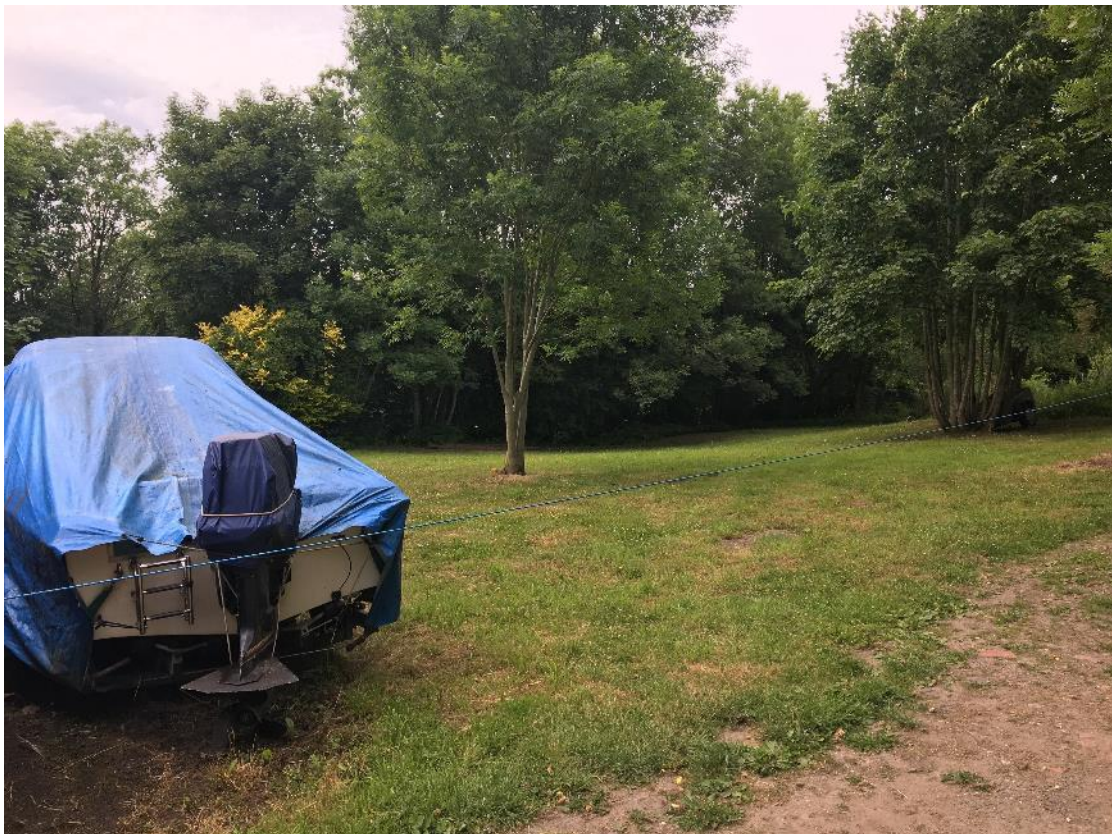
Photograph 14 - Photograph of the permitted land falling outside the landfill site's western ownership boundary facing west

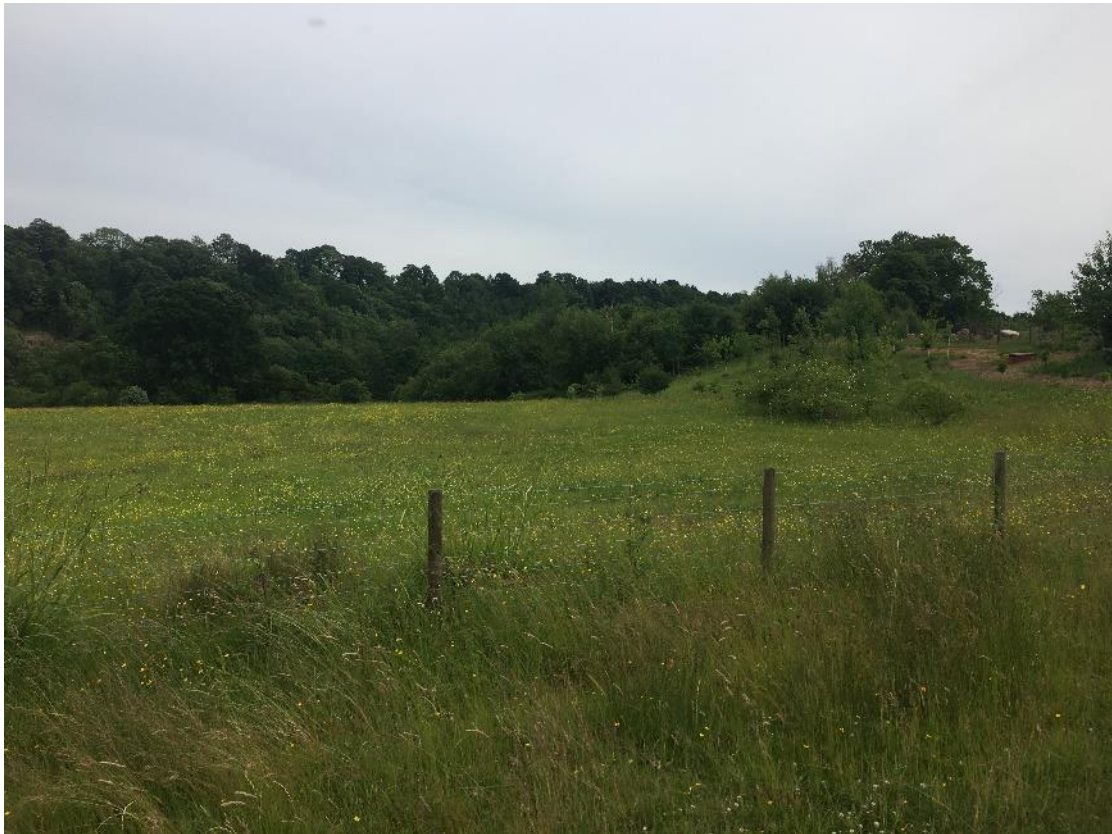
Photograph 15 – Photograph taken facing east across the permitted area to be surrendered located at the north eastern extent of Pen-y-bont Landfill site

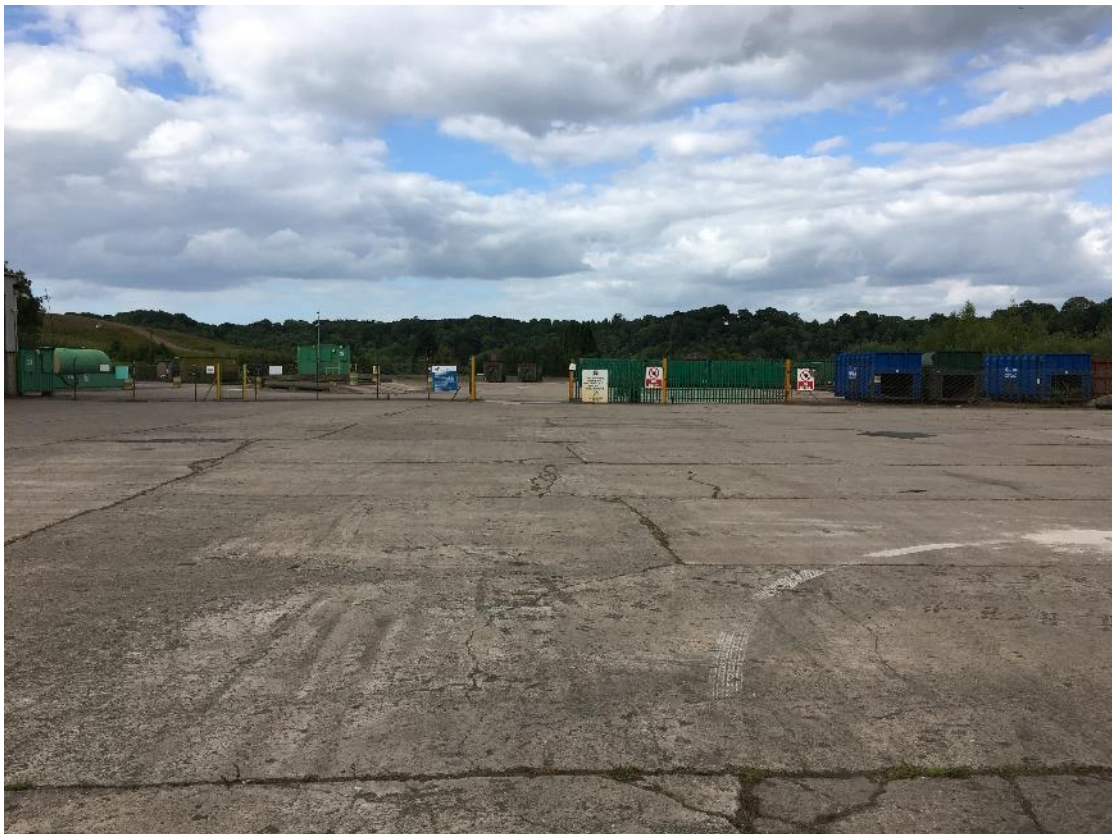
Photograph 16 – Photograph taken facing north across the hardstanding and colliery spoil heap
