PROPOSED COMMERCIAL DEVELOPMENT  
BIOCATALYSTS, NANTGARW  
RHONNDA CYNON TAFF

BIOCATALYSTS LTD

GEOENVIRONMENTAL ASSESSMENT

Document Ref. 5742b.2241

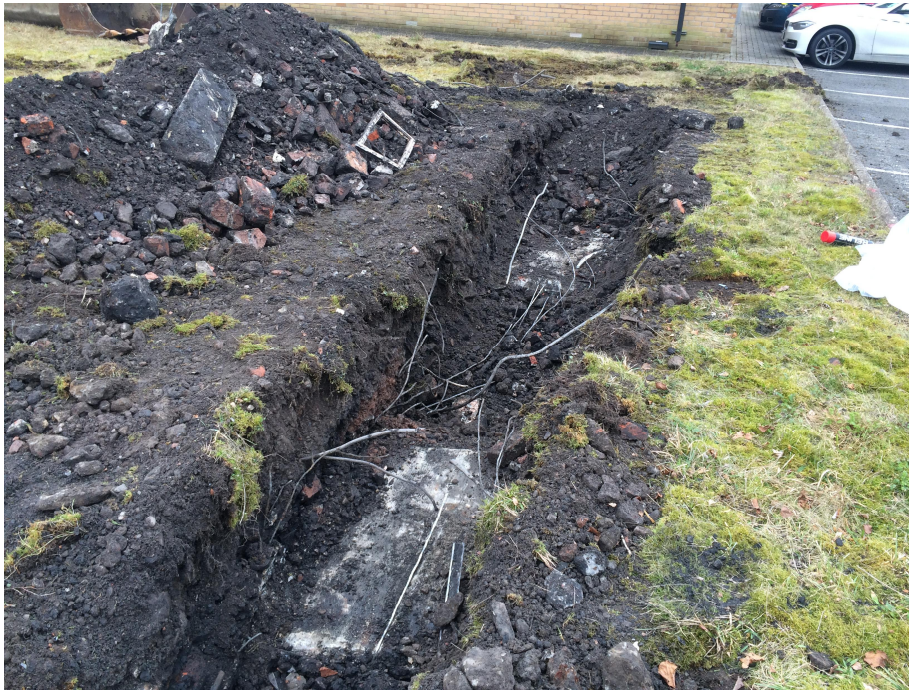
The concrete structures have a significant portion of steel rebar included within the slabs as shown in Insert 3, however this observation was not pervasive to the east of the site. Multiple brick walls have been encountered, however investigation indicated several as not being in situ and therefore these have not been plotted.

**Insert 3:** 2no. Subsurface Slabs with re-bar. Image taken looking South over TP1c

The historic infrastructure (steel reinforced concrete slabs and old foundations) associated with the former colliery will require grubbing up as part of the re-development. Prior to removal, the contamination status of all material to be taken off-site should be classified to allow suitable disposal.

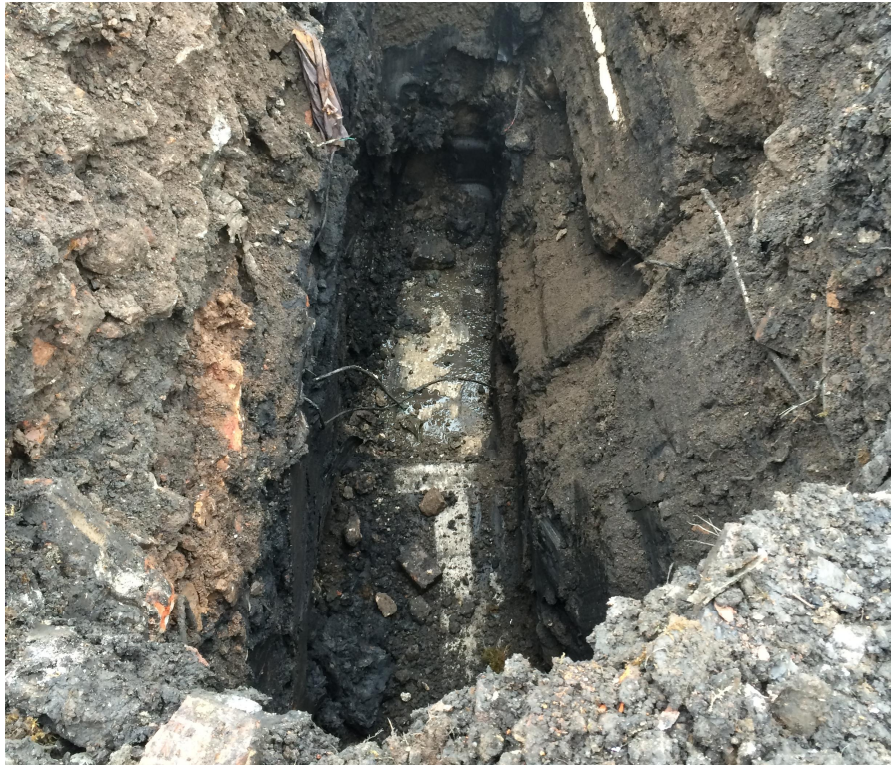
lateral extent of the slab indicated on the east of the site has not been proved. Typically all slabs exposed within 1m of surface level are approximately 0.6m thick, see Insert 3. An additional concrete surface is approximately 3m below surface level and is located in the south west quadrant of the site, see Insert 4. This is bounded by a concrete wall (to the west) extending to within 0.4m of the surface aligned roughly north south.

**Insert 4:** Subsurface concrete slab observed striking north south at 3m depth (Tp2d)

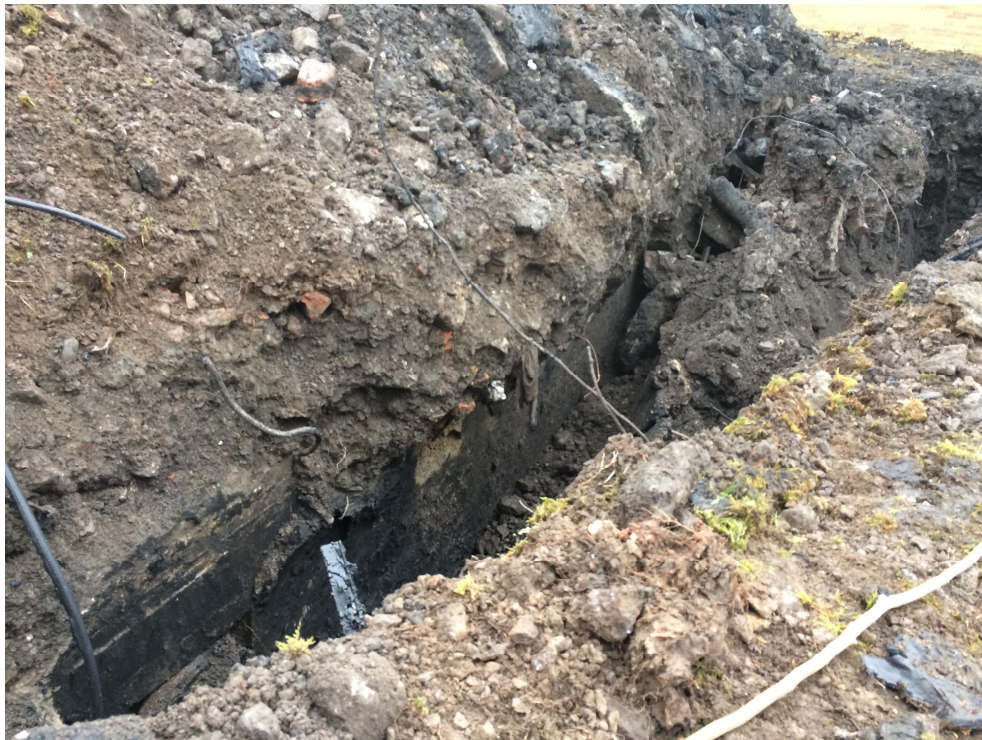
The historic footprint of the structures has been superimposed upon the exposed concrete slabs and brick walls. The overlay is shown in Figure 6 and shows a correlation between the historic building footprints and the identified slabs. This is principally relevant in two locations; where the concrete wall uncovered strikes parallel to the 1958-1974 building footprint and the oval concrete pad observed in the west of the site. The concrete wall uncovered is shown in Insert 5.

**Insert 5:** Subsurface concrete wall observed adjacent to 3m deep concrete slab striking roughly north south in the centre of the site. Note. The Made Ground has peeled from the wall.

The concrete slab may represent a basement floor however further investigation is required to determine the conditions below the concrete. There is no significant evidence for any basement structures associated with structures in place between 1920 and 1943.
