Compliance Assessment Report

Report ID:
CAR_NRW0033671

Site	Bryn Posteg Landfill	Permit Ref	BU77661C		
Operator/Permit holder	Sundorne Products (Ilanidloes) Ltd				
Regime	Installations				
Date of assessment	04/05/2018	Time in	08:44	Out	14:37
Assessment type	Audit				
Parts of the permit assessed	All below.				
Lead officer's name	Ellis, Rhys				
Accompanied by	Arlett, Timothy				
Recipient's name/position	David Williams / Technical manager	Date issued	02/08/2018

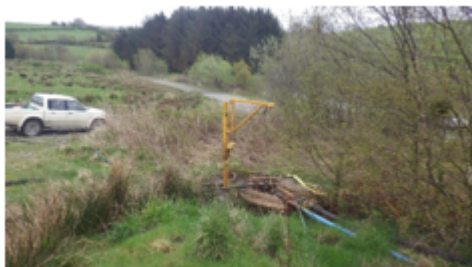
Photograph 1: Sump 1

- David Williams took officers to 'Sump1' which has been confirmed as a source of emission on site. Improvements are imminent to seal this chamber to improve emissions. Emission of 20,000 ppm Methane were detected from the sump during the visit. See Photograph 2.

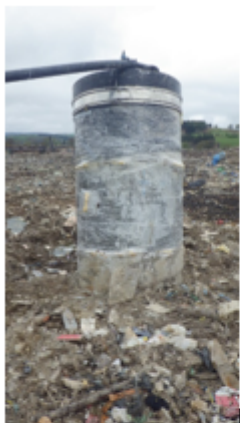
It was noted that some improvements had been made to the leachate chambers to try and reduce methane emissions however these appeared to be not effective in reducing emissions as demonstrated in methane emissions readings noted today. You did confirm that improvements efforts made to date are not your proposed final solution.

Photograph 2: Attempts made to reduce methane emission from Leachate chambers.

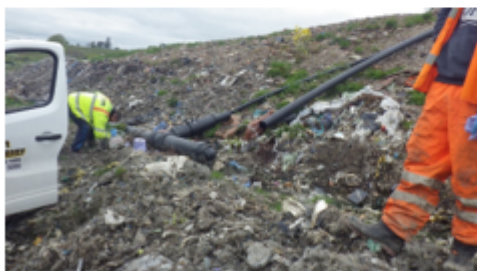
- SGG undertaking repair work on one of the gas collection lines (located near the gas main following machinery puncturing the gas line (Photograph 1). Please note that in the event of a breach of permit (i.e emission to air) the operator must immediately inform Natural Resources Wales.

Photograph 3. Repair work on one of the gas collection lines
