Appendix 1

**Photographs taken on 20th March
2018 during site inspection at
Bryn Posteg Landfill
(Permit BU7766IC)**

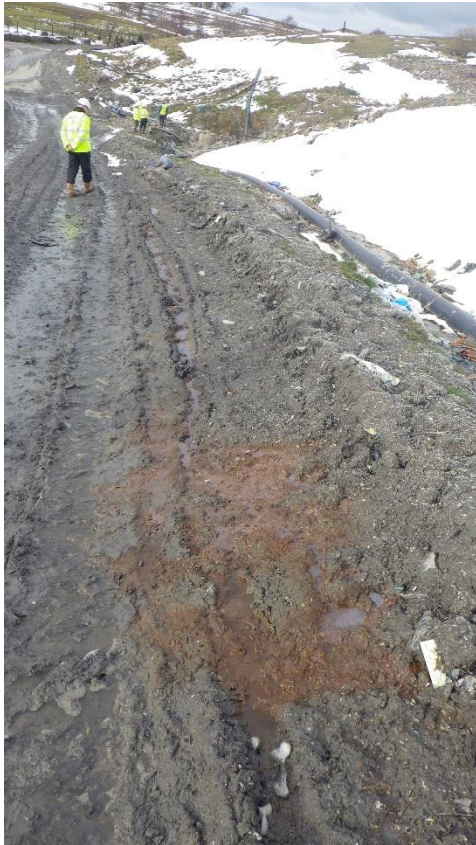
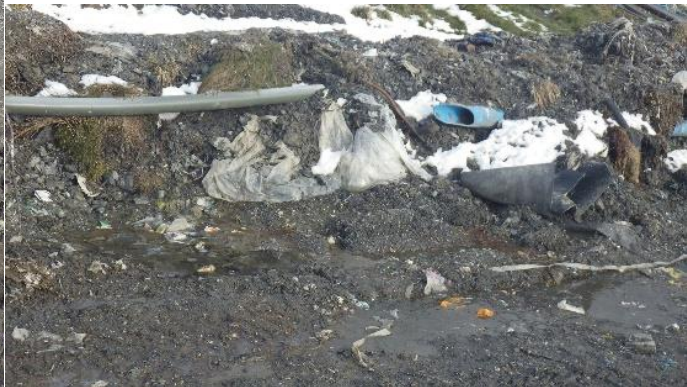
Leachate outbreaks noticed in haul road

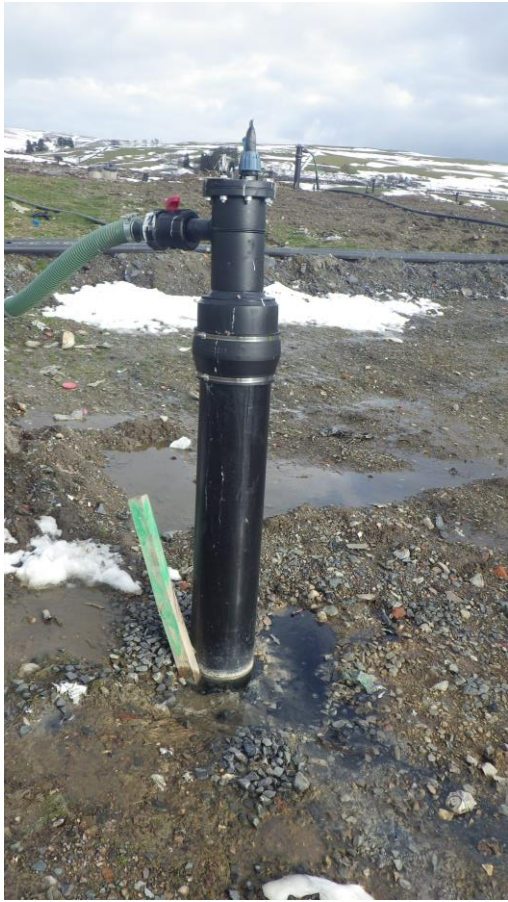
Leachate ponding around base of gas well

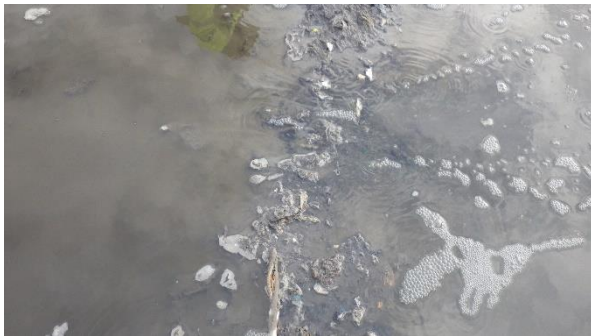
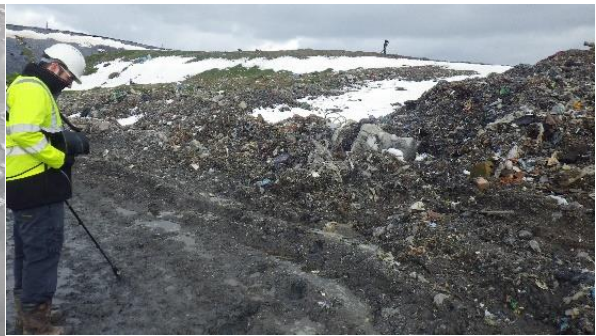
Landfill gas emanating from the haul road (See bubbling in haul's surface water/runoff)

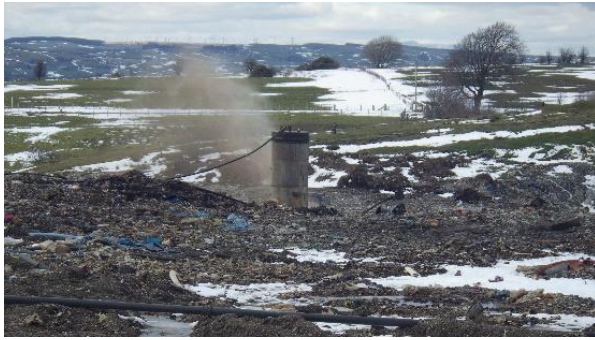
Spreading of what appeared to be leachate on tipping face

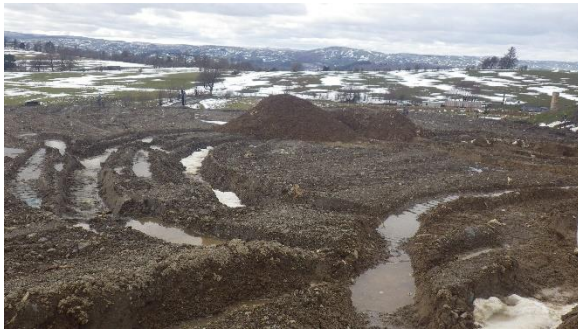
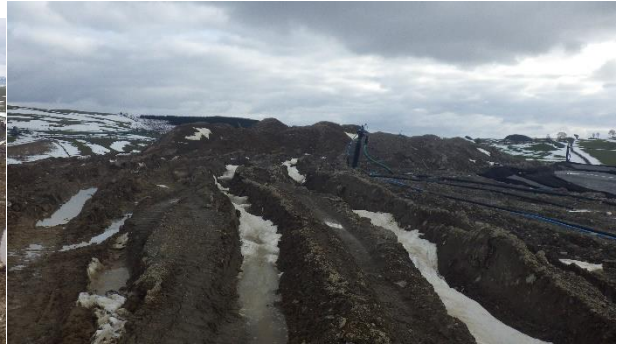
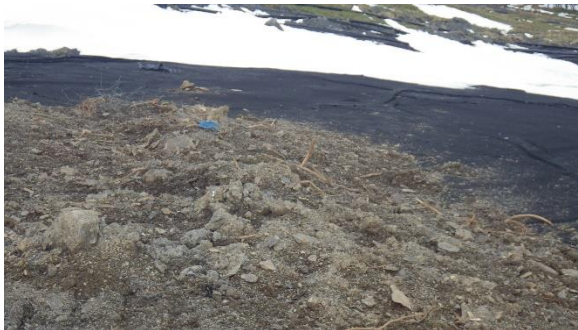
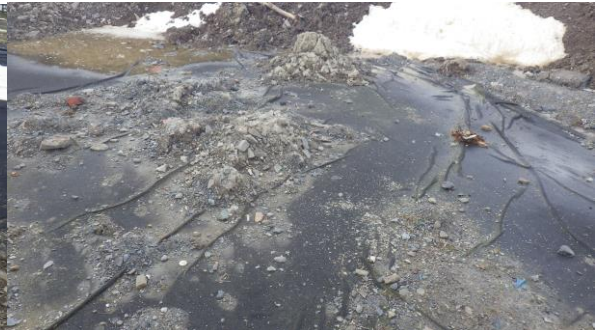
Stockpiled soil (which appeared to be waste) was observed on the geomembrane and geotextile capping during our inspection
