Appendix 2

Bryn Posteg Landfill Audit

18th and 19th April 2018

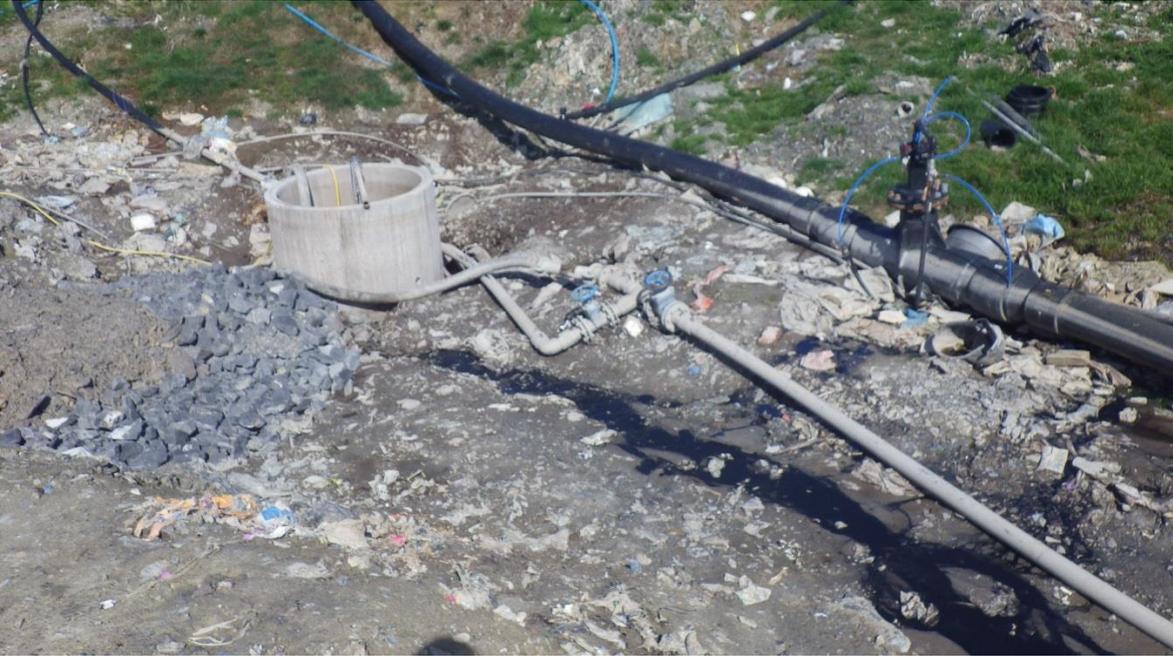
Photograph 1

1	Photograph taken opposite (9D(ii)) opposite the MRF-where previously significant amount of leachate has been visible flowing/cascading out of the flank and into the collection sum , although leachate was still evident flowing the flows were significantly lower.
2	Leachate flowing along the bottom of flank near 9D(ii)
3	Evidence of leachate flowing from the flank of cell 9D(ii)
4	High methane emissions of up to 64.6 % emanating near the entrance to Cell 9. Noticed due to bubbling in leachate ditch flowing adjacent haul road. Landfill gas management in this area should be investigated as a matter of urgency.
5	High methane emissions of up to 64.6 % emanating near the entrance to Cell 9. Noticed due to bubbling in leachate ditch flowing adjacent haul road. Landfill gas management in this area should be investigated as a matter of urgency.
6	High methane emissions emanating from haul track on Cell 9. Noticed due to bubbling in standing water above the holes. Landfill gas management in this area should be investigated as a matter of urgency.

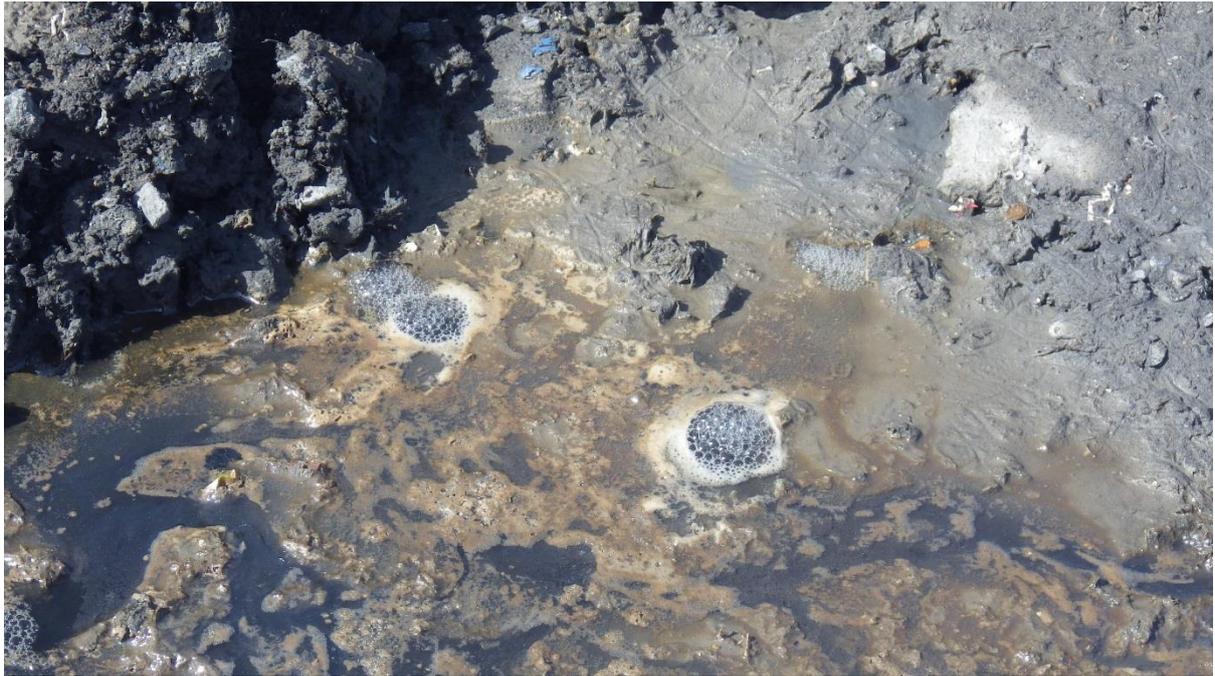
Photograph 7

7	High methane emissions emanating from haul track on Cell 9. Noticed due to bubbling in standing water above the holes. Landfill gas management in this area should be investigated as a matter of urgency.
8	High methane emissions emanating from haul track on Cell 9. Noticed due to bubbling in standing water above the holes. Landfill gas management in this area should be investigated as a matter of urgency.
9	High methane emissions emanating from leachate ditch alongside haul track on Cell 9. Noticed due to bubbling in standing water above the holes. Landfill gas management in this area should be investigated as a matter of urgency.
10	High methane emissions emanating from leachate ditch alongside haul track on Cell 9. Noticed due to bubbling in standing water above the holes. Landfill gas management in this area should be investigated as a matter of urgency.
11	Further work is required to gas collection pipework to improve falls and eliminate low spots where condensate can form and cause slugging effect etc

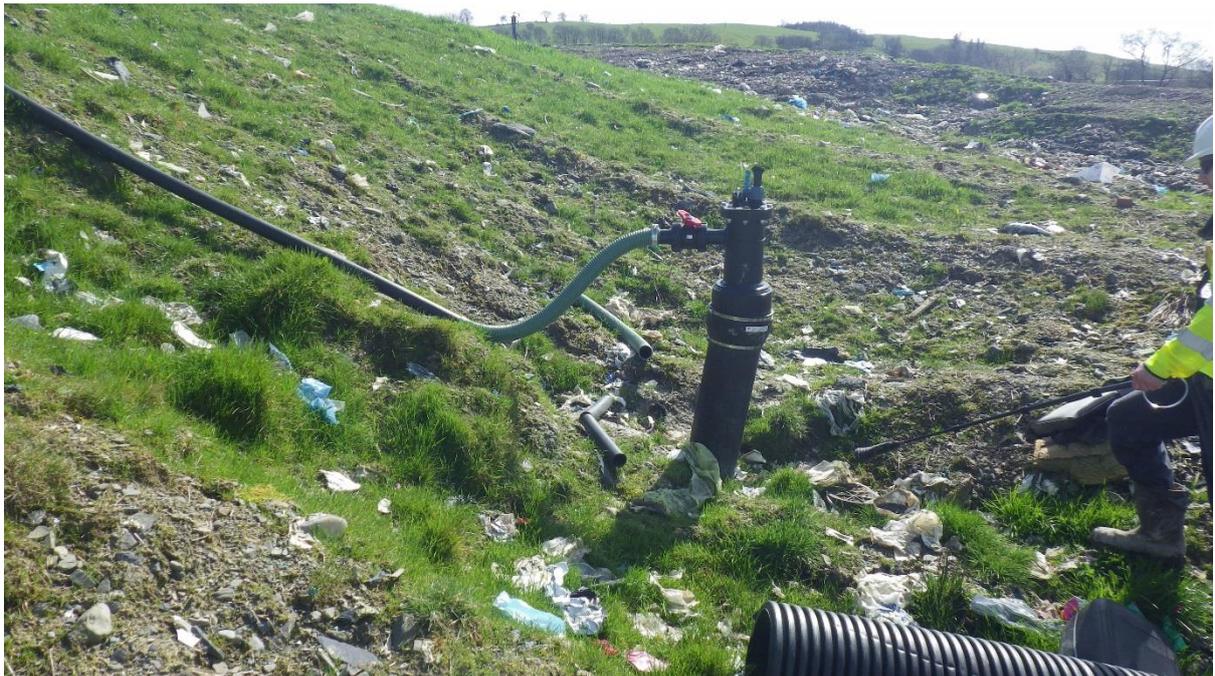
Photograph 12

12	Condensate trap in hose

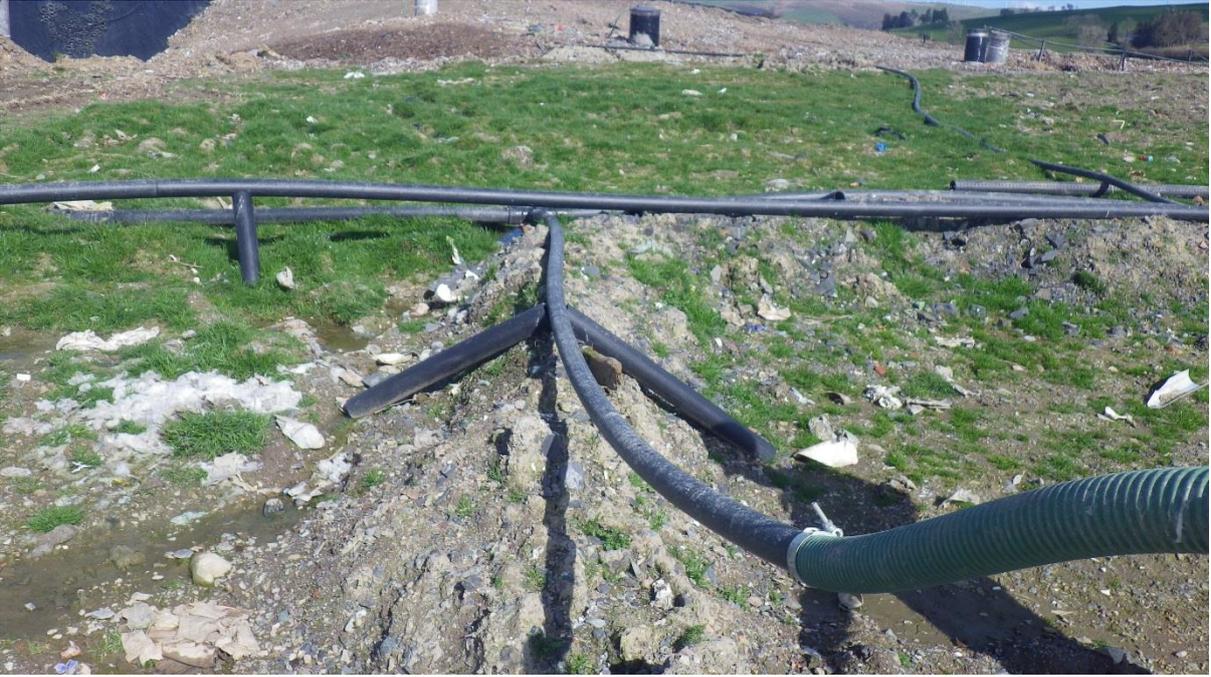
Photograph 13

13	Further work is required to gas collection pipework to improve falls and eliminate low spots where condensate can form and cause slugging effect etc
14	Further work is required to gas collection pipework to improve falls and eliminate low spots where condensate can form and cause slugging effect etc
15	Further work is required to gas collection pipework to improve falls and eliminate low spots where condensate can form and cause slugging effect etc
16	Example of one of these inaccessible high leachate towers where high methane readings were also noted around the base.
17	An area that needs de-watering urgently and gas extraction infrastructure improved considering all appropriate health and safety measures.
18	An area that needs de-watering urgently and gas extraction infrastructure improved considering all appropriate health and safety measures.
19	A hole in the flank demonstrating methane forcing its way out under pressure and readings as high as 21.9% was noted in the (south west corner of cell 9D)

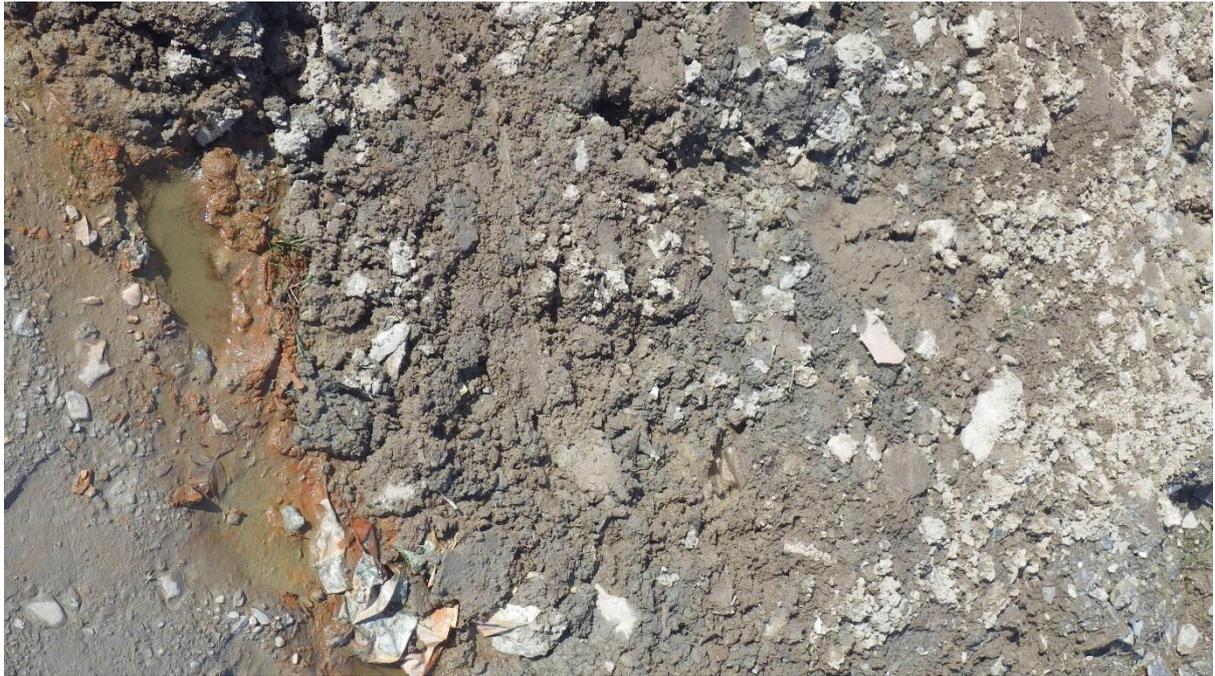
Photograph 20

20	A hole in the flank demonstrating methane forcing its way out under pressure and readings as high as 21.9% was noted in the (south west corner of cell 9D)
21	A trench been excavated by the operator to contain contaminated water that had been previously noted by officer to be pooling at the top of Phase 9DA and been running down the capping on the southern flank, to the haul road
22	A trench been excavated by the operator to contain contaminated water that had been previously noted by officer to be pooling at the top of Phase 9DA and been running down the capping on the southern flank, to the haul road
23	Well bunged and not properly sealed. Well head should be replaced with sealed screw top well head
24	Bailing tool left permanently in well. Unable to seal due to rope attached to bailing tool.
25	Rock placed on top of well- Replace with well casing and lid fit for purpose
26	Unable to sample due to broken valve
