## **Bryn Posteg Landfill Site**

## **Stability Risk Assessment**

### **Addendum No.5**

**Doc ref:** 3248-CAU-XX-XX- RP-Y-0305-S1-P2

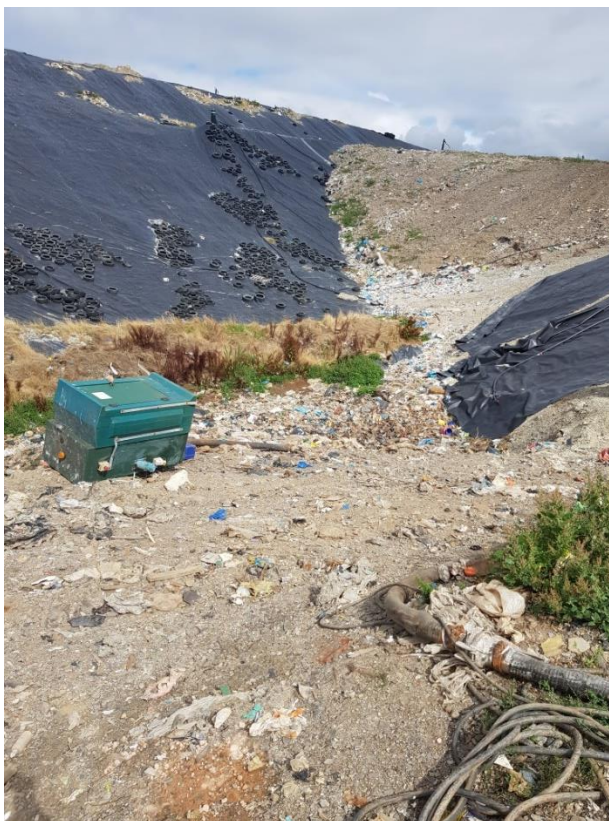
- 1.4.7 The long and steep southerly facing waste slopes have occurred as a result of the cessation of the landfilling activities. These slopes bound the former active landfilling area at the Site in Phase 9. These steep slopes would formerly have been considered to temporary slopes which would have been filled against over time to achieve the final pre settlement restoration profile. The covered waste slopes are typically in the order of 100m long at gradients predominantly in the order of 1 in 2 to 1 in 2.3 with localised areas as steep as 1 in 1.8. These slopes are steeper than the 1 in 2.5 gradient detailed in the SRA Addendum 4 and their stability has therefore been assessed herein.

*Plate 1; the long and steep southerly facing waste slopes in Phase 9 with the pumped sump at the toe.*

2.3.4 On the basis of the above results the current long and steep waste slopes (which face south) in Phase 9 are considered to be short term stable and will require to be filled against to create a stable profile.

2.3.5 The infilling of waste against these slopes as proposed in the Planning and Permit Variation applications will develop shallower and long term stable waste slopes of approximately 1 in 5 or shallower (in line with the analysis carried out in SRA Addendum 4).

- 3.5 A toe drain is installed to the northern, eastern and southern capped slopes.
- 3.6 The protection geotextile is removed from the LLDPE cap and replaced with a GDL.
- 3.7 The Phase 9 area is infilled with waste to achieve the proposed pre settlement profile.

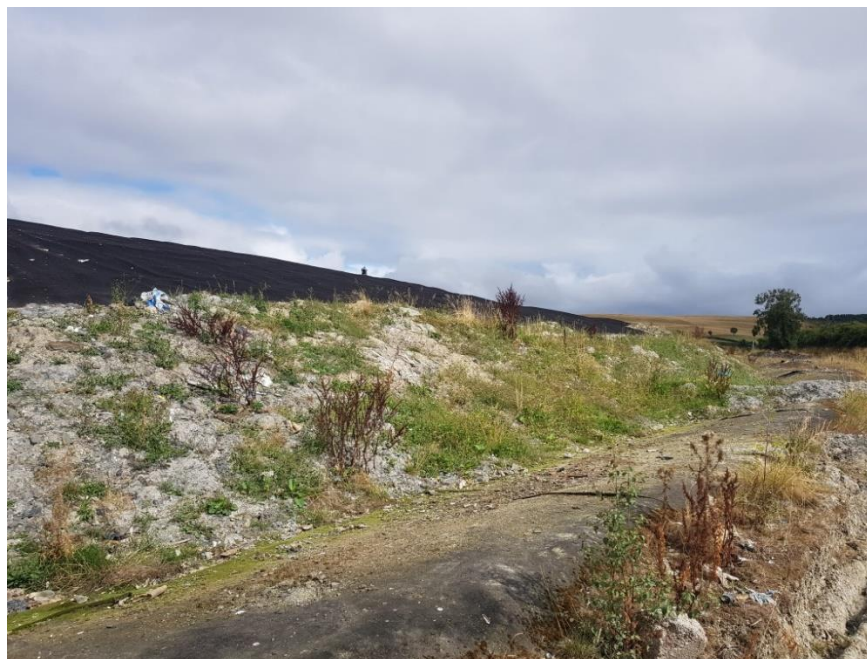
- 1.4.9 Around the perimeter to Phase 9 short sections of slope were capped in 2017 with an LLDPE geomembrane (textured) and covered with a protection geotextile. These slopes are generally in the order of 30m long and have gradients up to 1 in 2.7 in places which is considerably steeper than the 1 in 6.5 gradient which was detailed as a minimum gradient criteria in SRA Addendum 4 for a stable slope capped with a textured LLDPE geomembrane and a protection geotextile. To accord with the SRA Addendum 4 the steepest slope should be shallower than 1 in 5 and incorporate a Geocomposite Drainage Layer (GDL) on slopes steeper than 1 in 6.5.

*Plate 2; Capped Slope to the Phase 9 Southern Boundary.*

- 1.4.12 Due to their gradient these short perimeter slopes have been assessed herein.
- 1.4.13 It is noted that the slopes which have been capped with the LLDPE geomembrane in 2017 have been covered with a Geofabrics HPS3 protection geotextile. This protection material does not comply with the requirements of SRA Addendum A. For steeper slopes a GDL should be installed. The stability of these slopes has therefore been assessed within this document with regards to the existing protection geotextile and a GDL.

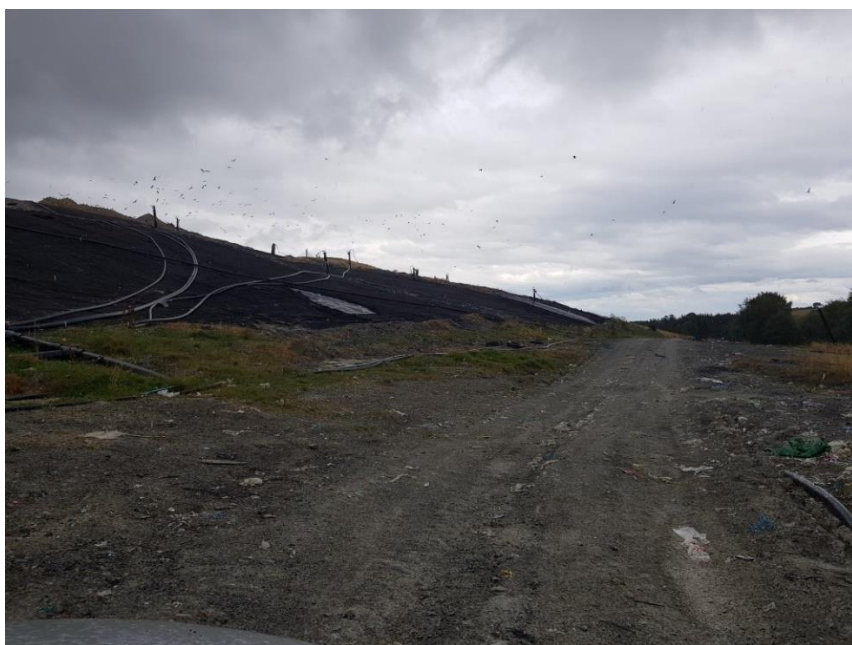
- 1.4.14 The perimeter slopes (along with a section of the crest of the Site) were capped in 2017 with an LLDPE geomembrane (textured) and covered with a protection geotextile. These slopes are generally in the order of up to 100m long and have gradients up to 1 in 3.5 in places which is considerably steeper than the 1 in 6.5 gradient which was detailed as a minimum gradient criteria in SRA Addendum 4 for a stable slope capped with a textured LLDPE geomembrane and a protection geotextile. To accord with the SRA Addendum 4 the steepest slope should be shallower than 1 in 5 and incorporate a Geocomposite Drainage Layer (GDL) on slopes steeper than 1 in 6.5.

*Plate 3; the capped slope to the Eastern boundary of the site covered with the protection geotextile.*

1.4.18 It is noted that the slopes which have been capped with the LLDPE geomembrane in 2017 have been covered with a Geofabrics HPS3 protection geotextile. This protection material does not comply with the requirements of SRA Addendum A. For steeper slopes a GDL should be installed. The stability of these slopes has therefore been assessed within this document with regards to the existing protection geotextile and a GDL.

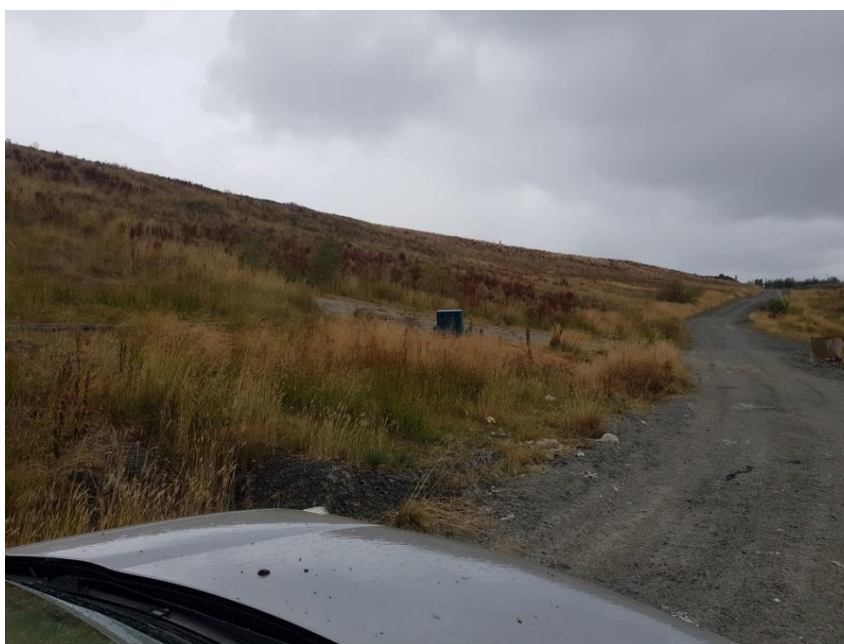
*Plate 4; the Northern capped and restored slope.*

- 1.4.23 During the inspection of the Site no signs of instability were observed in connection with the northern slopes, however they are steeper than the criteria stated in SRA Addendum 5. The long term stability of the northern slopes are therefore assessed in this report below.

- 1.4.24 On the basis of the inspection and discussions with the Site operator it is apparent that the GDL to the Northern slope and the protection geotextile to the Eastern and Southern slopes terminate in the capping anchor trench which does not include a drain for the collected water at the soils / LLDPE capping geomembrane interface.

- 1.4.26 In order to provide long term stability the capped slopes must drain: a collection drain will therefore need to be installed at the toe of the capped slopes to collect and drain the water from the slopes. For the purposes of this SRA a saturated soil condition has been used to

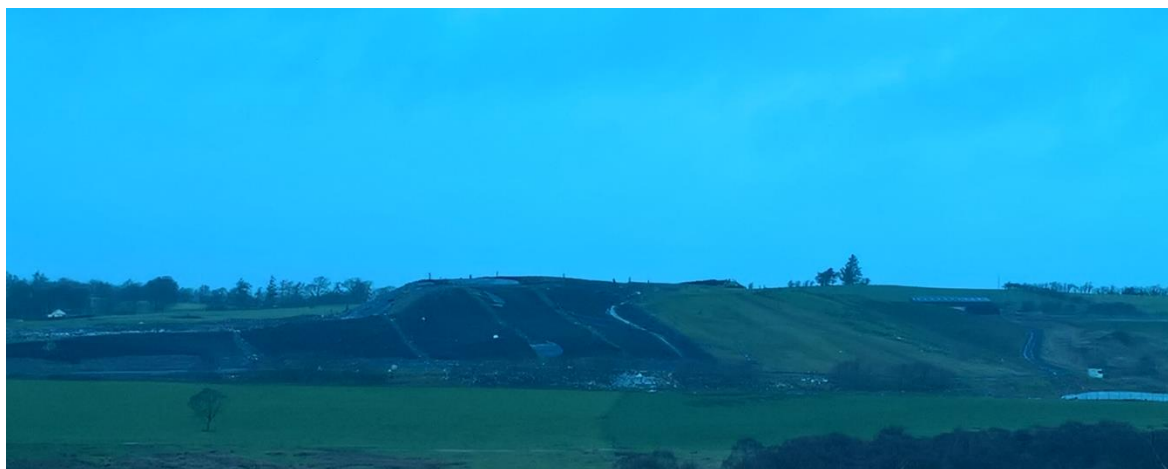
- 1.4.22 The extent of the capped and restored northern slope is seen as green to the right side of the landform on Plate 5 below.

*Plate 5; Eastern and Northern Slopes.*
