## Inspection of Leachate Lagoon Tanks Silent Valley Landfill Site Cwm, Ebbw Vale

March 2011

Doc Ref: CG/5438/Insp Rep

Inspection of Leachate Lagoon Tanks

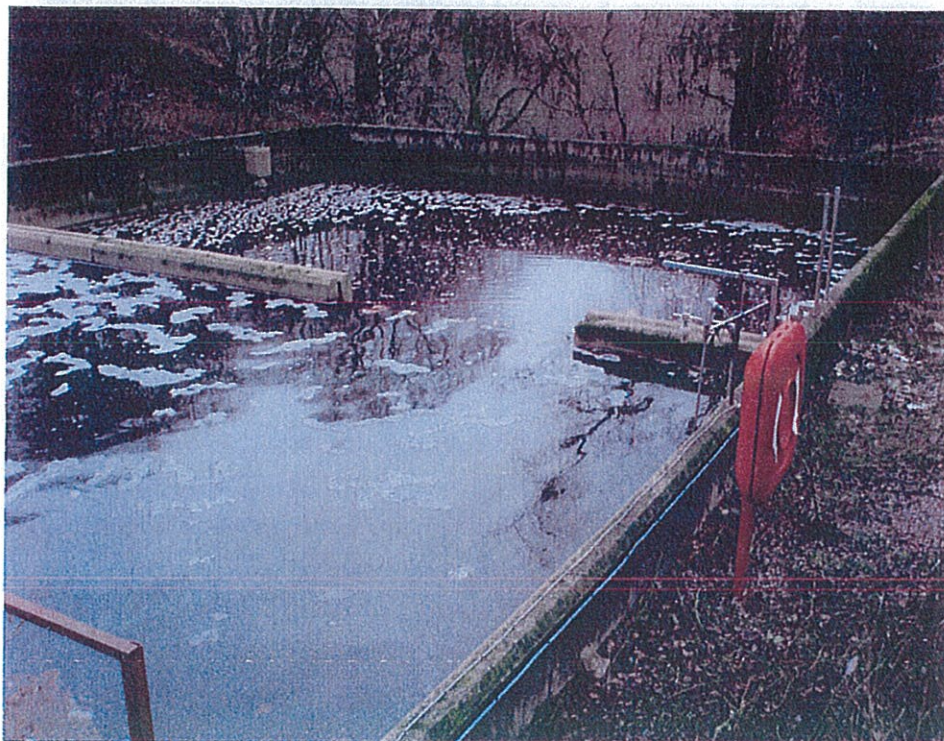
The structure consists of two separate tanks located next to one another and separated by a small horizontal gap that is sealed<sup>(1)</sup>. One tank, with internal dimensions of 7 metres wide x 17.55 metres long, is a settlement tank and the second tank, which is 16.1 metres wide x 17.55 metres long, is a storage tank. Both tanks have an internal height of 2.0 metres.

Photograph 1: View on structure looking south – settlement tank in foreground

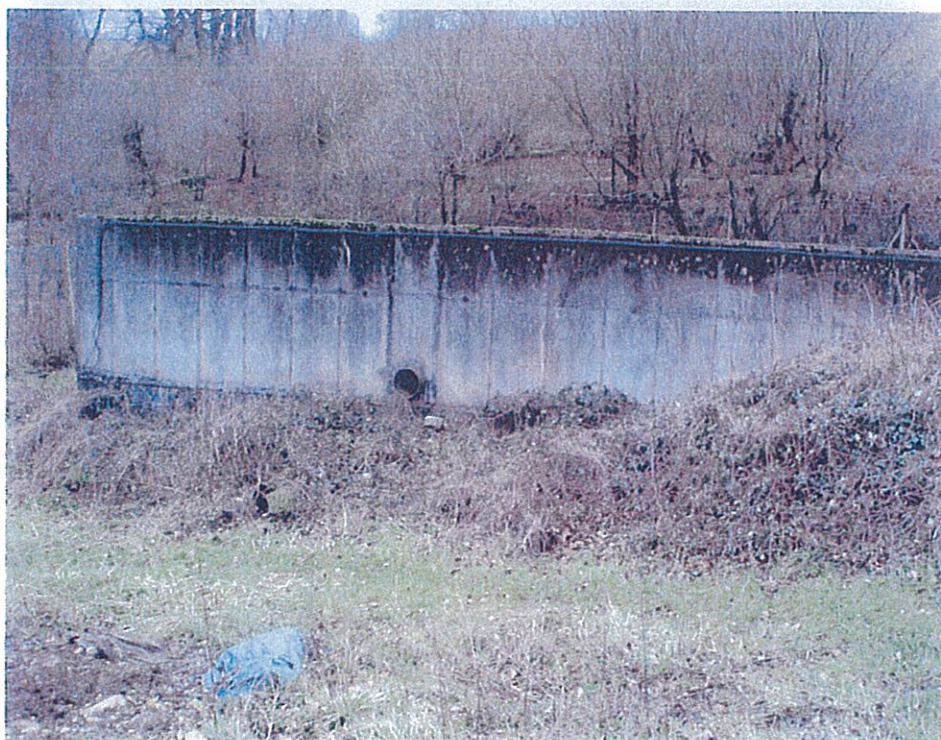
The walls of both tanks, where visible, were considered to be sound. Vertical cracks, of the order of 0.2 millimetres in width and sometimes spaced at approximately 1.5 to 2.0 metre centres, were evident in the outer faces of the above ground walls of both tanks<sup>(2 to 5)</sup>. Vertical cracks were also evident on the internal face of the southern wall of the storage tank<sup>(6)</sup>. It was judged that this cracking lined-up with the cracking on the outer face. A white to light grey-brown staining was evident along the length of some of the cracks. At the time of the inspection there was no evidence of water leakage on the outside faces of the structure.

Photograph 2: East wall

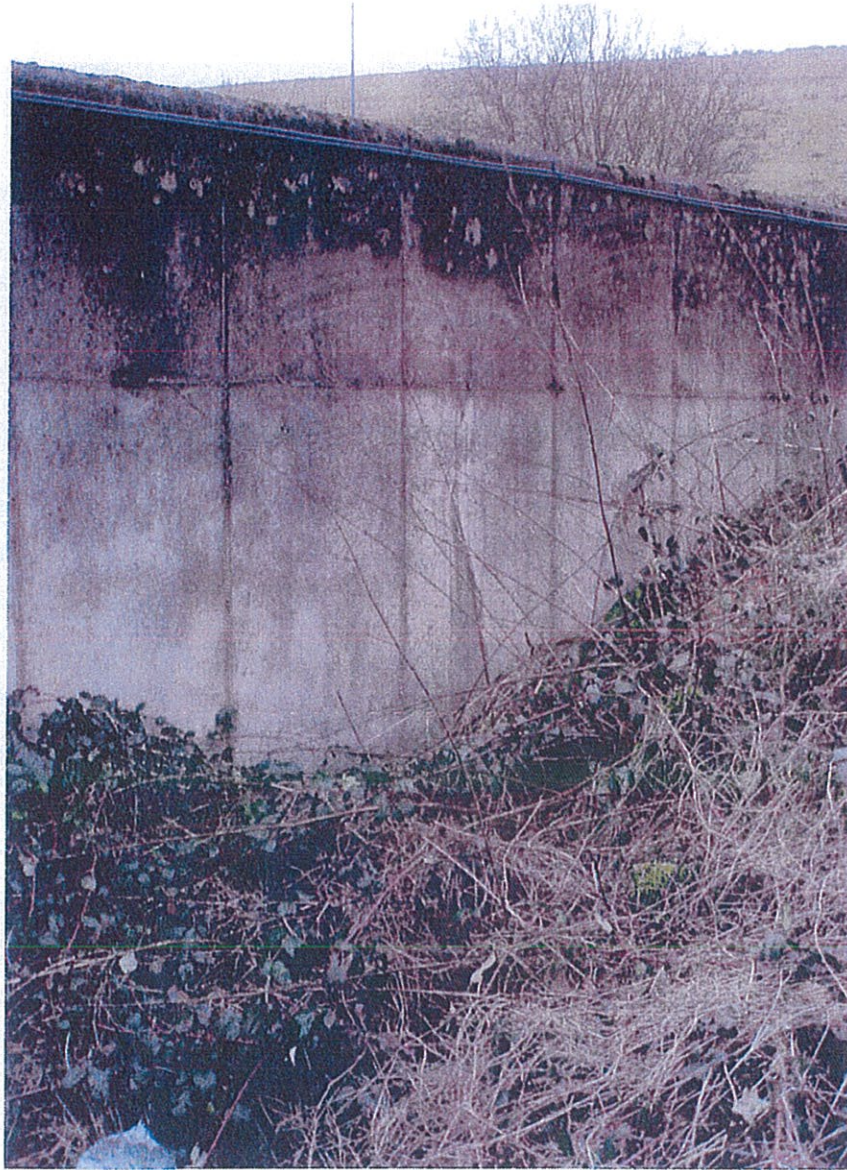
The fine vertical cracking observed in the structure is not considered to be of any structural significance. It is possible that the cracking is a result of early thermal contraction that took place early on in the life of the structure. Furthermore, the cracks appear to have undergone a process of self healing (autogenous healing) and are now probably sealed after more than 20 years in service.

Photograph 3: East wall – typical crack

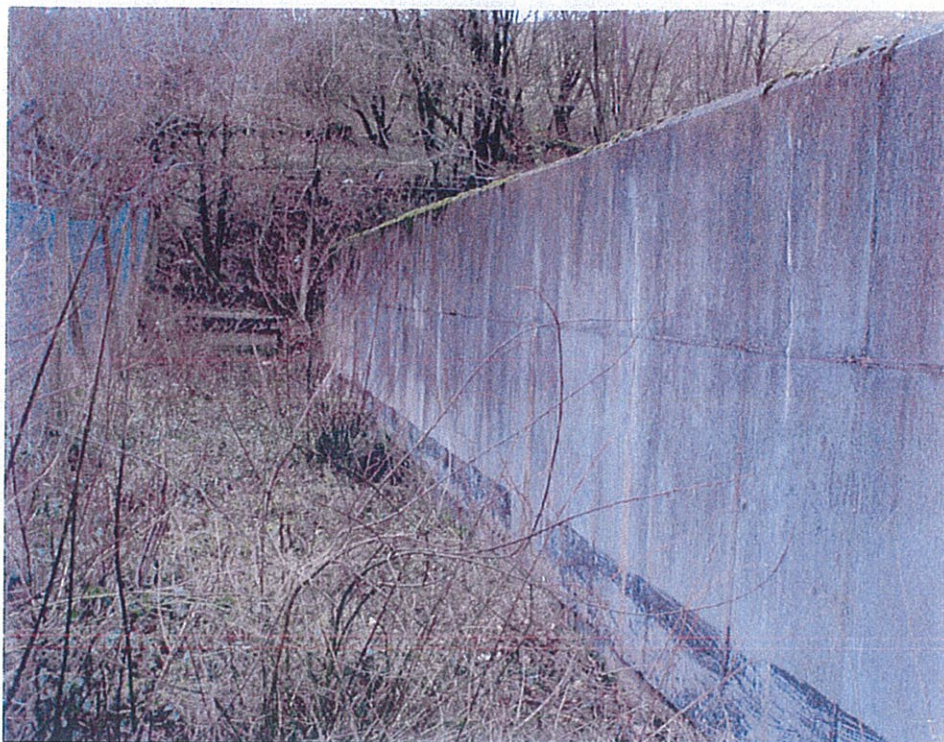
Photograph 4: South wall

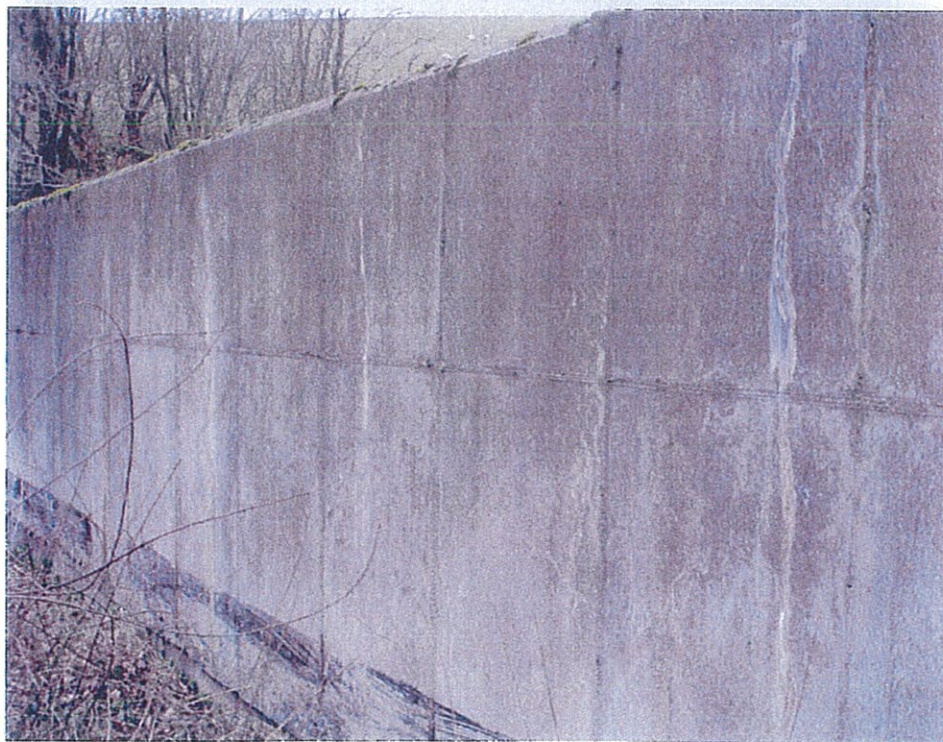
Photograph 5: South wall – typical cracking

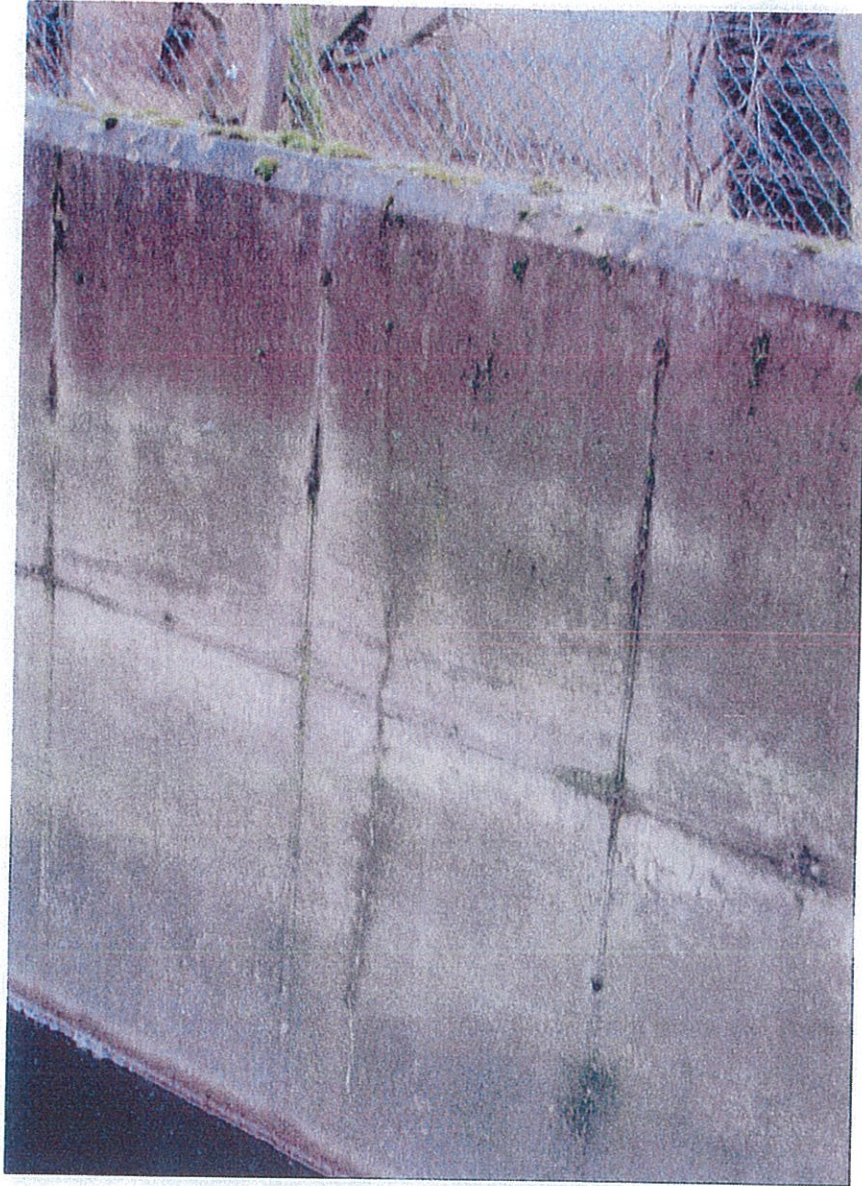
Photograph 6: South wall – crack on internal face
