# Memorandum

| Subject | Review of CCTV Survey of Leachate Pipe - Silent Valley Landfill January 2018 | |

| Project name :<br><b>6666 SILENT VALLEY PN 1</b> | Project number :<br><b>6666/0001</b> | Contact : | Date :<br><b>11/01/2018</b> |

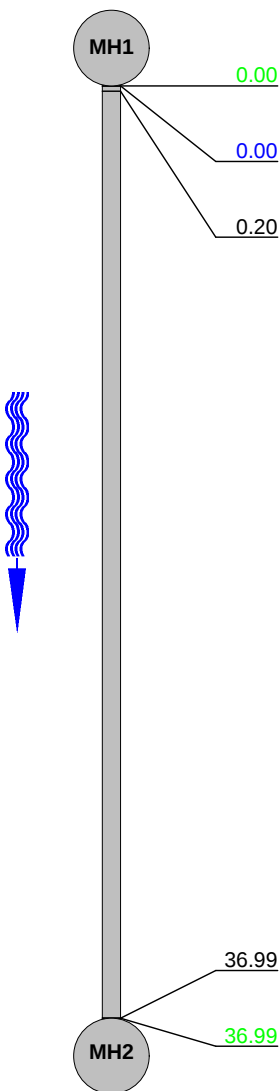
| 1:300<br>Depth: 2.64 | Position | Code | Observation | MPEG | Photo | Grade |
|---|---|---|---|---|---|---|
| | 0.00 | WL | Water level, 30% of the vertical dimension Remarks: VERY FAST | 00:00:02 | | (Serv) 0 |
| | 0.20 | S01 | CUW Loss of vision, camera under water, Start Remarks: IN AND OUT OF FLOW | 00:00:02 | | (Misc) 0 |

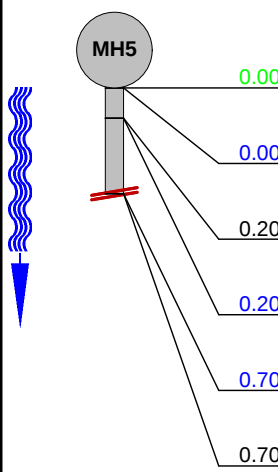
| No. | PLR | Dir. | Use | Shape / Size | Date | Mat. | Total Length | Insp. Length | Peak HWG | Peak Score | Grade | Mean Score | Total Score |
|---|---|---|---|---|---|---|---|---|---|---|---|---|---|
| 6 | MH5X | D | T | C 150 | 11/01/2018 | VC | 0.70 | 0.70 | 3 | 5 | 5 | 14.29 | 10 |

| 1:50 | Position | Code | Observation | MPEG | Photo | Grade | | | |
|---|---|---|---|---|---|---|---|---|---|
| | | MH | Start node type, manhole, reference number : MH5 | 00:00:02 | | (Constr) 0 | | | |
| | | WL | Water level, 80% of the vertical dimension | 00:00:02 | | (Serv) 0 | | | |
| | | CUW | Loss of vision, camera under water | 00:00:02 | | (Misc) 0 | | | |

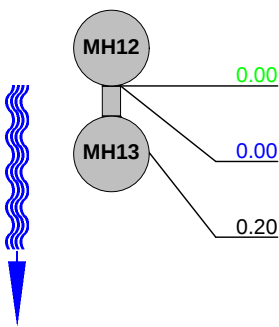
| 1:50 | Position | Code | Observation | MPEG | Photo | Grade |
|---|---|---|---|---|---|---|
| | MH12 | MH | Start node type, manhole, reference number : MH12 | 00:00:02 | | (Constr) 0 |
| | MH13 | WL | Water level, 30% of the vertical dimension Remarks: VERY FAST | 00:00:02 | | (Serv) 0 |
| | 0.20 S01 | CUW | Loss of vision, camera under water, Start Remarks: IN AND OUT OF FLOW | 00:00:02 | | |
