Project name :  
**6666 SILENT VALLEY PN 1**

Project number :  
**6666/0001**

Date :  
**11/01/2018**

## Inspection report

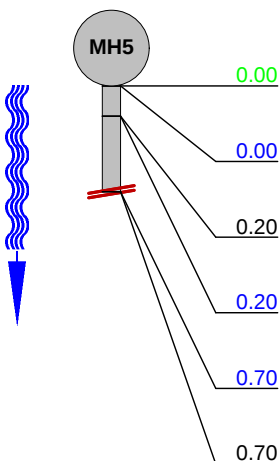
| 1:50 | Position | Code | Observation | MPEG | Photo | Grade |
|---|---|---|---|---|---|---|
| | 0.00 | WL | Water level, 80% of the vertical dimension | 00:00:02 | | (Serv) 0 |
| | 0.20 | CUW | Loss of vision, camera under water | 00:00:02 | | (Misc) 0 |

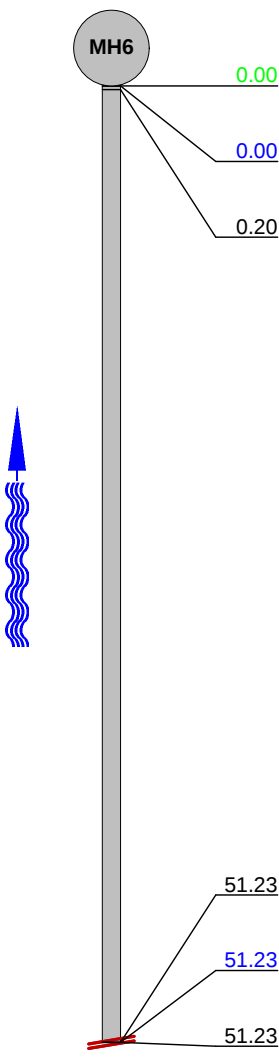
| 1:405<br>Depth: 1.74 | Position | Code | Observation | MPEG | Photo | Grade |
|---|---|---|---|---|---|---|
| | <u>51.23</u> | <b>DER</b> | Settled deposits, coarse, 35% cross-sectional area loss | 00:00:02 | | (Serv) 4 |
| | <u>51.23</u> | <b>SA</b> | Survey abandoned Remarks: UNABLE TO PASS | 00:00:02 | | (Misc) 0 |

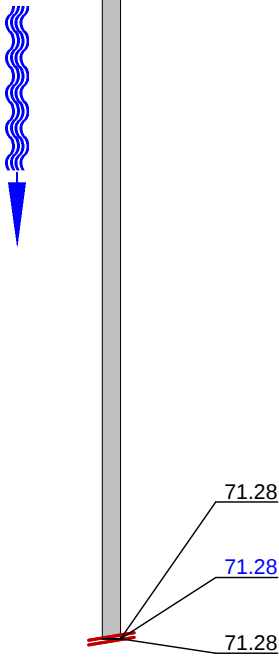
| 1:570<br>Depth: 1.24 | Position | Code | Observation | MPEG | Photo | Grade |
|---|---|---|---|---|---|---|
| | 71.28 | DER | Settled deposits, coarse, 40% cross-sectional area loss | 00:00:02 | | (Serv) 4 |
| | 71.28 | SA | Survey abandoned Remarks: UNABLE TO PASS | 00:00:02 | | (Misc) 0 |
