## **Dow Corning Ltd Site SPMP Report – 2014**

# 1. H2 INFRASTRUCTURE MONITORING REPORT

2014 Dow Corning Ltd Site Protection and Monitoring Program (PPC permit BR9685IX)

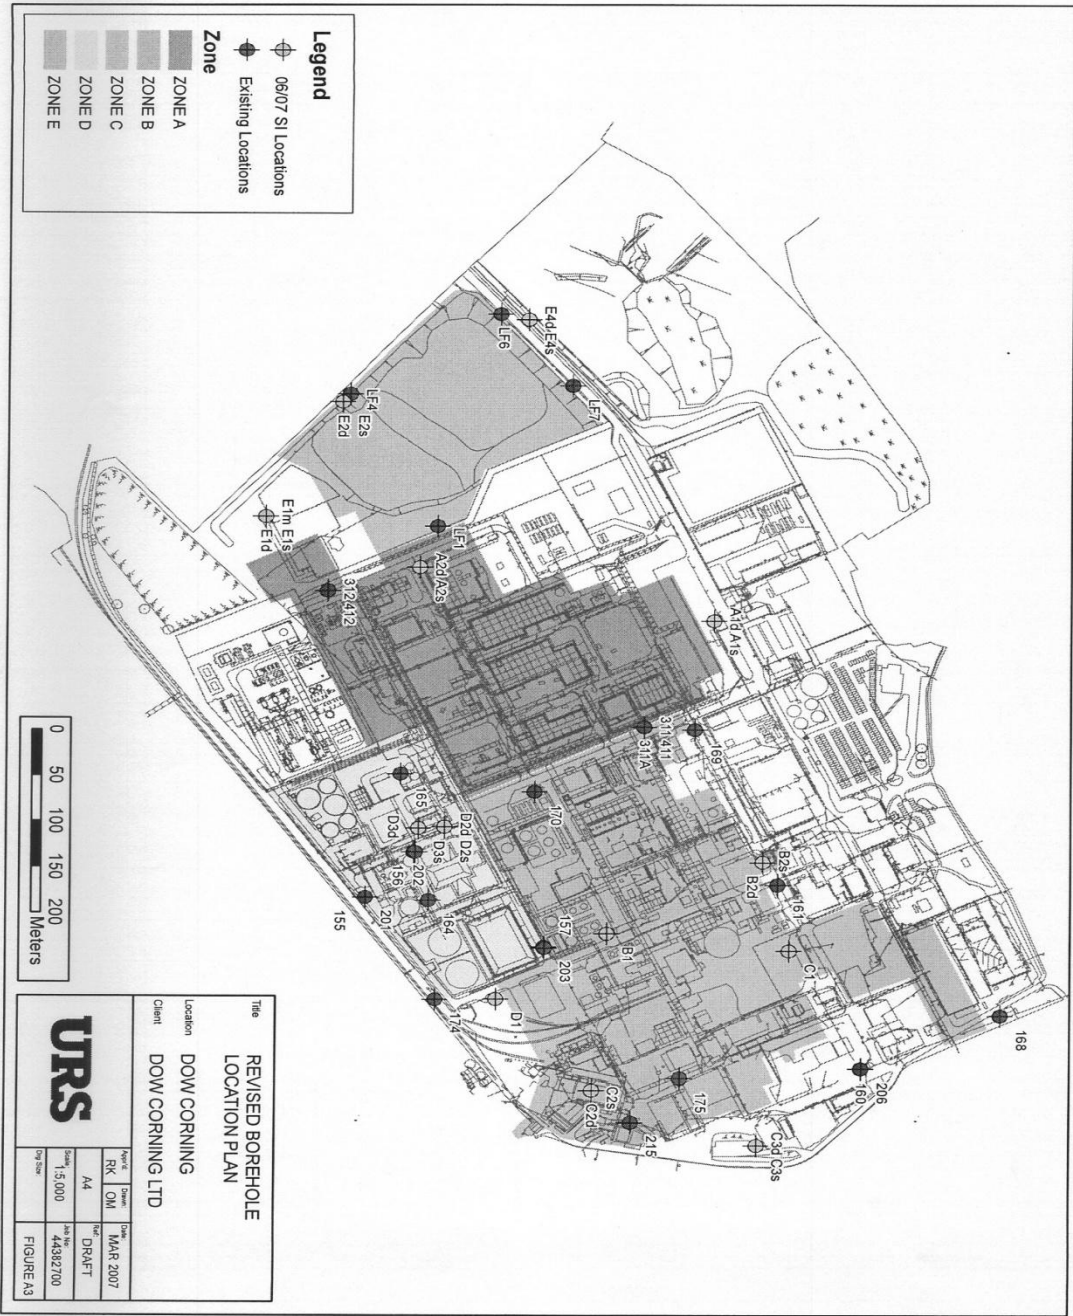
## Borehole Location Map On Landfill and Current Status

| <b>Q1 (LANDFILL)</b> | <b>Jan'15 status</b> |
|---|---|
| LF1 (if not waterlogged) | Unable to sample – borehole lost, collar destroyed. |
| E2s (if not waterlogged) | Unable to sample – borehole lost to reeds/timber pond |
| E2d (if not waterlogged) | Unable to sample – bore hole lost to reeds/timber pond |
| LF2 (if not waterlogged) | Unable to sample – bore hole collar full of solid waste, needs to be dug out, access to bore hole is restricted due to unstable ground surrounding bore hole. |
| LF3(if not waterlogged) | Unable to sample – bore hole lost. |

The above table highlights the condition of the existing boreholes. A number of the boreholes are difficult to sample or have been lost. A project was initiated in 2014 to review the data and determine if there were any gaps in the data gathering. A report from an external company is expected back on 31<sup>st</sup> January 2015 and provision has been made within the site infrastructure and planning teams for installation of additional boreholes during 2015.
