## Incident report: Stores Fire at EnerSys Newport

Report prepared by Gavin Thomas

## 1. Introduction

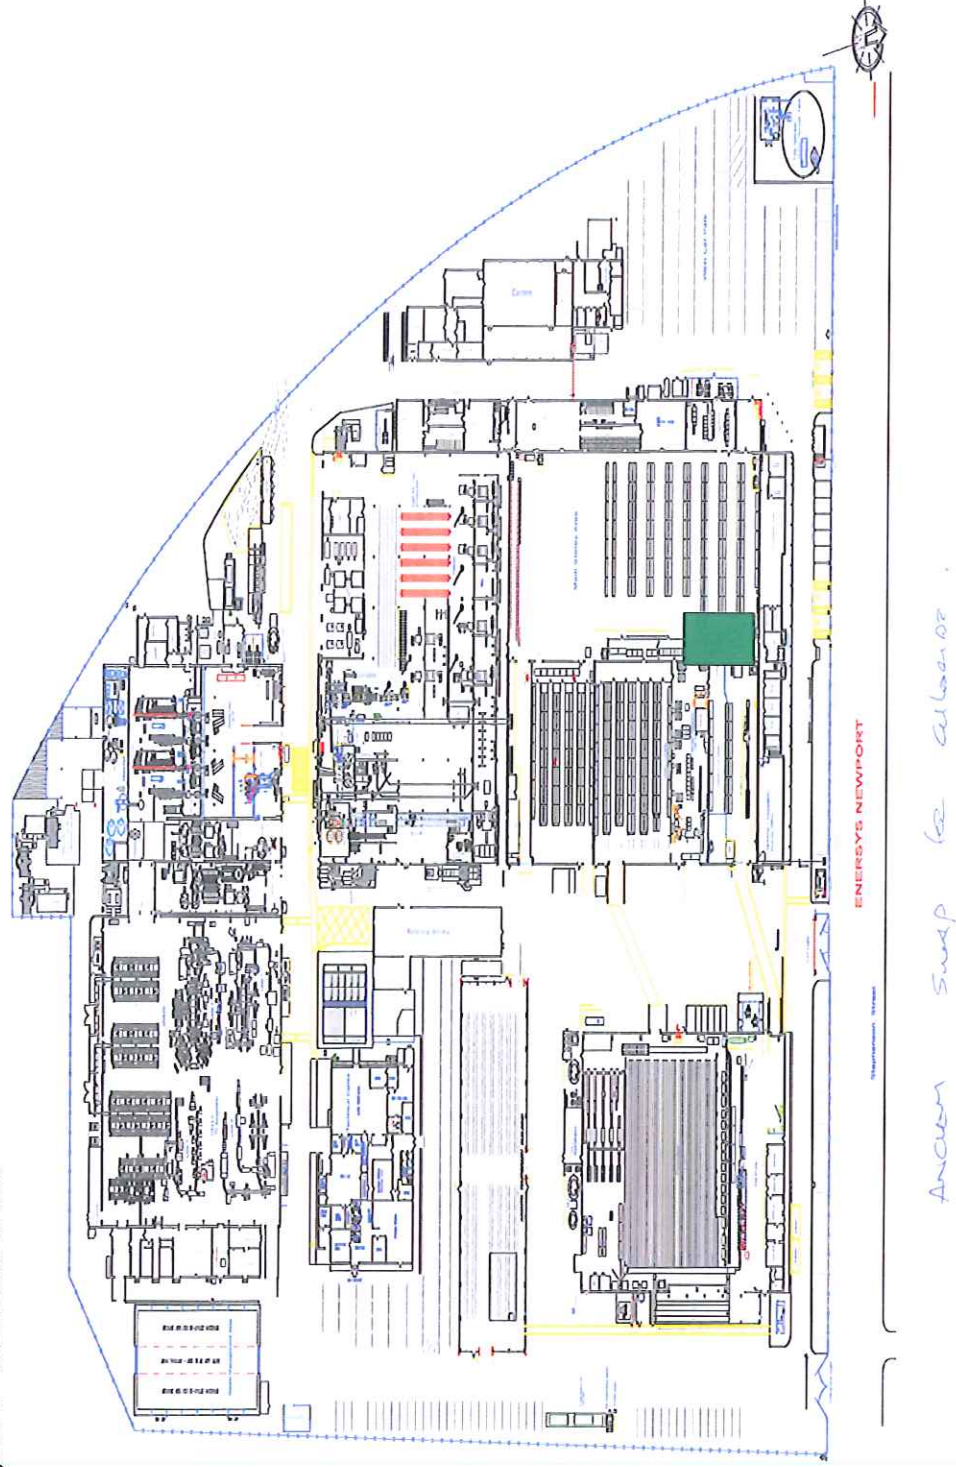
Figure 1 – Location of fire

During the night of the 13<sup>th</sup> November 2015, a fire started within the stores department situated in building A1, figure 1 shows the location of the fire in context of the site. The fire started in the 'resin racking', the sprinkler system activated confining the fire and resultant damage to racking and nearby structures. The fire service attended site and assisted in the extinguishing of the fire. The fire fight resulted in fire water being generated. The fire water allowed the resin to spread to other areas, namely the offices. This resulted in the floors becoming contaminated with the resin. Figure 2 shows these locations,

Location of the fire identified by 'green' box.

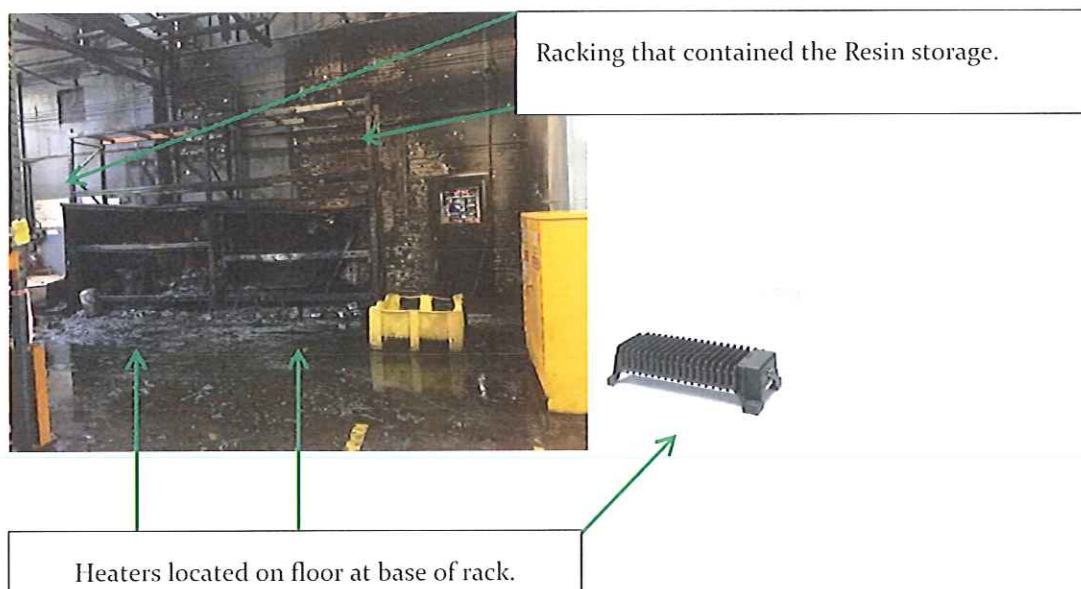
Figure 3 – Racking layout.

The racking resin was essentially 2 bays of racking with the resins stored on the first level and the hardeners stored above. The racking, and heating system were installed in 2004. A rough layout can be seen in figure 3 below. The wiring used was high temperature grade. The chemicals required a stable temperature to ensure the correct viscosity was maintained. The temperature range was 15-25°C. Floor heaters were placed under the chemicals to ensure the range could be achieved. Each bay of racking had two 1kw heaters. These were controlled by thermostats, one per bay. As part of the quality management system, a daily check on the temperature was undertaken. Any readings outside of the range were reported to Maintenance who could then fix the issue/concern.

On the day of the fire Andy Block carried out his daily check and noted that the temperature on the left hand bay, as you faced racking, were slightly low at 17 °C. Andy promptly reported this to Maintenance who in turn ordered new heaters. The heaters on the right hand side were recorded at 21 °C, this was considered normal. The daily record sheet was filled in and filed next to the racking. Unfortunately this record was lost in the fire.

The fire caused extensive localized damage and therefore destroyed the critical evidence. That being said, the 'witness' marks on the wall adjacent and behind the rack indicate that the heat from the fire was more intense. This could indicate that the fire started on the right hand bay of the rack. Furthermore, the wood on side of racking and the fact that some containers on the left hand side weren't fully burnt certainly support this theory.

The heaters were checked after the fire, however, the checks were limited due to the fire damage. However, the checks did indicate that the 13 amp fuses were still in place and did not blow. This could possibly rule out a short circuit as had that occurred you would expect the fuses to blow and de-energize the systems.

The preferred option for Newport would be to purchase an external temperature controlled storage unit sited in close proximity to the Assembly area, so that when called for use the Bitrez resins are at a suitable temperature for production use.

The temperature controlled, and bunded external storage unit will be purchased from Chemstore and will also have fire protection built in.

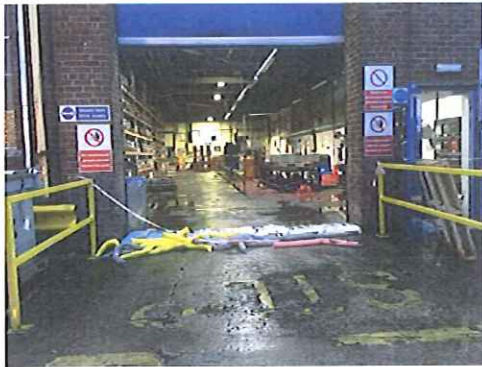
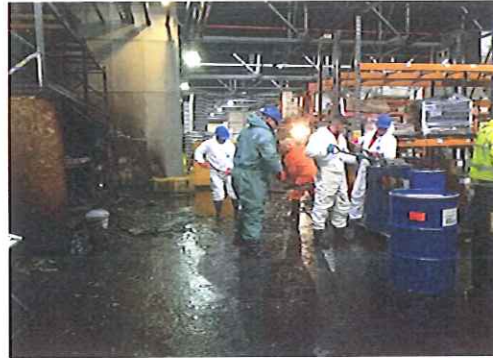
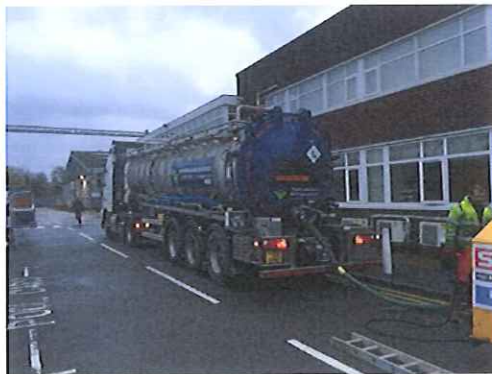
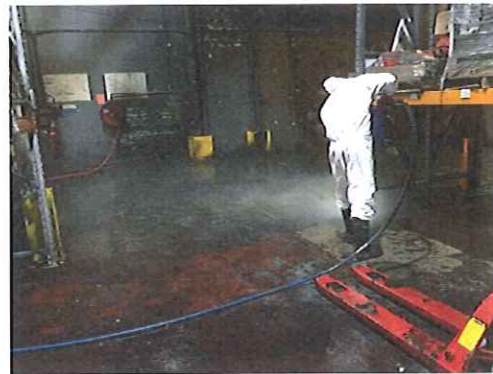
As mentioned above, following the initial actions to contain the fire etc. a specialized industrial cleaning company was engaged. The following pictures show the clean-up and actions to address environmental concerns such as, spill containment and tanker use for liquid wastes generated.

Throughout Saturday and Sunday the Qualitech team and a strong team effort from Managers and employees continued to clean up / recover the situation, removing damaged materials and fire-water / resin remains, including office furniture.

Monday the recovery operation continued across all shifts. Waste was removed by Tradebe and GD Environmental, who were appointed by Qualitech. Two tankers of firewater and interceptor water were removed by Tradebe and four skips of office and production equipment that had been ruined by the fire and or water were removed by GD Environmental. Heavily resin contaminated materials in drums and plastic bins were also removed by Tradebe.
