PERMIT NUMBER BR9685IX

DOW CORNING LTD

SCHEDULE 5 INCIDENT NOTIFICATION

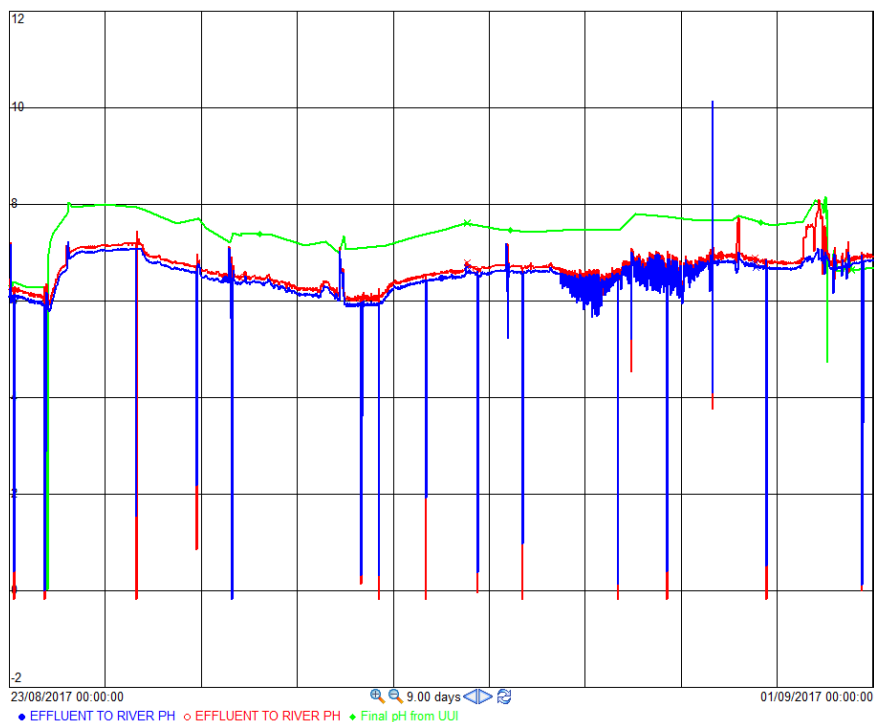
Investigation was carried out and it was established that the recalibration of the SWWT probes on 23rd August had been incorrect. All Primary Waste Water Treatment (PWWT) and SWWT pH probes were recalibrated by the Dow Corning analyser technicians and the pH of the process was brought back under control.

The green line in the graph below shows the period where the mis-calibrated pH probe was being used to control the SWWT process. All 3 of the lines on this graph should read similar results as they are on the same stream

Recalibration of all PWWT and SWWT pH probes using the same method and qualified analyser technicians. The SWWT probes have now been added to the tasks of the analyser technicians – this will take away the potential for error.

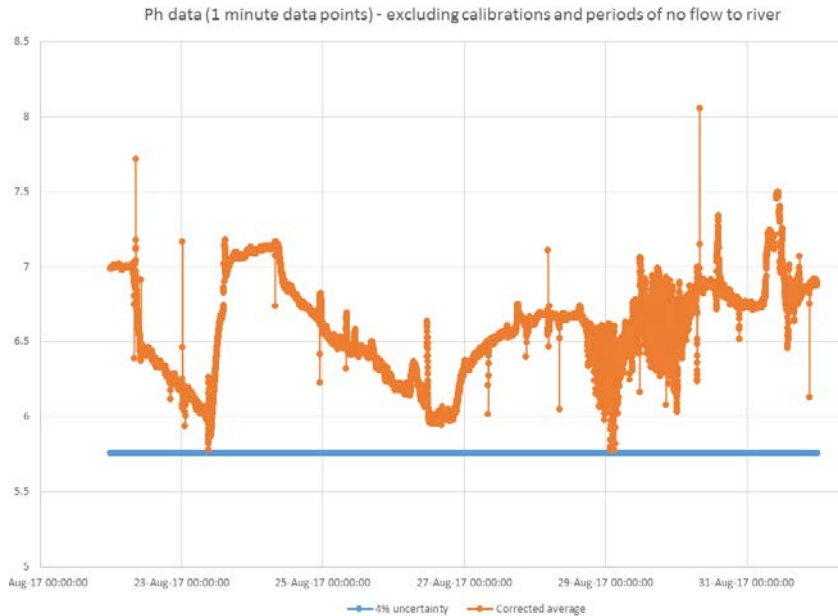
The graph below shows the minute values for pH for the whole period (with recalibrations and periods of no flow to river removed) This shows that whilst the pH did dip below pH 6 at times, it was not outside of the uncertainty of the pH probe measurement.
