Annual Performance and Monitoring review EPR Permit BR9685IX, Dow Corning Ltd

This report is to fulfil ERP permit BR9685IX condition 4.2.2

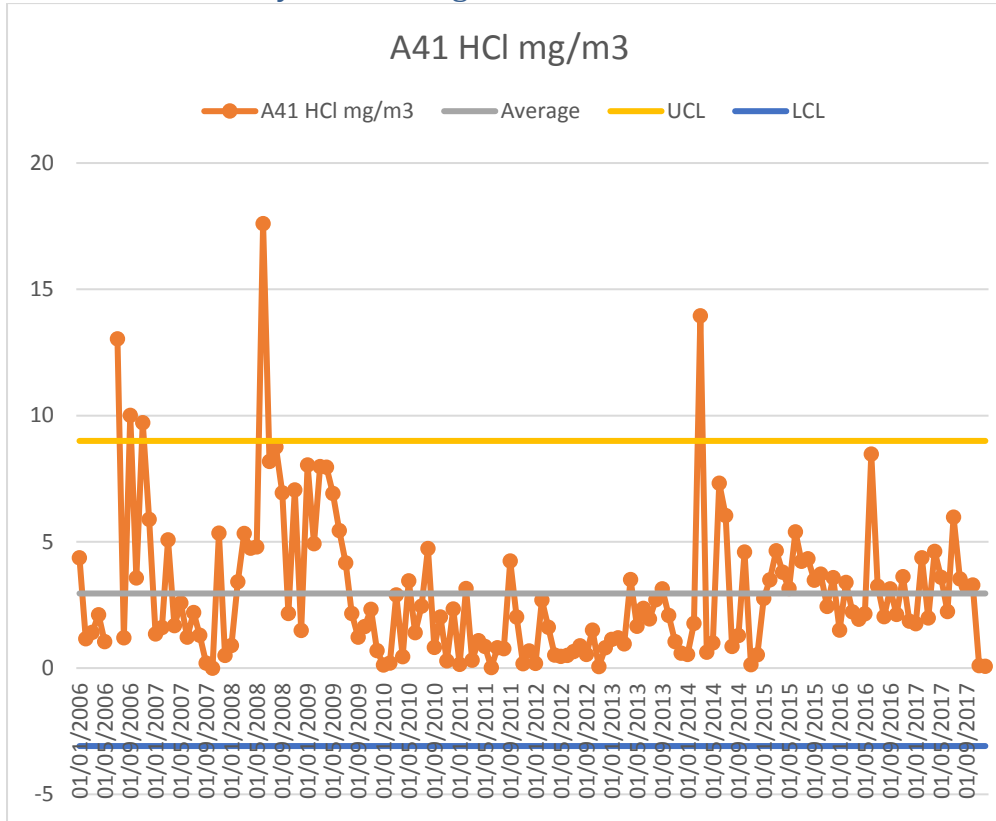
Results in control and within permit limit (15mg/m3).

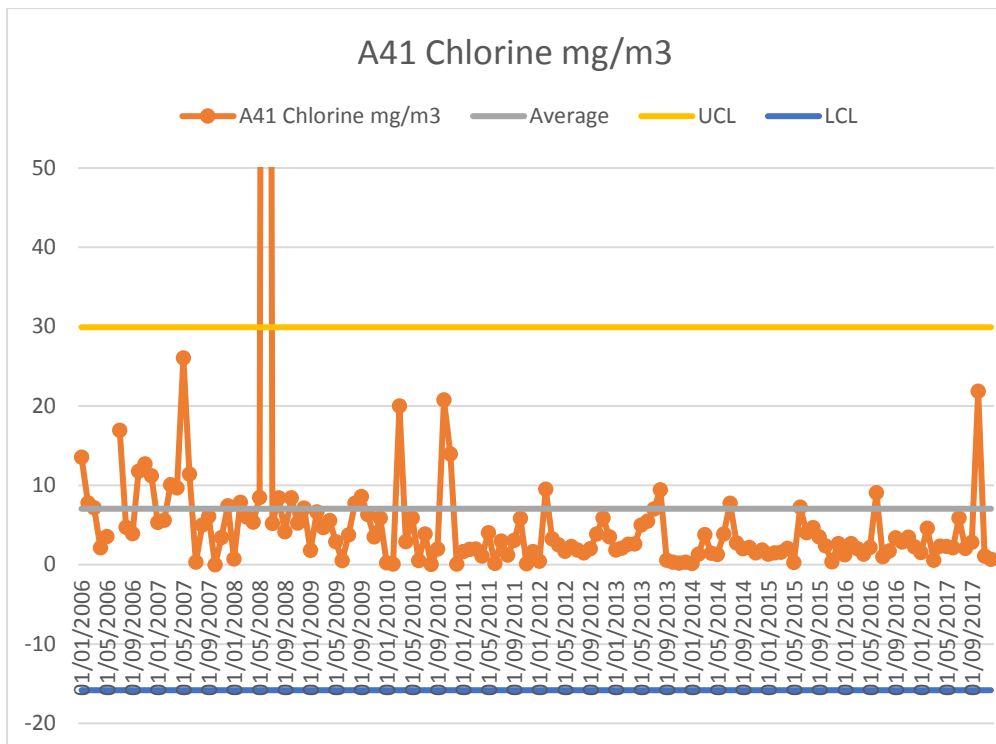
Results in control, 1 point above the annual average limit. This sample was taken during a period of transition between having the caustic column online and it not being online, following caustic supply shortage.

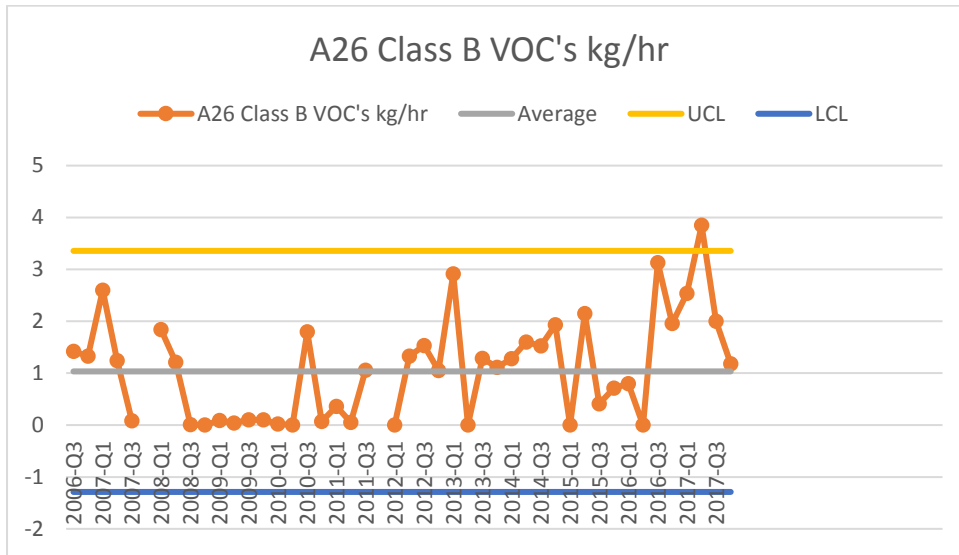
1 result just outside of the upper control limit, but 2 subsequent samples have been back in control. There was no specific assignable cause.

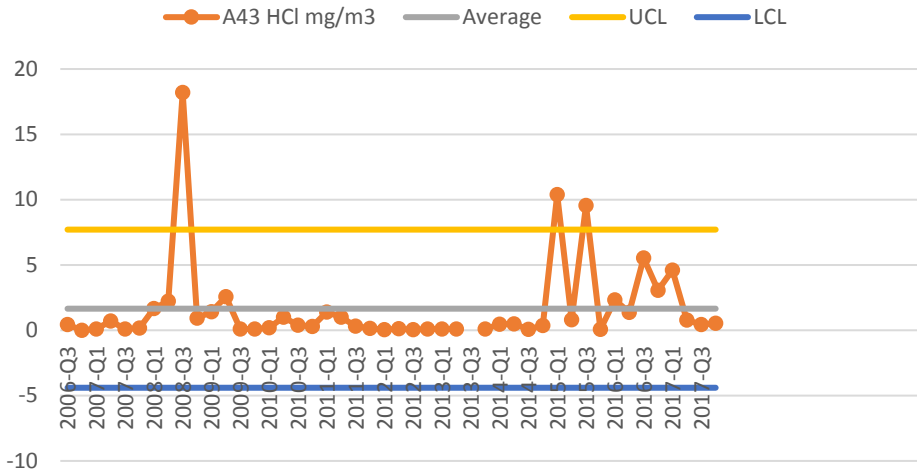
A43 HCl mg/m3

Results in control and within permit limit (10mg/m3).

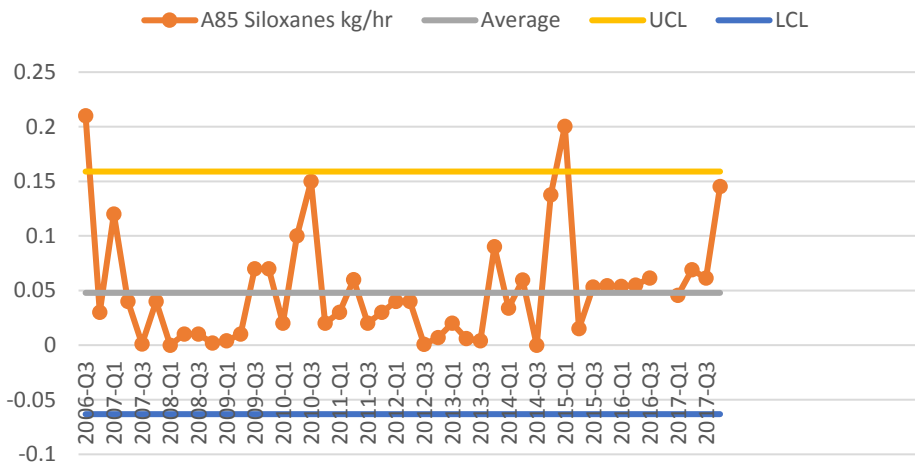
A85 Siloxanes kg/hr

Results in control.
Q4 result was higher than normal. This will continue to be monitored.

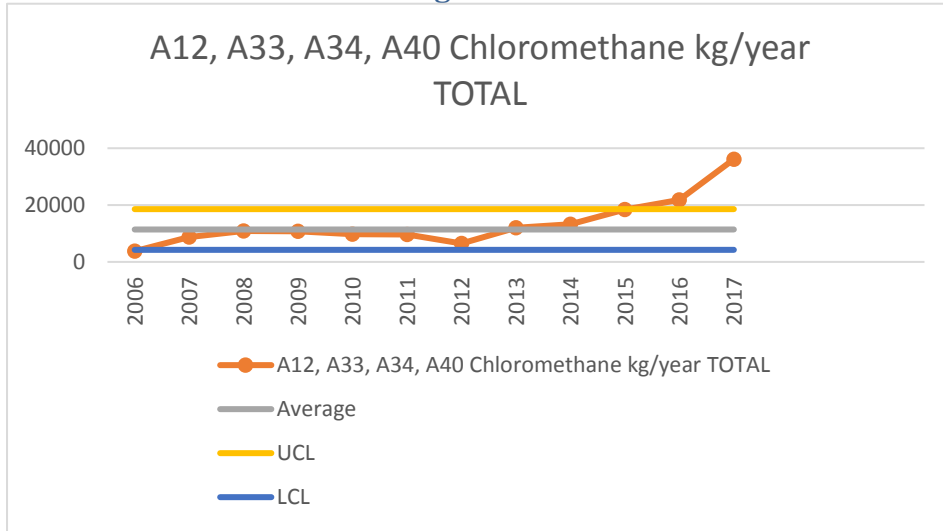
- Reduction in incineration due on of the outlets struggling to process our materials.
- Methyl chloride venting to atmosphere from A12 has increased. is a conscious decision to allow Dow Corning to increase the on line time of one of the Recovery processes, thus reducing the quantity of solid hazardous waste produced. This waste is shipped to Europe for recovery, so reducing at source has an environmental benefit. The vented quantity is still well within the annual permitted limit.

Results out of control high but within permit limit (60,000 kg/year).

This is a conscious decision to allow Dow Corning to increase the online time of one of the Recovery processes, thus reducing the quantity of solid hazardous waste produced.

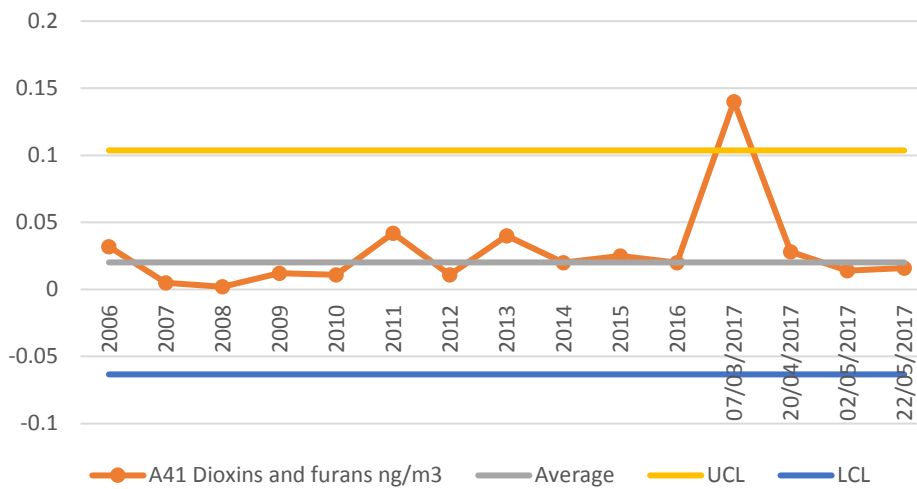
A41 Dioxins and furans ng/m3

Sample taken in March 2017 indicated that the Dioxins and furans were above the permit level. It was noted that the internal soot removal equipment failed on 23rd December 2016 and had not been put back on line due to unavailability of spares. The soot blower was run as soon as the failed sample result was received. Butanes in feed stream were increased due to recent configuration change, which may have increased the potential for carbon build up with the soot blower off line (carbon can act as a catalyst to create dioxins) The unit was shutdown for a full clean in May. The ERU burner was found to be fouled, but this did not reduce residence time below required value.

Having operated the soot blower, the fire tube was found to be relatively clean.

Two sets of testing carried out after operation of the soot blower and before the cleanout show that the operation of the soot blower is key to minimise the dioxins emitted from the unit. The criticality of this item had not previously been recognized. A spare has now been purchased.

One further sample has been taken and analysed since the clean – which also shows very low levels of dioxins.

Annual result obtained in March out of control high and permit exceedance. Further samples taken, following RCI and action completion. Results in control and within permit limit (0.1ng/m3).

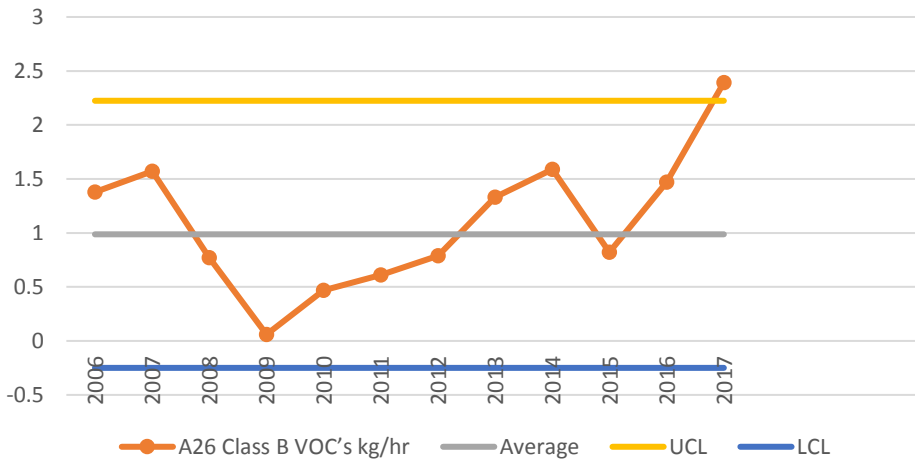
A26 Class B VOC's kg/hr

This result is out of control high. VOC's contained in this vent are carried forward from an earlier process. There are a large number of variables which affect this. We will investigate this if the quarterly results continue to track higher than normal.

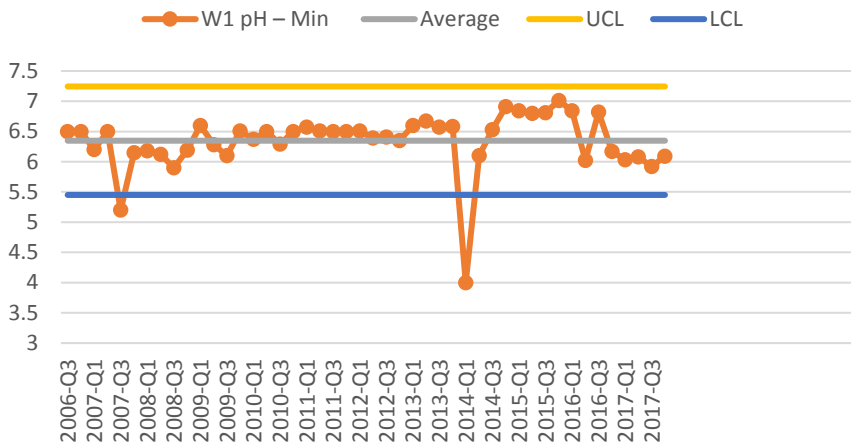
W1 pH – Min

On 23rd August dropping pH levels were identified. The additive dosing system to increase the pH was brought back online, having been offline due to blockages. In addition to this the pH probes were recalibrated. The renewed additive addition had the desired effect and the pH recovered.

Over the next few days the Secondary Waste Water Treatment (SWWT) was controlled using the pH measurements within the SWWT process. A couple of instances during this period the pH of the final effluent to river dipped down again to around pH 6.

Investigation was carried out and it was established that the recalibration of the SWWT probes on 23rd August had been incorrect. All Primary Waste Water Treatment (PWWT) and SWWT pH probes were recalibrated by the Dow Corning analyser technicians and the pH of the process was brought back under control.

Results in control. Q3 instantaneous minimum result below permit limit, but when the uncertainty of the meter in taken into account, the result was within the permitted limit (>pH6). This was reported to NRW as a Schedule 5 when it was identified. Corrective actions have been put in place to prevent a recurrence.

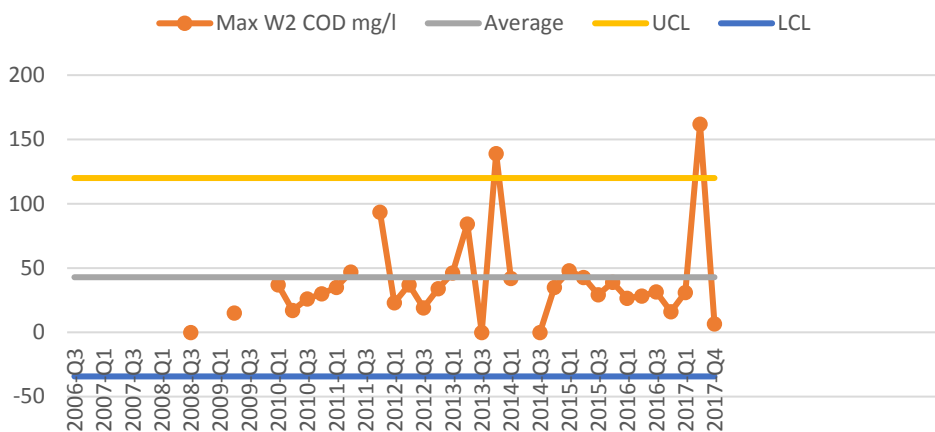
Max W2 COD mg/l

Q2 result was 162 mg/l – which is above the permit limit – but within the permit condition which allows spot samples to be up to 50% above the permit limit (125 mg/l)

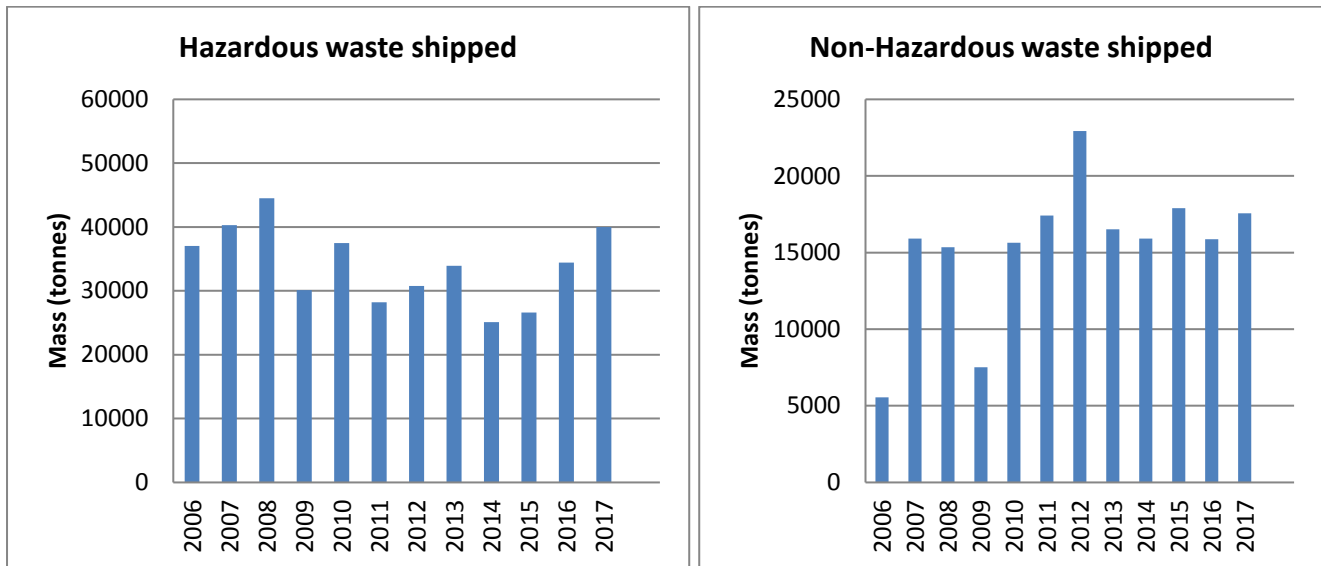
The increase in hazardous waste shipping during 2017 was eliminating the stockpile of DPR to allow the old site landfill to be closed.

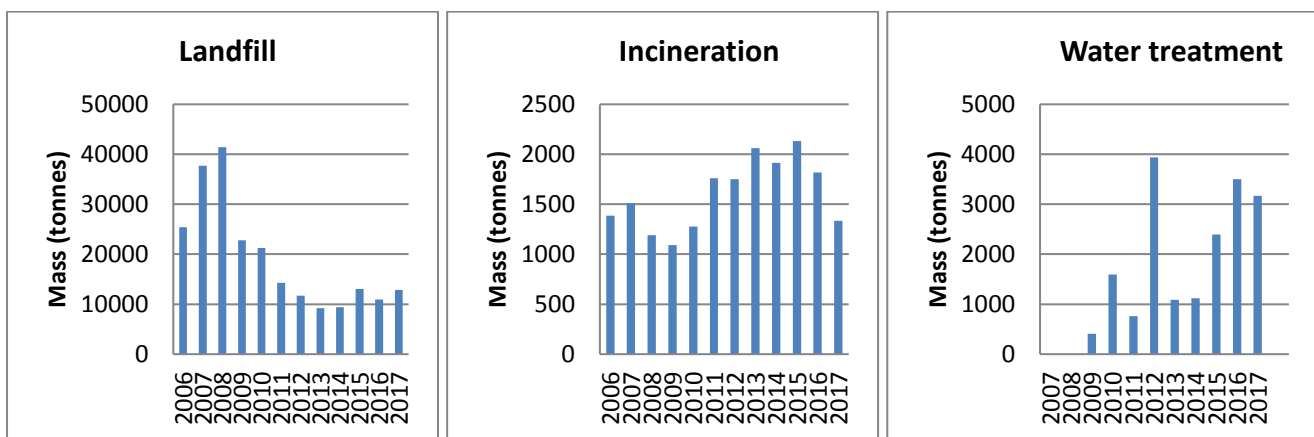
Disposal

- Incineration was low this year due to one of our outlets struggling to process our materials.

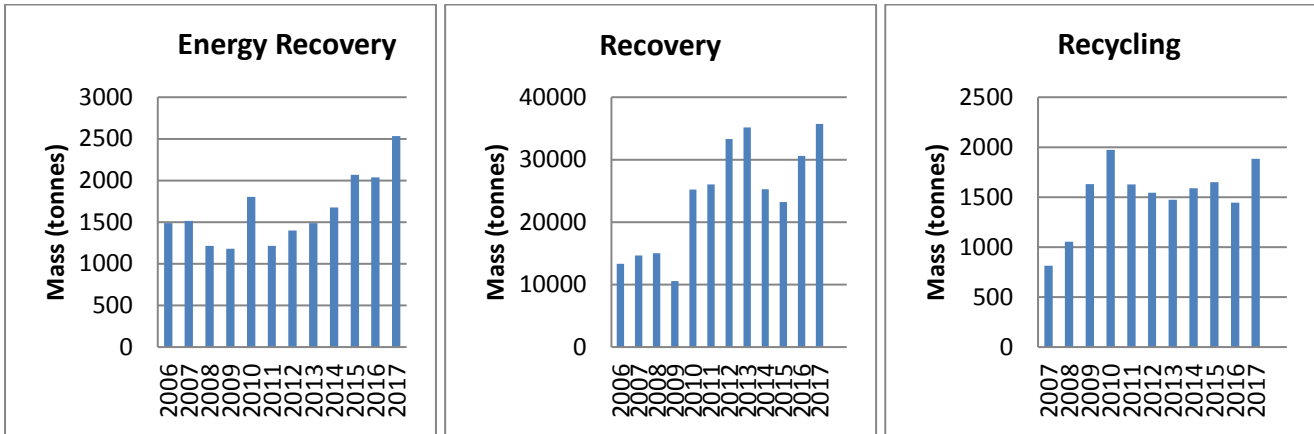
- Rubber to energy recovery increased due to not being able to send it to India for Recycling due to Indian legislation change.
- Recovery up this year due to the increase in shipping to eliminate the stockpile of Hazardous DPR to allow the old site landfill area to be closed
