Review of Fugitive Emissions January to December 2016

**Permit EPR/BV5386IX
Variation EPR/BV5386IX/V003**

Annual Review of Fugitive Emissions

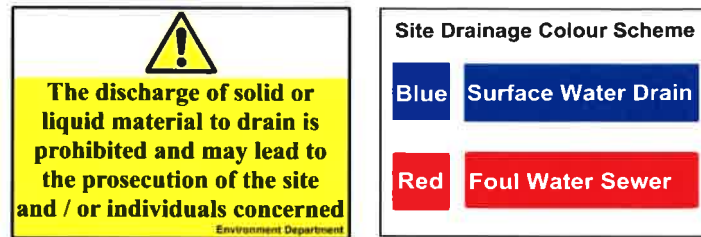
6.8 In 2009, new environmental warning signs were placed at all main entrances in respect of surface water drains. Similarly, signage was also placed around the site in regard to site drain colours. These signs have been rechecked to ensure they remain clearly visible in all appropriate areas:-

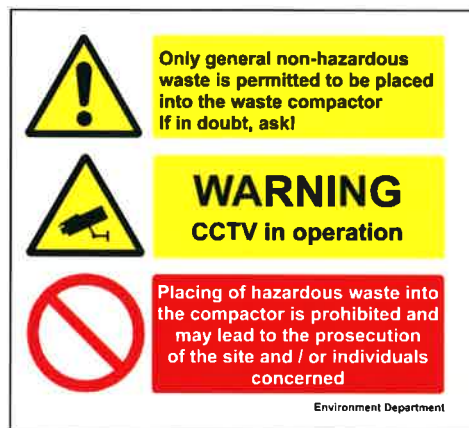
6.9 A warning sign continues to be displayed at the waste compactor as below in order to keep awareness raised and the area is also monitored by a Closed Circuit Television Camera (CCTV). The site CCTV system was last expanded in 2012.

The site now has lead waste stored inside so as to prevent the possibility of Lead contaminated rain water run-off.
