**MORFA CLOSED  
LANDFILL,  
PORT TALBOT**

**PERMIT EPR/AP3292LT**

**2014 Annual Review  
of Environmental  
Monitoring Results**

*Report Number 1394r1v1d0315*

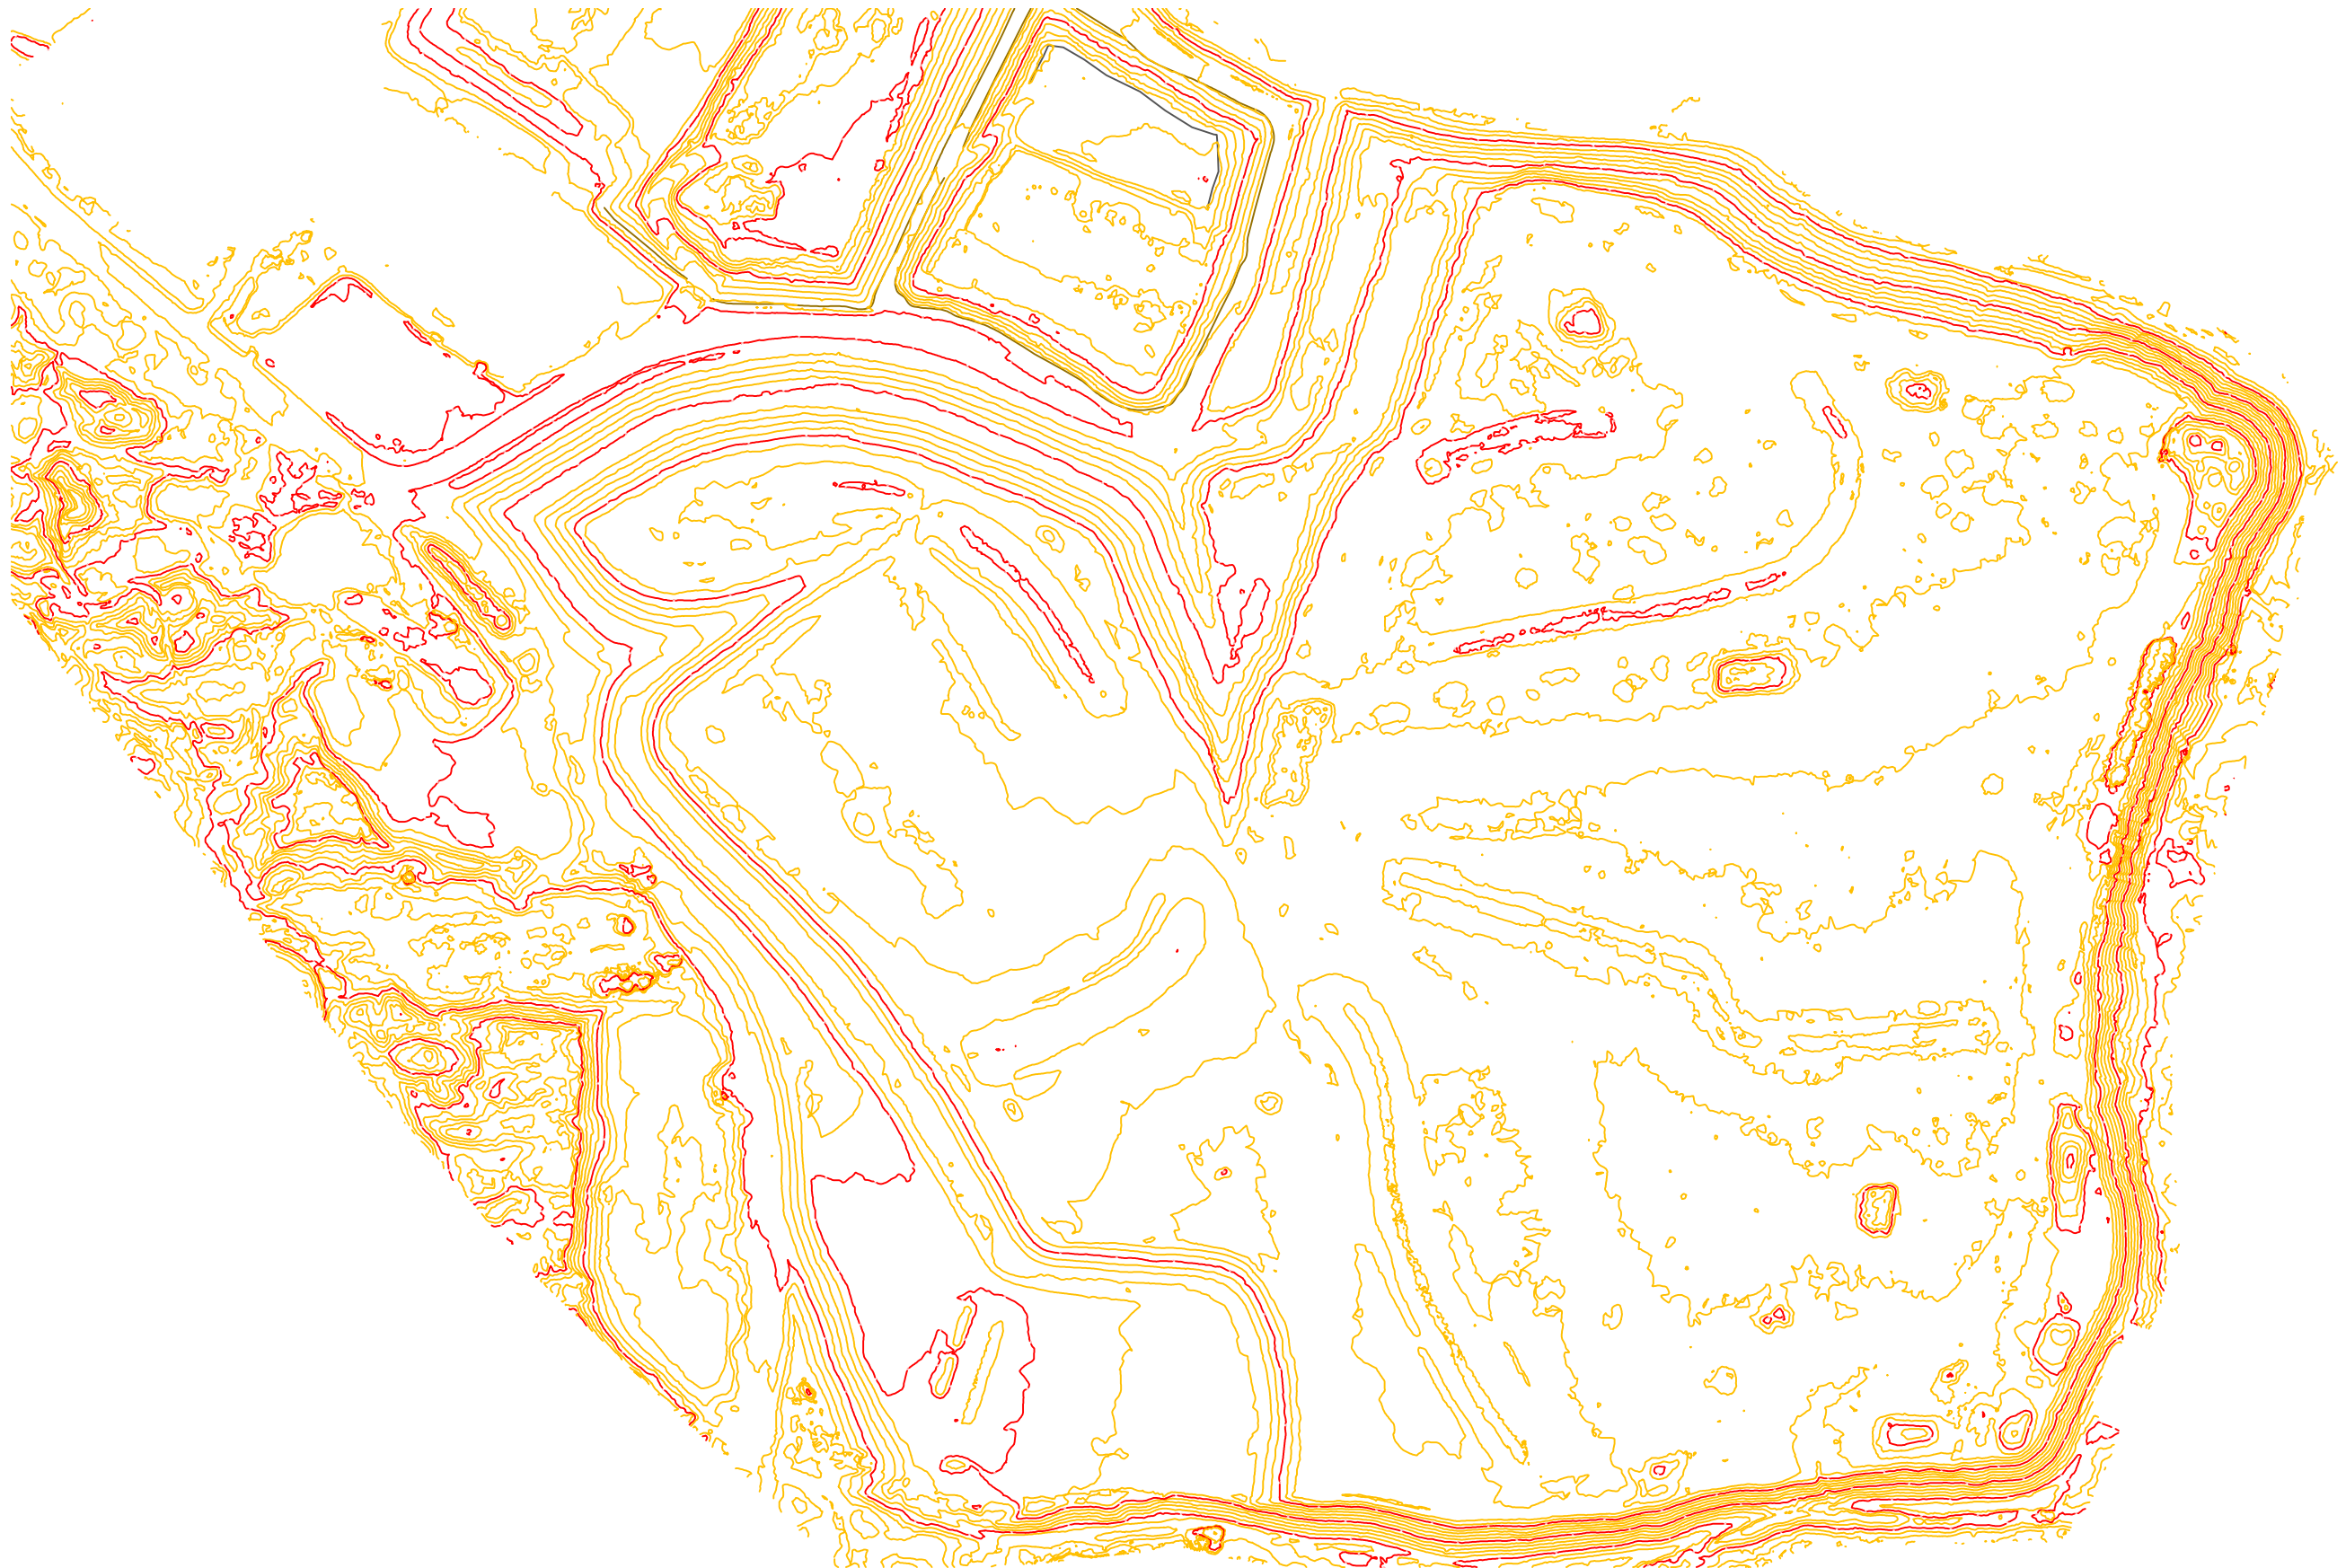
Figure 3 Current Topographic Plan of Landfill

Visual inspection for signs of settlement and instability are undertaken as part of the quarterly monitoring programme and also more frequently by the landfill manager. To date, the only area where settlement has been observed is a small area (<20m<sup>2</sup>) on an access track on the lower northwestern bench between the site and MNHL bio cells. The suspected cause of this settlement is the removal of restoration materials from below the access road by the flow of water off the cap.

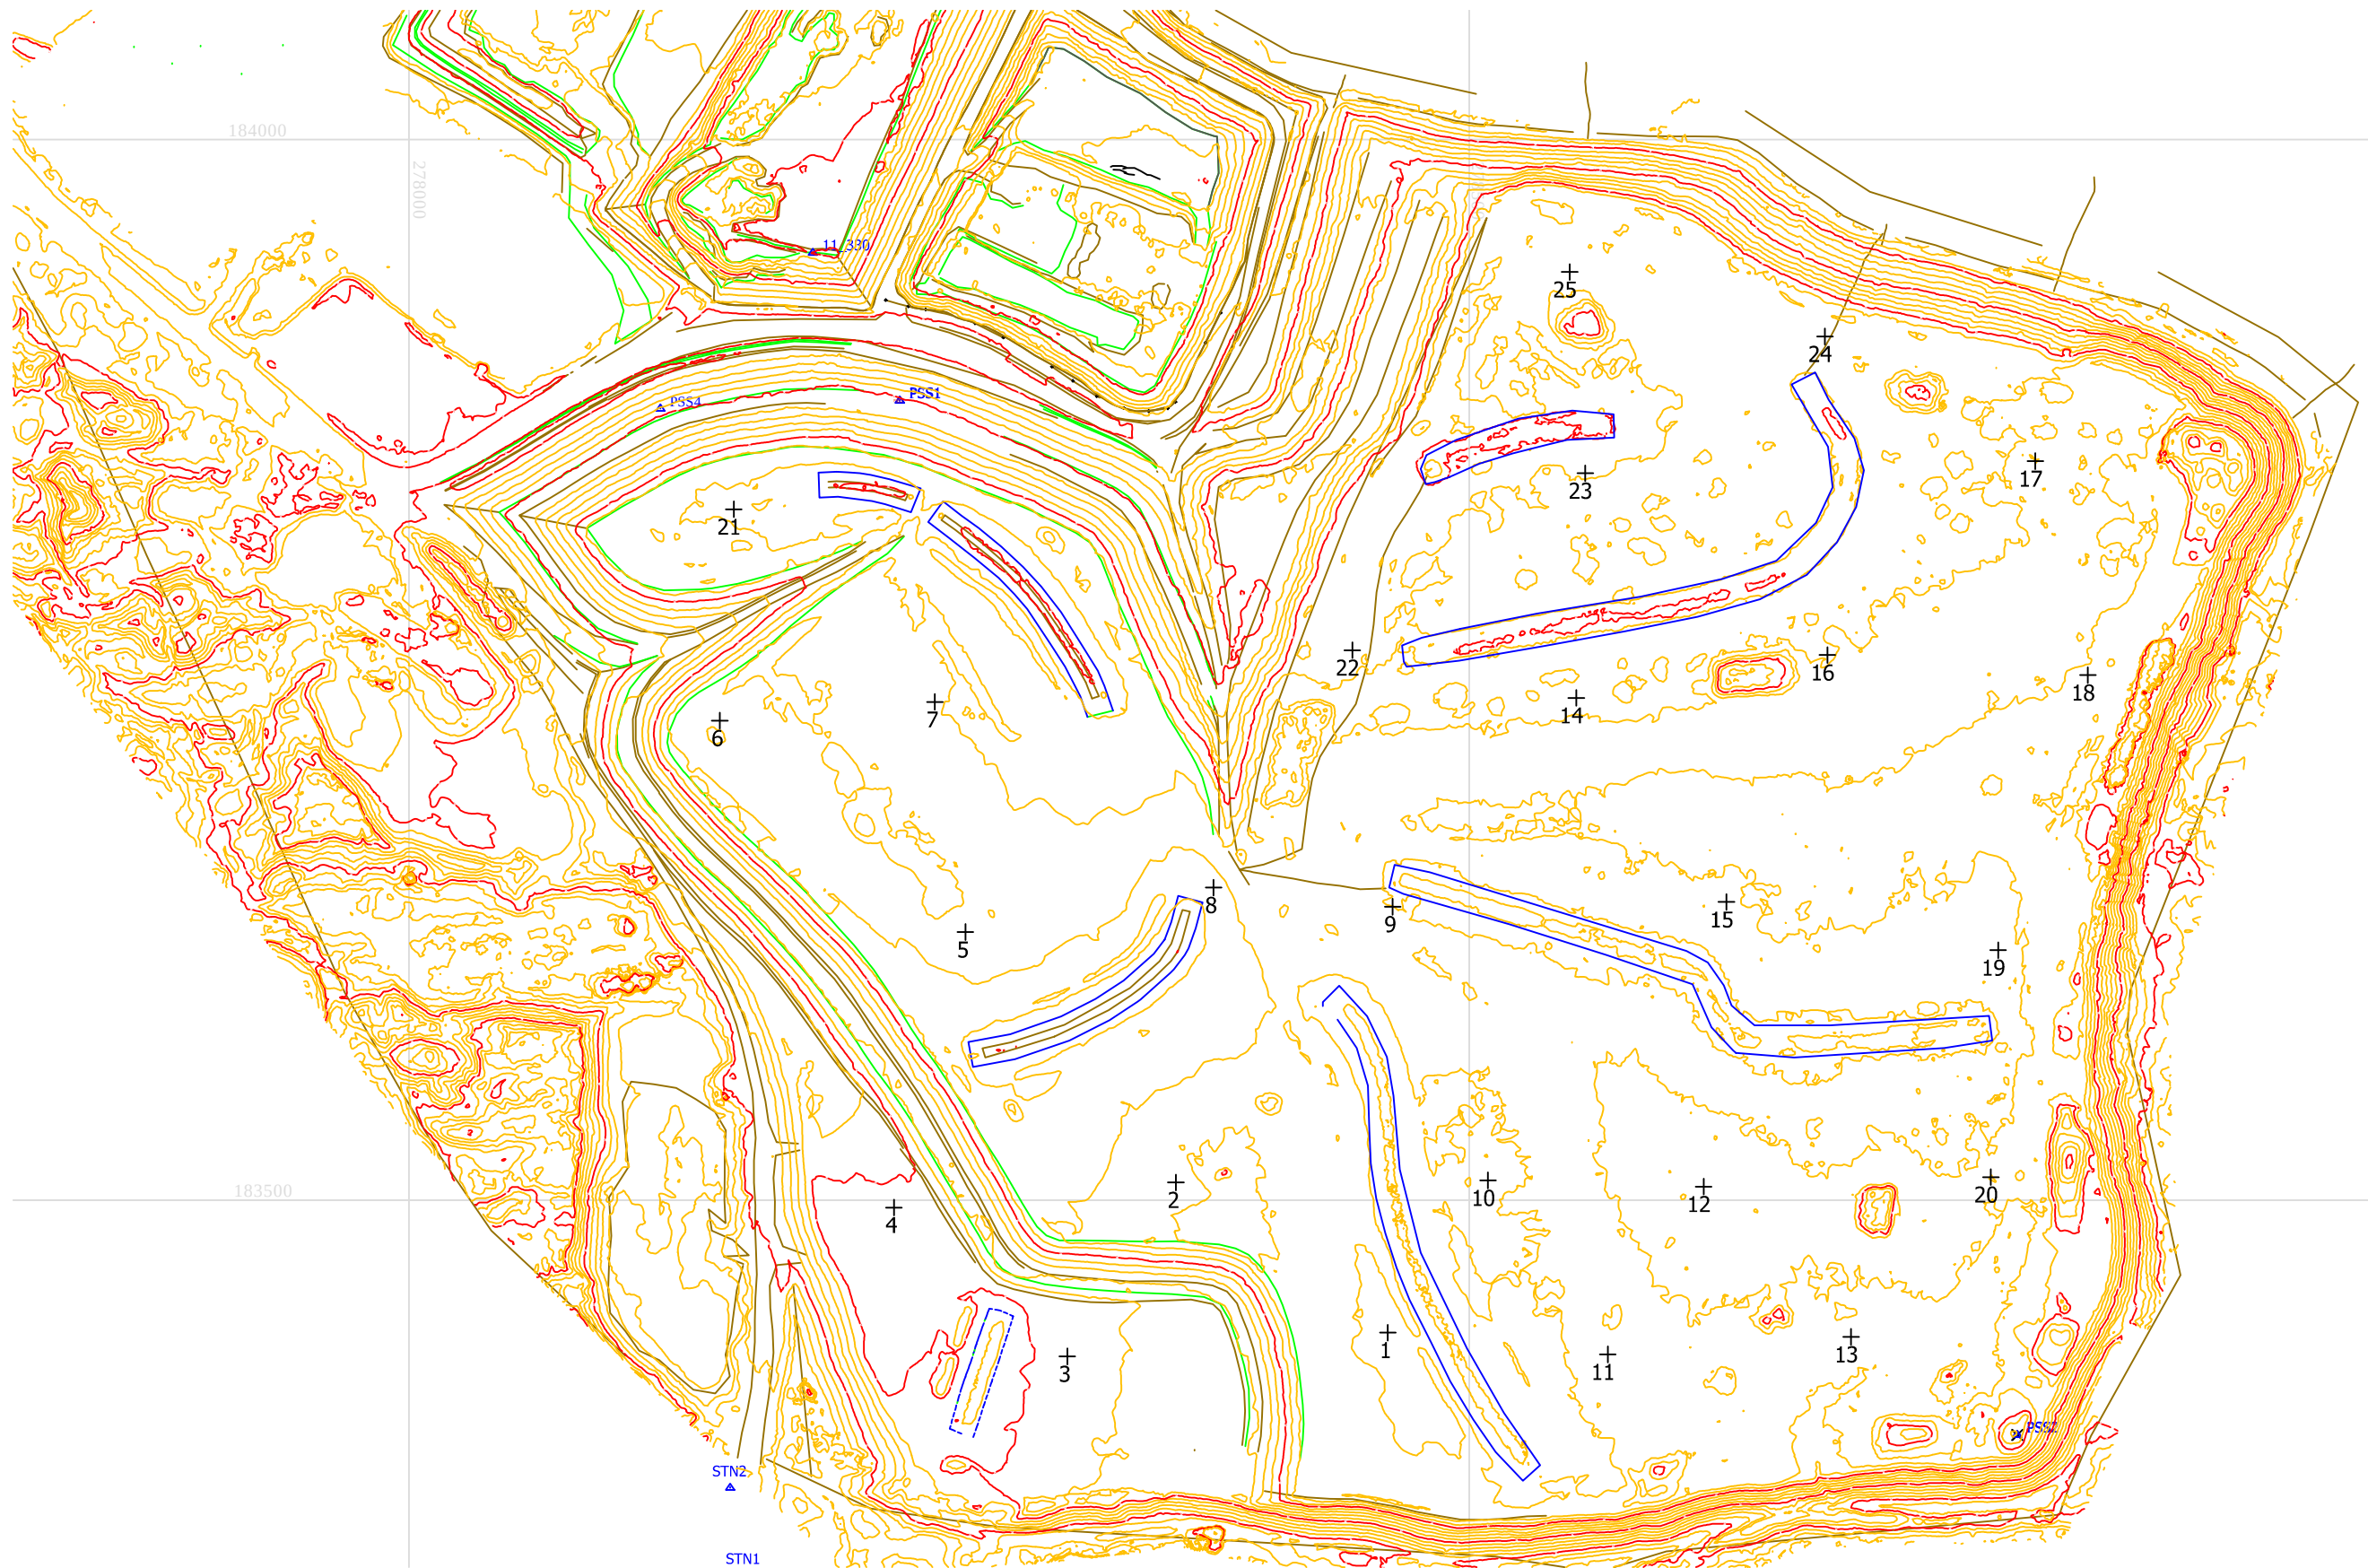
Figure 4 Settlement Markers on Morfa Closed Landfill

Now that the landfill is capped, evaluation of settlement is achieved using a network of settlement markers. The location of these markers is shown on Figure 4. Monitoring of these positions will satisfy the requirements of Permit condition 4.2.2 and negate the need for an annual topographic survey as required by Permit condition 3.5.3.

- A network of settlement monitoring markers will be monitored annually. The location of the markers is included in the 2013 annual report and satisfies condition 4.2.2 of the permit. At the time of site inspection no dips and hollows were noted and no standing water was seen, other than where recharge ponds have been engineered in accordance with the permit to allow recharge of groundwater.
