## HANSON CEMENT WORKS - PADESWOOD LANDFILL SITE

# Landfill Closure Report

**Report Number** 1419741.501/A.0

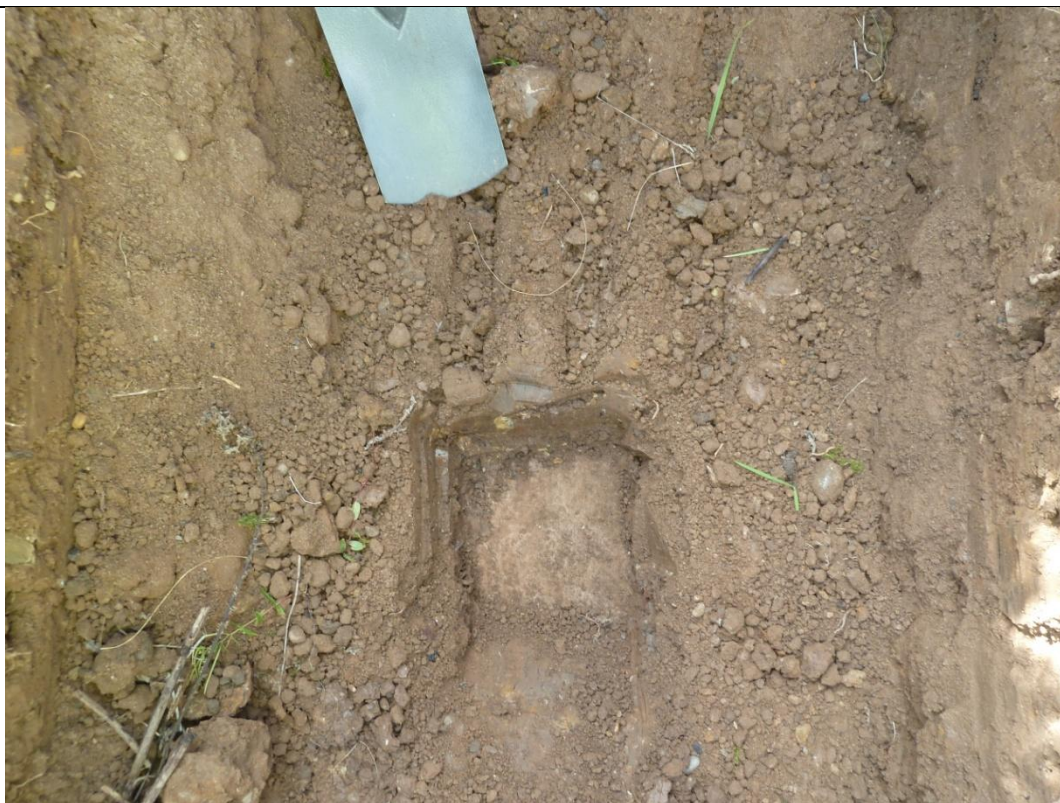
Plate 515/1: Restoration Soils 1

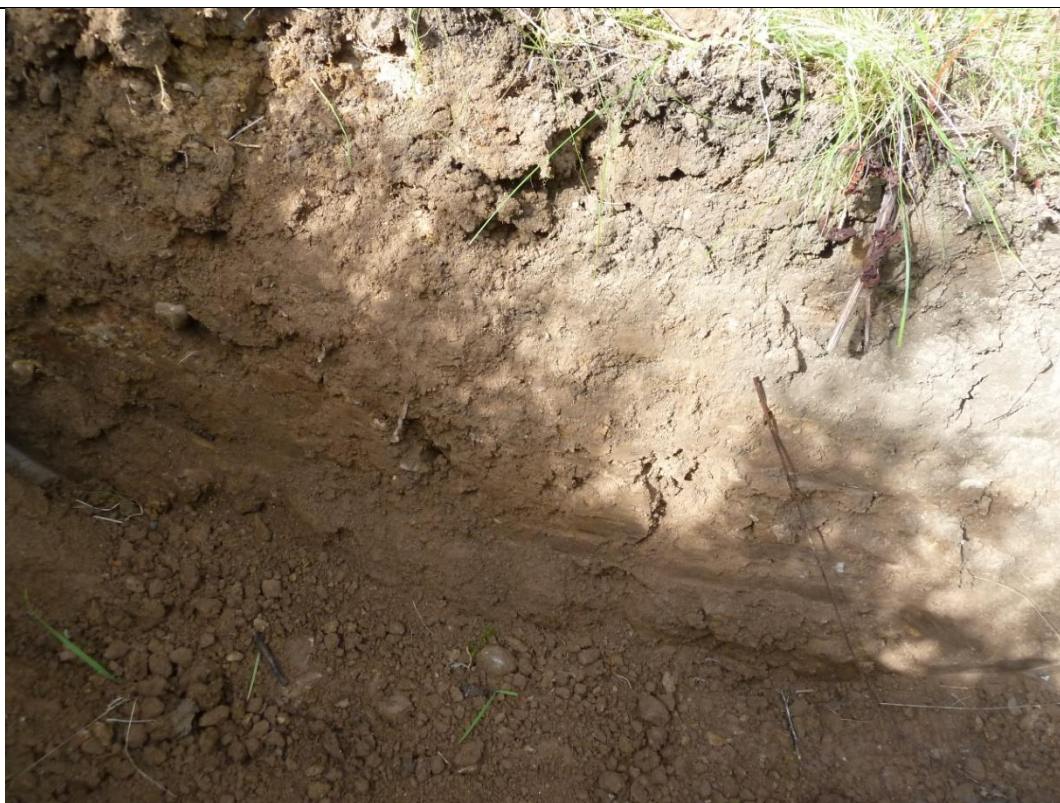
Plate 515/2: Restoration Soils 2

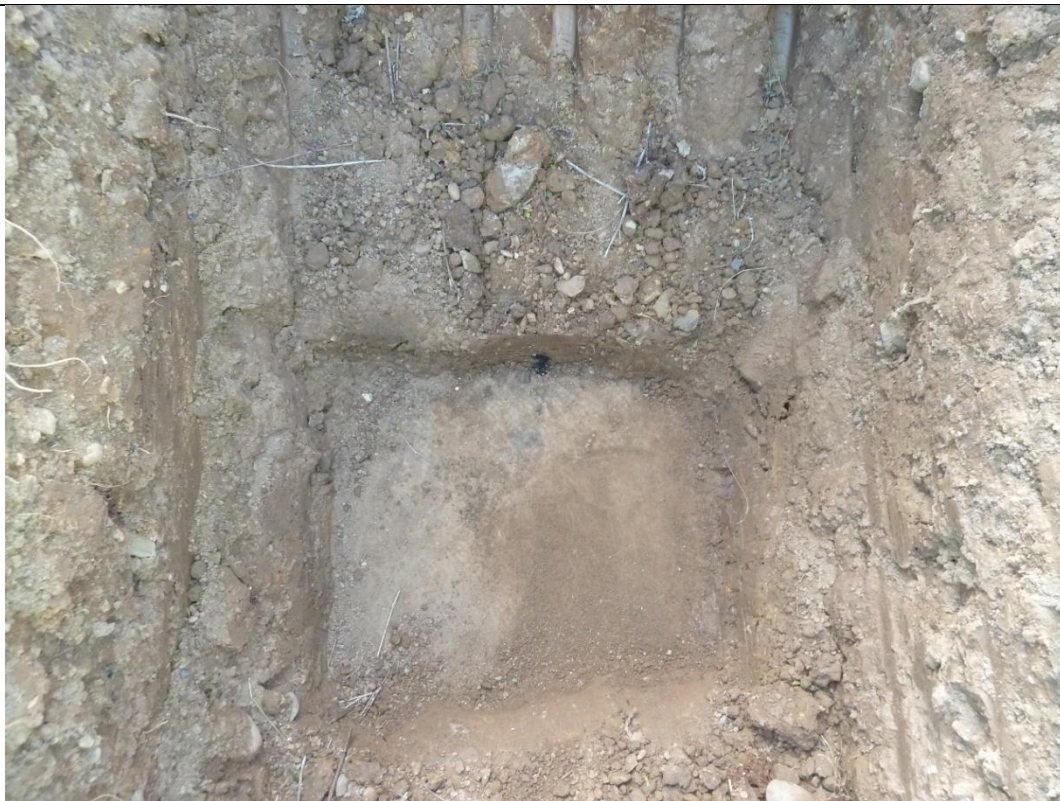
Plate 515/3: Exposed GCL 1

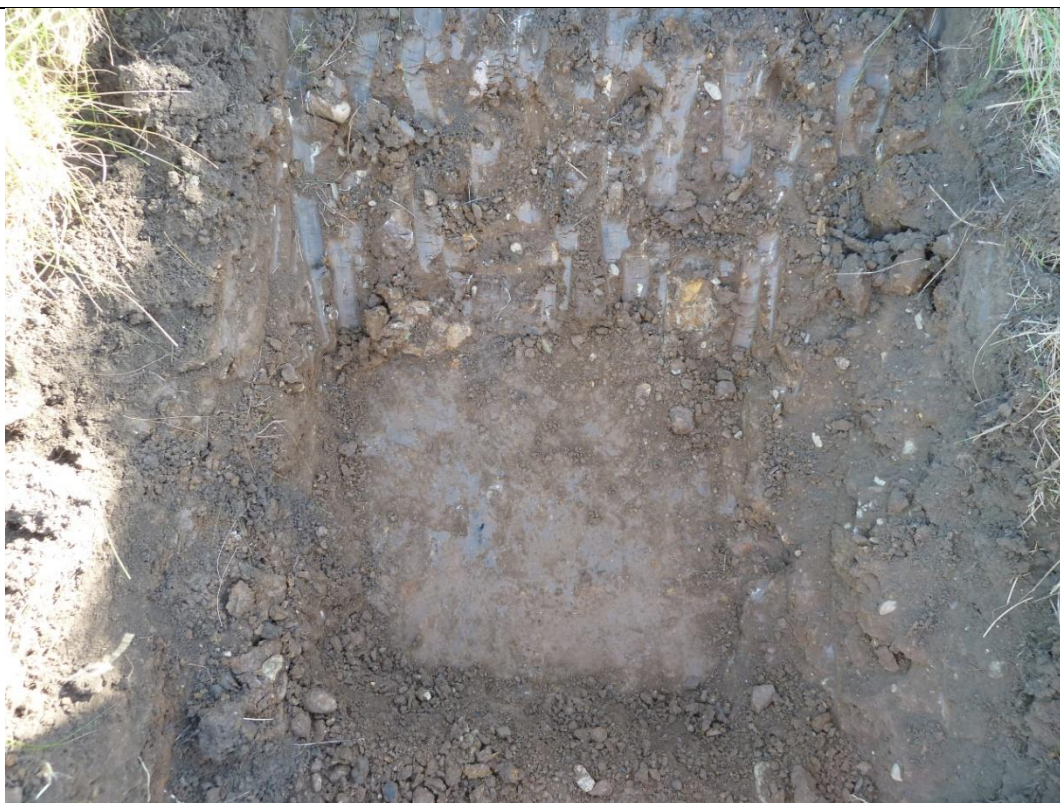
Plate 515/4: Exposed GCL 2

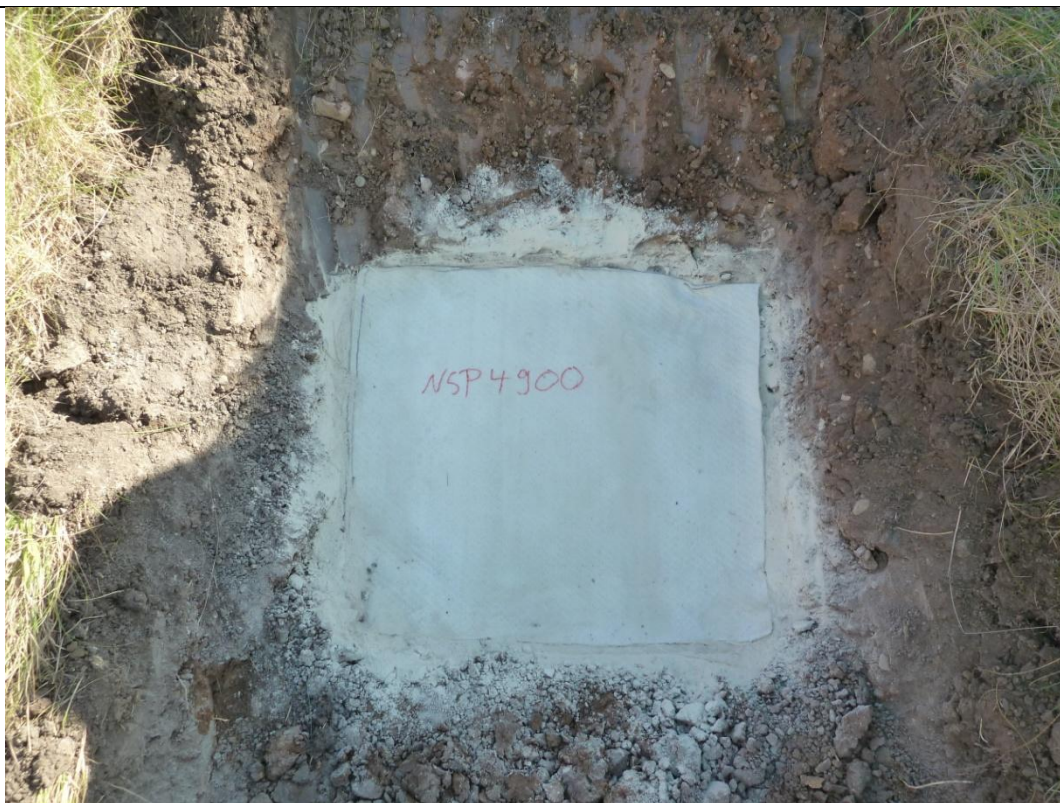
Plate 515/5: GCL Patch 1

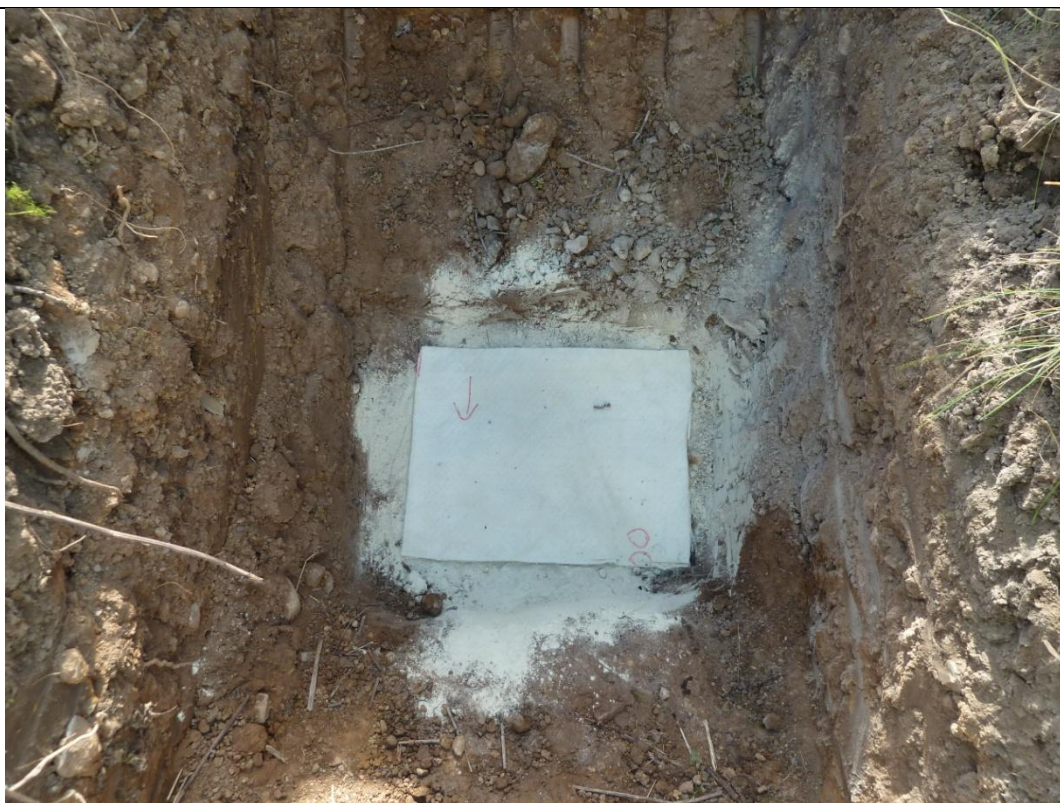
Plate 515/6: GC Patch 2

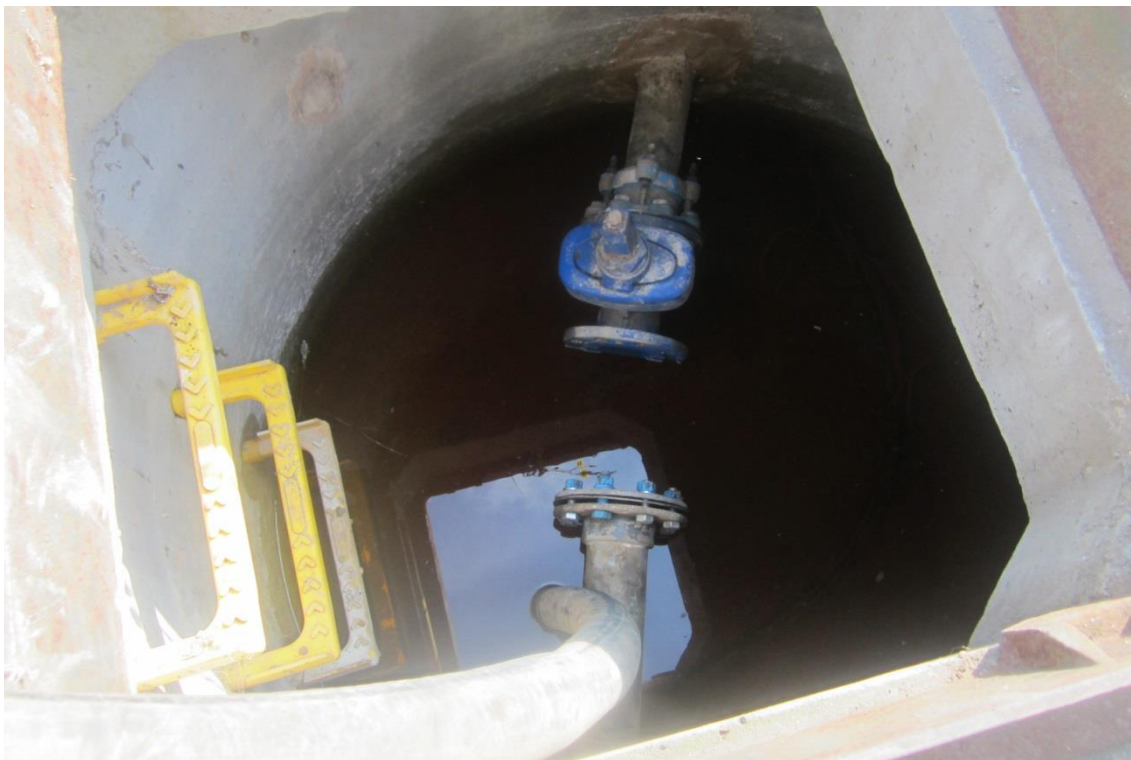
*Photograph 1: TD1 drain chamber with the non-return valve removed and the blanking plate fitted. The pipe at the top comes from the toe drain, and the pipe at the bottom goes to the sump (S1). The temporary pumping pipe is also visible from the surface.*

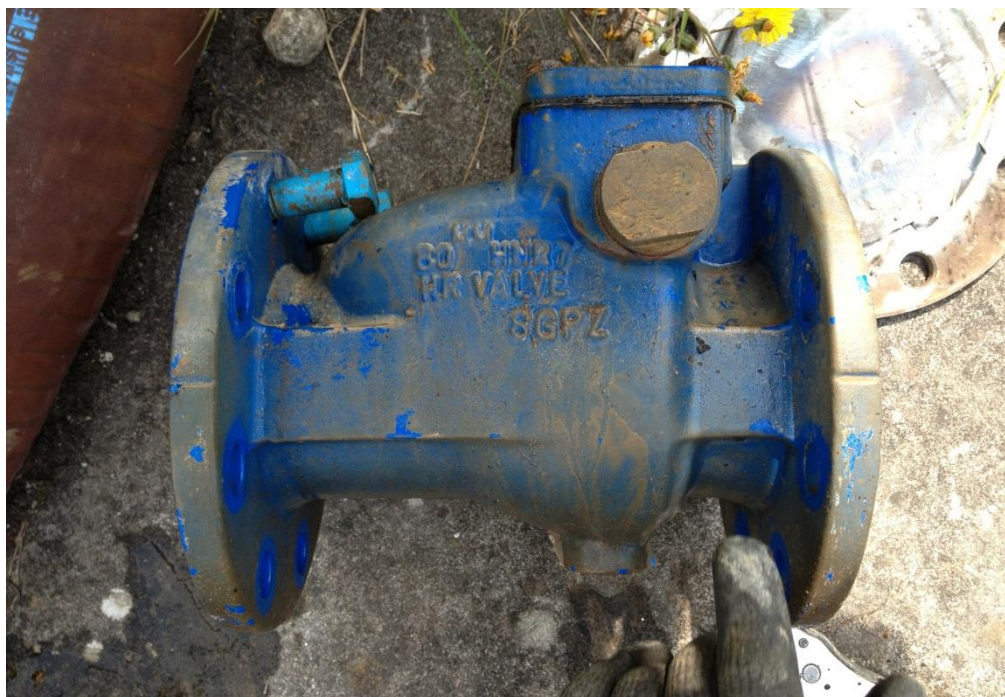
*Photograph 2: Non-return valve after removal from TD1 pipework. It was installed in a direction where flow was stopped from the toe drain and allowed from S1 to TD1.*

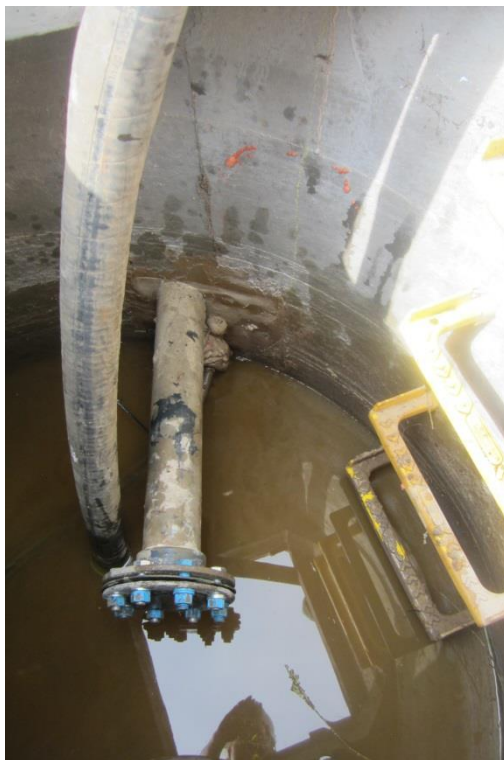
*Photograph 3: TD1 pipework showing the fitted blanking plate. This is fitted to stop and potential flows between S1 and TD1.*

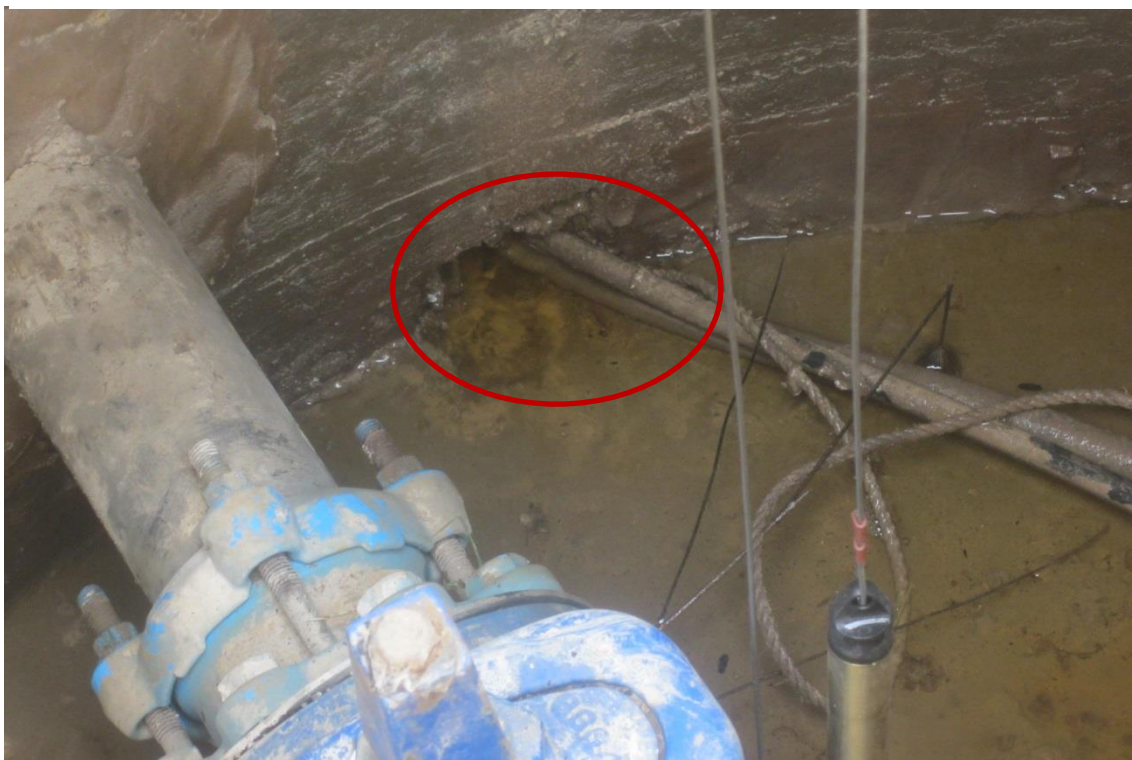
*Photograph 4: Area of inflow into TD1. Several cables enter TD1 through the concrete (see the red circle), and it is this area that leaks water into TD1.*

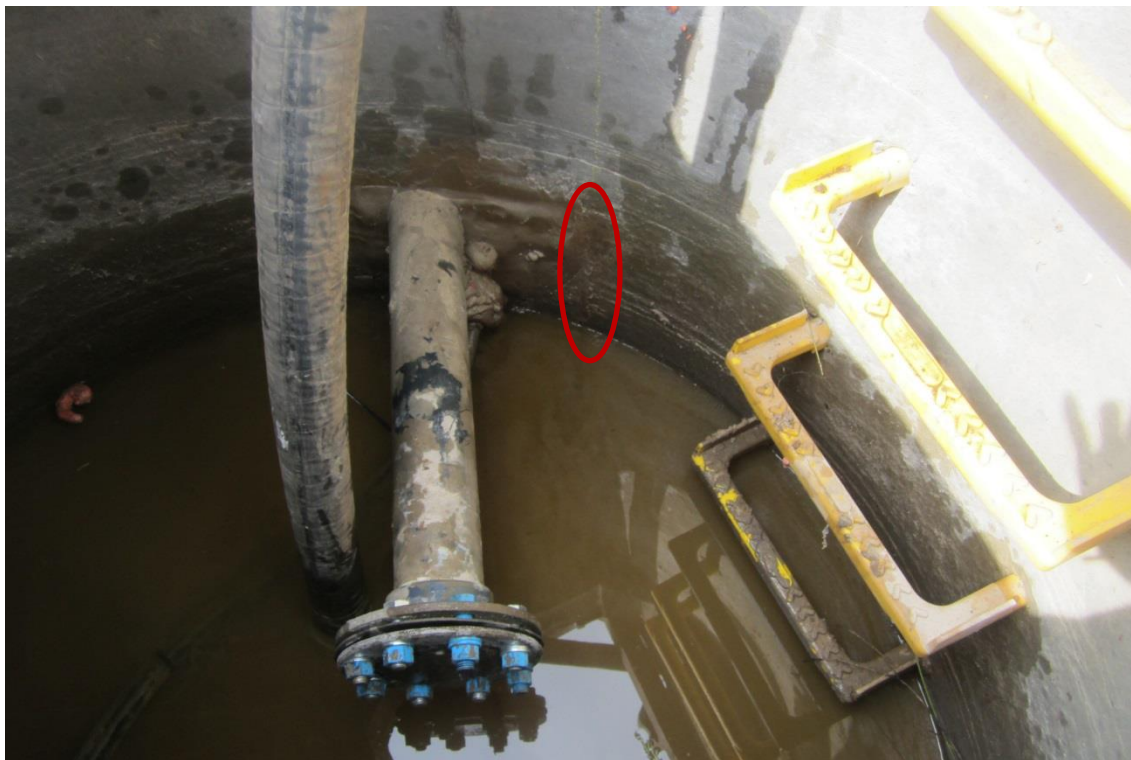
*Photograph 5: Area of inflow into TD1. A vertical seam in the concrete ring chamber casing (see the red circle) appears to be poorly sealed and allows water to leak into TD1.*

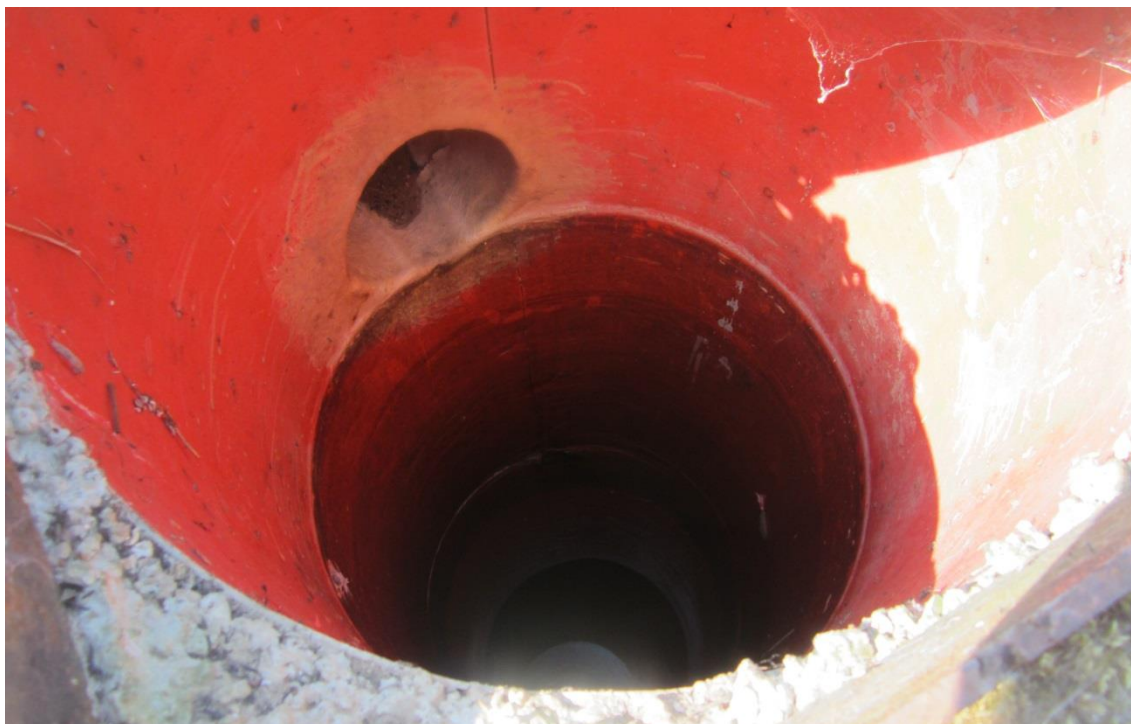
*Photograph 6: TD2 following removal of the standing water. The water reached the level indicated on the wall of the chamber by the black coloured residue. The inlet pipe from the toe drain is observed towards the top photograph. No outlet pipe is visible from the ground surface.*

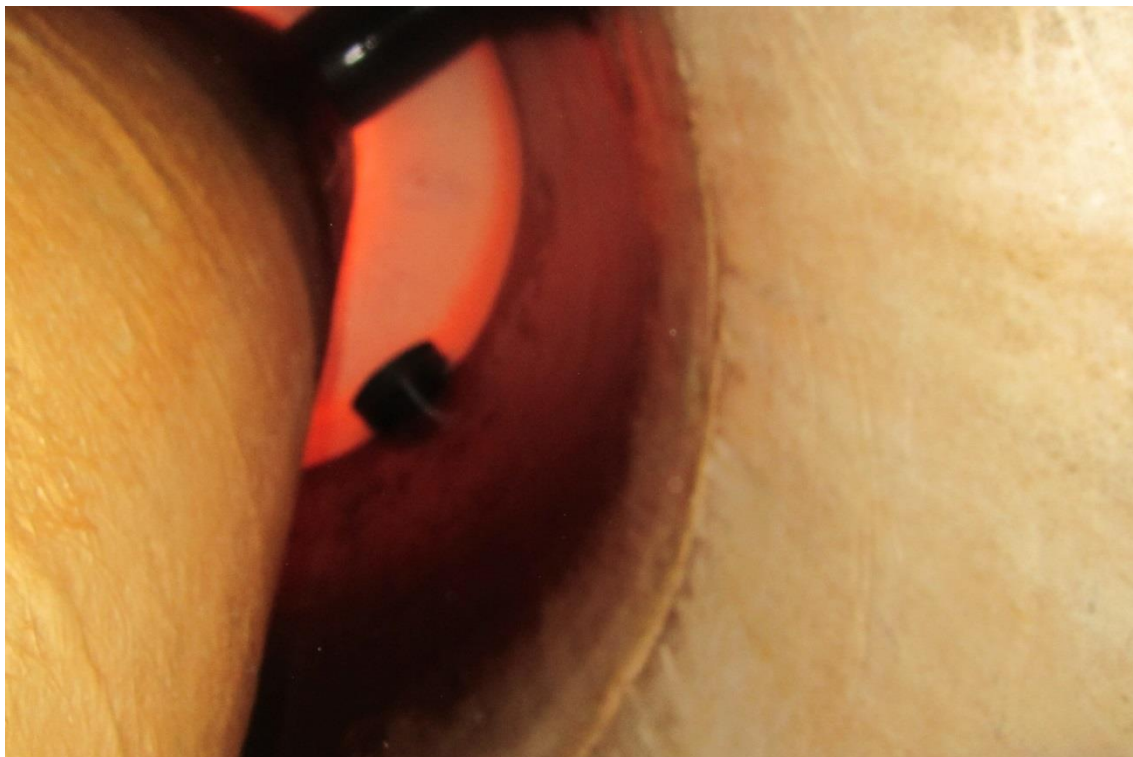
*Photograph 7: TD2 taken from the base of the chamber and looking up to the ground surface. The cylinder to the left of this photograph is the red tube in Photograph 6 from the outside. The inlet pipe can be seen at the very top of the photograph, and the assumed outlet pipe is noted towards the centre of the photograph.*

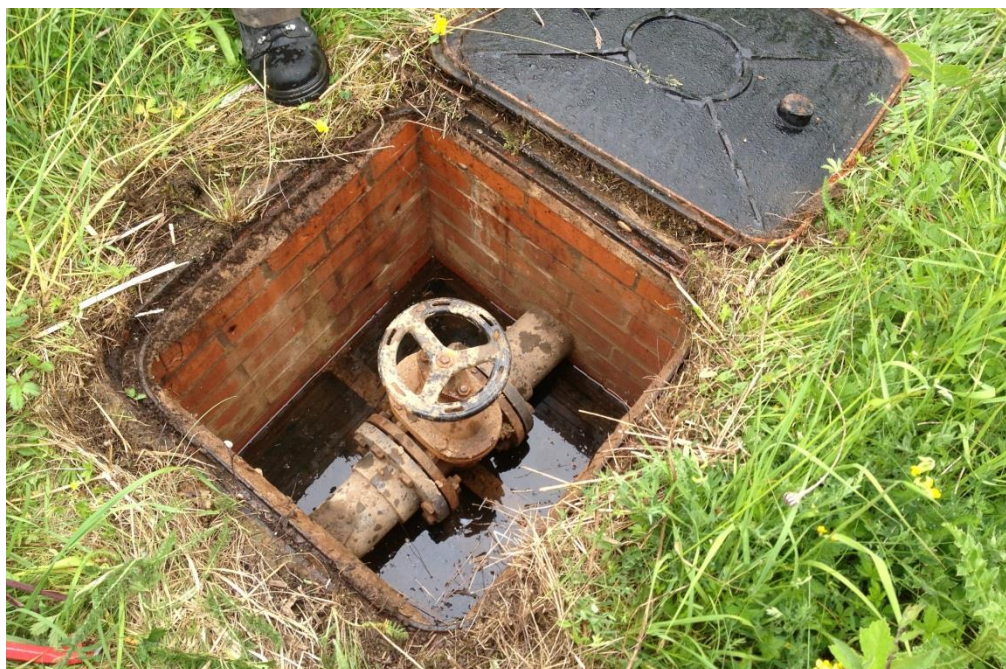
*Photograph 8: Emergency outflow pipe and valve from TD2. TD2 is located towards the bottom left of this photograph.*
