## Compliance Assessment Report CAR\_NRW0039161

For: Aberthaw Works EPR/BL3986ID, held by Tarmac Cement and Lime Limited

At: Aberthaw Works , East Aberthaw, Barry, Vale of Glamorgan, CF62 3ZR.

#### **Emissions and reporting review and site incident update – 31 December 2021**

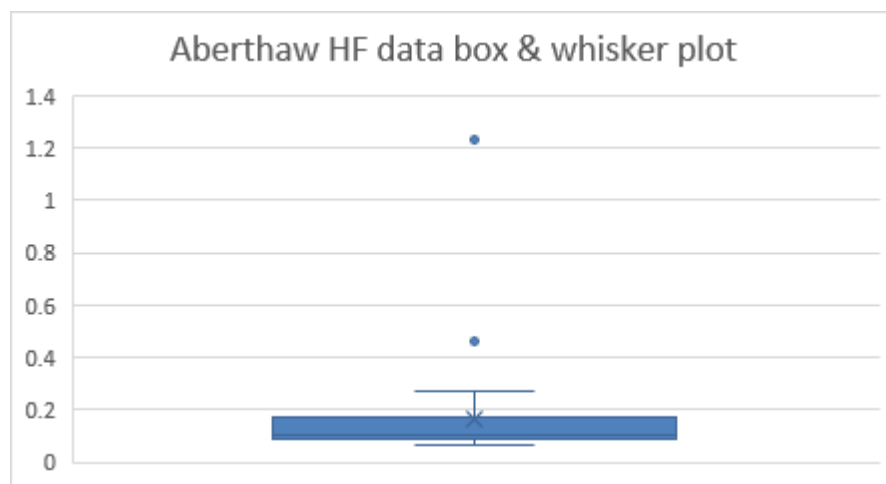
An elevated hydrogen fluoride (HF) extractive monitoring result on 23<sup>rd</sup> March 2021 of 1.2 mg/m<sup>3</sup>, over the emission limit value (ELV) of 1 mg/m<sup>3</sup>, has been shown to be an outlier result using non-parametric and robust statistical outlier tests on data for Aberthaw dating back to 2005. Typical results are below 0.2 mg/m<sup>3</sup> and this appears to be the case for cement plants across the UK and Europe. The data are best illustrated using a standard “box and whisker” plot, clearly showing at least two suspected outlier results in the data set:

An investigation by the monitoring contractor found no identifiable cause for the outlying result. However, no process chemistry basis has been provided explaining why elevated HF levels could not be present in the flue gas due to exceptional fluorine levels in raw materials or fuels. Nevertheless, statistically the current data set suggests that the result is an anomaly and has not been considered a valid exceedance of the ELV in this instance. Future data will be kept under review.
