**MORFA HAZARDOUS  
LANDFILL  
PORT TALBOT**

**PERMIT BW2692IM**

**2021 Annual Review of  
Environmental  
Monitoring Results**

*Report Number 2191r1v1d0222*

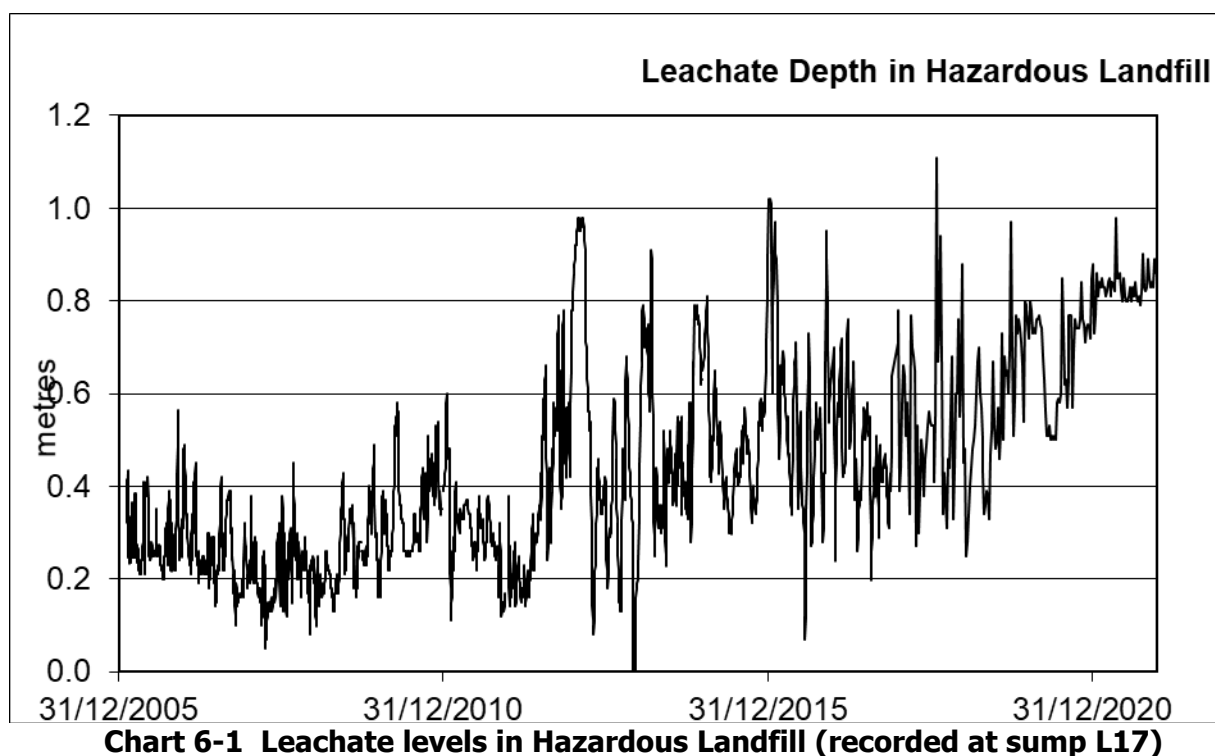
Based on monitoring undertaken by the landfill operator, the variation of leachate head is illustrated in Appendix 1 and Chart 6-1. In accordance with the Permit conditions, the head of leachate has not exceeded one metre above the base of leachate monitoring point (L17) apart from a few weeks at the start of 2016 and in August 2018. At GA30, leachate has never been found to be present.

During 2021, leachate levels did come close to the Permit limit and there does appear to be an increasing baseline. This should be carefully evaluated within the context of the new leachate management system to ensure that heavy, intense and prolonged rainfall events do not result in elevated leachate levels.

To maintain leachate levels within the Permit levels, significant quantities of leachate are extracted and taken back into the steelworks for treatment. Given the large volumes involved, Geotechnology has previously suggested that Tata could consider measures to reduce the volume, such as progressive restoration. As the leachate levels have not been reduced to the same lower levels as previous, and the waste may be close or at its field capacity, leachate levels can be potentially expected to respond quickly in response to rainfall.

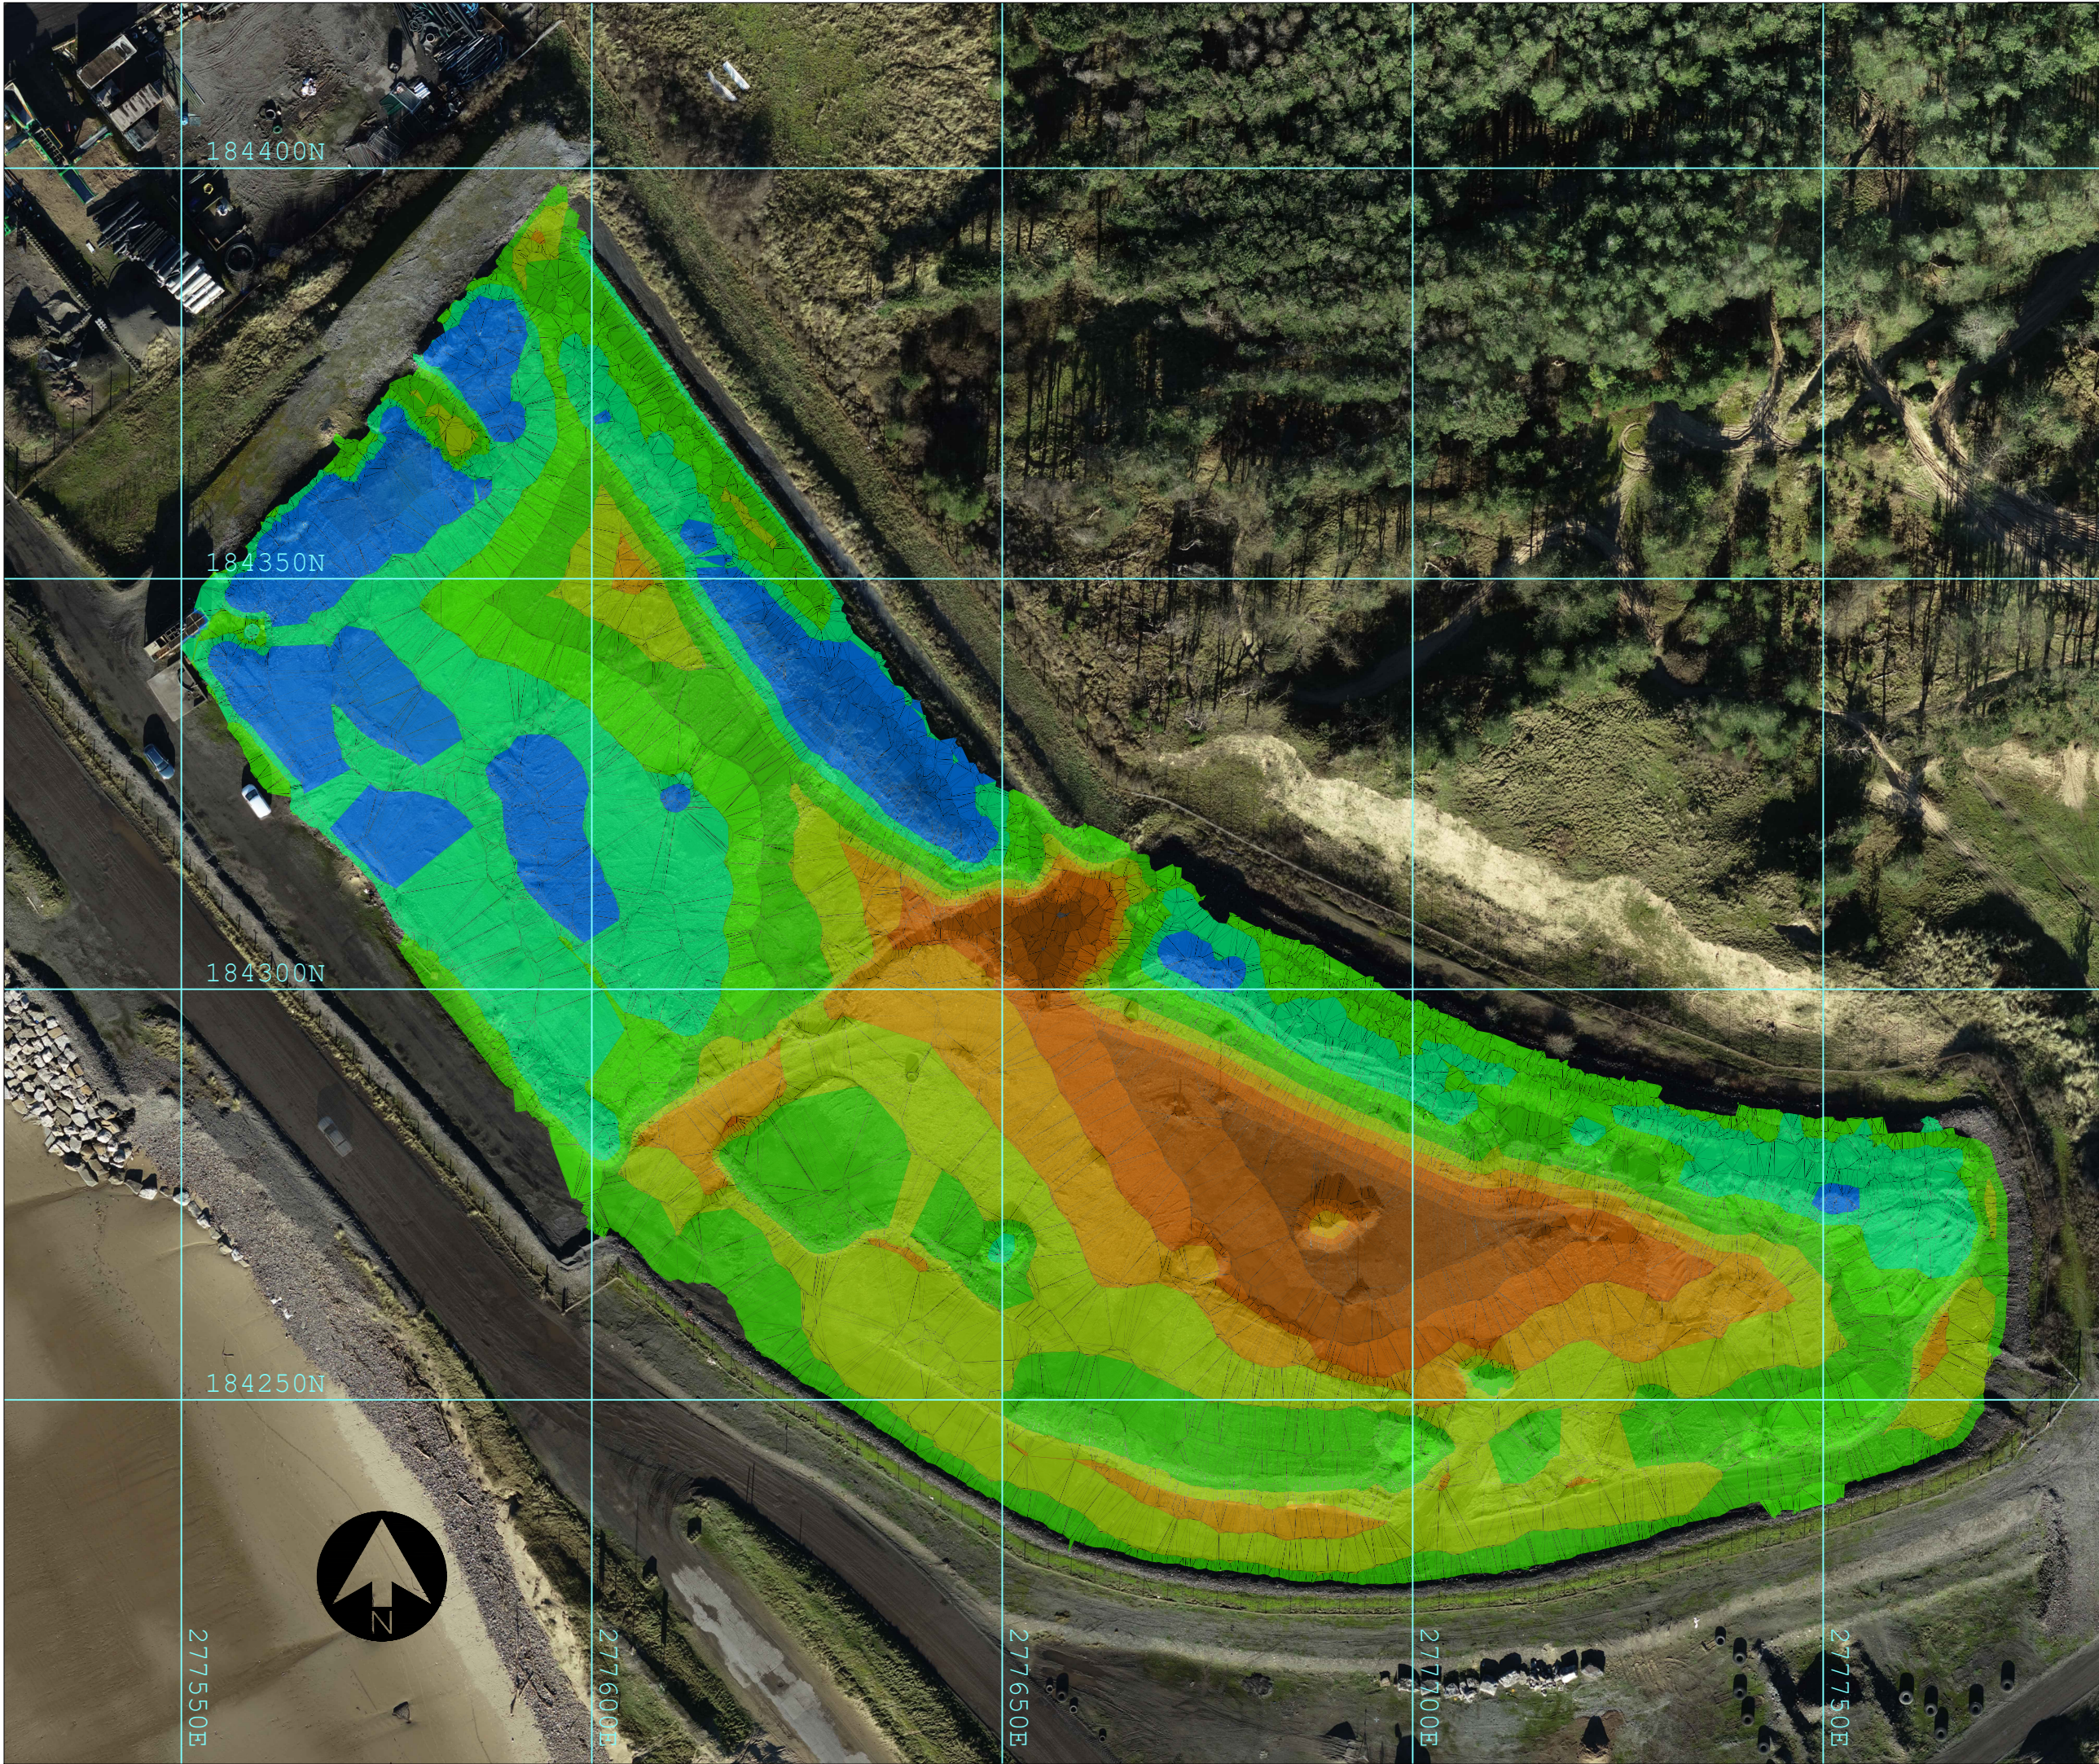
Hazardous Landfill  
Waste Profile Isopachyte

A comparison of the recent topographic survey with the survey from January 2021 has shown that the differences between the survey models for Hazardous Sub-Cell 1 are within the tolerances of the survey method. The settlement of the waste over this time period is therefore considered to be negligible.

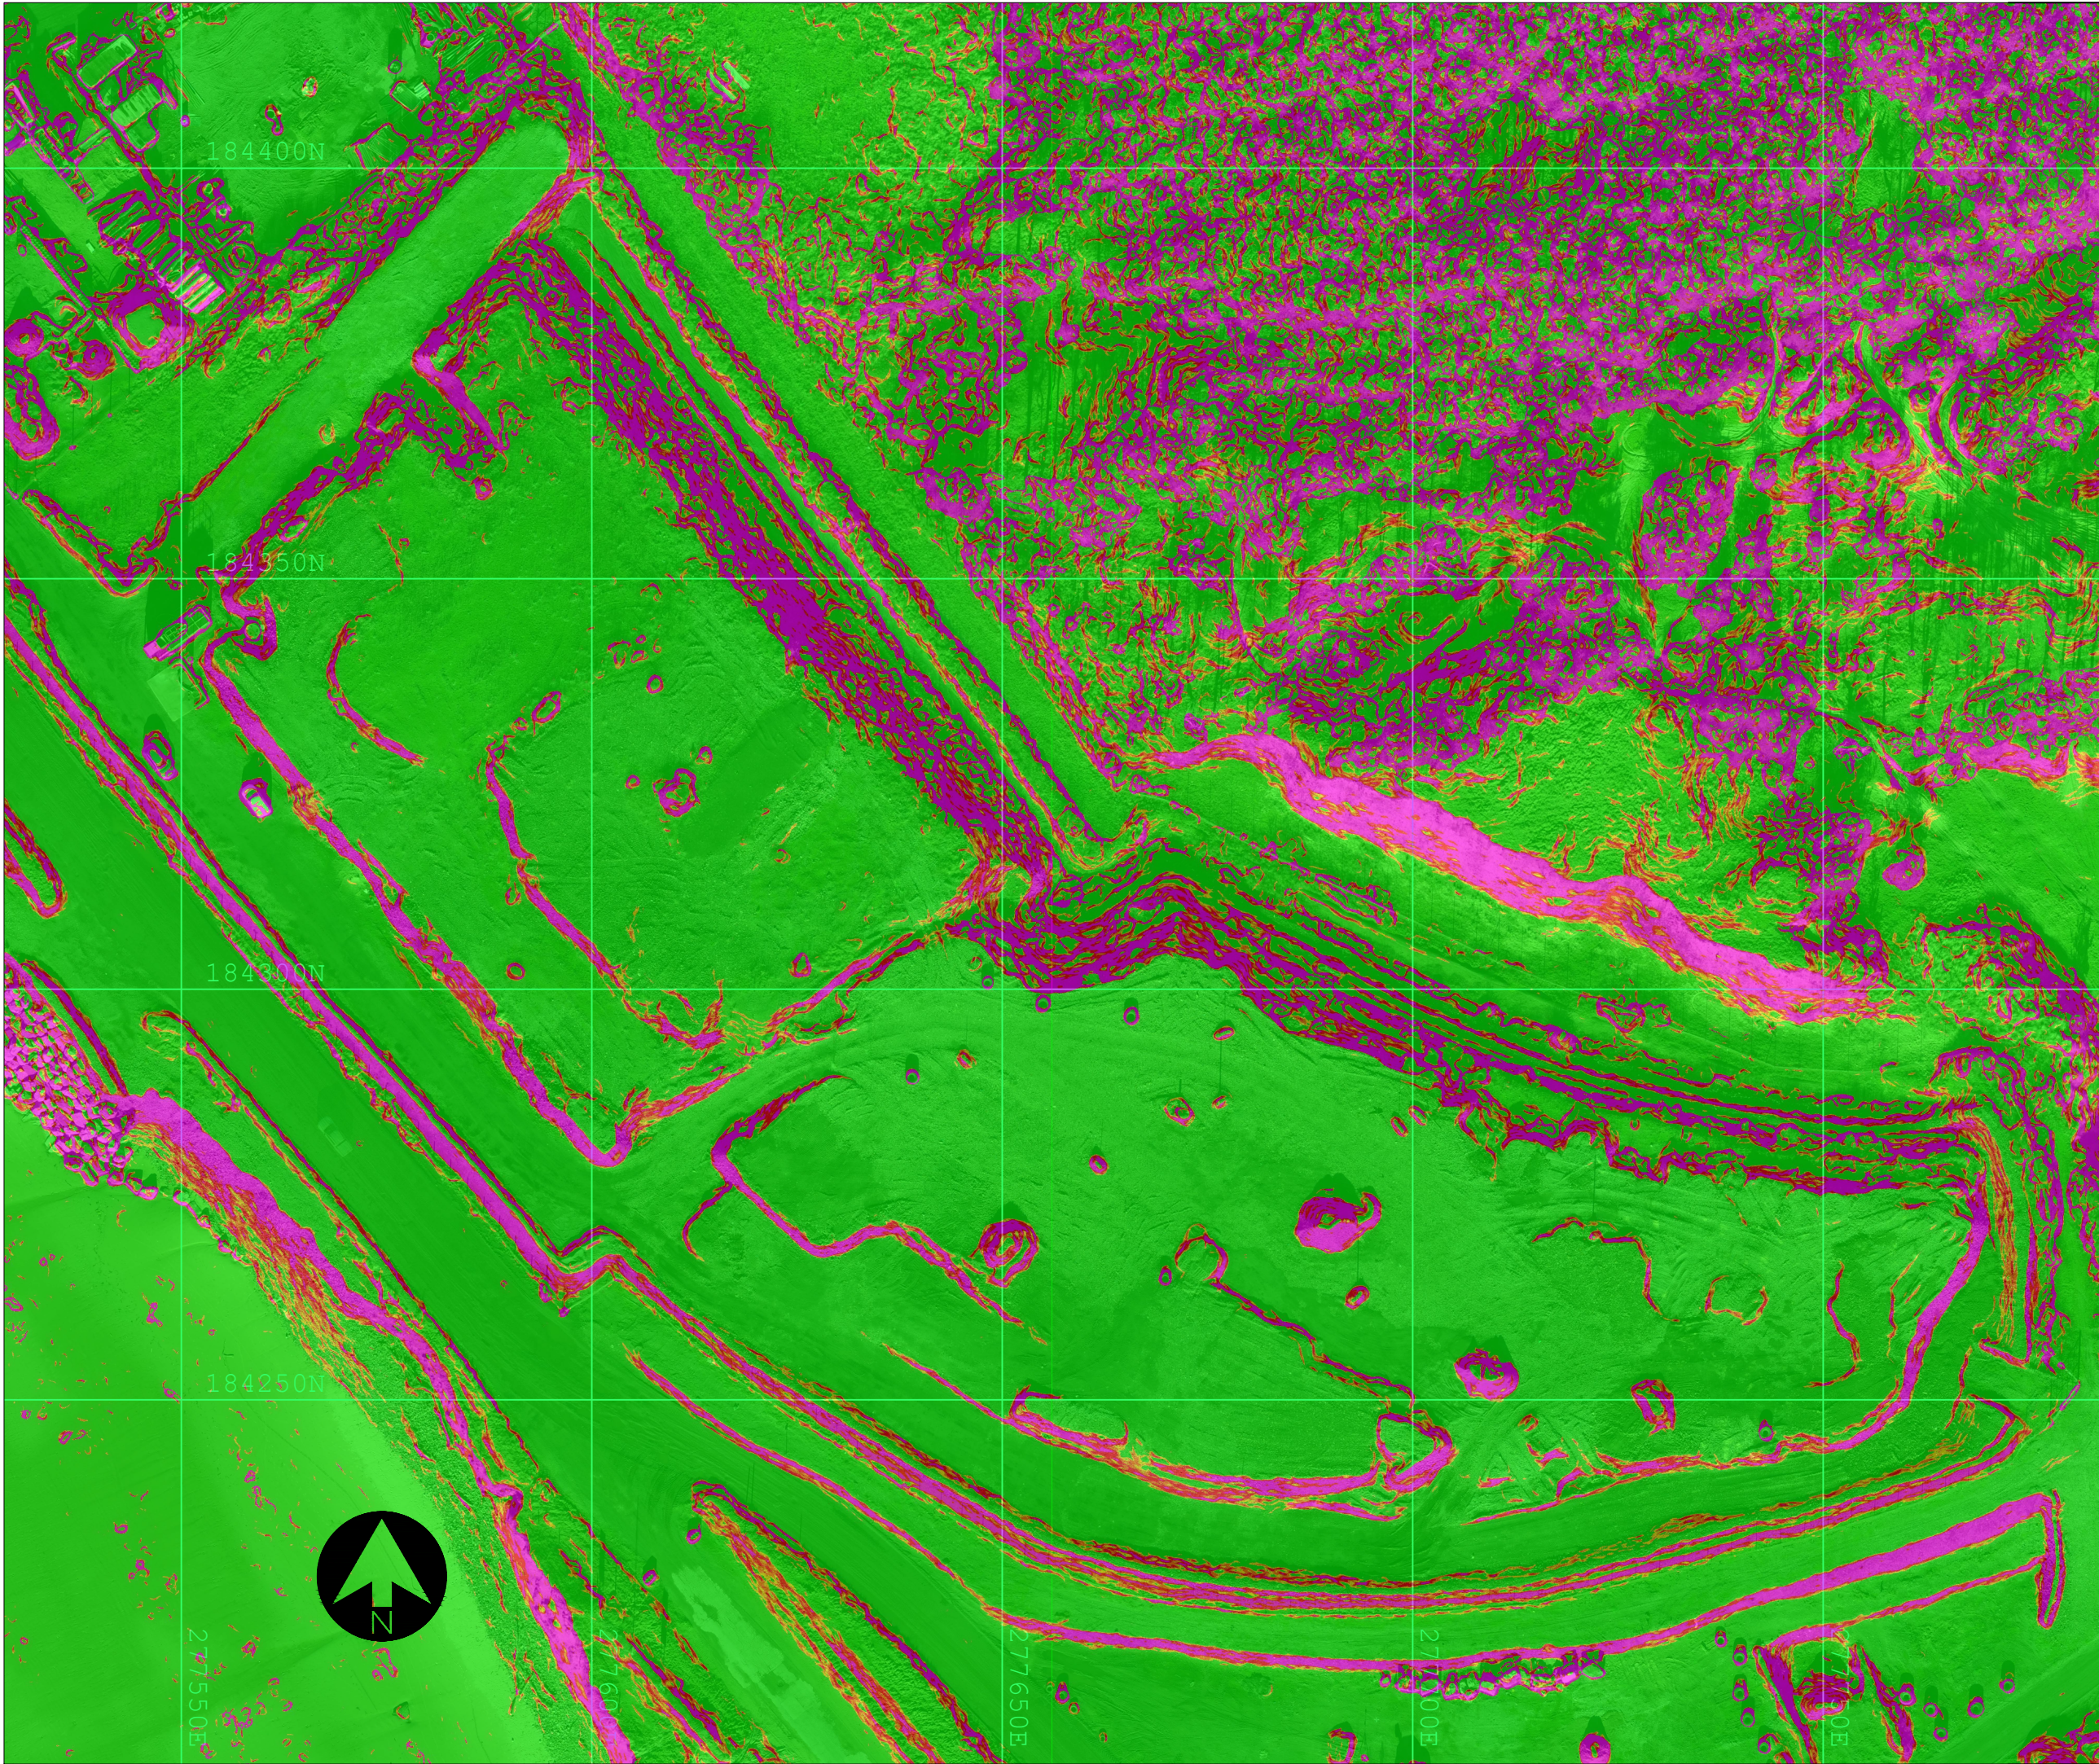
Hazardous Landfill  
Slope Gradient Map

Many of the external faces of Sub-Cell 1 exceed the gradient permitted for temporary slopes in the SRA. Given the nature of the wastes deposited in this cell, an assessment should be made of the best method for reprofiling these slopes to comply with the short- and long-term gradients permitted by the SRA. It should be noted that these are relatively short slopes with a height slope height of <2m.
