**MORFA TIP CLOSED  
LANDFILL,  
PORT TALBOT**

**PERMIT EPR/AP3292LT**

**2021 Annual Review  
of Environmental  
Monitoring Results**

*Report Number 2192r1v1d0222*

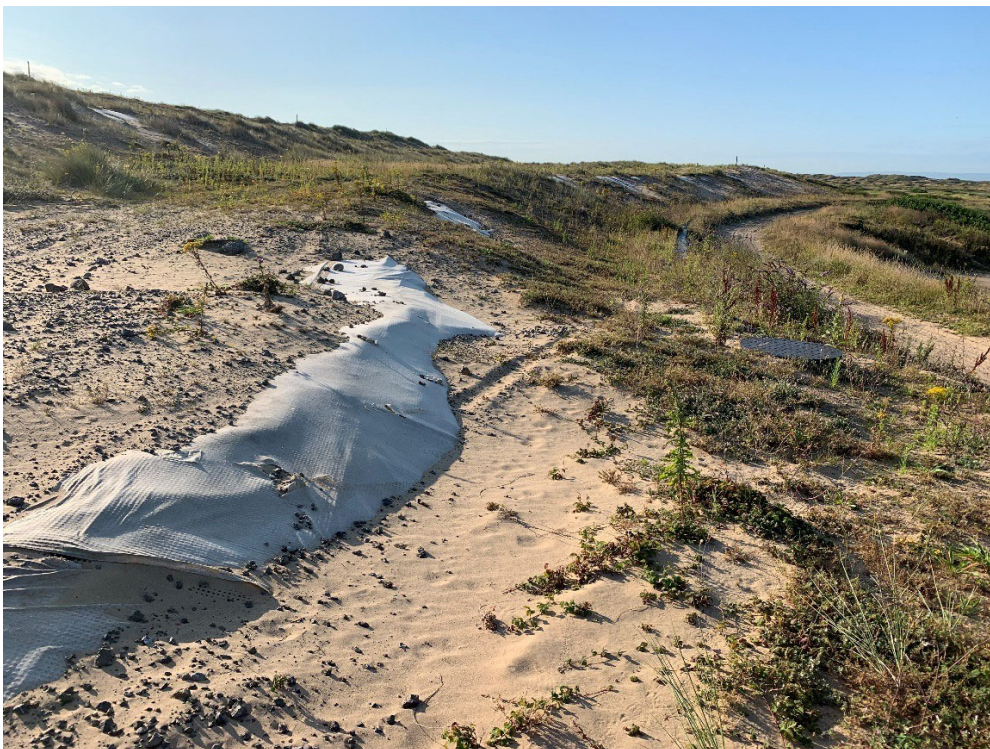
Since completion, several elements of the restoration system have been damaged by direct and determined vandalism, indirect action caused by trespassers on scramblers and wind action, as shown in Plate 2-2. The wind turbine intended to power the recharge trench penstocks has been severely damaged and where capping membranes have been exposed by wind action, these have been subsequently punctured by the passage of scramblers. Geotechnology is aware that Tata is reviewing boundary security at the site and maintenance of the cap. These aspects are routinely discussed by the Technical Working party overseeing management of the site that includes NRW.

**Plate 2-3 Exposed geomembranes on southwestern flank**

During 2021, following advice from the ecologist who prepared the site Ecological Management Plan, Tata started to trial new techniques for stabilising exposed flanks prone to wind-blow causing sands redistribution.

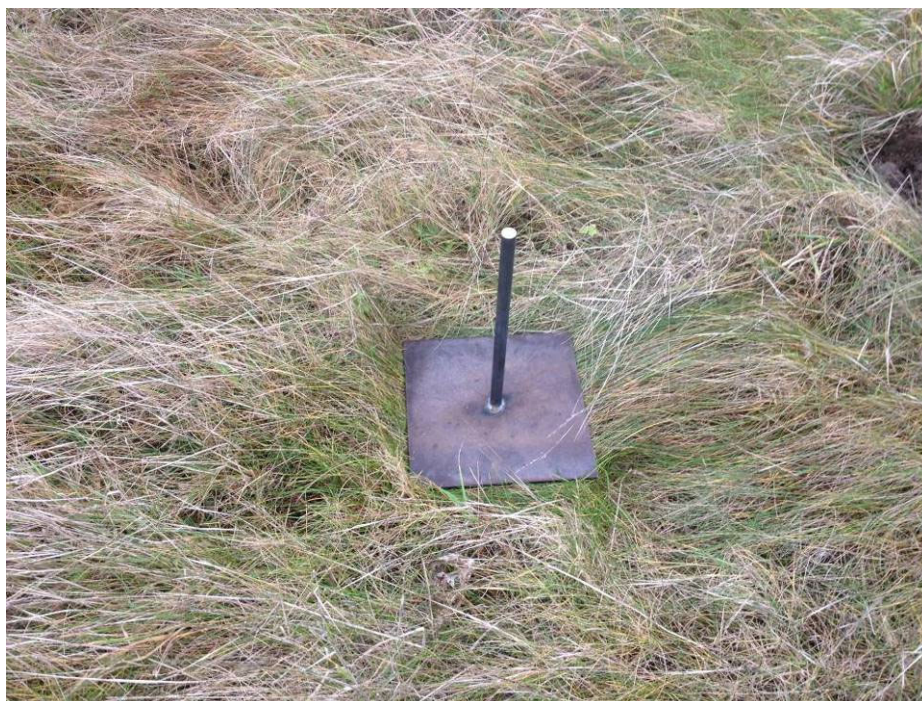
**Plate 5-1 Permanent Settlement Marker on MCL (Before Final Installation)**

Twenty-five settlement markers were installed in December 2013 along with two fixed survey stations in the stable ground approximately 100m to the southwest of the closed landfill. At each monitoring position a hand dug hole was made in the restoration soils and the settlement monitoring marker (as seen above) was placed directly onto the pozidrain. The marker was then secured in place with a bag of ready mixed cement and covered over with restoration soil. Monitoring data gathered from annual repeat surveys of the settlement markers identifies changes in elevation which are within the tolerance of the survey method. This would suggest negligible settlement has taken place, which is to be expected given the age and nature of the deposited wastes.

The recent survey found that 6 markers have been destroyed and require replacement.

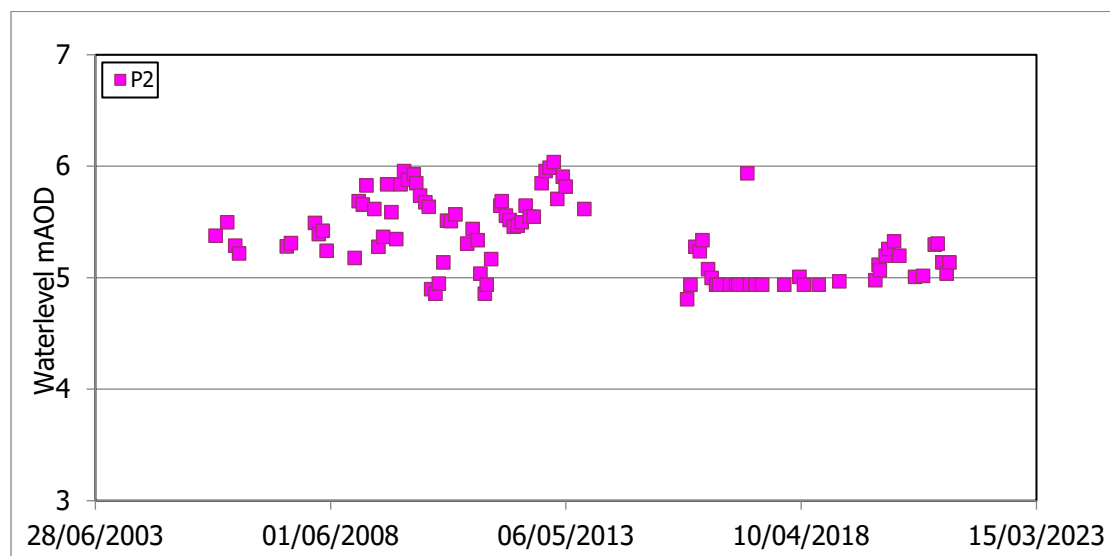
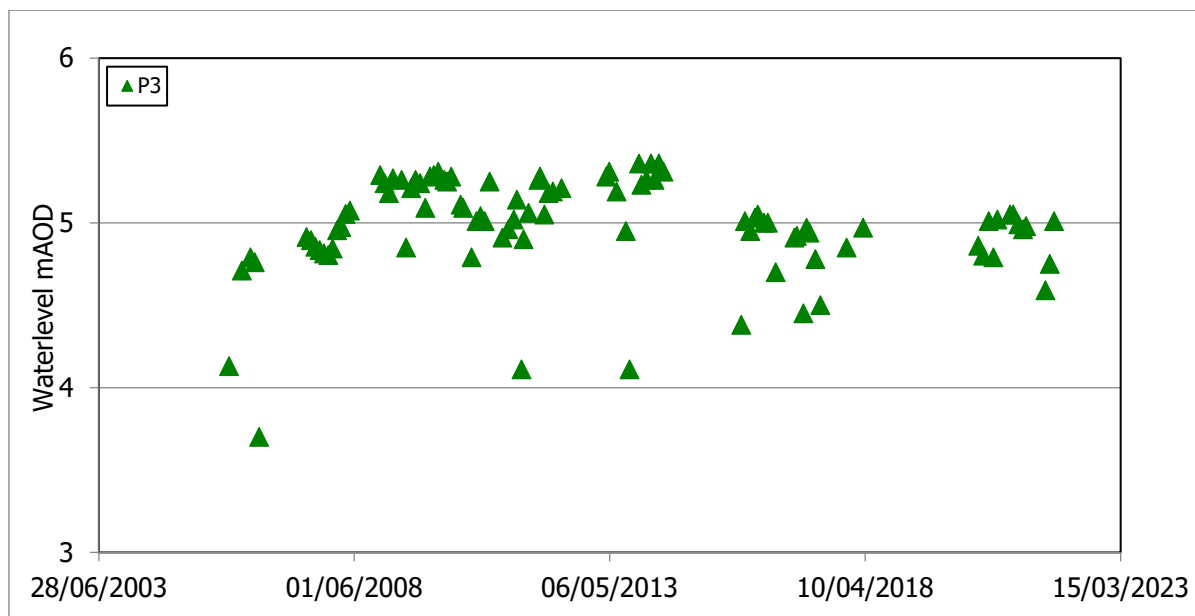
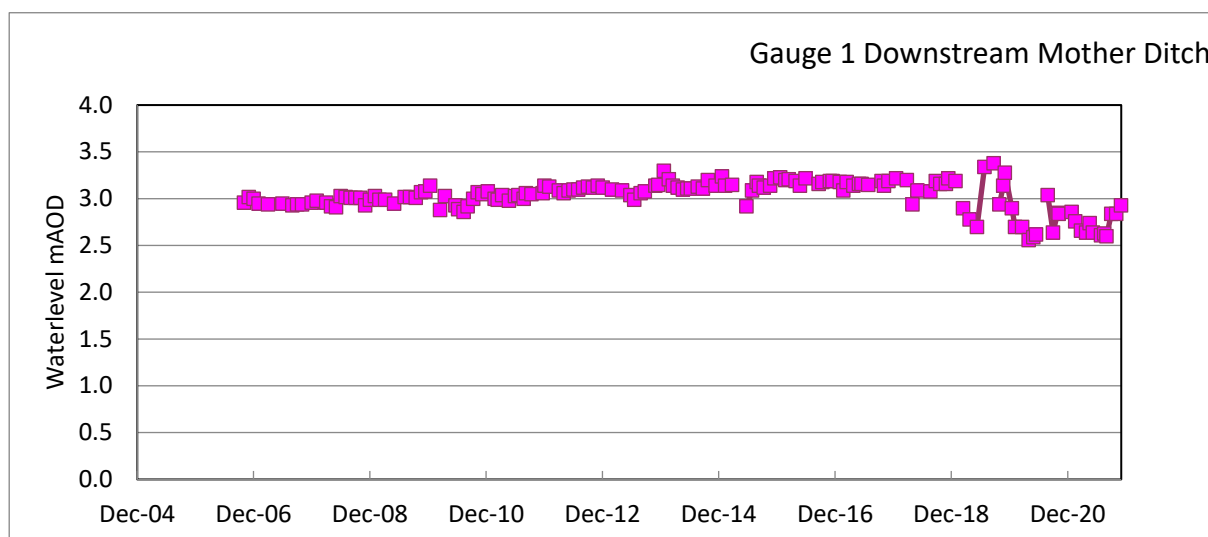
**Chart 7-1 Selected waterlevel monitoring results from P2, P3 and surface water gauge 1**

Close review of the data does however potentially indicate that some of the previous winter high waterlevels have not been recently reached, as suggested in Chart 7-1. Some of these variations are likely due to a change in the management of the reens with clearance occurring more often in recent years.

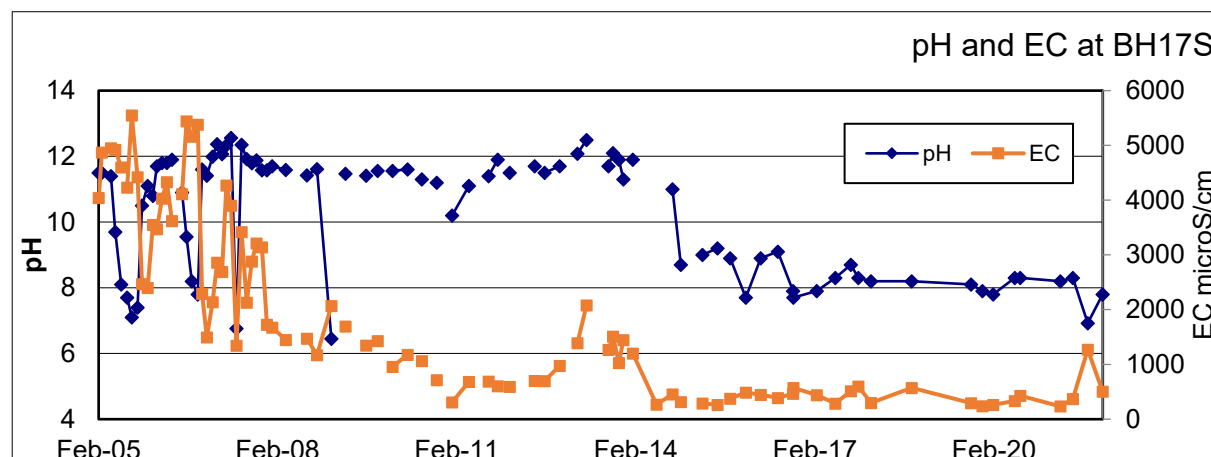
**Chart 7-2 Temporal variations of water chemistry at BH17S**

The groundwater chemistry observed during 2021 is very similar to that noted previously. At some locations, such as BH15S on the southern side and BH17S on the northern side, groundwater quality appears to be sustainably improving with falls in pH and EC (see graphs below). This is thought to be the direct consequence of capping directing dilute run-off around the edge of the site.

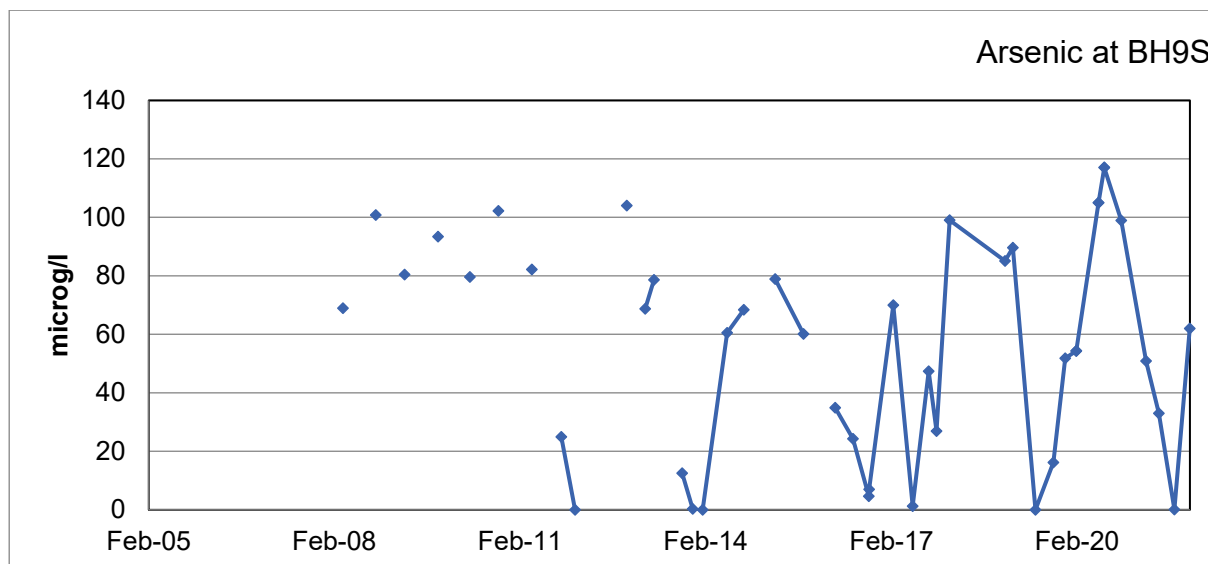
**Chart 7-3 Temporal variation of Arsenic at BH9S**

The mobility of arsenic, and other trace metals may be influenced by the improving water quality. As rainwater is largely prevented from leaching the wastes beneath the cap, groundwater at BH9 (and other positions) is transitioning from being strongly alkaline to more circumneutral. As these changes occur, the mobility of trace metals such as arsenic, that can form oxyanions, may alter.
