Synthite and TS Resins – Containment audit photos 26/06/2019

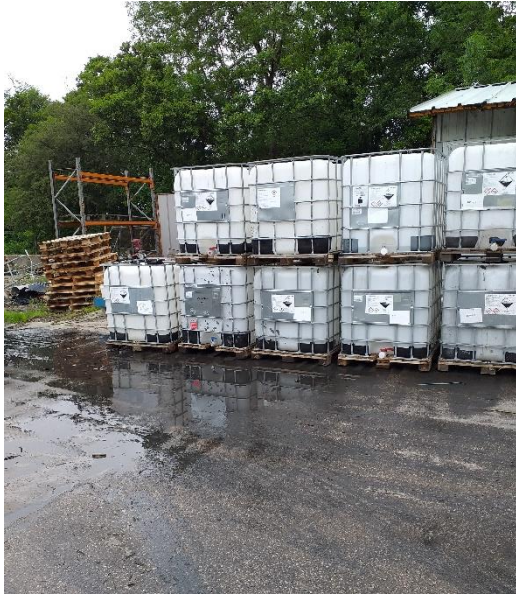
Formic acid containers stored adjacent to area of permeable surfacing

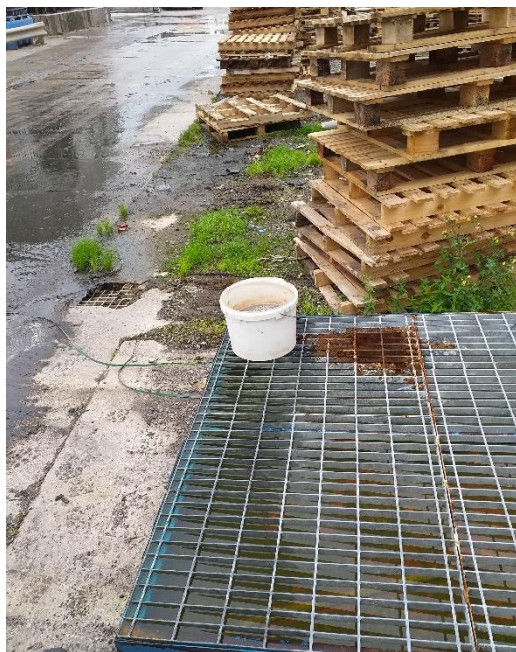
Drain position allowing surface water flows to drain to an area of permeable surfacing.

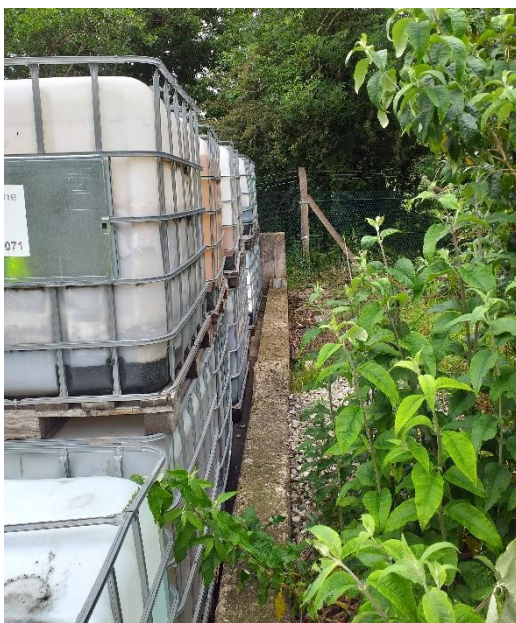
Lack of separation between stored IBCs and adjacent gravel surfacing

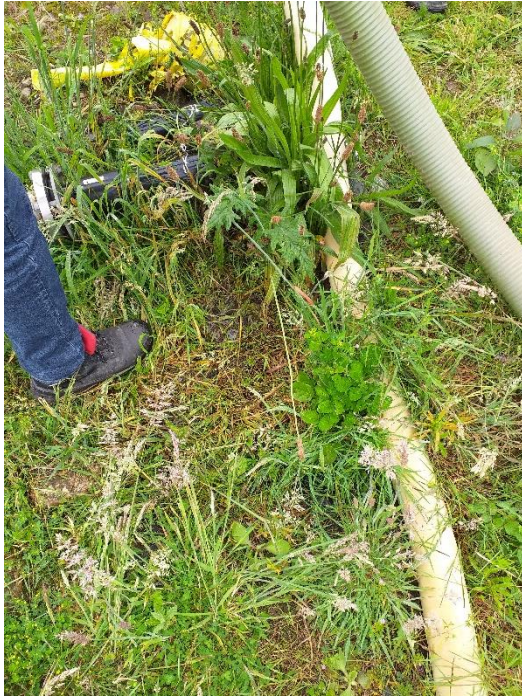
Ground below dripping lagoon pipework manifold

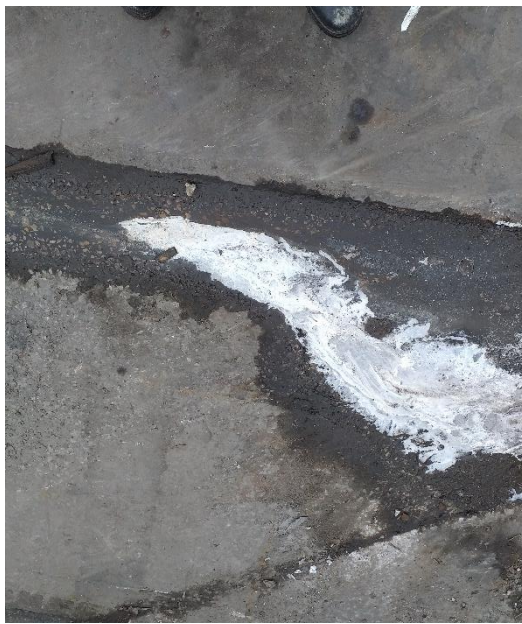
Spills in area of concrete jointing/ cracking adjacent to the tank farm

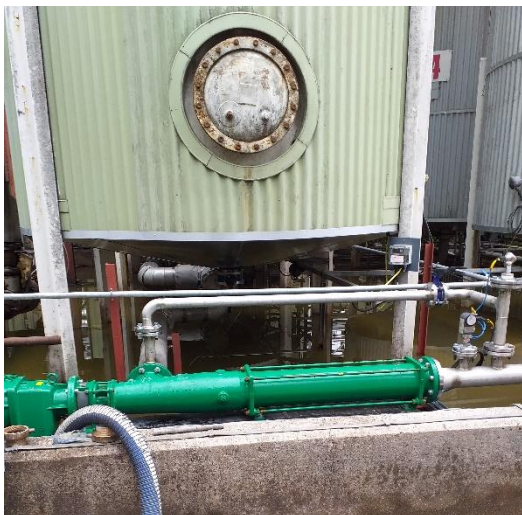
TS tank farm bund approx. 1/3<sup>rd</sup> full of rainwater

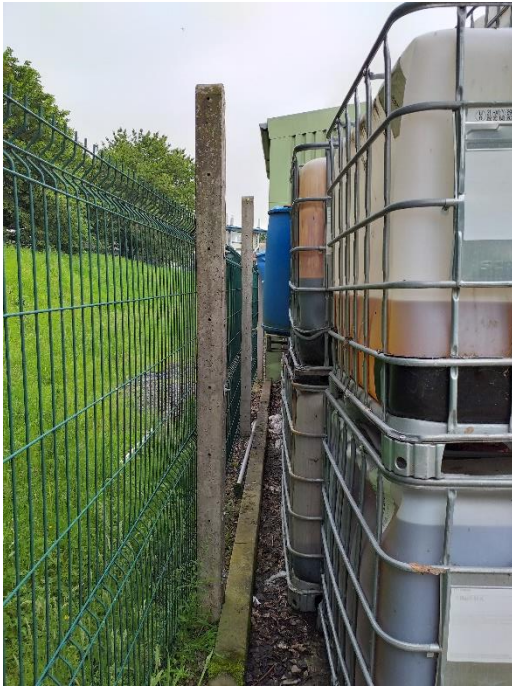
Lack of spacing between container storage and fencing adjacent to warehouse. Blue drum leaning on fence.

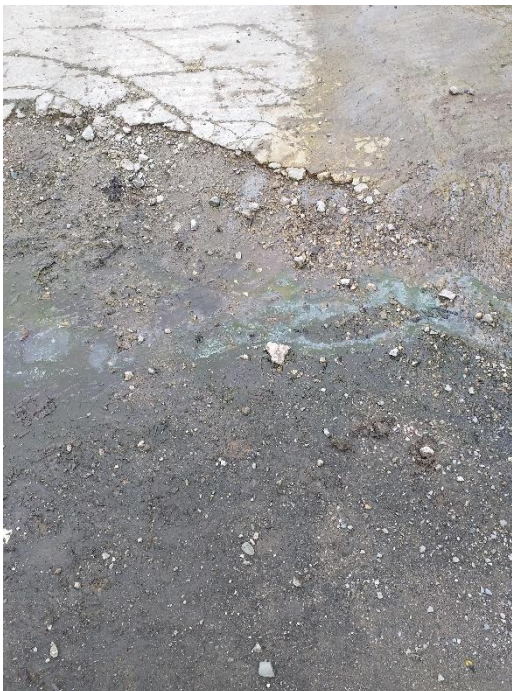
Concrete degraded on lower yard area adjacent to lagoon access ramp
