Compliance Assessment Report CAR_NRW0039369

Permit being assessed: AW1005301

For: TALGARTH STW BRONLLYS ROAD TALGARTH, held by DWR CYMRU
CYFYNGEDIG

Type of assessment carried out: Site Inspection, Reason: Routine.

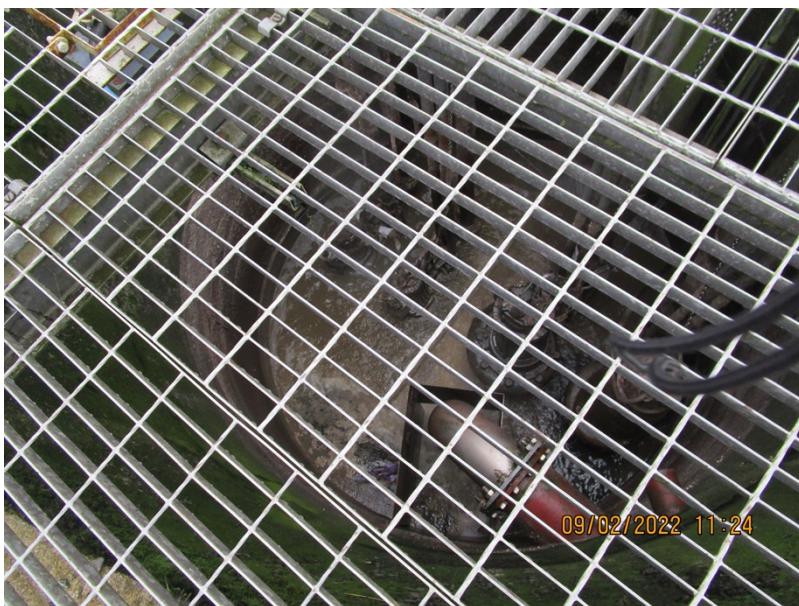
The incoming flow to the site arrives in an intel well where two pumps are in place to pump flow to the inlet of the works. There are also two separate pumps at a higher level for when incoming flows reach storm discharge levels. At the time of inspection, the storm pumps were above the water level and the works was not running to storm. In regular operation the incoming flow is pumped up to the inlet point, where telemetry is in place to monitor flows.

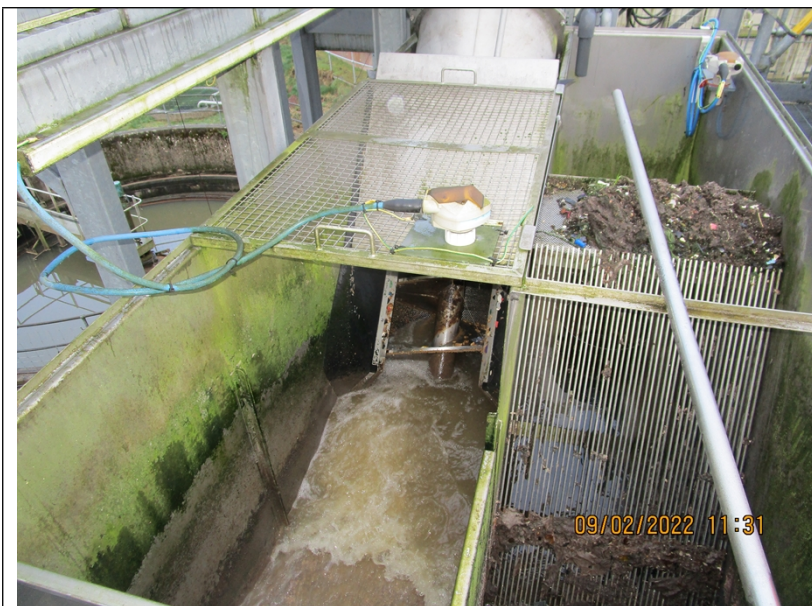
At the head of the works an Archimedes screw screen removes rag and large solids, this is also surrounded by a 6mm mesh screen. This was clearly operation and clear of blockages. There is a bypass screen (to the right) which is approximately 05 to 1 inch in aperture, this is used when the main screen is out of use or in the event of a failure. There were some solids build up present on the bypass screen, however as it was not in use this does not affect the process. There is EDM equipment in place to monitor flows, this appeared in working order.

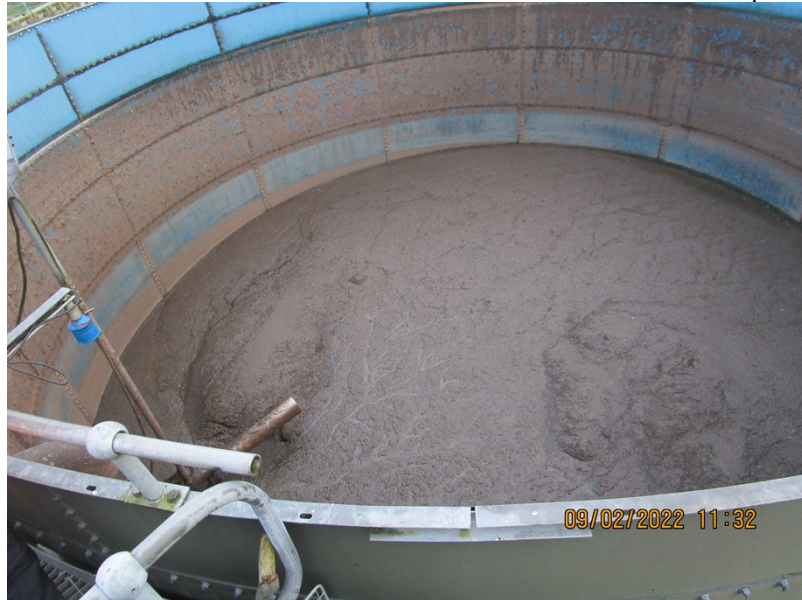
There is a single storm tank, which was empty (silt at the bottom but no liquid) at the time of inspection. The storm tank has an automatic return to the head of the works. The storm screen in place is a 6mm aperture.

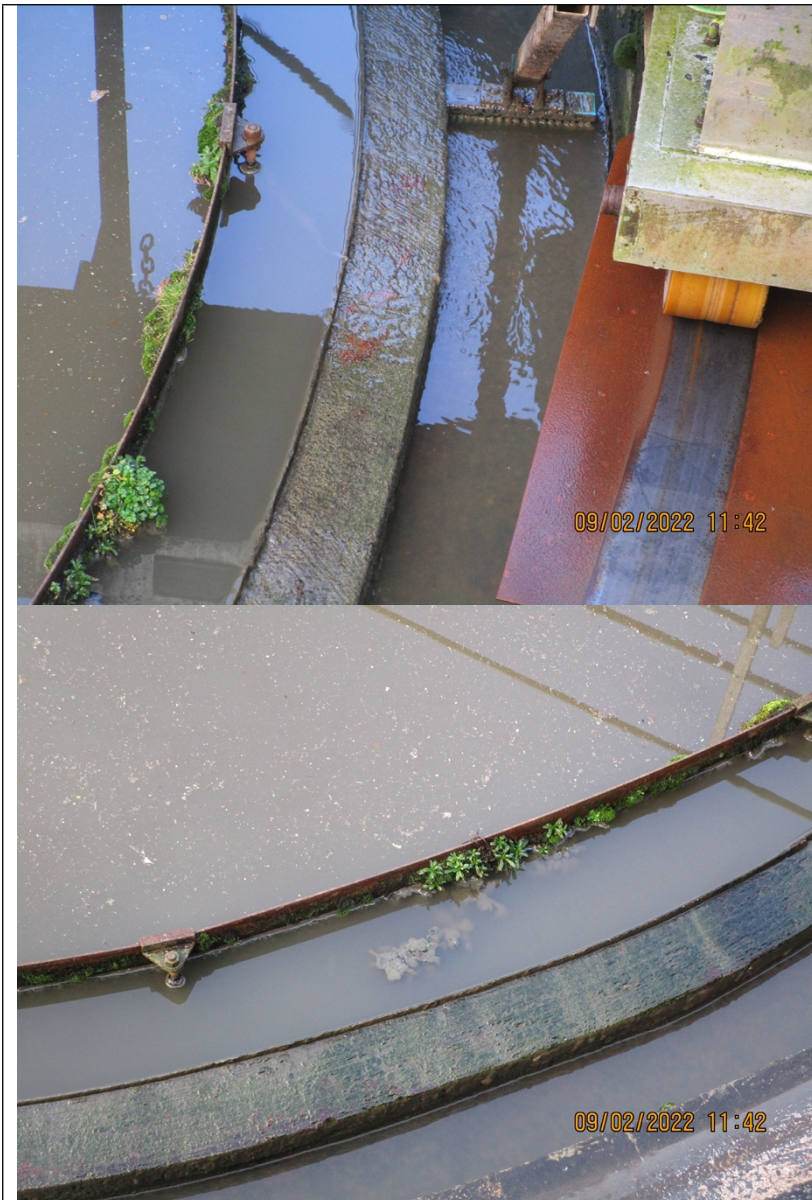
The primary settlement consists of two round designed tanks, with rotating sludge scrapers. Both tanks appeared in good working order and there were no signs of significant solids carrying over from either. Each settlement tank has individual monitoring in place. There were small amounts of sewage fungus observed in the outfall channels of the primary settlement tank, however this does not suggest any problem with effluent from the site.

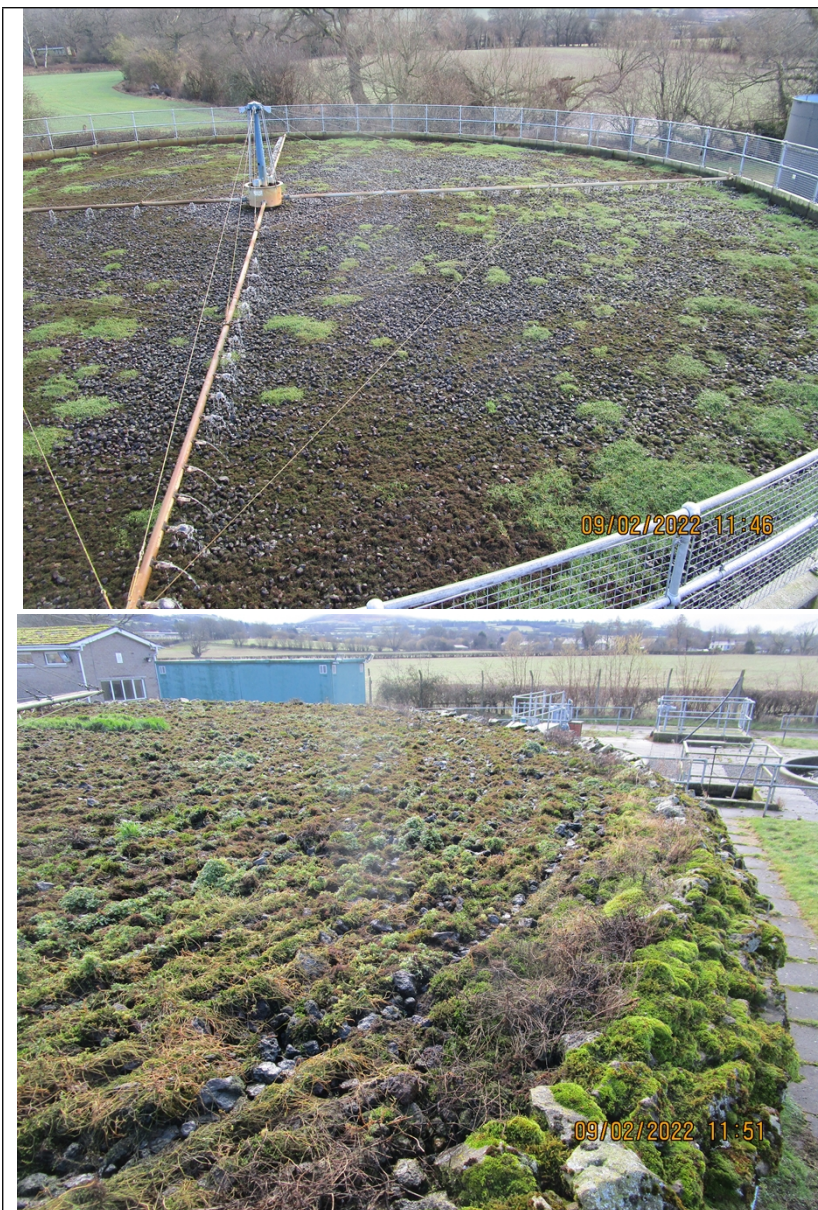
There was some vegetation build up on the newer filter at the top of the site. The three smaller filter beds had higher levels of vegetation build up on top of the filter media. I questioned about the vegetation management, and was advised that they are periodically cleared, there is a health and safety concerns with doing so. This is because the filter beds are raised and there is no guard rail. The vegetation present does not appear to be hindering the operation of the filter beds currently, so this is only any observation.

The works visually appears in good working order and well maintained. Ideally the older filter beds should be cleared of vegetation before any issues develop.

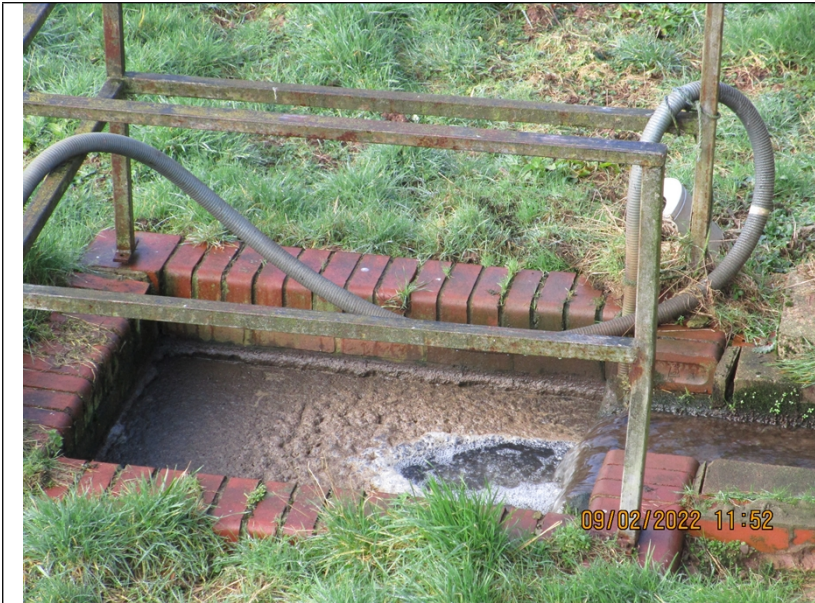
The outfall from the filter beds has foam visible on the surface. Which could suggest higher nutrient levels within the effluent.

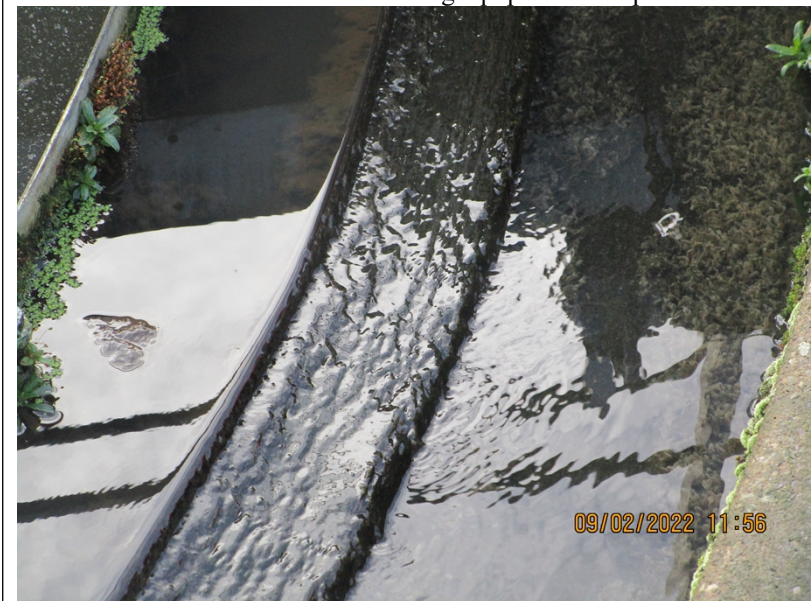
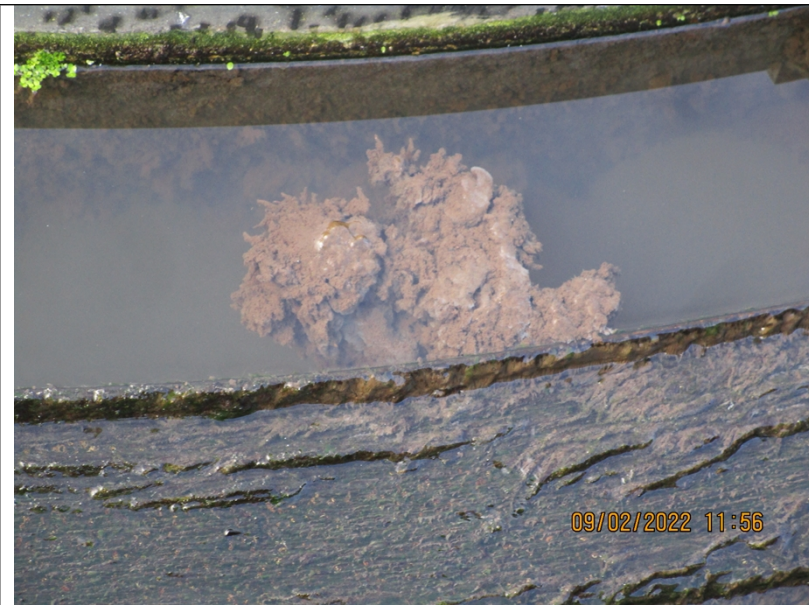
The works has three round humus tanks with rotating scum scrapers (Brush). There were no signs of solids passing over from the settlement tanks. The rotating brushes were clearly operational. There were no signs of significant solids passing over to the outfalls of the tanks. I located some build ups of sewage fungus on the outside of one of the scum retaining boards, and a slight build up on the outfall channels of the same tank, which suggests potentially raised ammonia within the effluent. Monitoring equipment is in place on the humus tanks in case of any issues.

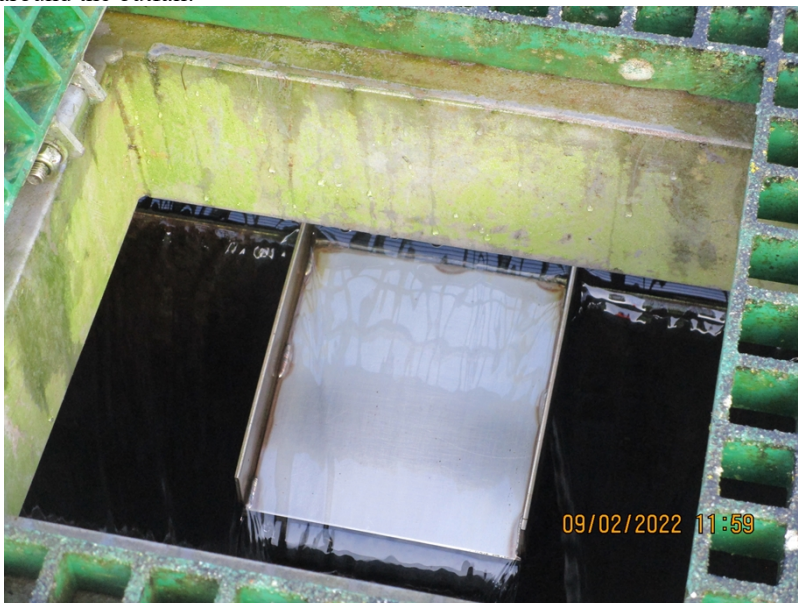
The final effluent from the humus tanks passes through a Magflow flow meter, which appeared to be operating as required and accessible for inspection. The sample point is clearly marked with appropriate signage including the sample point number. The effluent within the inspection point appeared clear of any solids or signs of polluting matter. The UWWTW sampling point was clearly marked and available. I checked the sampling data available onsite and shows that the effluent has been within consented limits. I observed no signs of negative impact on the receiving watercourse around the outfall.

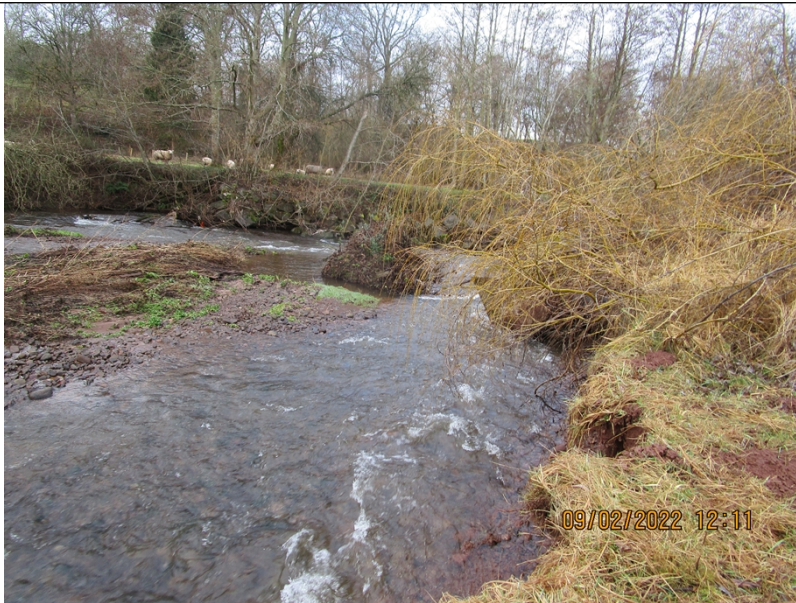
The outfall into the river has previously been damaged by a storm even. The banking behind the outfall chamber collapsed and washed away during storm Denis (February 2020). The concrete housing for the outfall was also damaged and swept downstream. As such the site is not currently discharging via the location stated on the permit. A grid reference was taken close to where it is currently discharging – SO 1507 3480

NRW have been made aware of the issue and this is not considered a breach of the permit at this time. I was advised that due to the complexity of the works required, they have not been able to confirm a contractor to complete the works. Several have attended with a view to providing quotes, however, have not been able to undertake the works. This will be an ongoing project as it will be difficult to restore.
