**EAST WASTE  
MANAGEMENT SITE,  
LLANWERN STEELWORKS**

**PERMIT EAWML/30003**

**2018 Annual Review of  
Environmental  
Monitoring**

*Report Number 1785r1v1d0219*

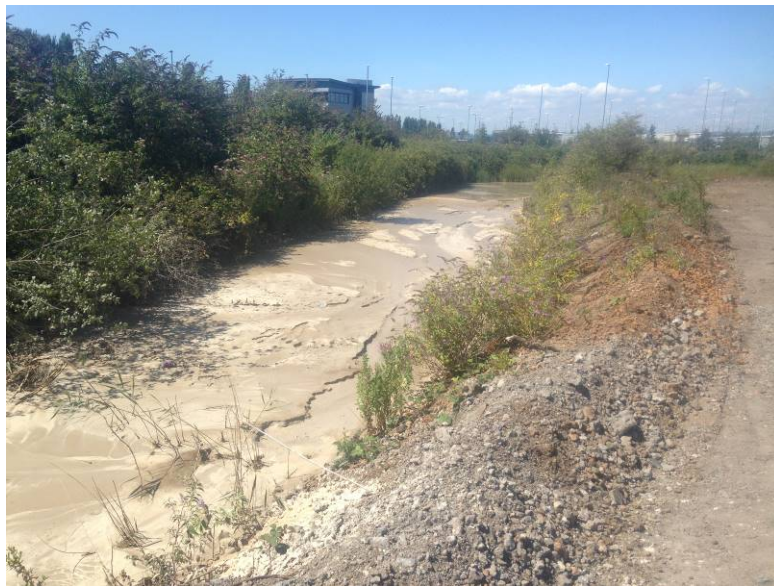
As the landfill is not formally lined, the only way of indirectly monitoring leachate quality is to sample the leachate collection ditch that runs along the western toe of the landfill. This started to be monitored in 2016.

As anticipated, the monitoring reveals that surface water running in the leachate collection ditch is dominated by leaching of slag wastes and is characterised by high pH, alkalinity and calcium and low metals. The mobility of many metals will be reduced under the strongly alkaline conditions. In 2018, pH was persistently over 12 and EC typically over 4000 microS/cm and dominated by Ca-HCO<sub>3</sub>. Ammonia and phosphate were frequently elevated but most trace metals are at low levels. The ditches drain to the on-site works treatment facility.

Plate 1. Leachate Collection Ditch at southwest corner of site

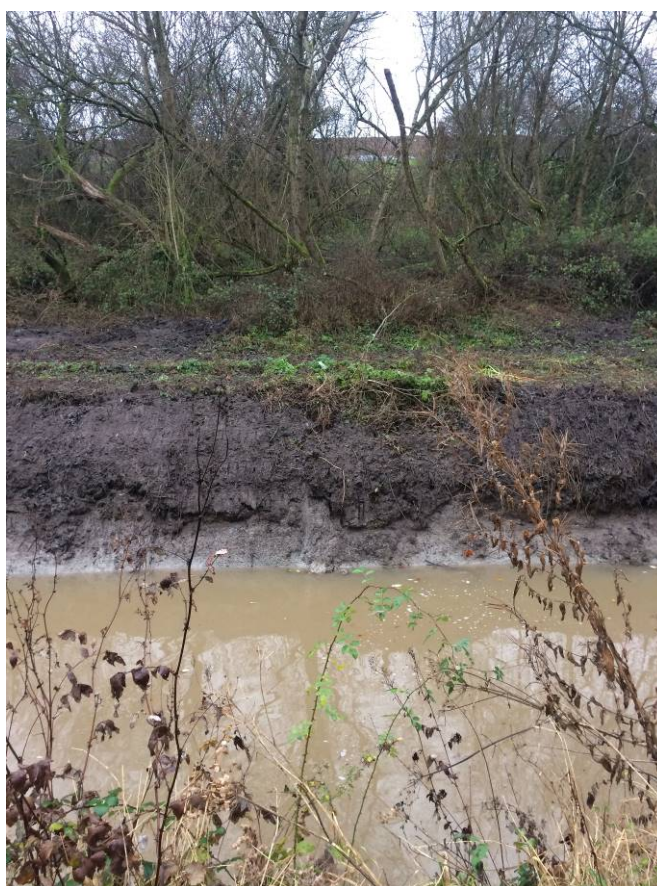
The latest monitoring data continues to indicate that upgradient and downgradient surface water chemistry is generally very similar. However, there are times when there are abrupt changes in several parameters including pH and alkalinity. Subtle differences in the concentration of sodium, potassium, chloride, sulphate and alkalinity are also apparent and as leachate has been observed along this flank and as the waste in the landfill is being exposed during the restoration works, this aspect of the monitoring programme should continue to be closely scrutinised. Recent inspection of the adjacent reen indicates that the reen is cut into low permeability deposits and that there are no obvious visual signs of staining indicative of leachate (see Plate 2). At this stage, there is no clear evidence that the reen quality is being impacted by the landfill.

Plate 2. Reen flowing from right to left along eastern side of site.  
Landfill can be seen in background beyond tree.

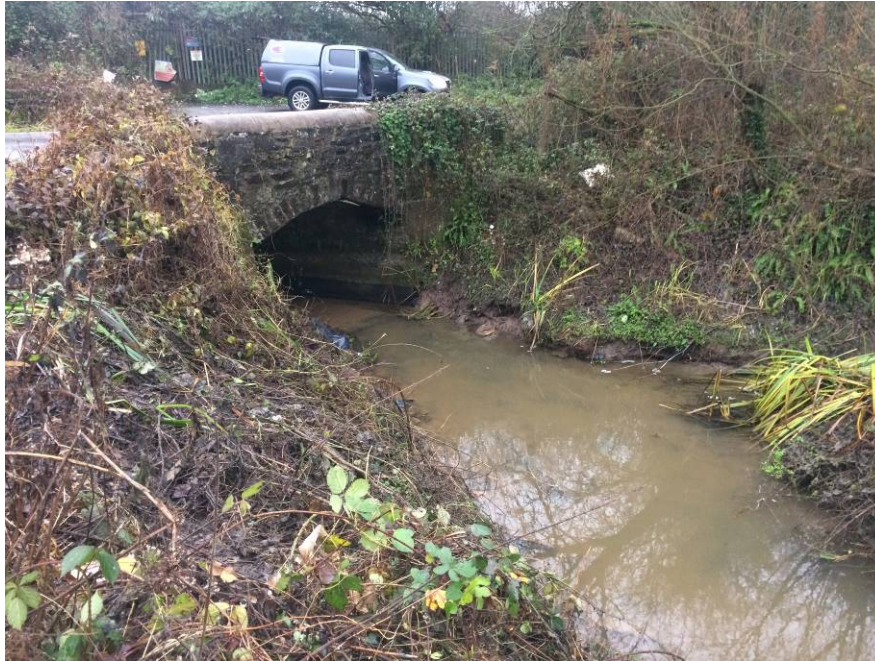
Continued scrutiny of upstream influences is also required as observations in December 2016 (see Plate 3) suggest that there are upstream sources of suspended solids.

Plate 3. Suspended solids in surface water upstream of site
