# APPENDIX B PHOTOGRAPHIC LOG

**PHOTOGRAPHIC LOG**

**Site Location: BBC Llandaff, Cardiff**

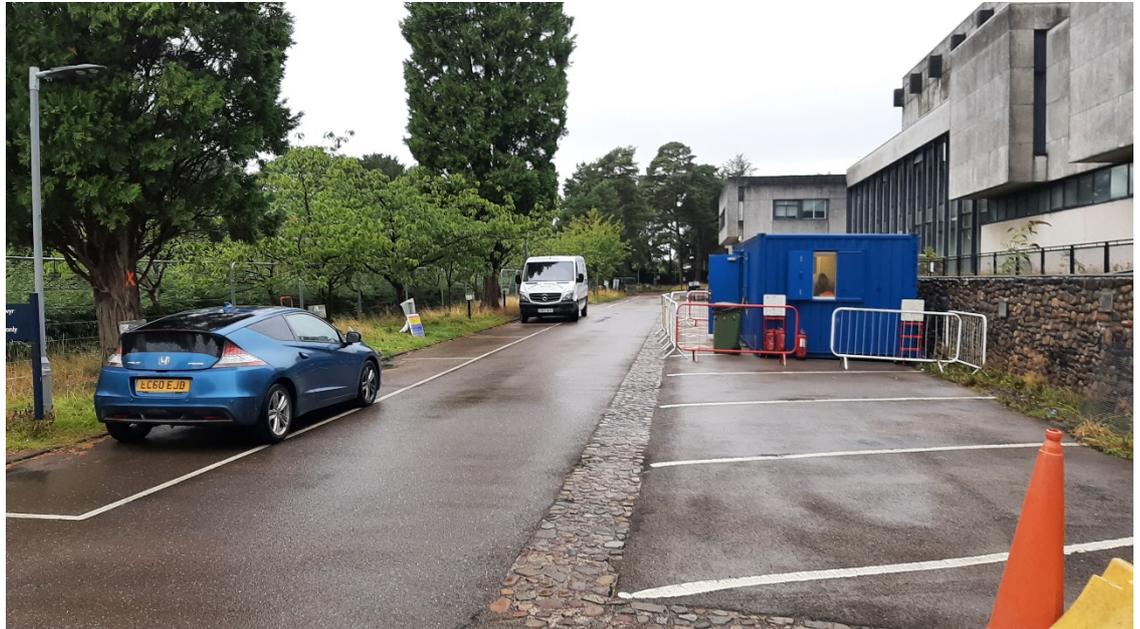
**Photo No.**  
1

General view looking west along front of main building

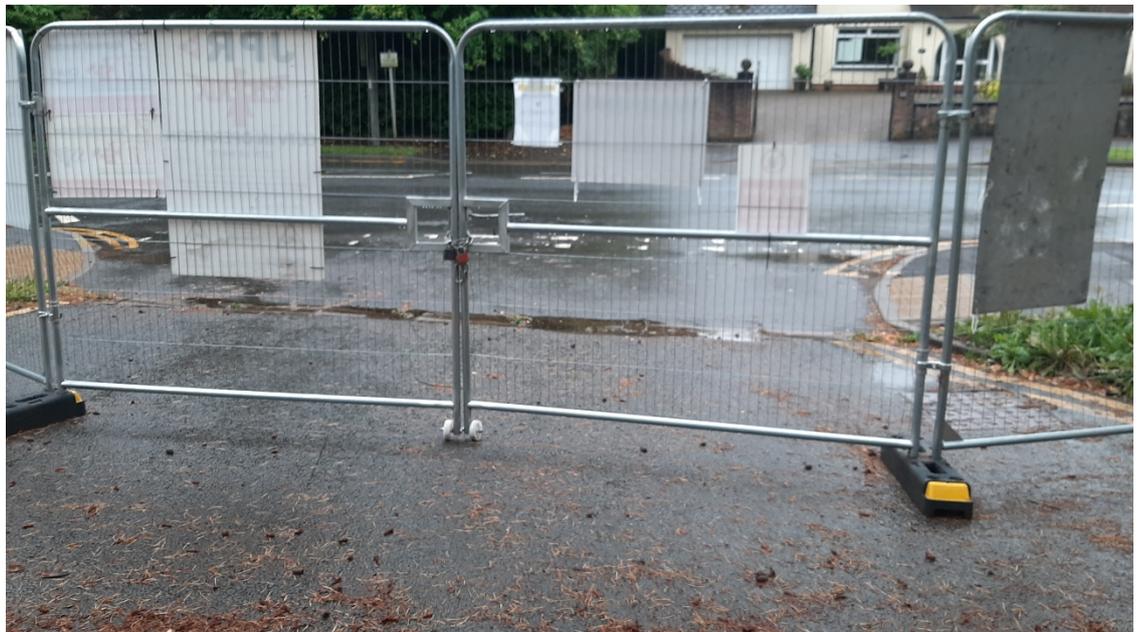
**Photo No.**  
2

General view of site exit on western boundary looking towards Llantrisant Road

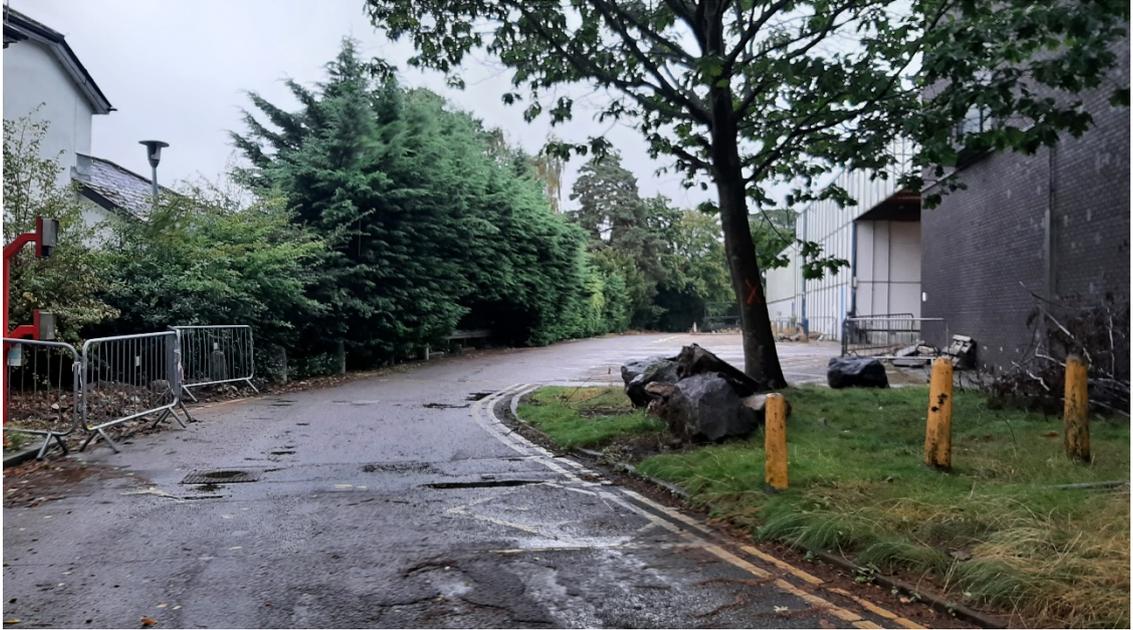
<p><b>Photo No.</b> 3</p>

<p><b>Date:</b> 9<sup>th</sup> Sept 2021</p>	
<p>General view looking north from exit</p>

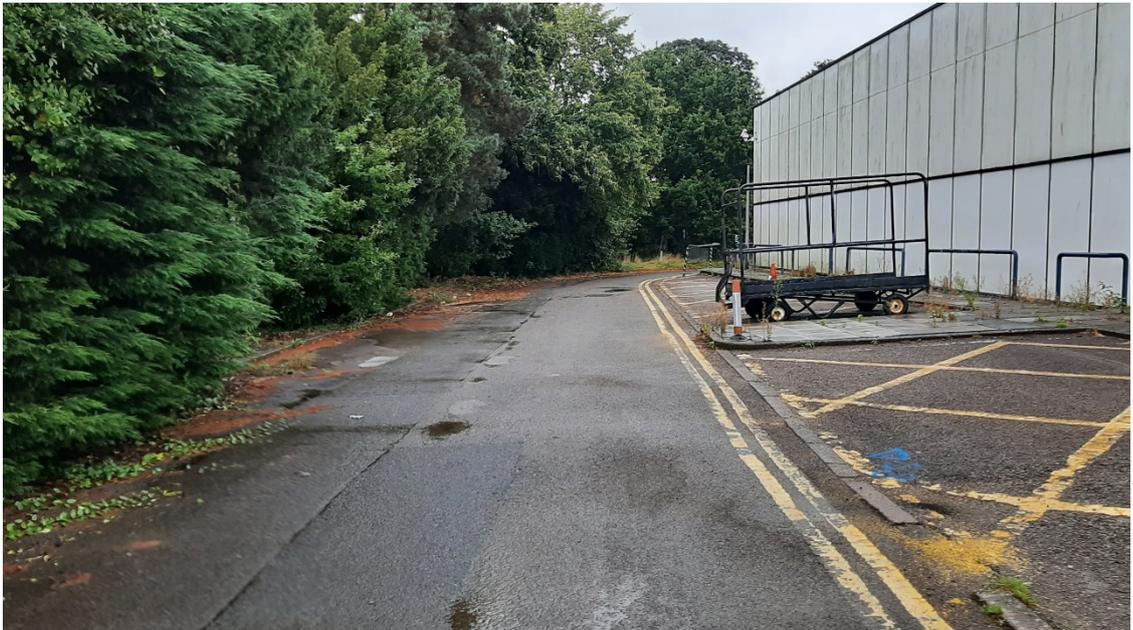
<p><b>Photo No.</b> 4</p>

<p><b>Date:</b> 9<sup>th</sup> Sept 2021</p>	
<p>Further view looking north along western boundary</p>

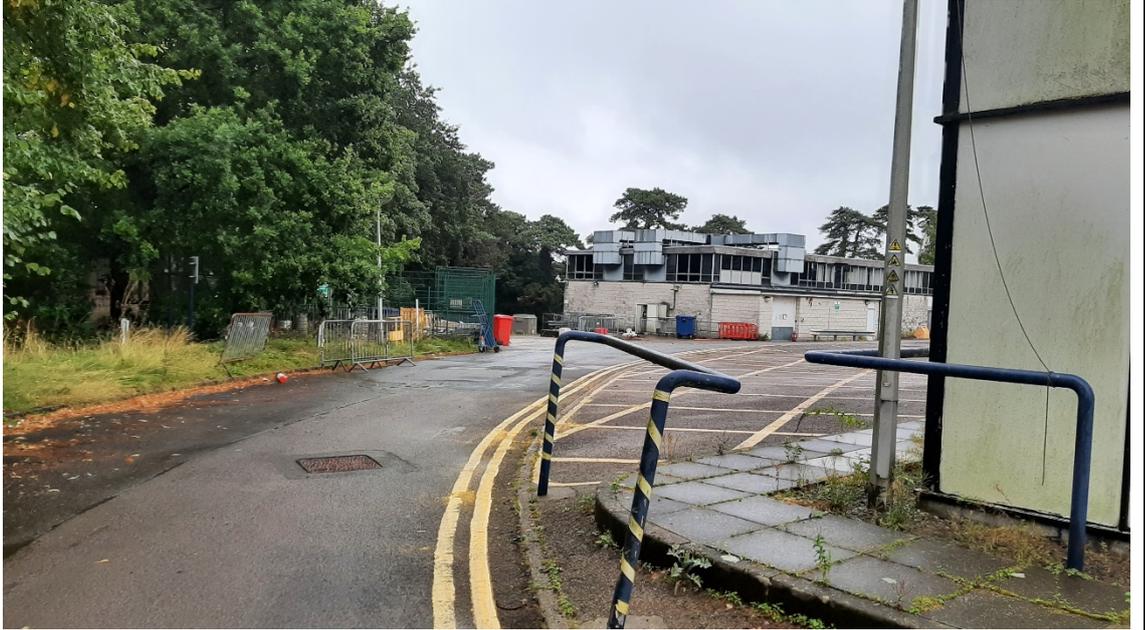
<p><b>Photo No.</b> 5</p>

<p><b>Date:</b> 9<sup>th</sup> Sept 2021</p>	
<p>Further view looking north along western boundary</p>

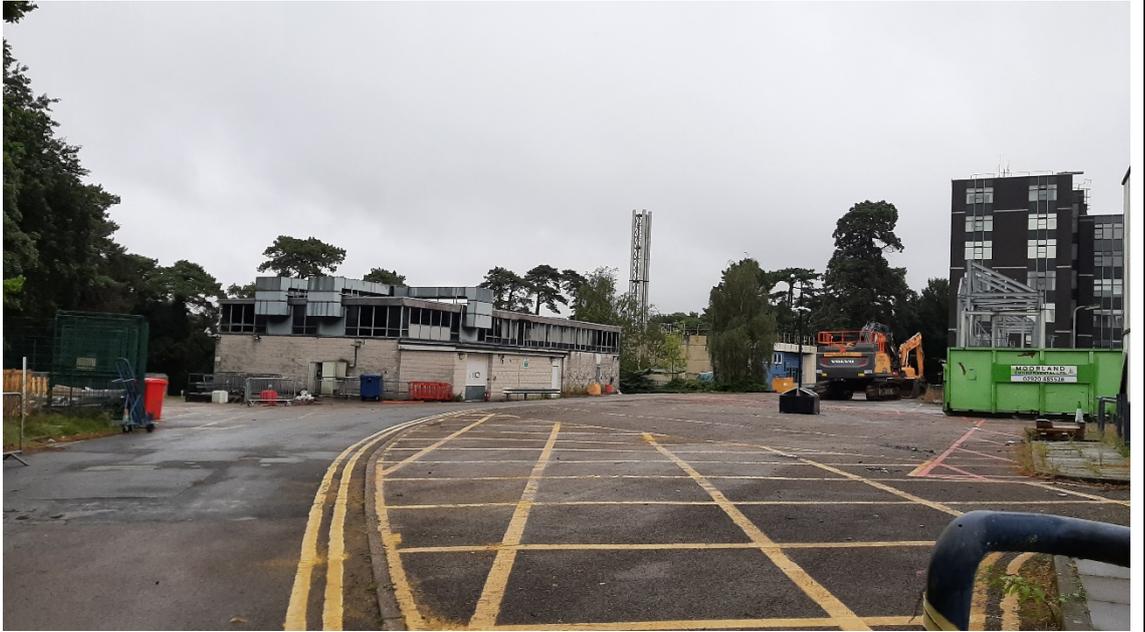
<p><b>Photo No.</b> 6</p>

<p><b>Date:</b> 9<sup>th</sup> Sept 2021</p>	
<p>View looking east from western boundary</p>

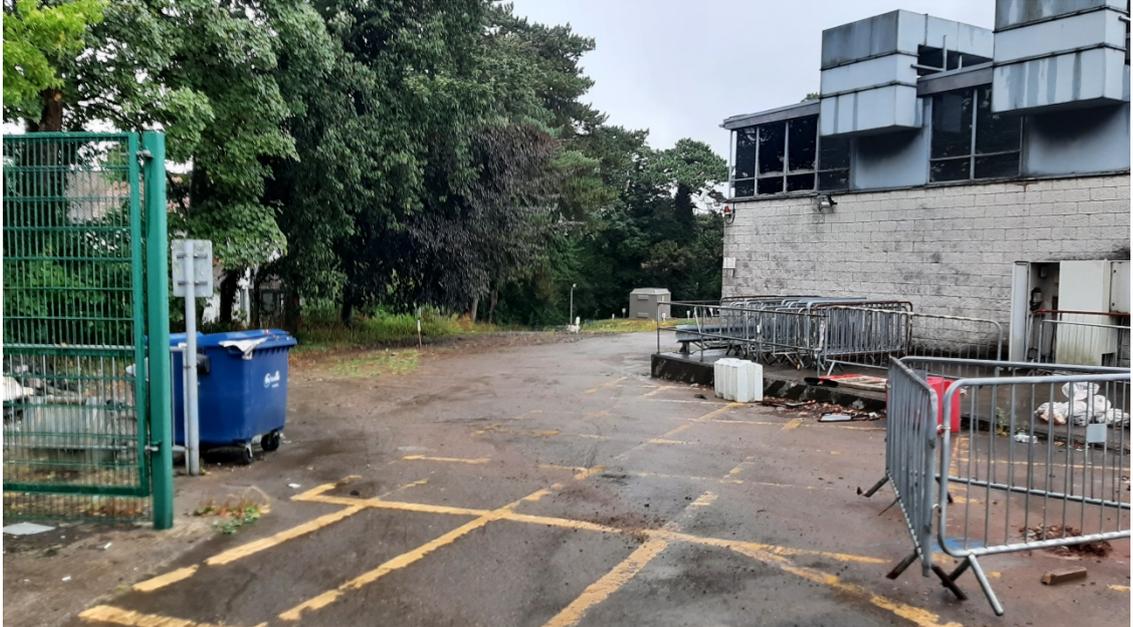
<p><b>Photo No.</b> 7</p>

<p><b>Date:</b> 9<sup>th</sup> Sept 2021</p>	
<p>View along north western boundary, showing slope down to northern boundary</p>

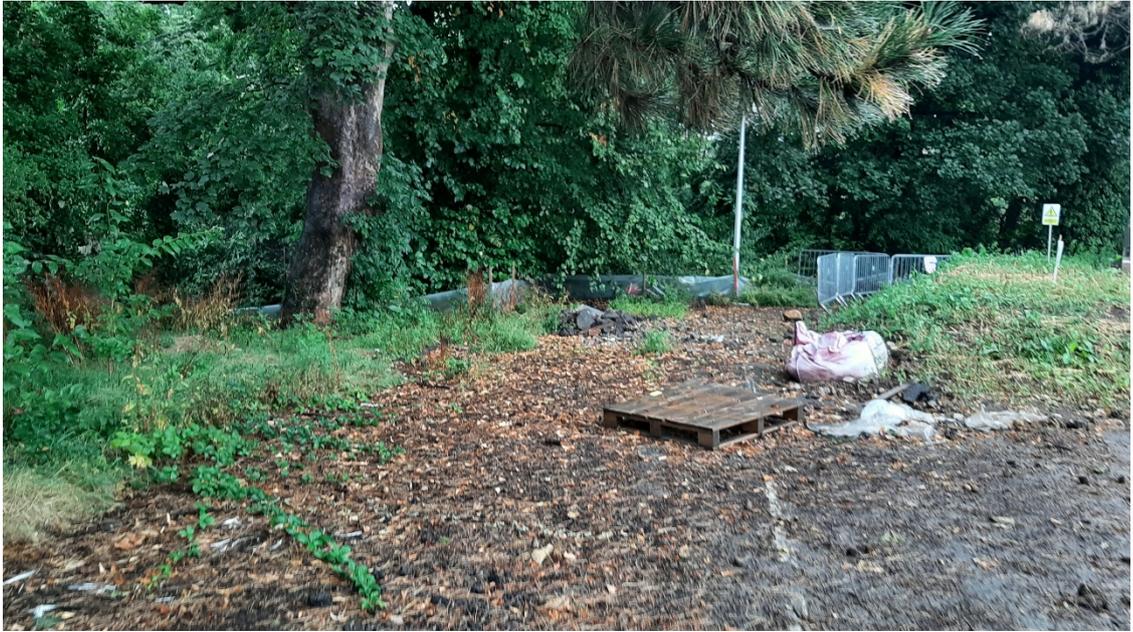
<p><b>Photo No.</b> 8</p>

<p><b>Date:</b> 9<sup>th</sup> Sept 2021</p>	
<p>View of north western boundary, note ecological fencing in place</p>

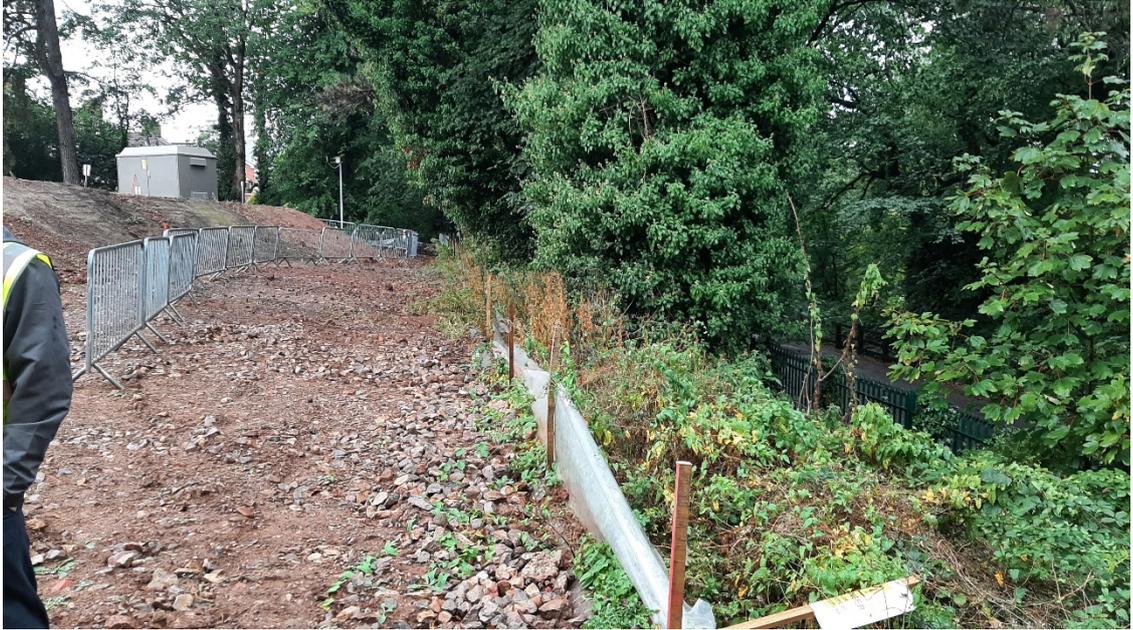
<p><b>Photo No.</b> 9</p>

<p><b>Date:</b> 9<sup>th</sup> Sept 2021</p>	
<p>View looking west along northern boundary</p>

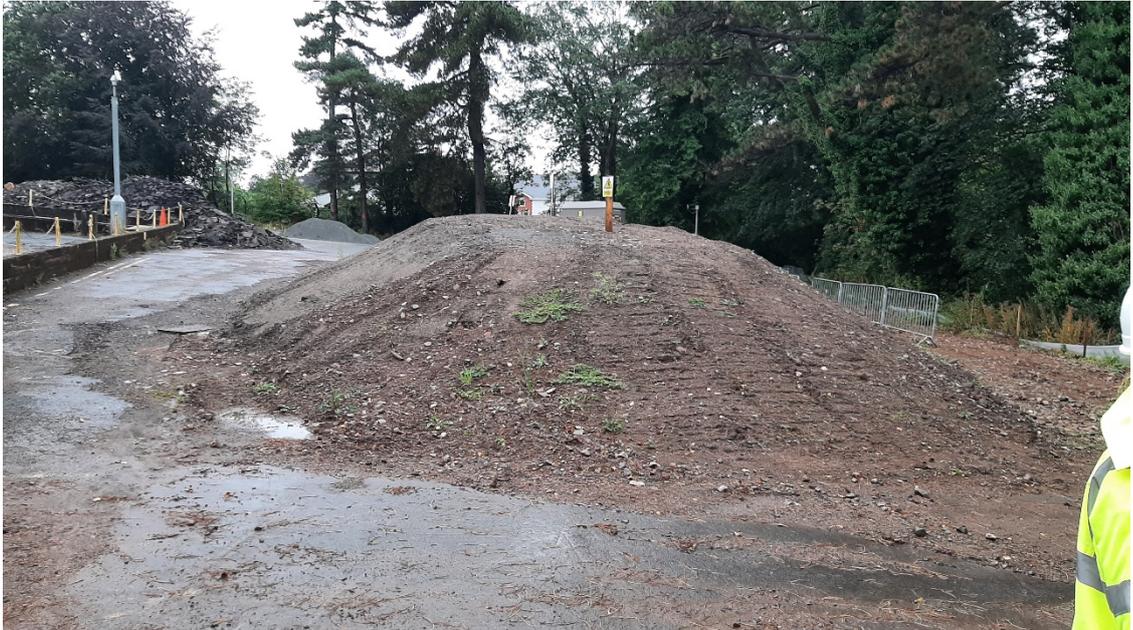
<p><b>Photo No.</b> 10</p>

<p><b>Date:</b> 9<sup>th</sup> Sept 2021</p>	
<p>Small stockpile in northwest area of site</p>

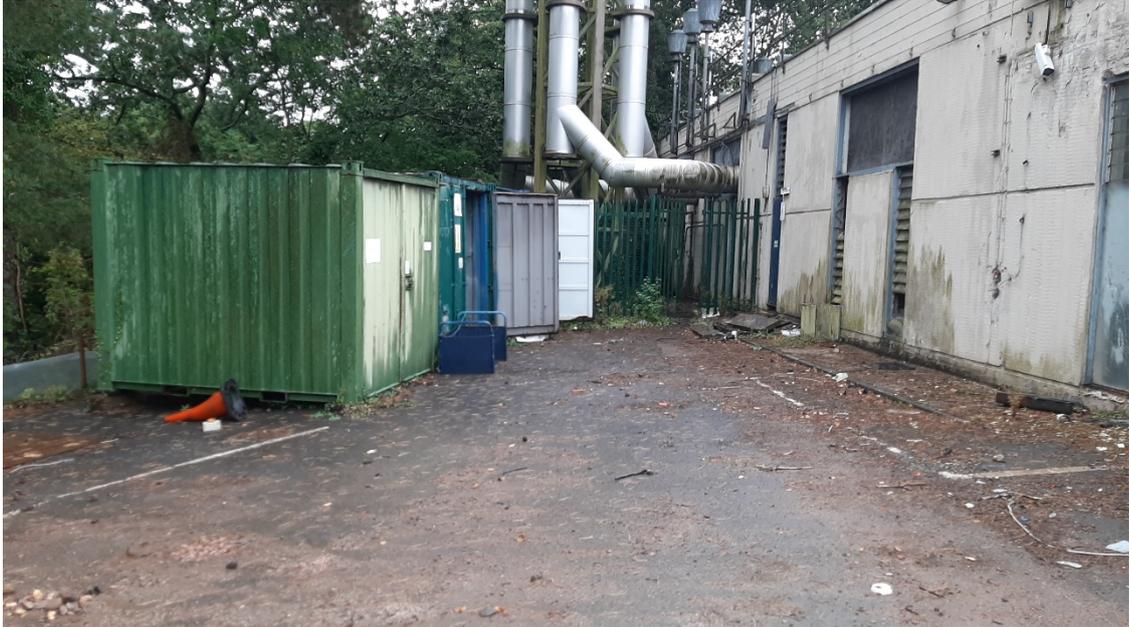
<p><b>Photo No.</b> 11</p>

<p><b>Date:</b> 9<sup>th</sup> Sept 2021</p>	
<p>View at rear of building near to north boundary</p>

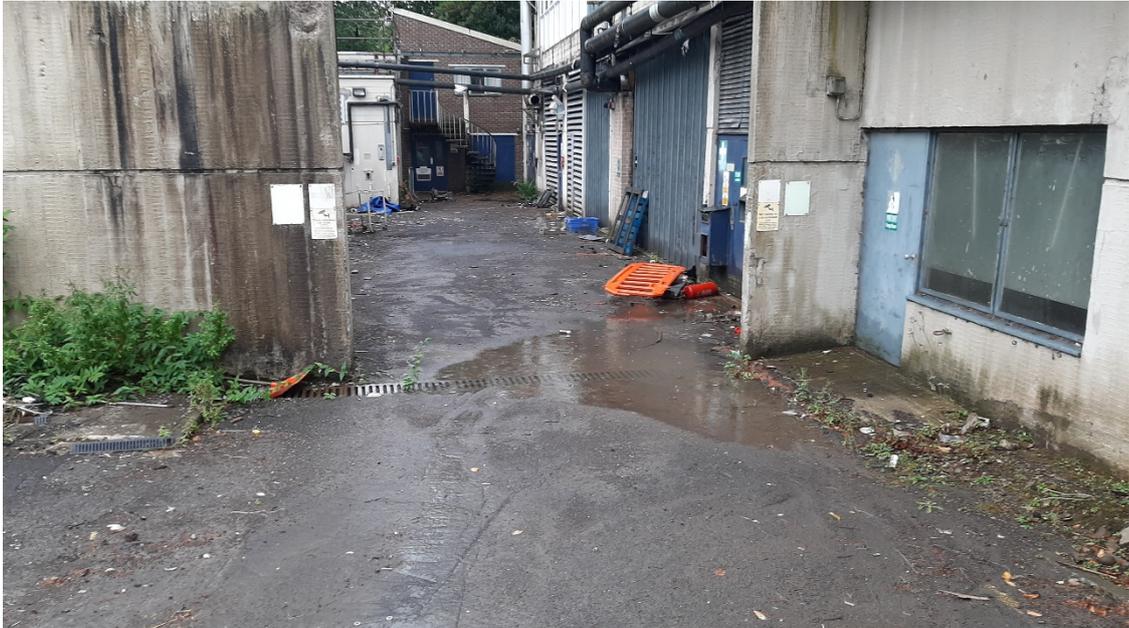
<p><b>Photo No.</b> 12</p>

<p><b>Date:</b> 9<sup>th</sup> Sept 2021</p>	
<p>View showing drainage systems in place at rear of building</p>

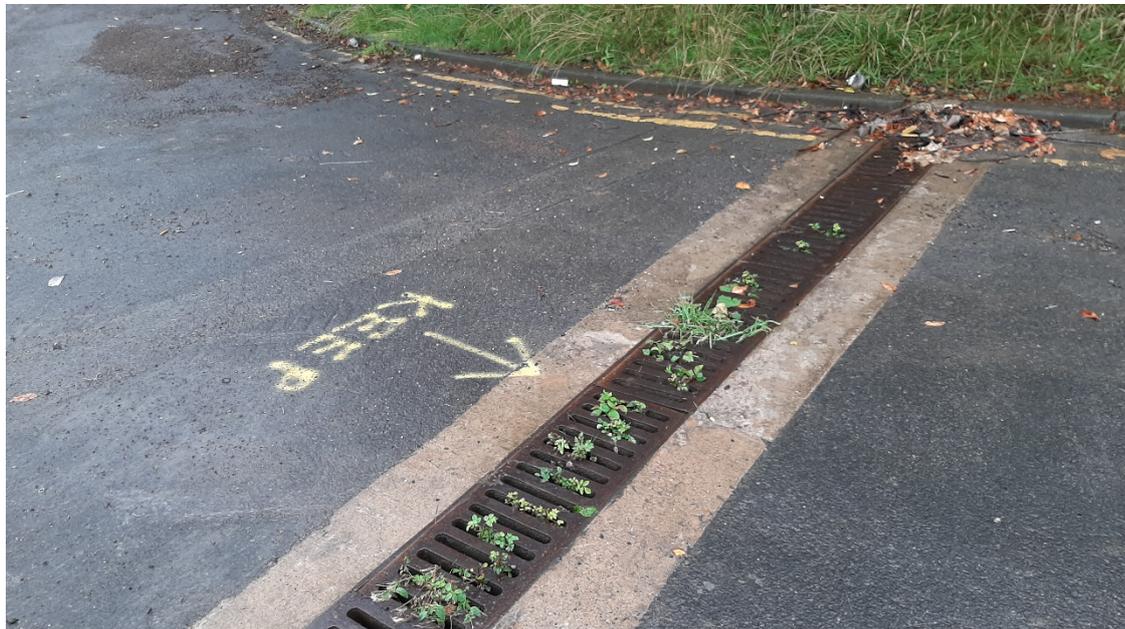
**Photo No.**  
13

Drainage systems are to be kept in place and utilised as part of the SWSMP

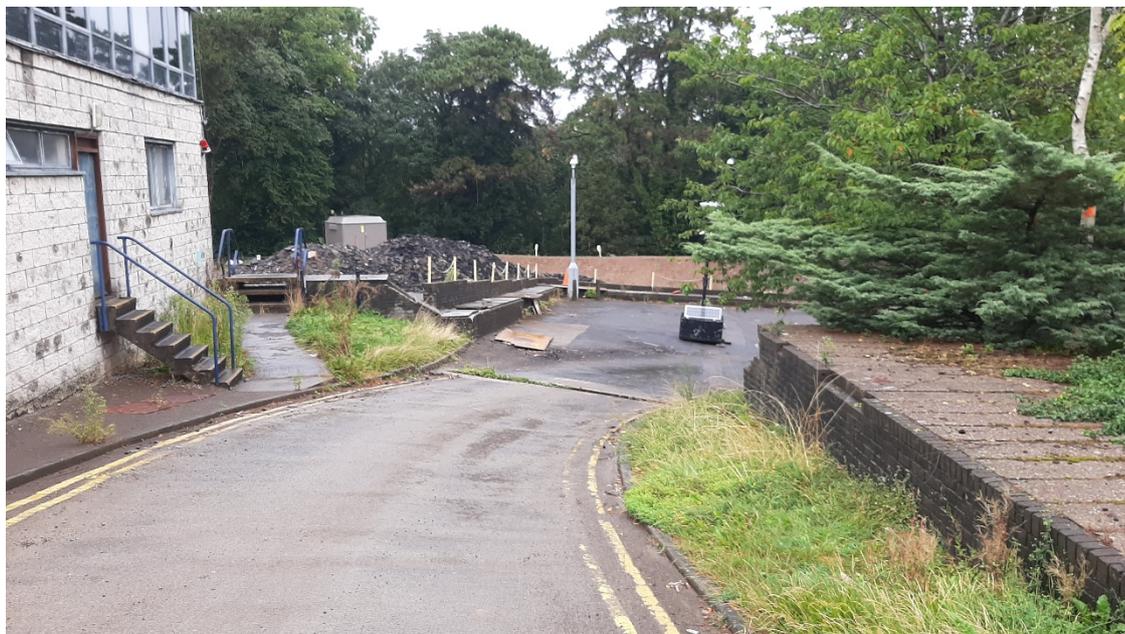
**Photo No.**  
14

View looking north showing slope within central north area of site at opposite end of building

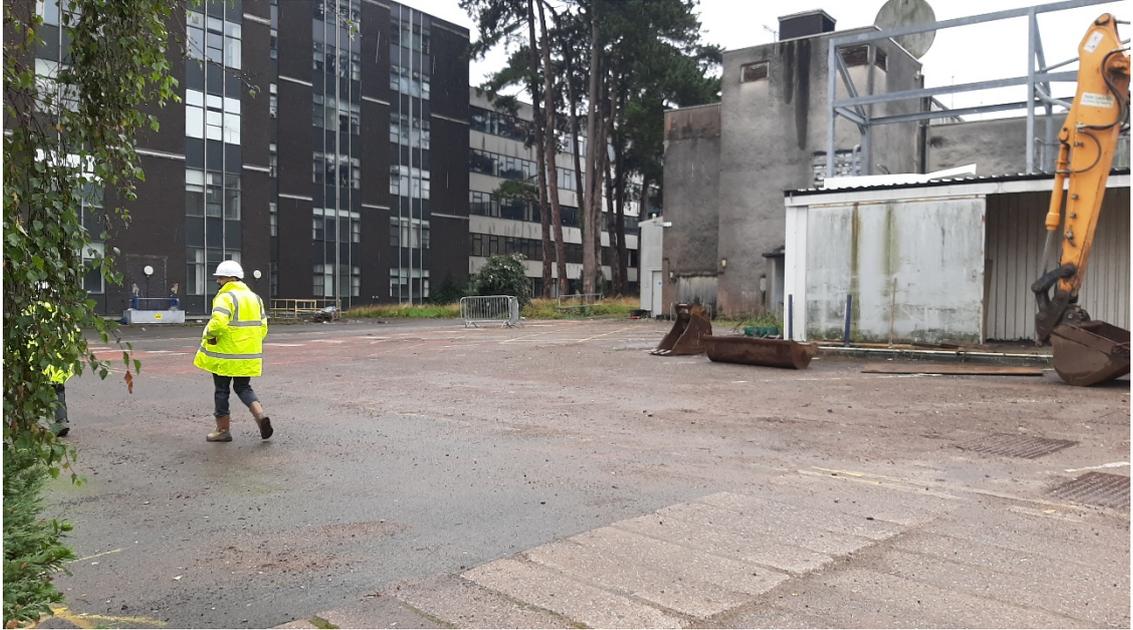
<p><b>Photo No.</b> 15</p>

<p><b>Date:</b> 9<sup>th</sup> Sept 2021</p>	
<p>Hardstanding area in central north part of site, note area of a well, demarcated by the barriers</p>

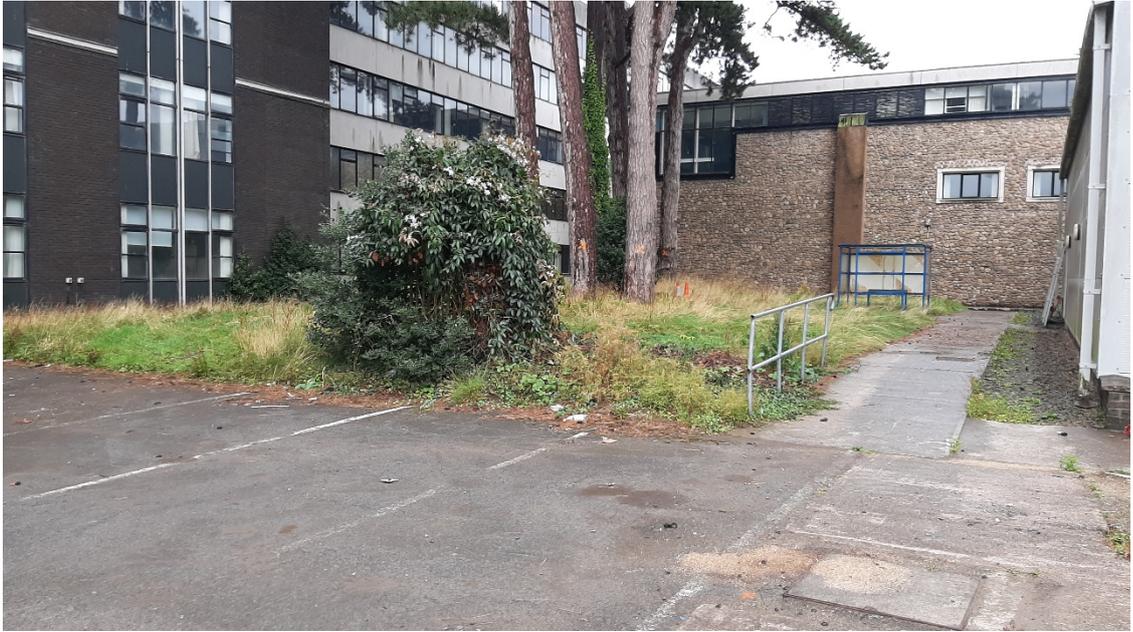
<p><b>Photo No.</b> 16</p>

<p><b>Date:</b> 9<sup>th</sup> Sept 2021</p>	
<p>Area of soft standing south of well</p>

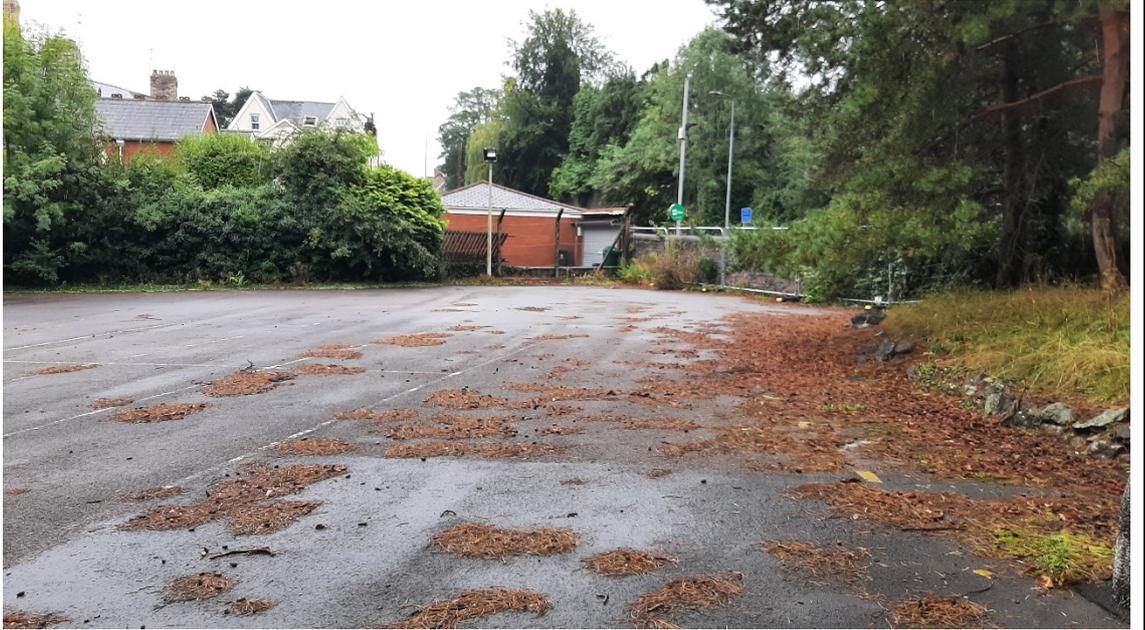
<p><b>Photo No.</b> 17</p>

<p><b>Date:</b> 9<sup>th</sup> Sept 2021</p>	
<p>Hardstanding in eastern area of northern development parcel</p>

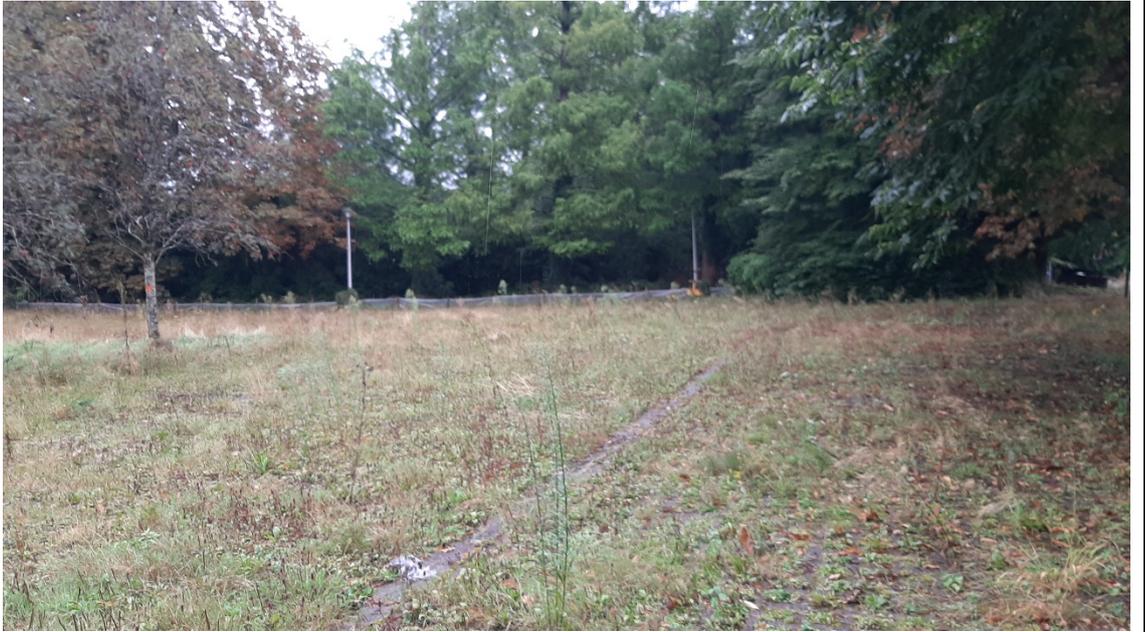
<p><b>Photo No.</b> 18</p>

<p><b>Date:</b> 9<sup>th</sup> Sept 2021</p>	
<p>Soft standing in eastern area of northern development parcel</p>

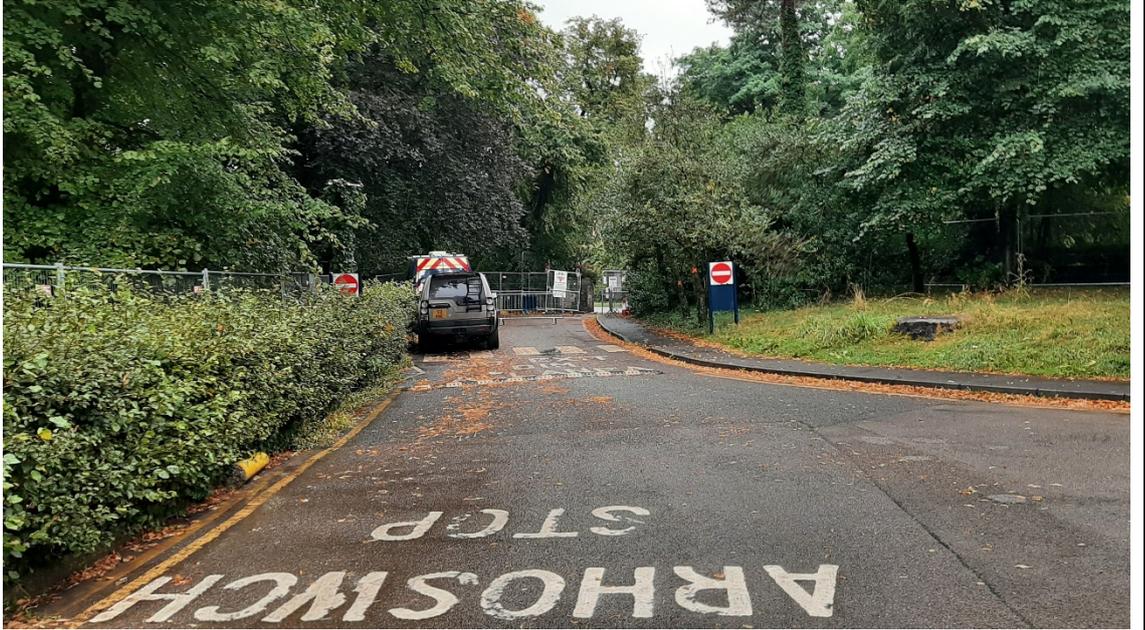
<p><b>Photo No.</b> 19</p>

<p><b>Date:</b> 9<sup>th</sup> Sept 2021</p>	
<p>General view looking east towards site entrance</p>

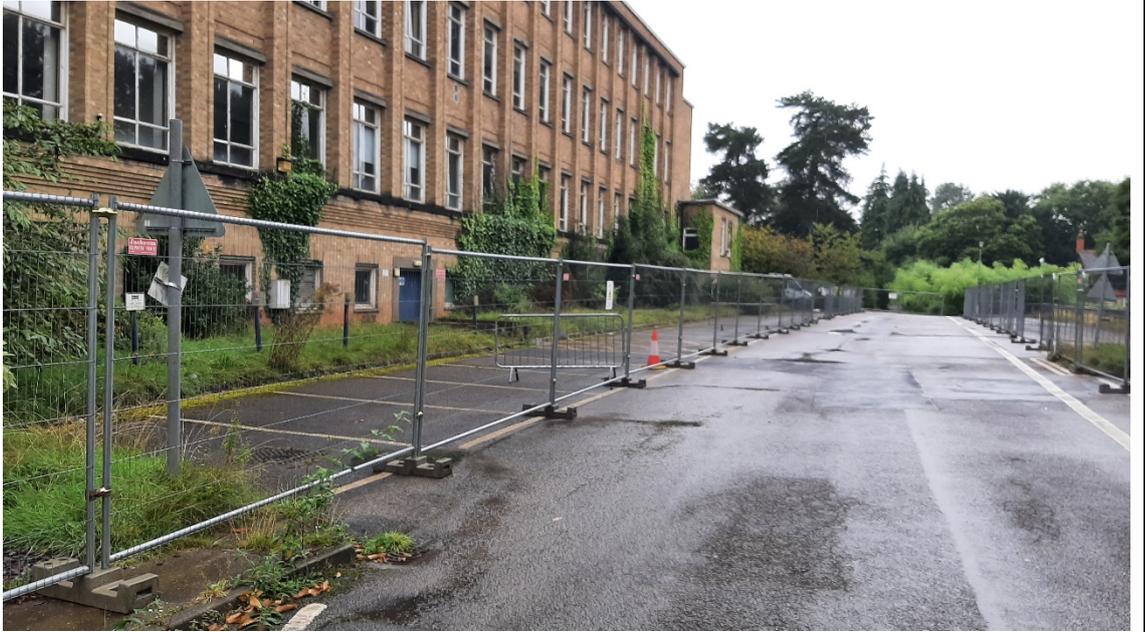
<p><b>Photo No.</b> 20</p>

<p><b>Date:</b> 9<sup>th</sup> Sept 2021</p>	
<p>View looking west along southern development parcel</p>

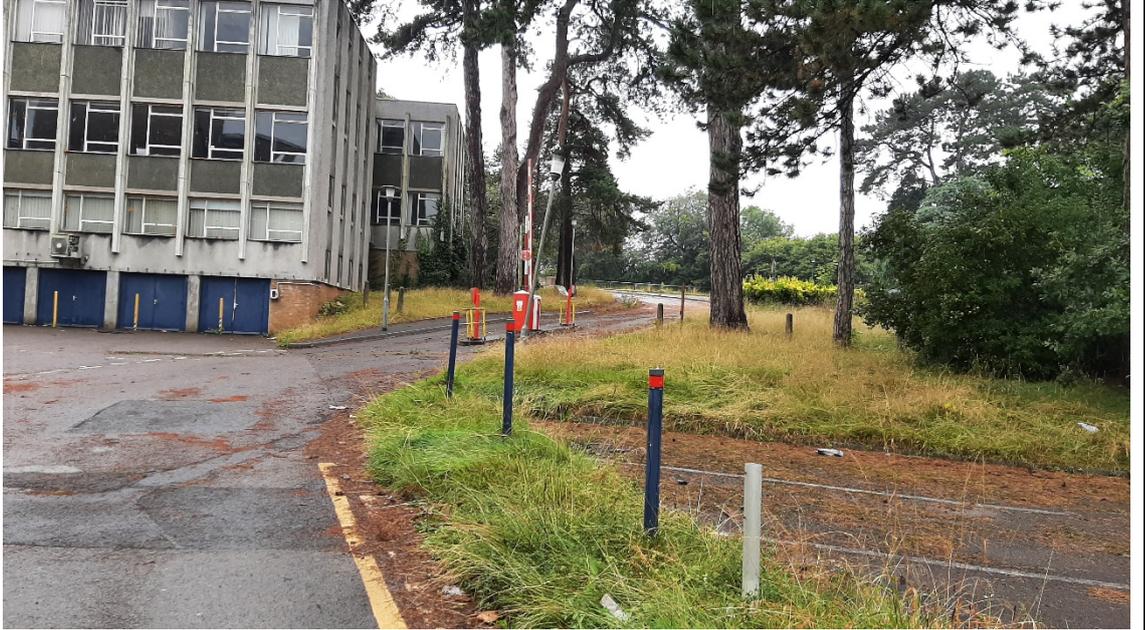
<p><b>Photo No.</b> 21</p>

<p><b>Date:</b> 9<sup>th</sup> Sept 2021</p>	
<p>General view from site entrance looking south. Note slope towards site entrance</p>

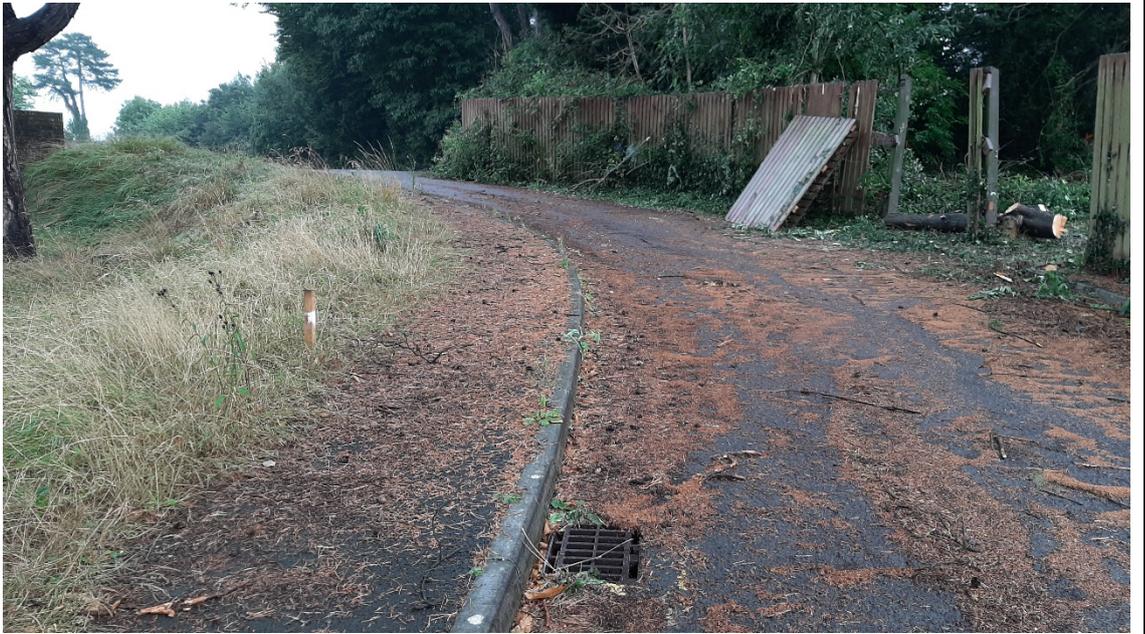
<p><b>Photo No.</b> 22</p>

<p><b>Date:</b> 9<sup>th</sup> Sept 2021</p>	
<p>Drainage systems still in place on roadway</p>

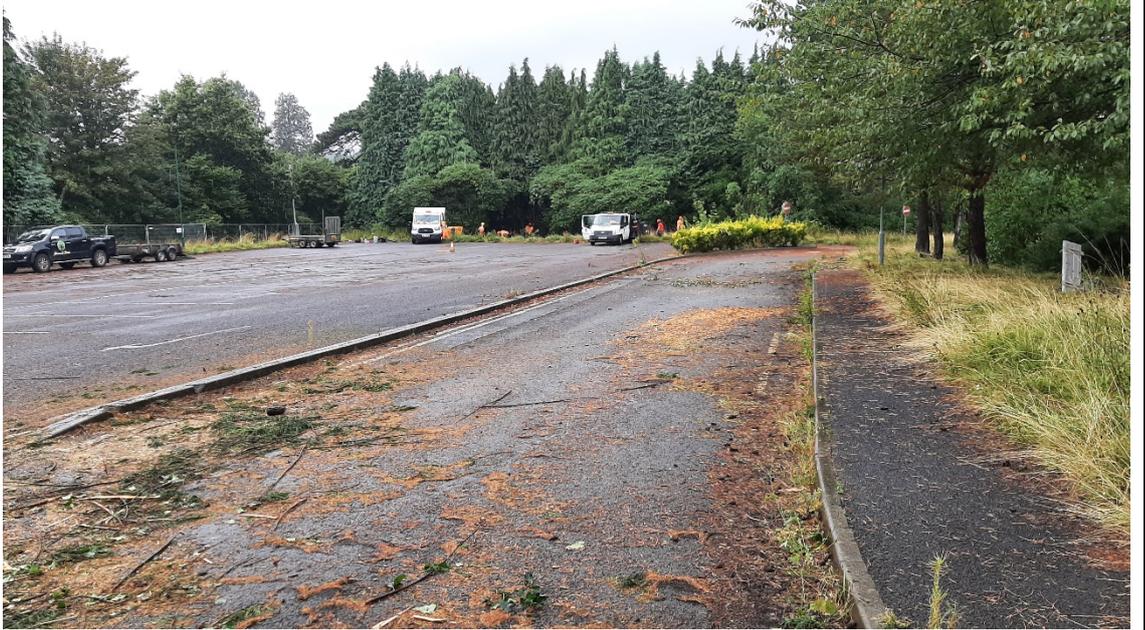
<p><b>Photo No.</b> 23</p>

<p><b>Date:</b> 9<sup>th</sup> Sept 2021</p>	
<p>General view of western boundary looking north west, tree cutting being undertaken at time</p>

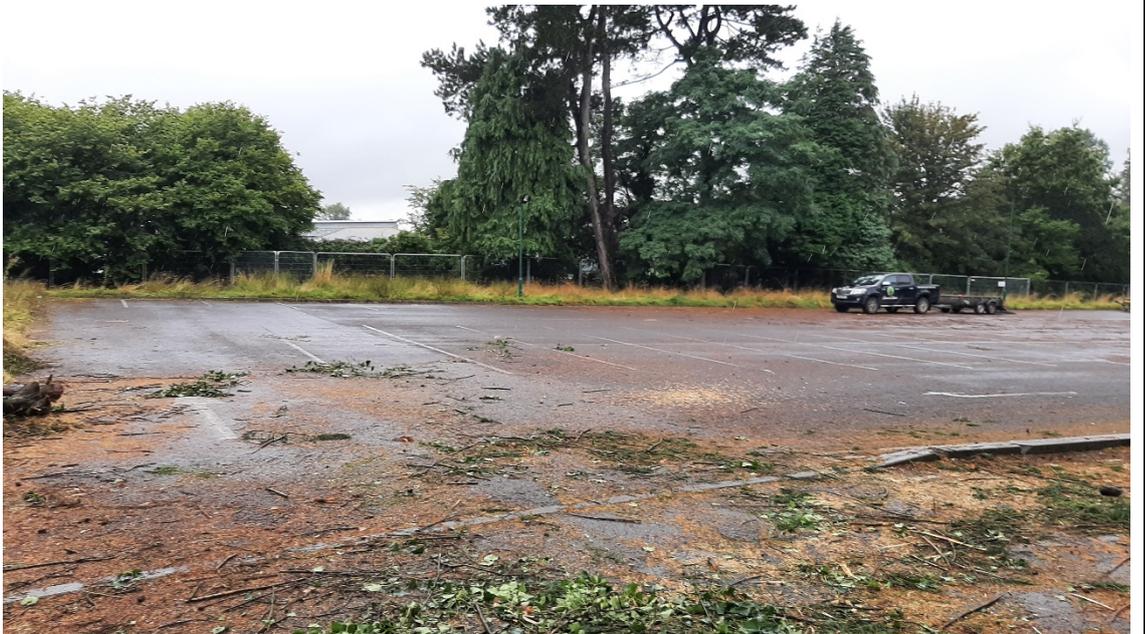
<p><b>Photo No.</b> 24</p>

<p><b>Date:</b> 9<sup>th</sup> Sept 2021</p>	
<p>Further view of western boundary</p>

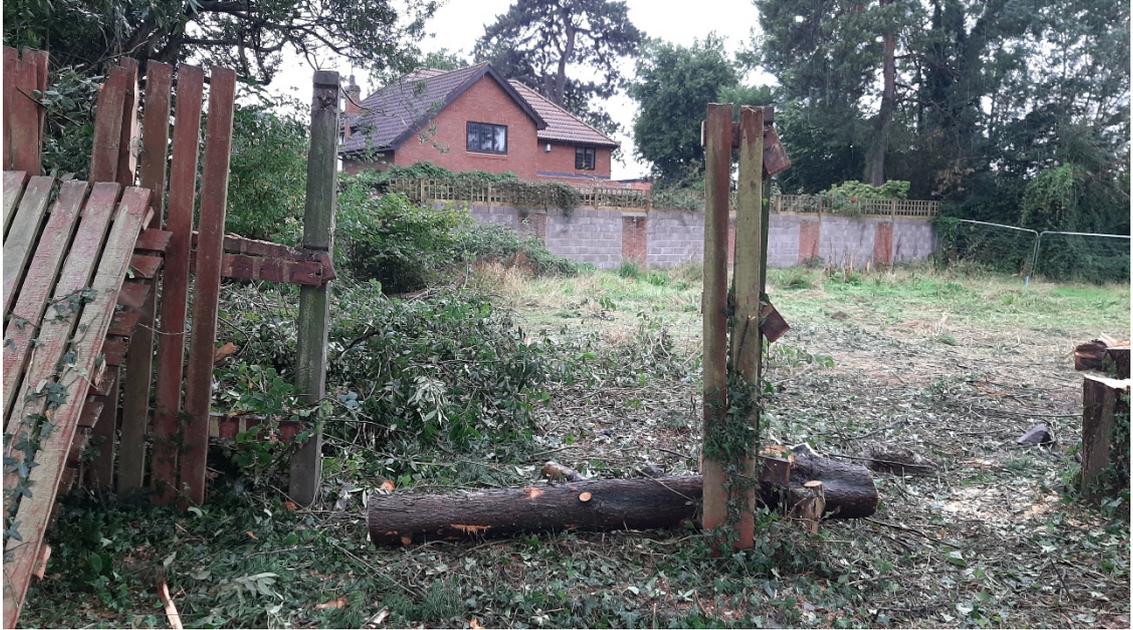
<p><b>Photo No.</b> 25</p>

<p><b>Date:</b> 9<sup>th</sup> Sept 2021</p>	
<p>General view of south western boundary</p>

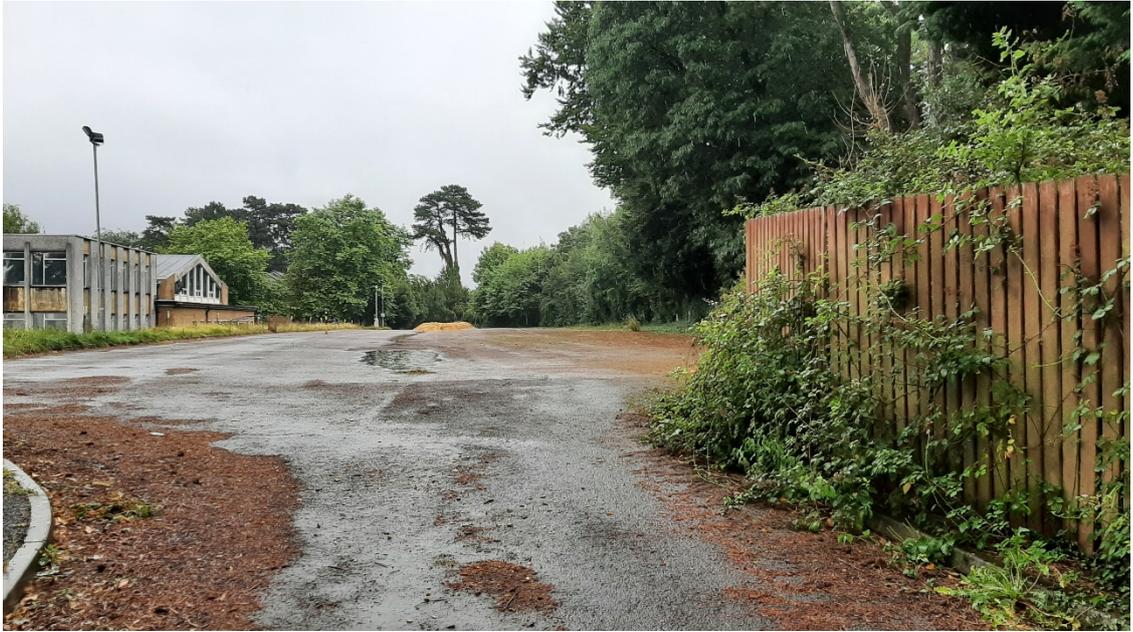
<p><b>Photo No.</b> 26</p>

<p><b>Date:</b> 9<sup>th</sup> Sept 2021</p>	
<p>Further view along southern boundary, looking east</p>

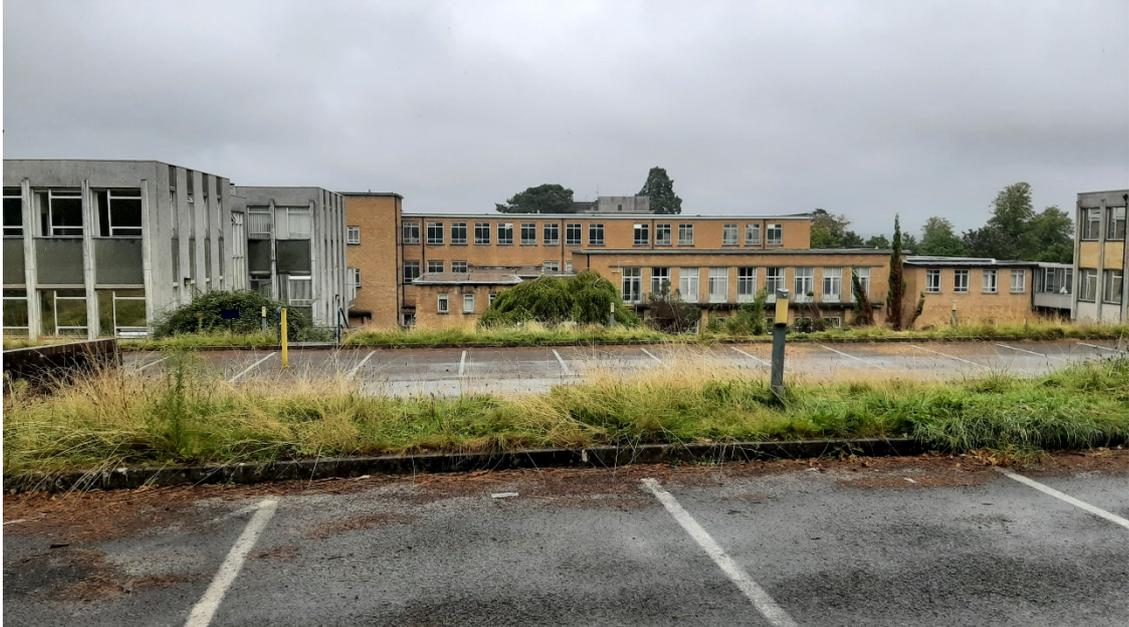
<p><b>Photo No.</b> 27</p>

<p><b>Date:</b> 9<sup>th</sup> Sept 2021</p>	
<p>General view looking north from southern boundary</p>

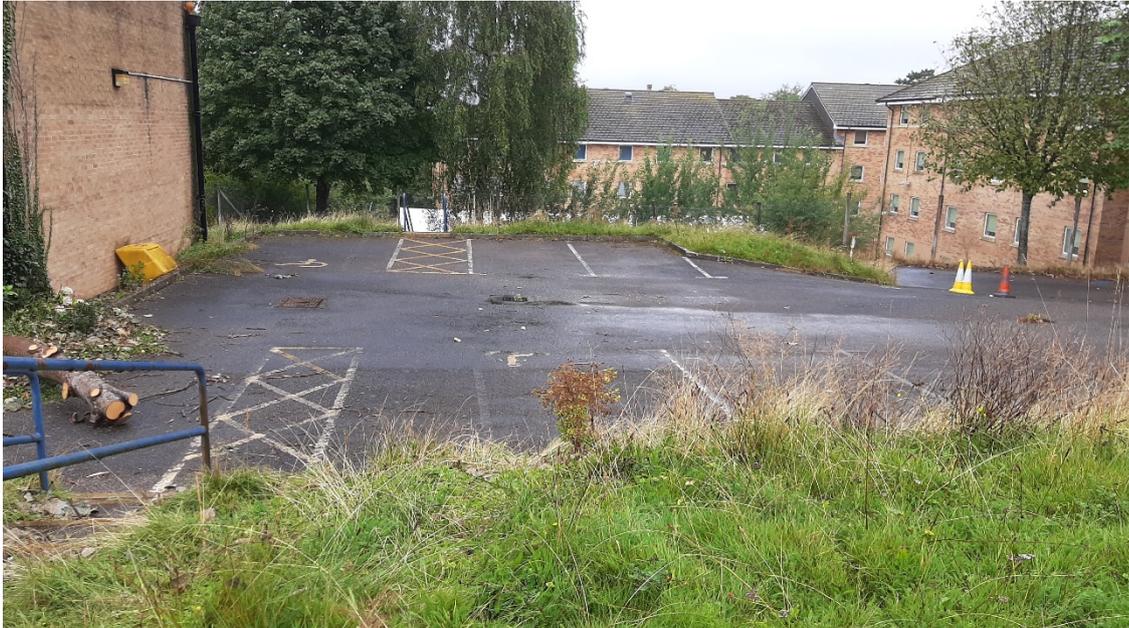
<p><b>Photo No.</b> 28</p>

<p><b>Date:</b> 9<sup>th</sup> Sept 2021</p>	
<p>General view along eastern boundary, university buildings on the right hand side of picture</p>

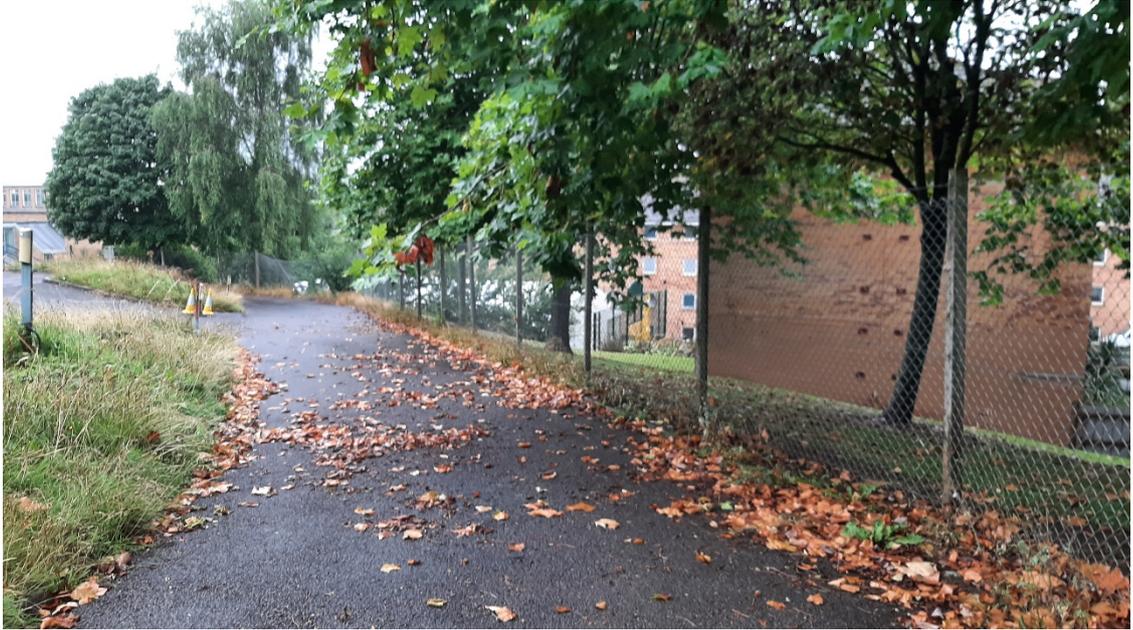
<p><b>Photo No.</b> 29</p>

<p><b>Date:</b> 9<sup>th</sup> Sept 2021</p>	
<p>General view of boundary to university buildings</p>

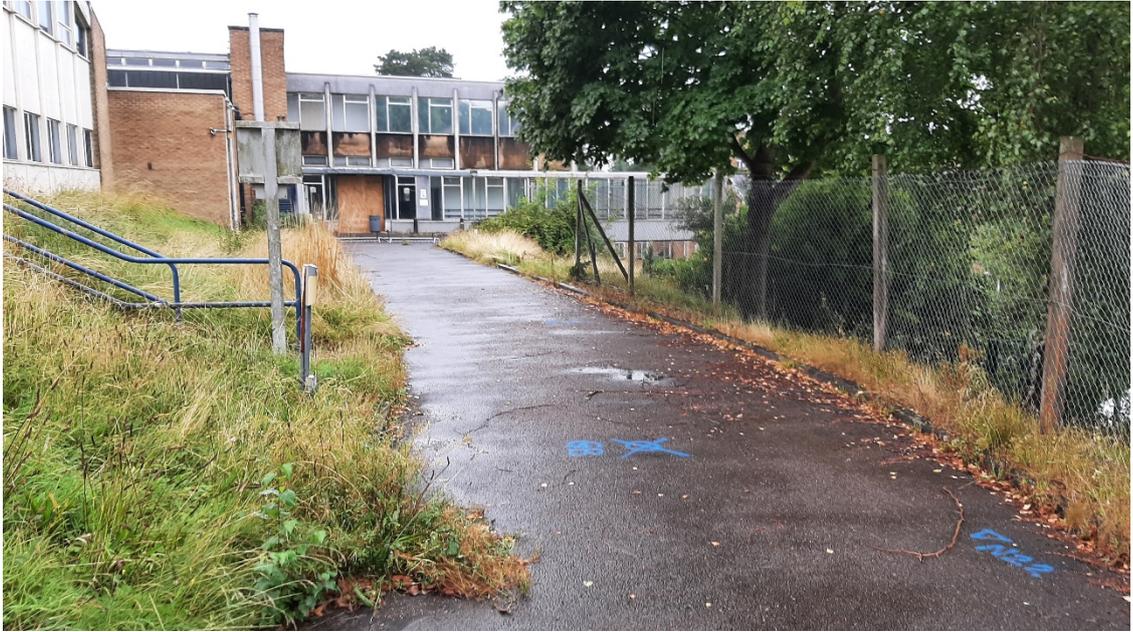
<p><b>Photo No.</b> 30</p>

<p><b>Date:</b> 9<sup>th</sup> Sept 2021</p>	
<p>General view further view along boundary</p>

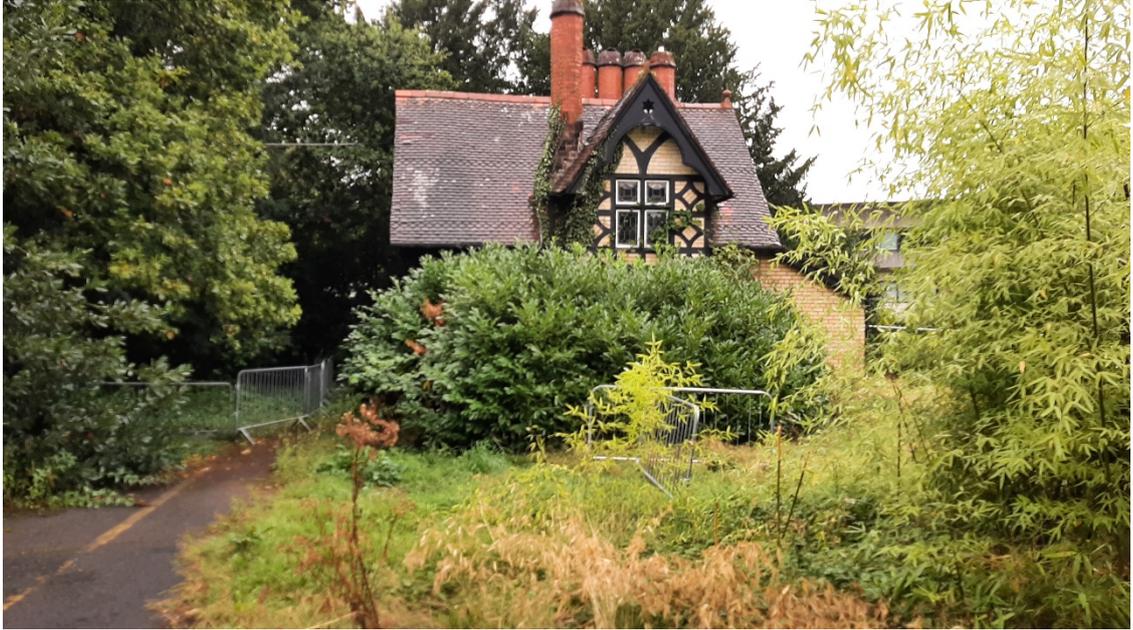
<p><b>Photo No.</b> 31</p>

<p><b>Date:</b> 9<sup>th</sup> Sept 2021</p>	
<p>House within north western part of site, believed to not be part of site</p>
